Profile/Photo Observation Report

| Street: | MAIN ST | Flow Control: | Not Controlled | | |
| City: | Hobart, IN | Year Renewed: | | | |
| US MH: | M-706-018 | DS MH: | M-806-024 | Total Length Surveyed (ft): | 171.4 |

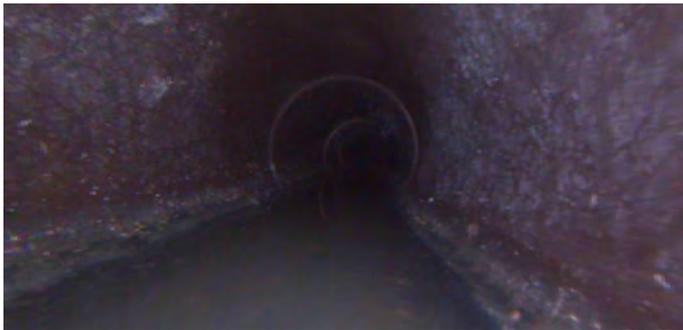
Code: **AMH**
 Description: **Manhole**
 Distance (ft): **.0**
 Structural Grade: **0**
 O&M Grade: **0**
 Clock Start/From:
 Clock To:
 1st Value:
 2nd Value:
 Value Percent:
 Continuous Index:
 Within 8" of Joint: **NO**
 Remarks: **M-706-018**

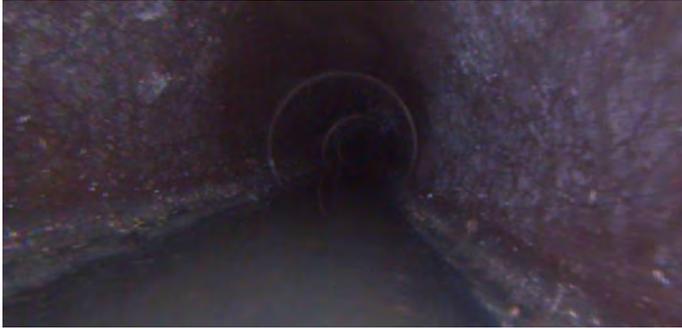
Code: **MWL**
Description: **Water Level**

Distance (ft): **.0**
Structural Grade: **0**
O&M Grade: **0**
Clock Start/From:
Clock To:
1st Value:
2nd Value:
Value Percent: **5.000**
Continuous Index:
Within 8" of Joint: **NO**
Remarks:

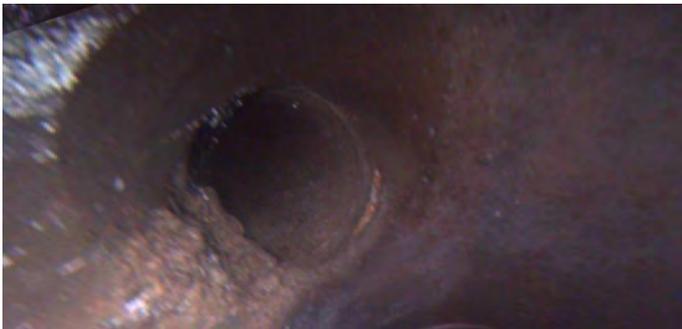
Code: **TF**
Description: **Tap Factory**

Distance (ft): **11.9**
Structural Grade: **0**
O&M Grade: **0**
Clock Start/From: **11**
Clock To:
1st Value: **4.000**
2nd Value:
Value Percent:
Continuous Index:
Within 8" of Joint: **YES**
Remarks:

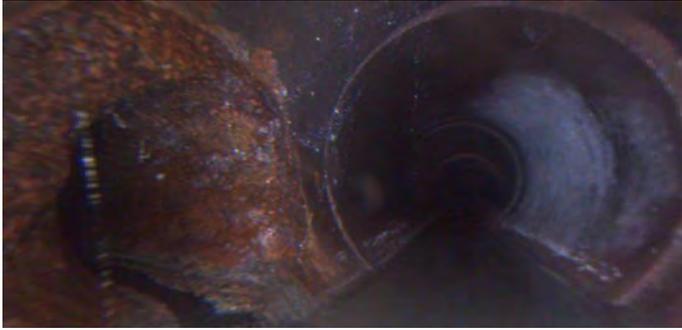
Code: **TB**
Description: **Tap Break-in**

Distance (ft): **24.4**
Structural Grade: **0**
O&M Grade: **0**
Clock Start/From: **9**
Clock To:
1st Value: **6.000**
2nd Value:
Value Percent:
Continuous Index:
Within 8" of Joint:
Remarks:

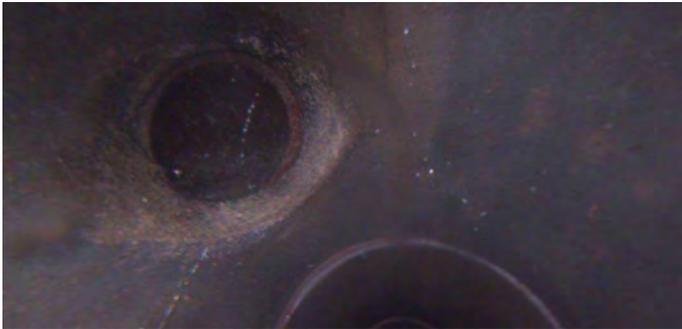
Code: **TF**
Description: **Tap Factory**

Distance (ft): **54.9**
Structural Grade: **0**
O&M Grade: **0**
Clock Start/From: **11**
Clock To:
1st Value: **4.000**
2nd Value:
Value Percent:
Continuous Index:
Within 8" of Joint: **YES**
Remarks:

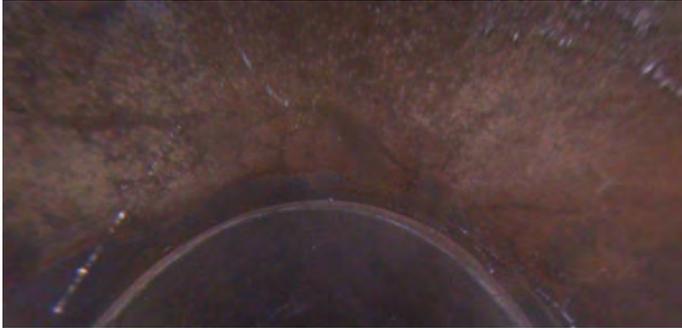
| Position | Code | Observation | Video (sec) | Grade |
|---|---|---|---|---|
| 61.5 | CM | Crack Multiple | 193 | S 3 |

Code: **CM**
Description: **Crack Multiple**

Distance (ft): **61.5**
Structural Grade: **3**
O&M Grade: **0**
Clock Start/From: **10**
Clock To: **2**
1st Value:
2nd Value:
Value Percent:
Continuous Index:
Within 8" of Joint: **YES**
Remarks:

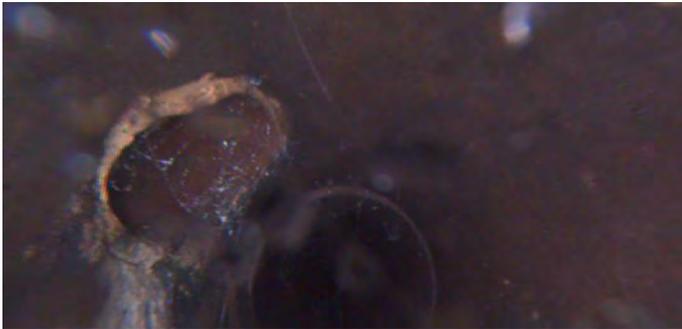
Code: **TB**
Description: **Tap Break-in**

Distance (ft): **105.3**
Structural Grade: **0**
O&M Grade: **0**
Clock Start/From: **10**
Clock To:
1st Value: **4.000**
2nd Value:
Value Percent:
Continuous Index:
Within 8" of Joint: **YES**
Remarks:

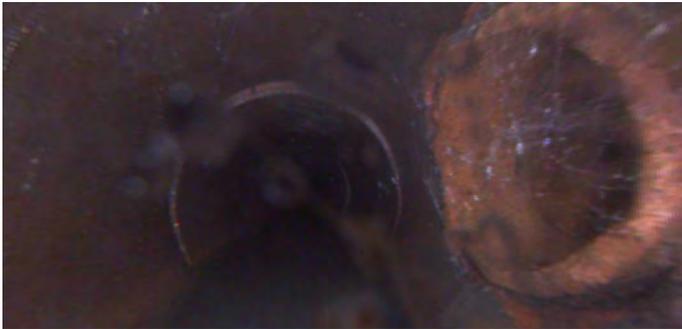
| Position | Code | Observation | Video (sec) | Grade |
|---|---|---|---|---|
| 118.1 | TBI | Tap Break-in Intruding | 341 | M 2 |

Code: **TBI**
Description: **Tap Break-in Intruding**

Distance (ft): **118.1**
Structural Grade: **0**
O&M Grade: **2**
Clock Start/From: **3**
Clock To:
1st Value: **4.000**
2nd Value: **1.000**
Value Percent:
Continuous Index:
Within 8" of Joint: **YES**
Remarks:

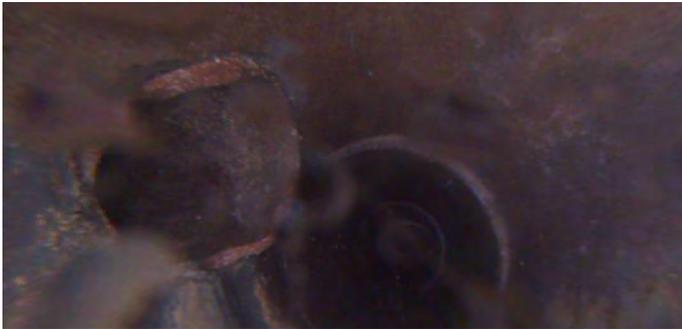
| Position | Code | Observation | Video (sec) | Grade |
|---|---|---|---|---|
| 169.3 | TBI | Tap Break-in Intruding | 467 | M 2 |

Code: **TBI**
Description: **Tap Break-in Intruding**

Distance (ft): **169.3**
Structural Grade: **0**
O&M Grade: **2**
Clock Start/From: **10**
Clock To:
1st Value: **4.000**
2nd Value: **1.000**
Value Percent:
Continuous Index:
Within 8" of Joint: **YES**
Remarks:

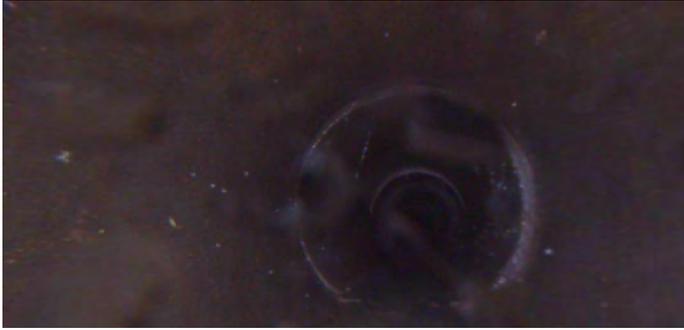
| Code: | MSA |
| Description: | Abandoned Survey |
| Distance (ft): | 171.4 |
| Remarks: | DAE |
