Profile/Photo Observation Report

Date:	02/26/2022	Weather:		Coding:	PACP 7.0
Pipe Length (ft):	373.0	Owner:	City of Hobart	Pre Clean:	Heavy Cleaning
P.O.#:	YES502259	Surveyor:	S. Bucklin	PSR:	P-806-024-018
Customer:	City of Hobart, IN (Red	Clean Date:	02/22/2022	Shape:	C

Street:	South Main Street	Flow Control:	Not Controlled
City:	Hobart, IN	Year Renewed:	
Location:	Local rural streets with light traffic, t	Tape/Media #:	
Purpose:	Routine Assessment	Dia/Height:	12"
Use:	Sanitary Sewage Pipe	Material:	VCP
Drain Area:		Lining:	None
Category:	NA		
Comment:			
Location Details:		Direction of Survey:	Downstream
US MH:	M-706-018	DS MH:	M-806-024
		Total Length Surveyed (ft):	368.5

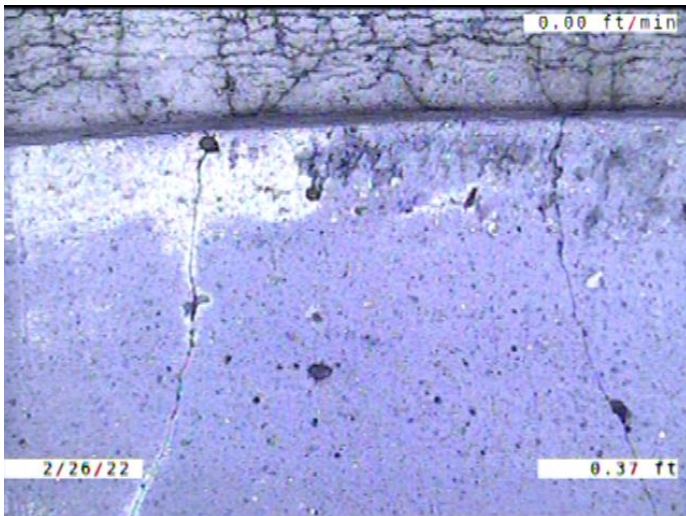
Code: **CM**
Description: **Crack Multiple**

Distance (ft): **.4**
Structural Grade: **3**
O&M Grade: **0**
Clock Start/From: **8**
Clock To: **4**
1st Value:
2nd Value:
Value Percent:
Continuous Index: **S01**
Within 8" of Joint: **YES**
Remarks:

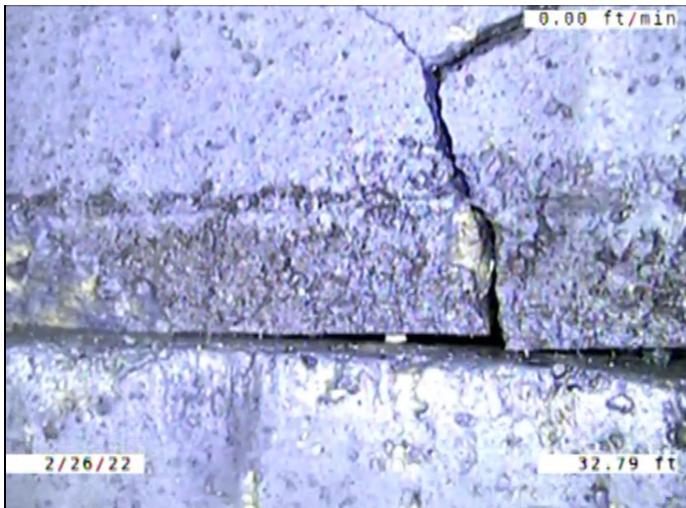
Code: **B**
 Description: **Broken**

Distance (ft): **32.8**
 Structural Grade: **4**
 O&M Grade: **0**
 Clock Start/From: **8**
 Clock To:
 1st Value:
 2nd Value:
 Value Percent:
 Continuous Index:
 Within 8" of Joint: **YES**
 Remarks:

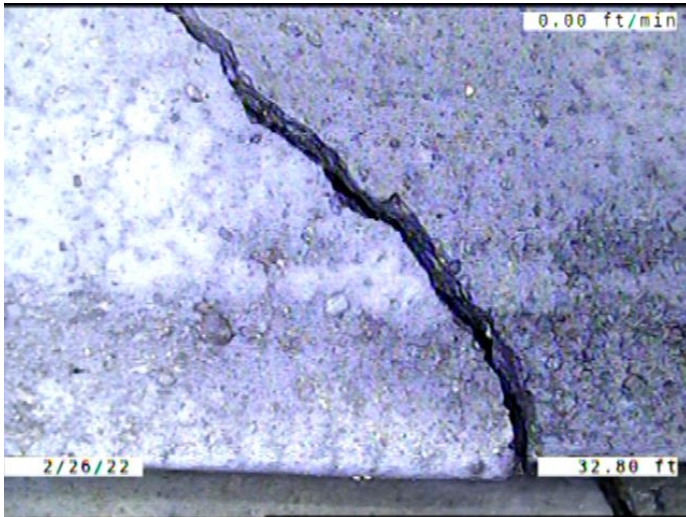
Code: **B**
Description: **Broken**

Distance (ft): **32.8**
Structural Grade: **4**
O&M Grade: **0**
Clock Start/From: **2**
Clock To: **4**
1st Value:
2nd Value:
Value Percent:
Continuous Index:
Within 8" of Joint: **YES**
Remarks:

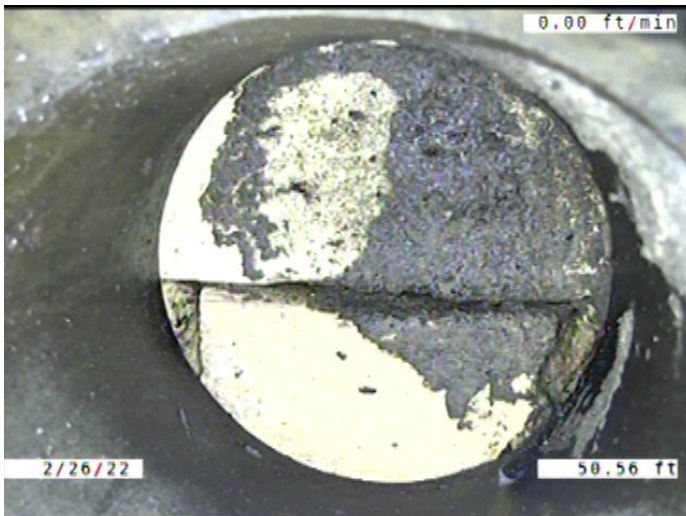
Code: **TFD**
Description: **Tap Factory Defective**

Distance (ft): **50.6**
Structural Grade: **0**
O&M Grade: **3**
Clock Start/From: **2**
Clock To:
1st Value: **6.000**
2nd Value:
Value Percent:
Continuous Index:
Within 8" of Joint: **YES**
Remarks: **CRACKED. CAPPED. CAP BROKEN.**

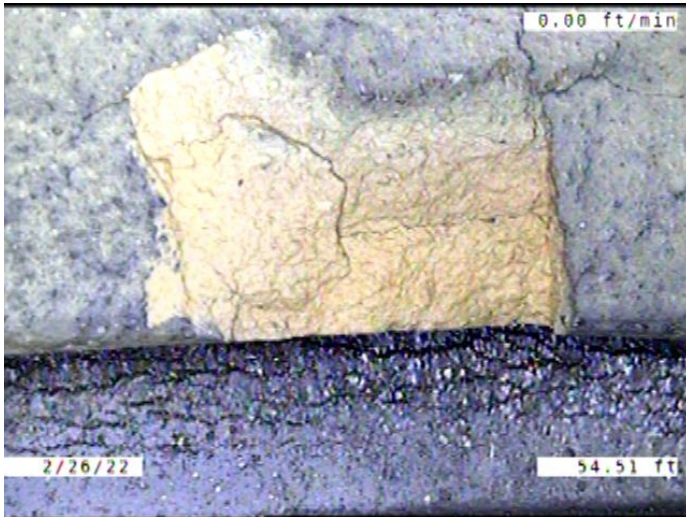
Code: **SZ**
 Description: **Surface Damage Other**

Distance (ft): **54.5**
 Structural Grade: **0**
 O&M Grade: **0**
 Clock Start/From: **10**
 Clock To:
 1st Value:
 2nd Value:
 Value Percent:
 Continuous Index:
 Within 8" of Joint: **YES**
 Remarks: **A PIECE CHIPPED AWAY FROM THE JOINT.**

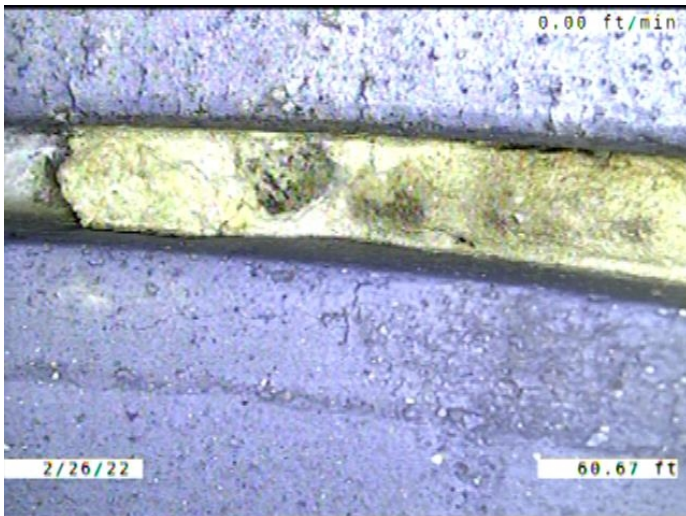
Code: **JAM**
 Description: **Joint Angular Medium**

Distance (ft): **60.7**
 Structural Grade: **3**
 O&M Grade: **0**
 Clock Start/From:
 Clock To:
 1st Value:
 2nd Value:
 Value Percent:
 Continuous Index:
 Within 8" of Joint: **NO**
 Remarks:

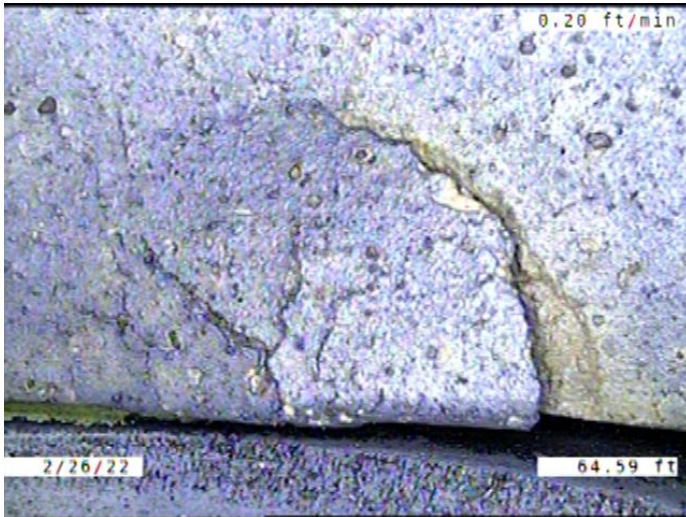
Code: **B**
Description: **Broken**

Distance (ft): **64.6**
Structural Grade: **4**
O&M Grade: **0**
Clock Start/From: **2**
Clock To:
1st Value:
2nd Value:
Value Percent:
Continuous Index:
Within 8" of Joint: **YES**
Remarks:

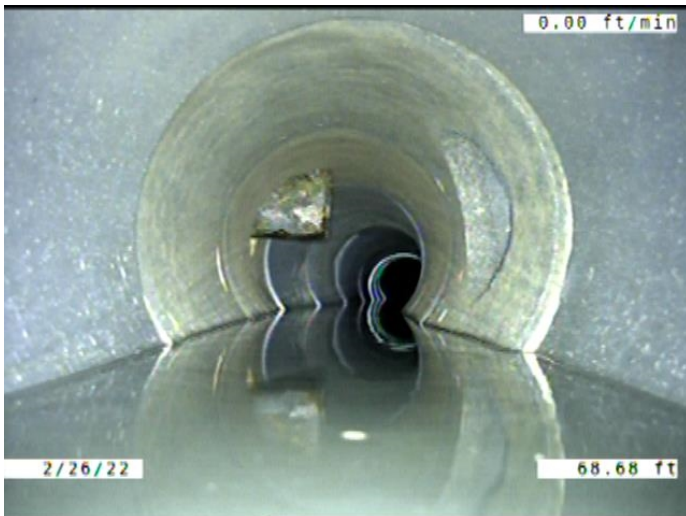
Code: **MWLS**
Description: **Miscellaneous Water Level Sag**

Distance (ft): **68.7**
Structural Grade: **2**
O&M Grade: **0**
Clock Start/From:
Clock To:
1st Value:
2nd Value:
Value Percent: **15.000**
Continuous Index:
Within 8" of Joint: **NO**
Remarks:

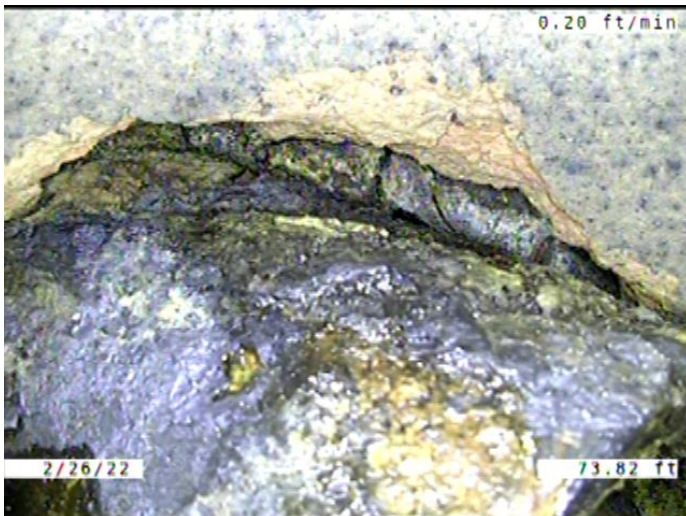
Code: **SSS**
 Description: **Surface Damage Surface Spalling**

Distance (ft): **73.8**
 Structural Grade: **2**
 O&M Grade: **0**
 Clock Start/From: **9**
 Clock To: **12**
 1st Value:
 2nd Value:
 Value Percent:
 Continuous Index:
 Within 8" of Joint: **YES**
 Remarks:

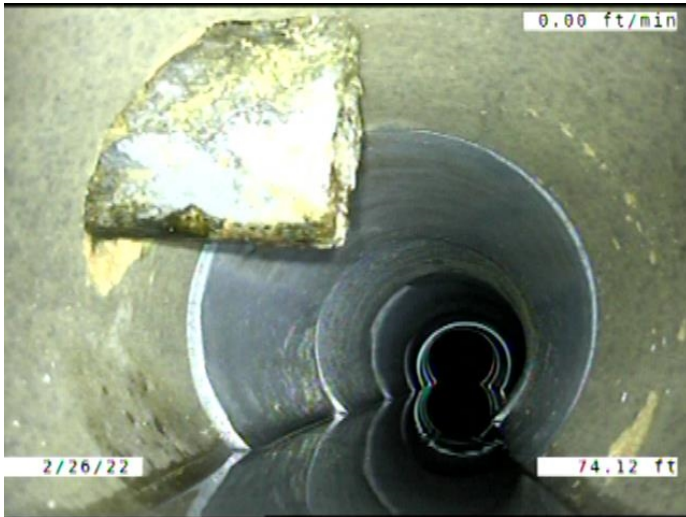
Code: **TBI**
 Description: **Tap Break-in Intruding**

Distance (ft): **74.1**
 Structural Grade: **0**
 O&M Grade: **2**
 Clock Start/From: **11**
 Clock To:
 1st Value: **4.000**
 2nd Value: **5.000**
 Value Percent:
 Continuous Index:
 Within 8" of Joint: **YES**
 Remarks:

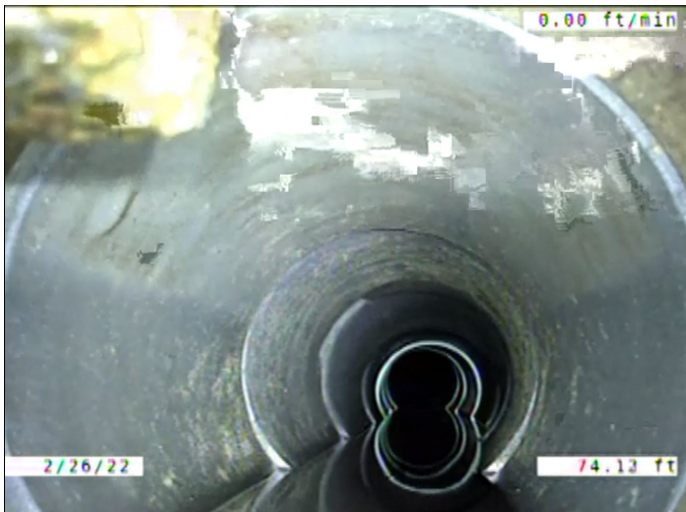
Code: **SZ**
 Description: **Surface Damage Other**

Distance (ft): **74.1**
 Structural Grade: **0**
 O&M Grade: **0**
 Clock Start/From: **10**
 Clock To:
 1st Value:
 2nd Value:
 Value Percent:
 Continuous Index:
 Within 8" of Joint: **NO**
 Remarks: **Indentation, Factory defect**

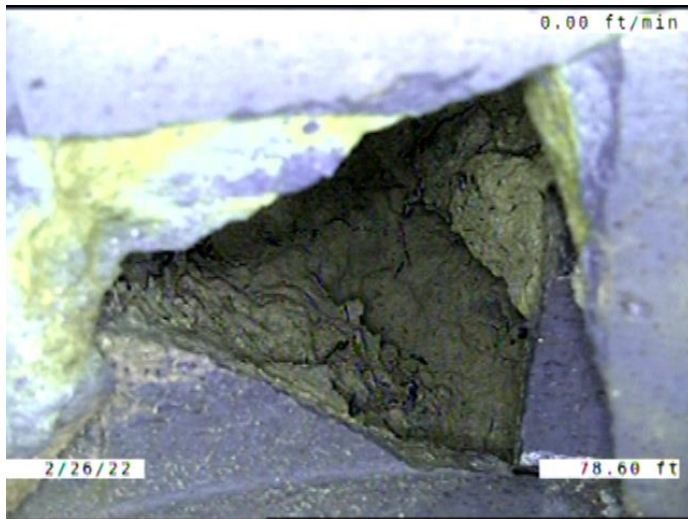
Code: **HVV**
Description: **Hole Void Visible**

Distance (ft): **78.6**
Structural Grade: **5**
O&M Grade: **0**
Clock Start/From: **9**
Clock To: **3**
1st Value:
2nd Value:
Value Percent:
Continuous Index:
Within 8" of Joint: **YES**
Remarks: **SOIL VISIBLE TOO**

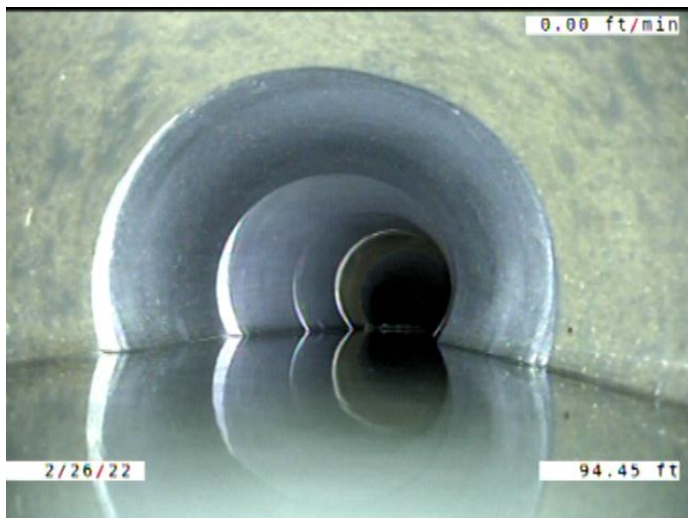
Code: **MWLS**
 Description: **Miscellaneous Water Level Sag**

Distance (ft): **94.5**
 Structural Grade: **2**
 O&M Grade: **0**
 Clock Start/From:
 Clock To:
 1st Value:
 2nd Value:
 Value Percent: **15.000**
 Continuous Index: **S03**
 Within 8" of Joint: **NO**
 Remarks:

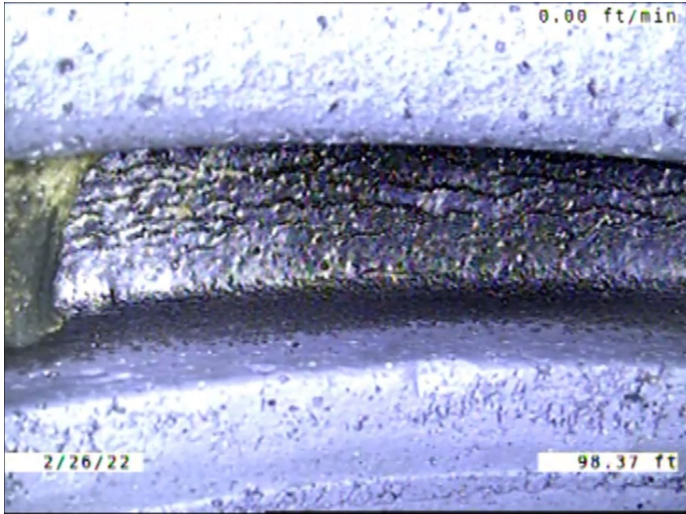
Code: **CM**
Description: **Crack Multiple**

Distance (ft): **98.4**
Structural Grade: **3**
O&M Grade: **0**
Clock Start/From: **8**
Clock To: **10**
1st Value:
2nd Value:
Value Percent:
Continuous Index:
Within 8" of Joint: **YES**
Remarks:

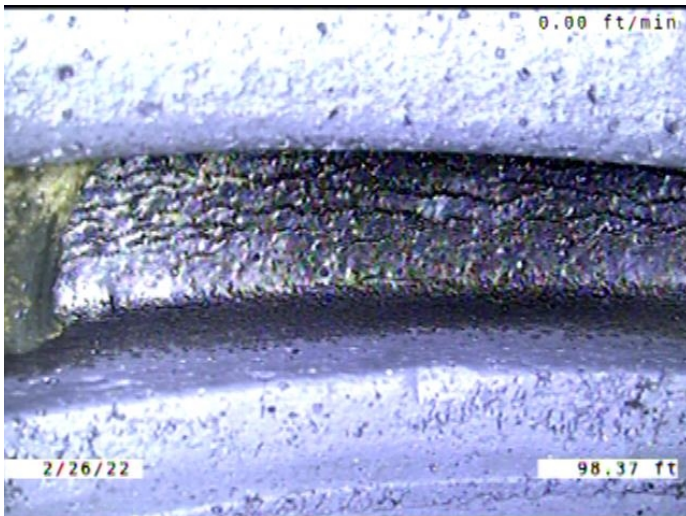
Code: **JAL**
Description: **Joint Angular Large**

Distance (ft): **98.4**
Structural Grade: **4**
O&M Grade: **0**
Clock Start/From:
Clock To:
1st Value:
2nd Value:
Value Percent:
Continuous Index:
Within 8" of Joint: **NO**
Remarks:

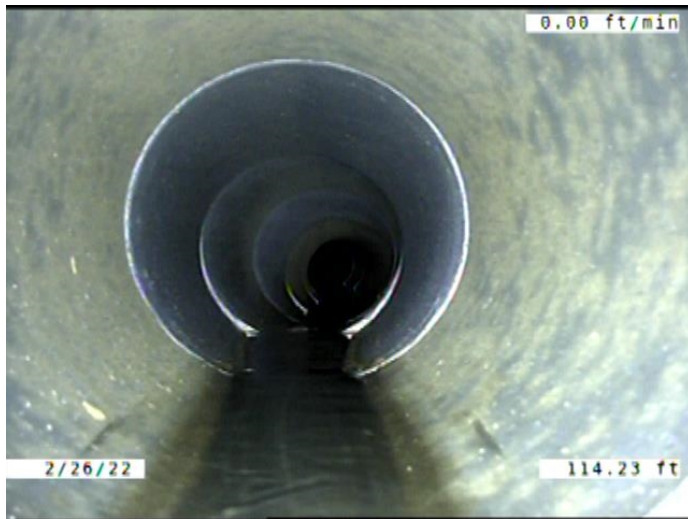
Code: **MWLS**
 Description: **Miscellaneous Water Level Sag**

Distance (ft): **114.2**
 Structural Grade: **2**
 O&M Grade: **0**
 Clock Start/From:
 Clock To:
 1st Value:
 2nd Value:
 Value Percent: **15.000**
 Continuous Index: **F03**
 Within 8" of Joint: **NO**
 Remarks:

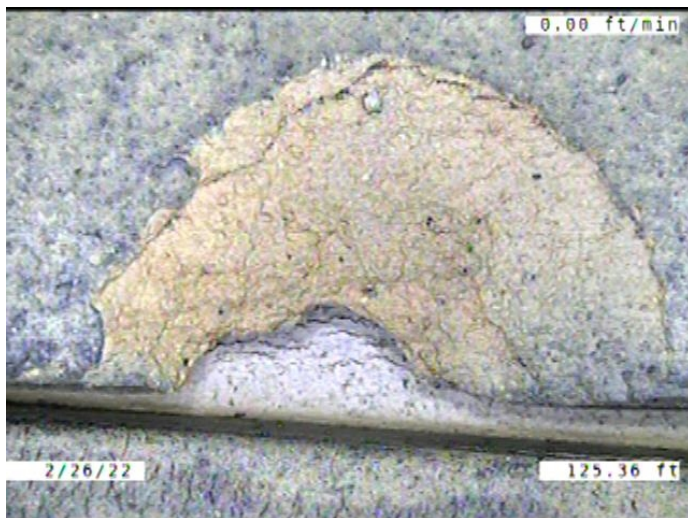
Code: **SZ**
 Description: **Surface Damage Other**

Distance (ft): **125.4**
 Structural Grade: **0**
 O&M Grade: **0**
 Clock Start/From: **12**
 Clock To:
 1st Value:
 2nd Value:
 Value Percent:
 Continuous Index:
 Within 8" of Joint: **YES**
 Remarks: **A PIECE CHIPPED AWAY FROM THE JOINT.**

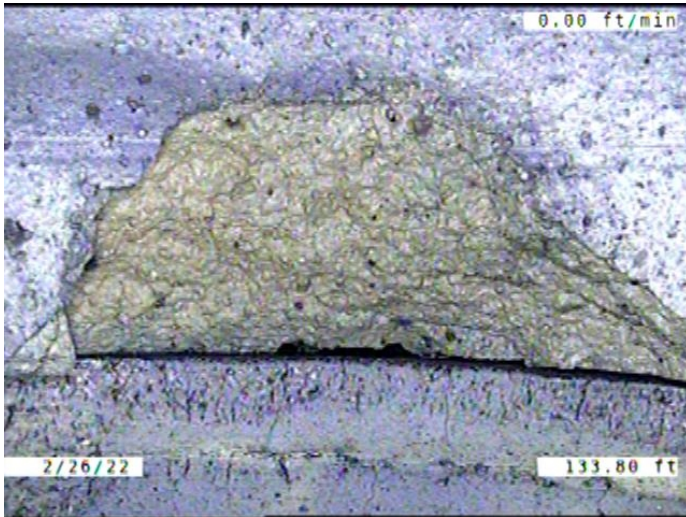
Code:	SZ
Description:	Surface Damage Other
Distance (ft):	133.8
Structural Grade:	0
O&M Grade:	0
Clock Start/From:	12
Clock To:	
1st Value:	
2nd Value:	
Value Percent:	
Continuous Index:	
Within 8" of Joint:	YES
Remarks:	A PIECE CHIPPED AWAY FROM THE JOINT.

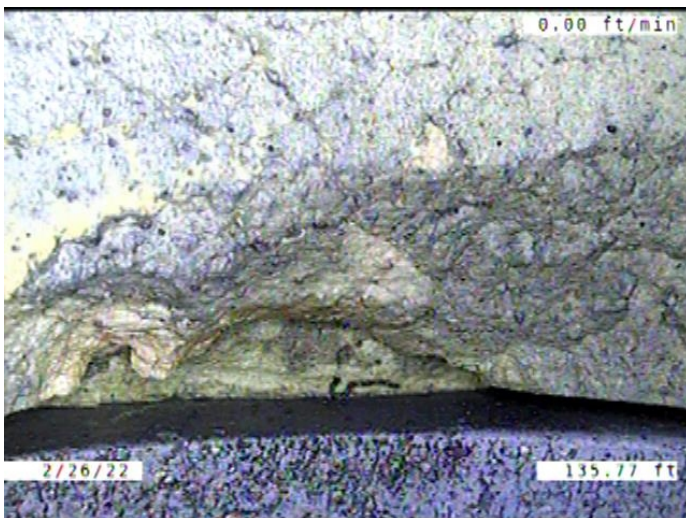
Code:	SZ
Description:	Surface Damage Other
Distance (ft):	135.8
Structural Grade:	0
O&M Grade:	0
Clock Start/From:	8
Clock To:	9
1st Value:	
2nd Value:	
Value Percent:	
Continuous Index:	
Within 8" of Joint:	YES
Remarks:	A PIECE CHIPPED AWAY FROM THE JOINT.

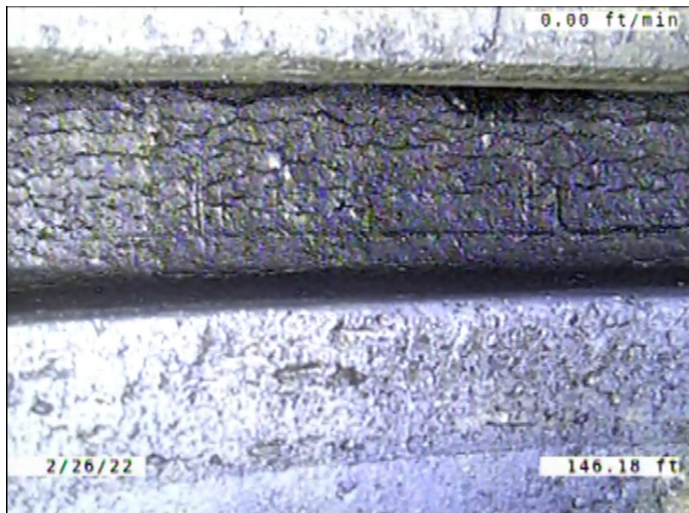
Code: **CM**
Description: **Crack Multiple**

Distance (ft): **146.2**
Structural Grade: **3**
O&M Grade: **0**
Clock Start/From: **8**
Clock To: **10**
1st Value:
2nd Value:
Value Percent:
Continuous Index:
Within 8" of Joint: **YES**
Remarks:

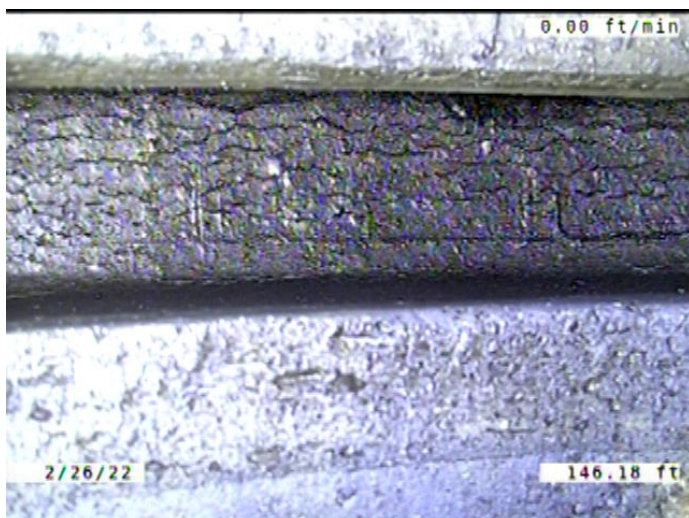
Code: **JAL**
Description: **Joint Angular Large**

Distance (ft): **146.2**
Structural Grade: **4**
O&M Grade: **0**
Clock Start/From:
Clock To:
1st Value:
2nd Value:
Value Percent:
Continuous Index:
Within 8" of Joint: **NO**
Remarks:

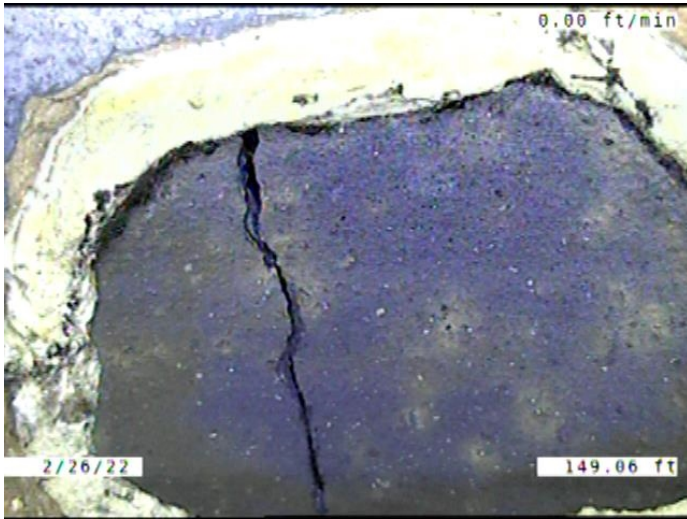
Code: **TBD**
Description: **Tap Break-in/Hammer Defective**

Distance (ft): **149.1**
Structural Grade: **0**
O&M Grade: **3**
Clock Start/From: **12**
Clock To:
1st Value: **4.000**
2nd Value:
Value Percent:
Continuous Index:
Within 8" of Joint: **NO**
Remarks: **Capped, Cap broken**

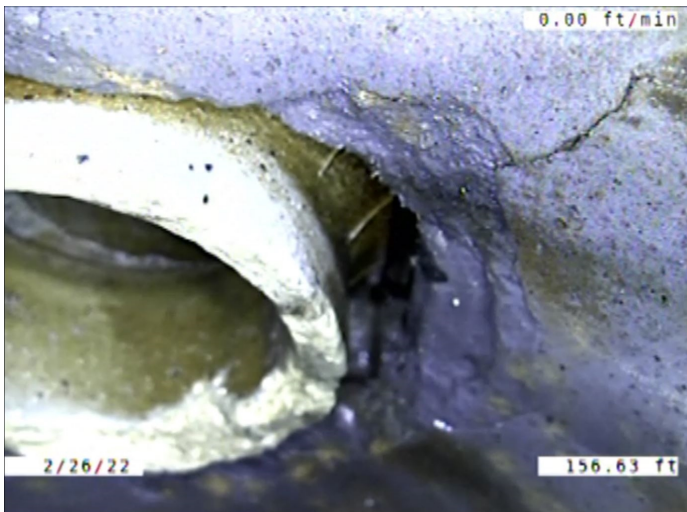
Code: **SSS**
Description: **Surface Damage Surface Spalling**

Distance (ft): **156.6**
Structural Grade: **2**
O&M Grade: **0**
Clock Start/From: **2**
Clock To: **4**
1st Value:
2nd Value:
Value Percent:
Continuous Index:
Within 8" of Joint: **NO**
Remarks:

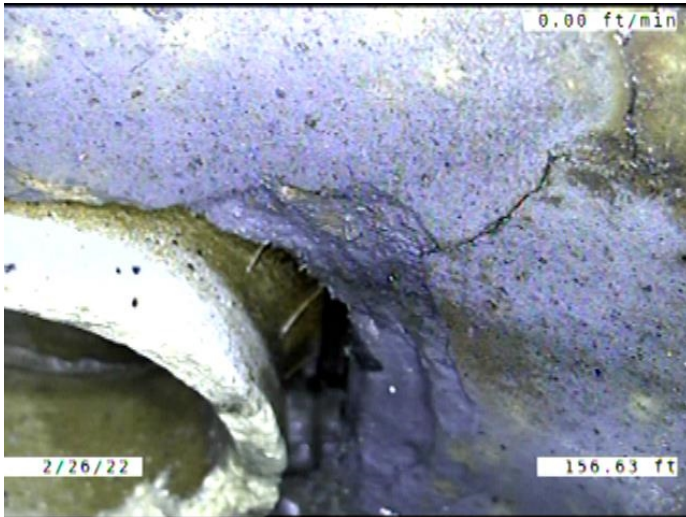
Code: **FM**
Description: **Fracture Multiple**

Distance (ft): **156.6**
Structural Grade: **4**
O&M Grade: **0**
Clock Start/From: **12**
Clock To: **4**
1st Value:
2nd Value:
Value Percent:
Continuous Index:
Within 8" of Joint: **YES**
Remarks:

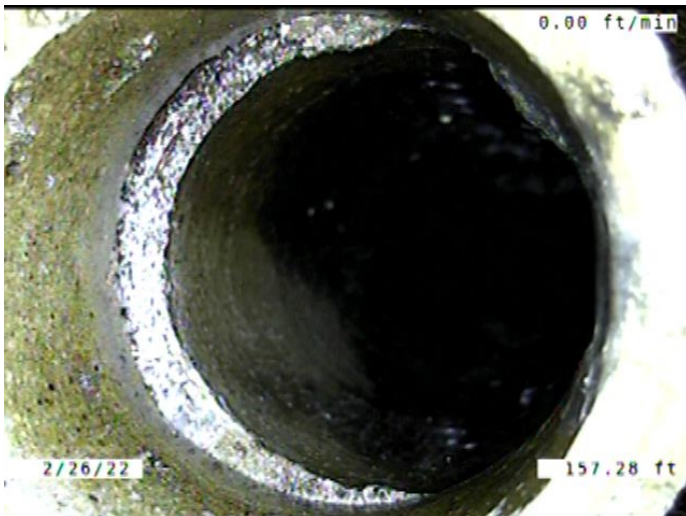
Code: **TBI**
Description: **Tap Break-in Intruding**

Distance (ft): **157.3**
Structural Grade: **0**
O&M Grade: **2**
Clock Start/From: **3**
Clock To:
1st Value: **4.000**
2nd Value: **1.000**
Value Percent:
Continuous Index:
Within 8" of Joint: **YES**
Remarks:

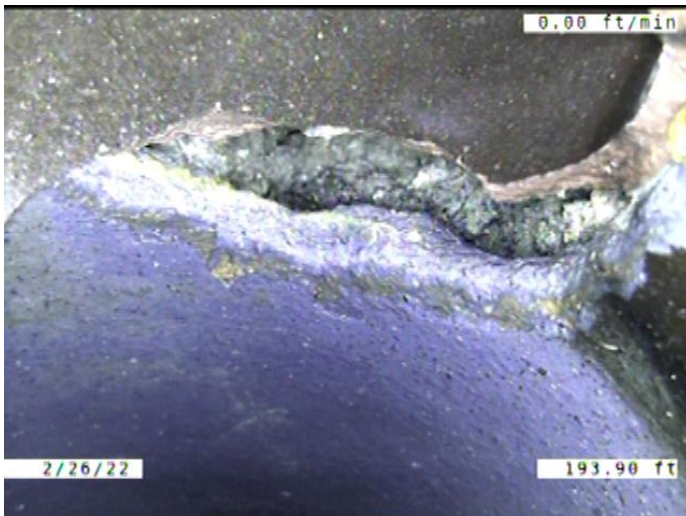
Code: **SSS**
 Description: **Surface Damage Surface Spalling**

Distance (ft): **193.9**
 Structural Grade: **2**
 O&M Grade: **0**
 Clock Start/From: **1**
 Clock To: **3**
 1st Value:
 2nd Value:
 Value Percent:
 Continuous Index:
 Within 8" of Joint: **NO**
 Remarks:

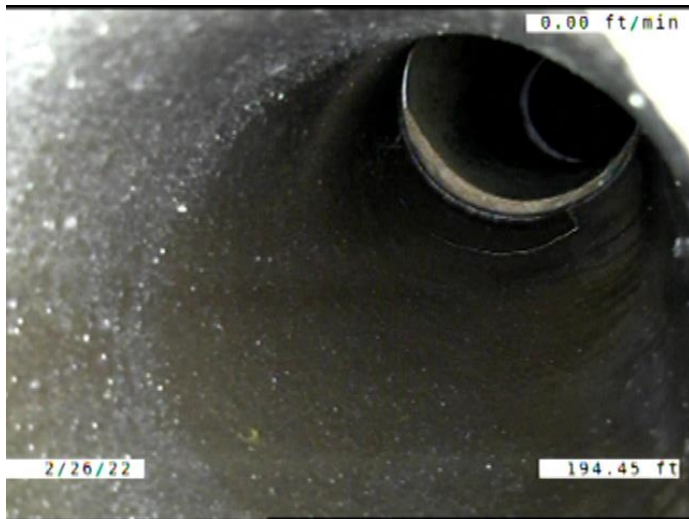
Code: **TBI**
Description: **Tap Break-in Intruding**

Distance (ft): **194.4**
Structural Grade: **0**
O&M Grade: **2**
Clock Start/From: **2**
Clock To:
1st Value: **6.000**
2nd Value: **2.000**
Value Percent:
Continuous Index:
Within 8" of Joint: **NO**
Remarks:

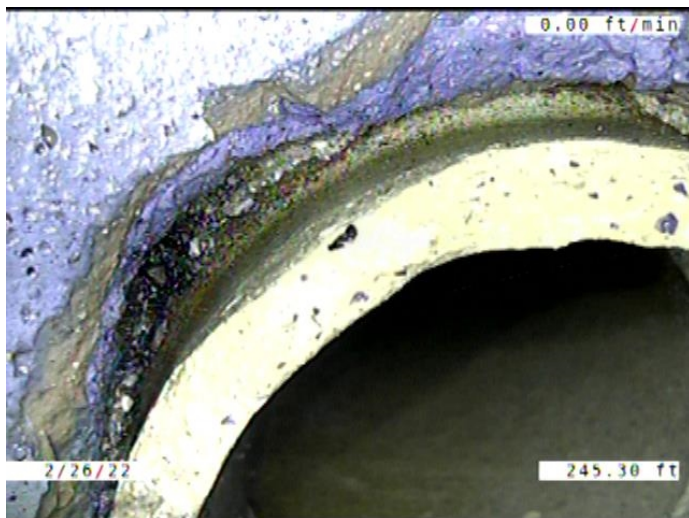
Code: **SSS**
 Description: **Surface Damage Surface Spalling**

Distance (ft): **245.3**
 Structural Grade: **2**
 O&M Grade: **0**
 Clock Start/From: **9**
 Clock To: **11**
 1st Value:
 2nd Value:
 Value Percent:
 Continuous Index:
 Within 8" of Joint: **NO**
 Remarks:

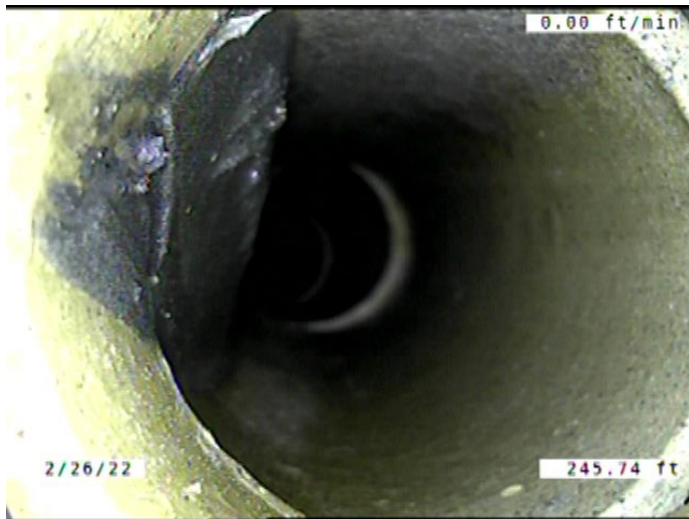
Code: **TBI**
 Description: **Tap Break-in Intruding**

Distance (ft): **245.7**
 Structural Grade: **0**
 O&M Grade: **2**
 Clock Start/From: **10**
 Clock To:
 1st Value: **4.000**
 2nd Value: **1.000**
 Value Percent:
 Continuous Index:
 Within 8" of Joint: **NO**
 Remarks:

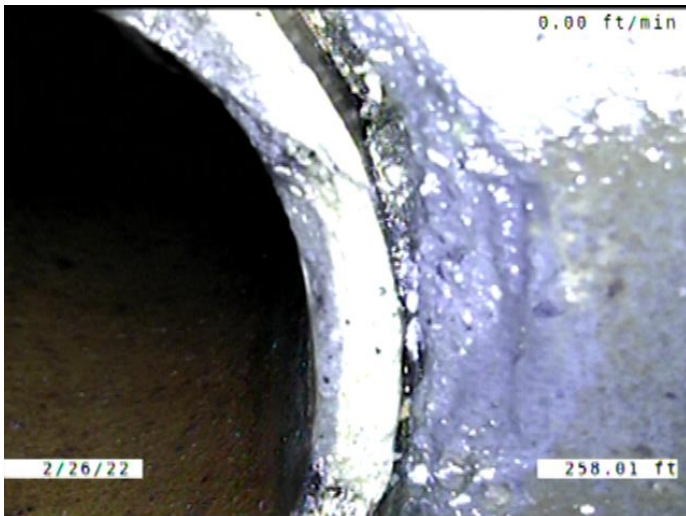
Code: **B**
 Description: **Broken**

Distance (ft): **258.0**
 Structural Grade: **4**
 O&M Grade: **0**
 Clock Start/From: **1**
 Clock To: **3**
 1st Value:
 2nd Value:
 Value Percent:
 Continuous Index:
 Within 8" of Joint: **YES**
 Remarks:

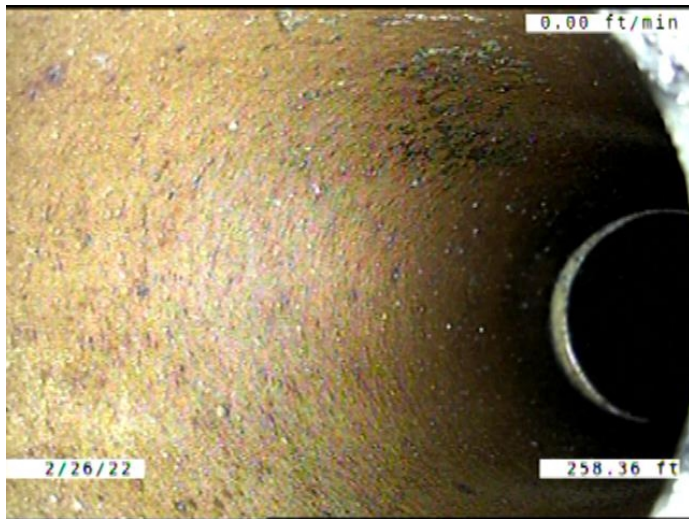
Code: **TBI**
 Description: **Tap Break-in Intruding**

Distance (ft): **258.4**
 Structural Grade: **0**
 O&M Grade: **2**
 Clock Start/From: **2**
 Clock To:
 1st Value: **6.000**
 2nd Value: **1.000**
 Value Percent:
 Continuous Index:
 Within 8" of Joint: **YES**
 Remarks:

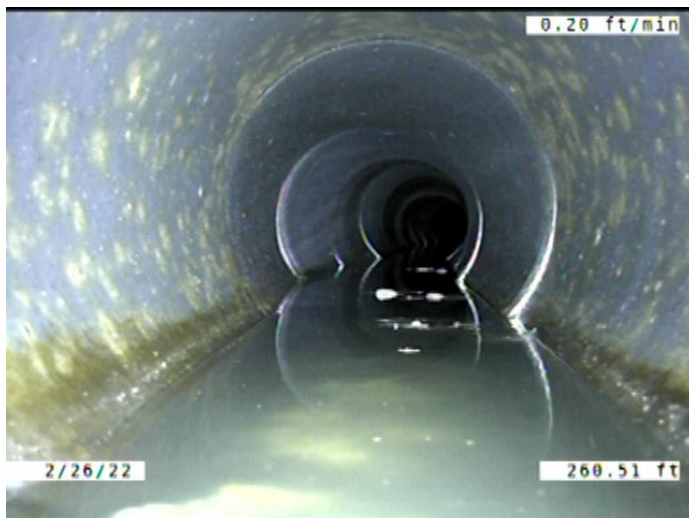
Code: **DSF**
 Description: **Deposits Settled Fine**

Distance (ft): **260.5**
 Structural Grade: **0**
 O&M Grade: **2**
 Clock Start/From: **5**
 Clock To: **7**
 1st Value:
 2nd Value:
 Value Percent: **5.000**
 Continuous Index: **S04**
 Within 8" of Joint: **YES**
 Remarks:

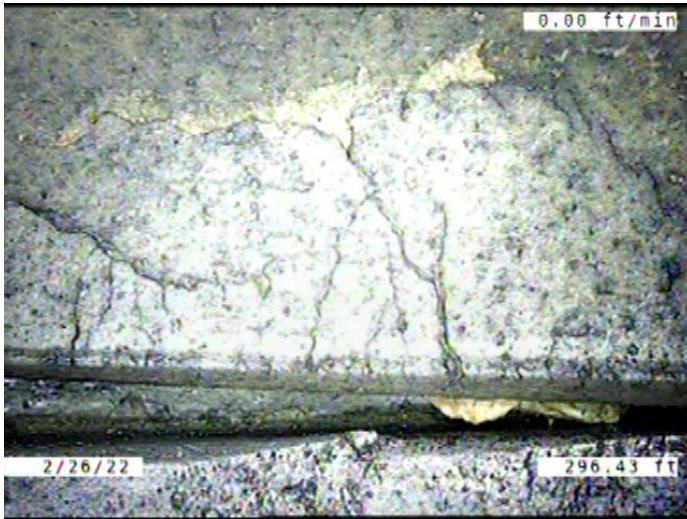
Code: **FM**
 Description: **Fracture Multiple**

Distance (ft): **296.4**
 Structural Grade: **4**
 O&M Grade: **0**
 Clock Start/From: **11**
 Clock To: **2**
 1st Value:
 2nd Value:
 Value Percent:
 Continuous Index:
 Within 8" of Joint: **YES**
 Remarks:

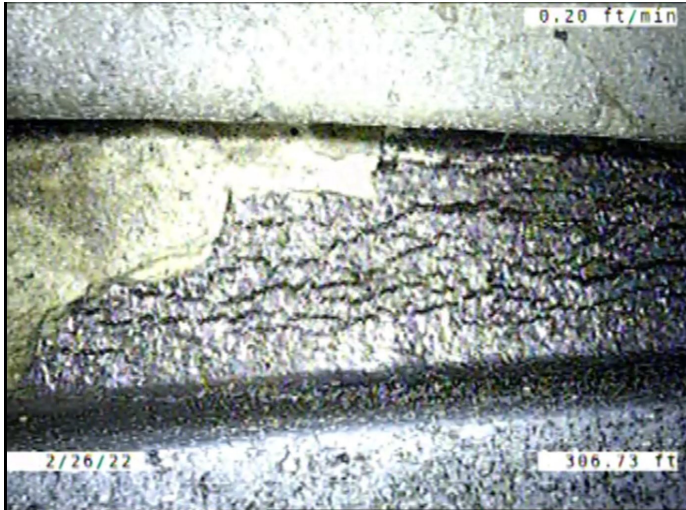
Code: **CM**
Description: **Crack Multiple**

Distance (ft): **306.7**
Structural Grade: **3**
O&M Grade: **0**
Clock Start/From: **8**
Clock To: **10**
1st Value:
2nd Value:
Value Percent:
Continuous Index:
Within 8" of Joint: **YES**
Remarks:

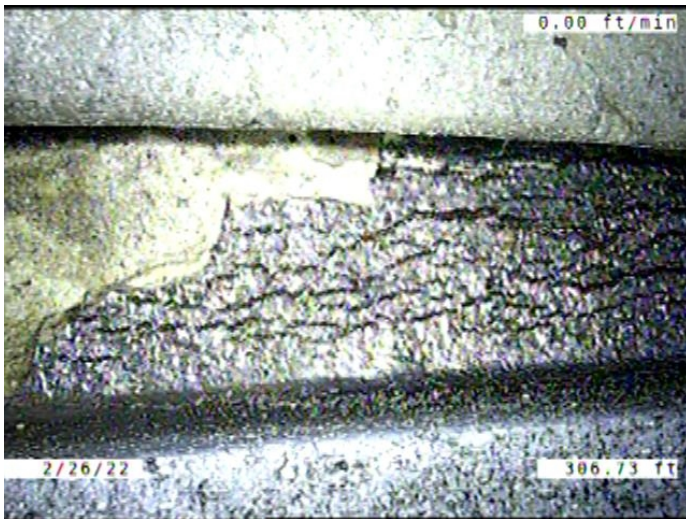
Code: **JAL**
Description: **Joint Angular Large**

Distance (ft): **306.7**
Structural Grade: **4**
O&M Grade: **0**
Clock Start/From:
Clock To:
1st Value:
2nd Value:
Value Percent:
Continuous Index:
Within 8" of Joint: **NO**
Remarks:

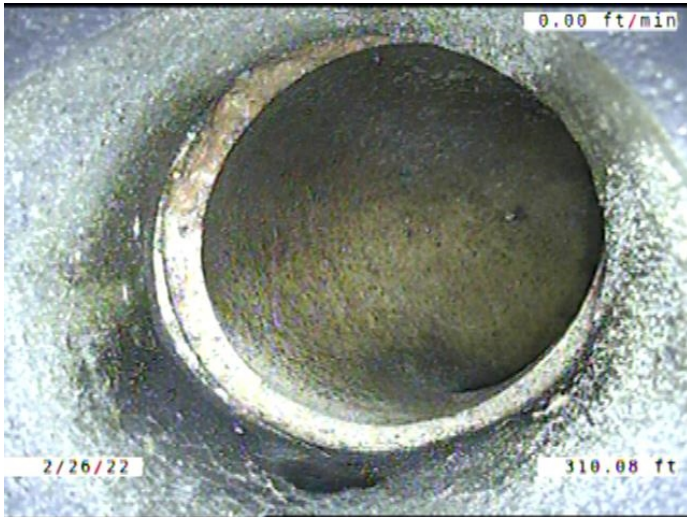
Code: **TF**
 Description: **Tap Factory**

Distance (ft): **310.1**
 Structural Grade: **0**
 O&M Grade: **0**
 Clock Start/From: **1**
 Clock To:
 1st Value: **6.000**

2nd Value:
 Value Percent:
 Continuous Index:
 Within 8" of Joint: **YES**
 Remarks: **SERVICE LINE SEPERATED FROM THE MAIN. SOIL VISIBLE**

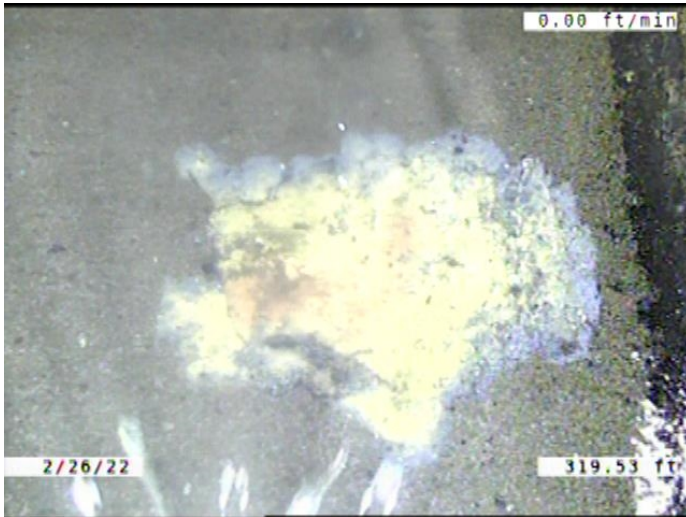
Code: **SSS**
Description: **Surface Damage Surface Spalling**

Distance (ft): **319.5**
Structural Grade: **2**
O&M Grade: **0**
Clock Start/From: **6**
Clock To:
1st Value:
2nd Value:
Value Percent:
Continuous Index:
Within 8" of Joint: **YES**
Remarks:

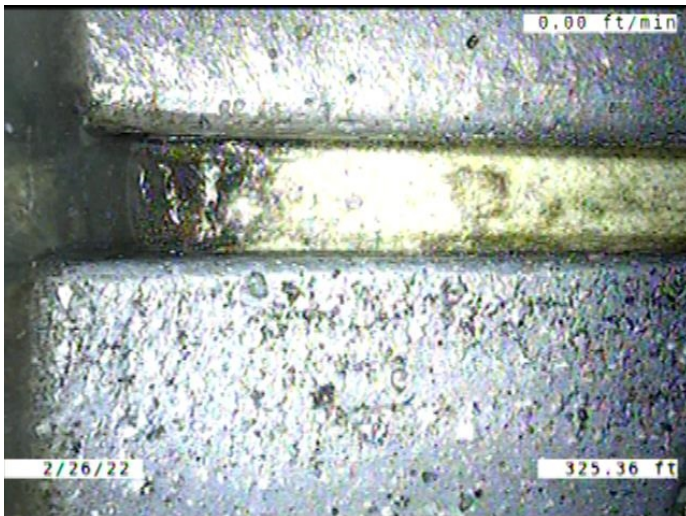
Code: **JAM**
Description: **Joint Angular Medium**

Distance (ft): **325.4**
Structural Grade: **3**
O&M Grade: **0**
Clock Start/From:
Clock To:
1st Value:
2nd Value:
Value Percent:
Continuous Index:
Within 8" of Joint: **NO**
Remarks:

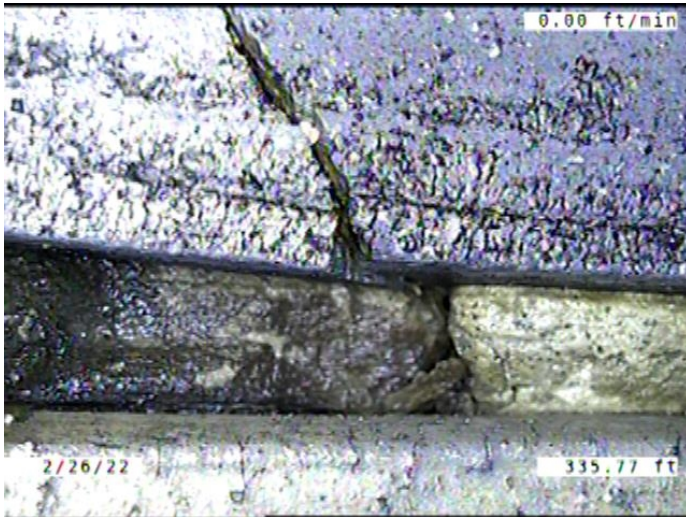
Code: **B**
 Description: **Broken**

Distance (ft): **335.8**
 Structural Grade: **4**
 O&M Grade: **0**
 Clock Start/From: **3**
 Clock To: **5**
 1st Value:
 2nd Value:
 Value Percent:
 Continuous Index:
 Within 8" of Joint: **YES**
 Remarks:

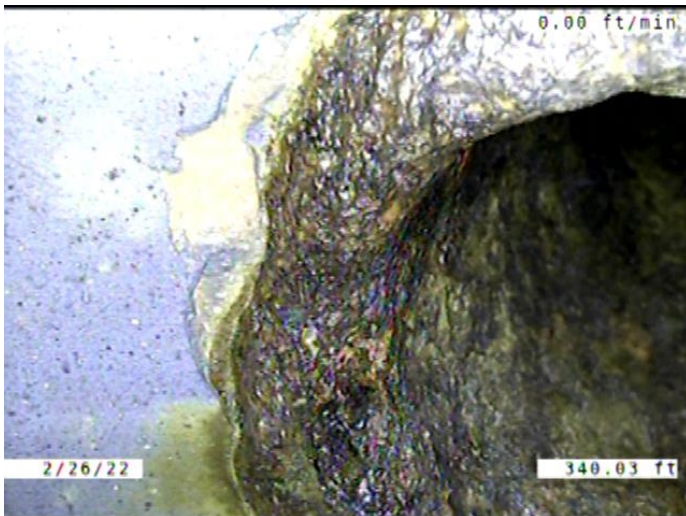
Code: **SSS**
 Description: **Surface Damage Surface Spalling**

Distance (ft): **340.0**
 Structural Grade: **2**
 O&M Grade: **0**
 Clock Start/From: **2**
 Clock To:
 1st Value:
 2nd Value:
 Value Percent:
 Continuous Index:
 Within 8" of Joint: **YES**
 Remarks:

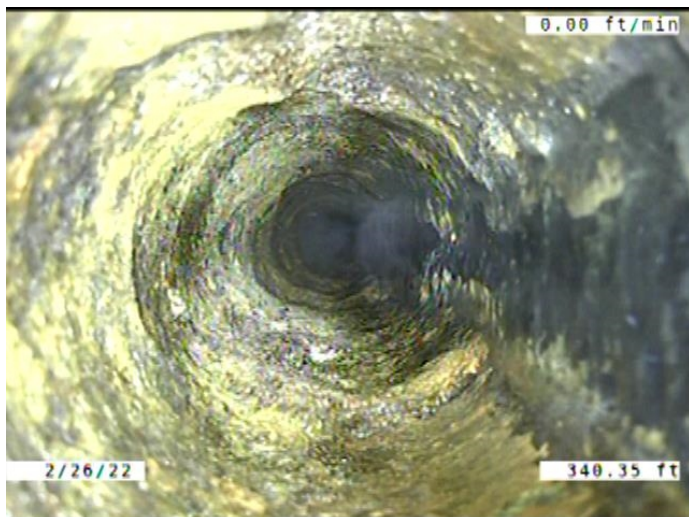
Code: **TBI**
 Description: **Tap Break-in Intruding**

Distance (ft): **340.4**
 Structural Grade: **0**
 O&M Grade: **2**
 Clock Start/From: **3**
 Clock To:
 1st Value: **4.000**
 2nd Value: **1.000**
 Value Percent:
 Continuous Index:
 Within 8" of Joint: **YES**
 Remarks: **ACTIVITY**

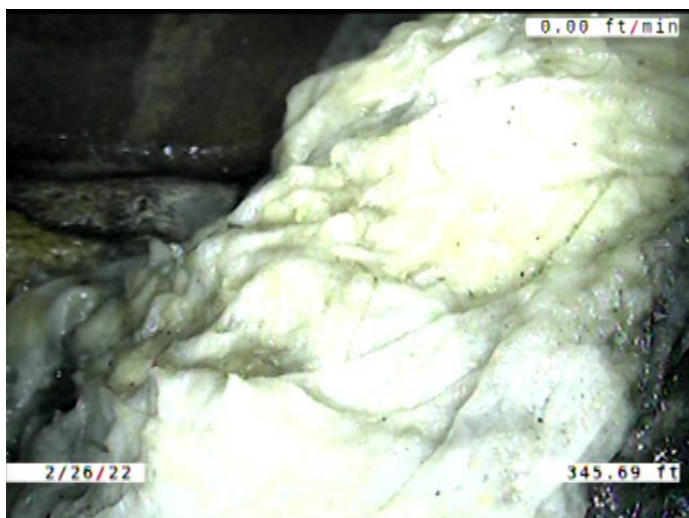
Code: **DAR**
 Description: **Deposits Attached Ragging**

Distance (ft): **345.7**
 Structural Grade: **0**
 O&M Grade: **2**
 Clock Start/From: **7**
 Clock To: **8**
 1st Value:
 2nd Value:
 Value Percent: **5.000**
 Continuous Index:
 Within 8" of Joint: **YES**
 Remarks:

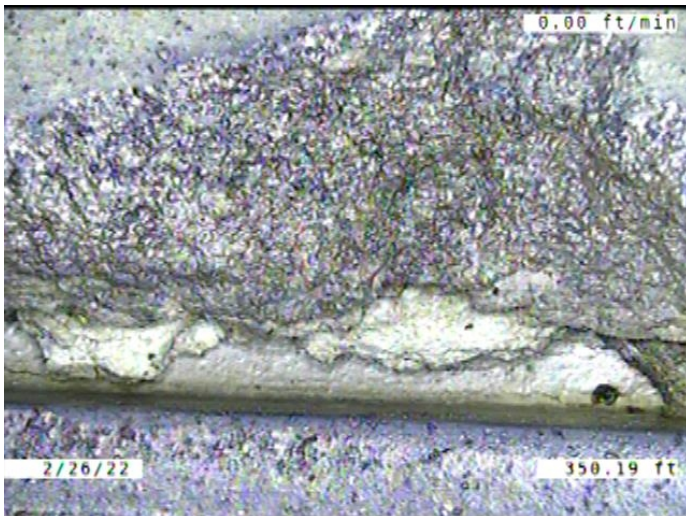
Code: **SMW**
 Description: **Surface Damage Missing Wall**

Distance (ft): **350.2**
 Structural Grade: **5**
 O&M Grade: **0**
 Clock Start/From: **1**
 Clock To: **3**
 1st Value:
 2nd Value:
 Value Percent:
 Continuous Index:
 Within 8" of Joint: **YES**
 Remarks:

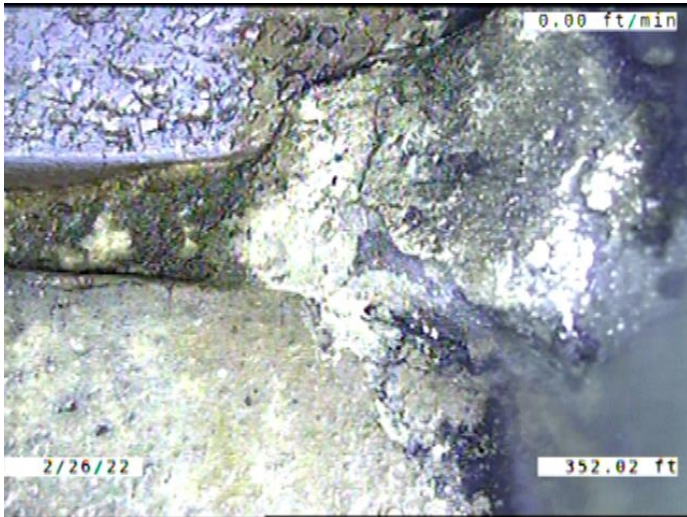
Code: **ISGT**
 Description: **Intruding Sealing Material Grout**

Distance (ft): **352.0**
 Structural Grade: **0**
 O&M Grade: **2**
 Clock Start/From: **4**
 Clock To: **8**
 1st Value:
 2nd Value:
 Value Percent: **5.000**
 Continuous Index:
 Within 8" of Joint: **NO**
 Remarks:

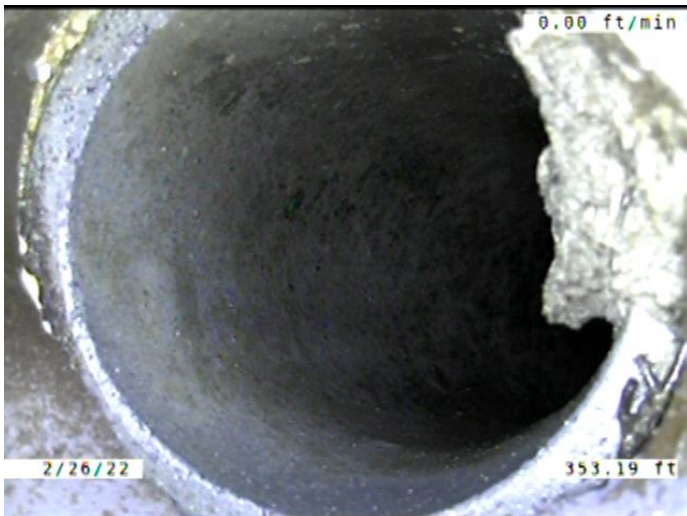
Code: **TFD**
 Description: **Tap Factory Defective**

Distance (ft): **353.2**
 Structural Grade: **0**
 O&M Grade: **3**
 Clock Start/From: **1**
 Clock To:
 1st Value: **6.000**
 2nd Value:
 Value Percent:
 Continuous Index:
 Within 8" of Joint: **YES**
 Remarks: **SOIL VISIBLE**

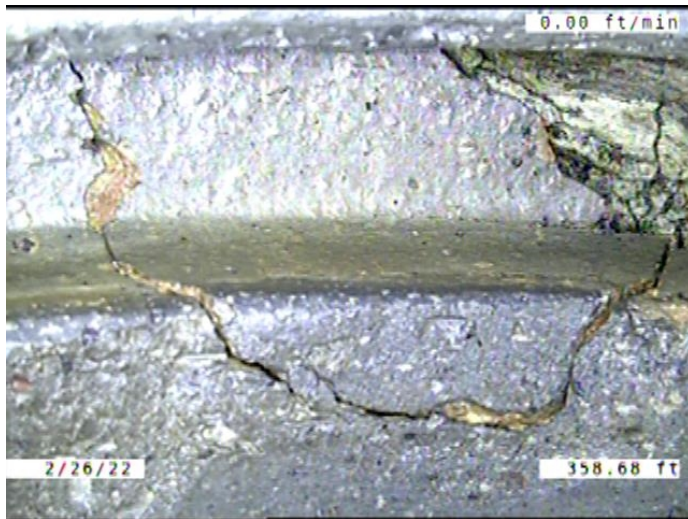
Code: **B**
 Description: **Broken**

Distance (ft): **358.7**
 Structural Grade: **4**
 O&M Grade: **0**
 Clock Start/From: **9**
 Clock To: **10**
 1st Value:
 2nd Value:
 Value Percent:
 Continuous Index:
 Within 8" of Joint: **YES**
 Remarks:

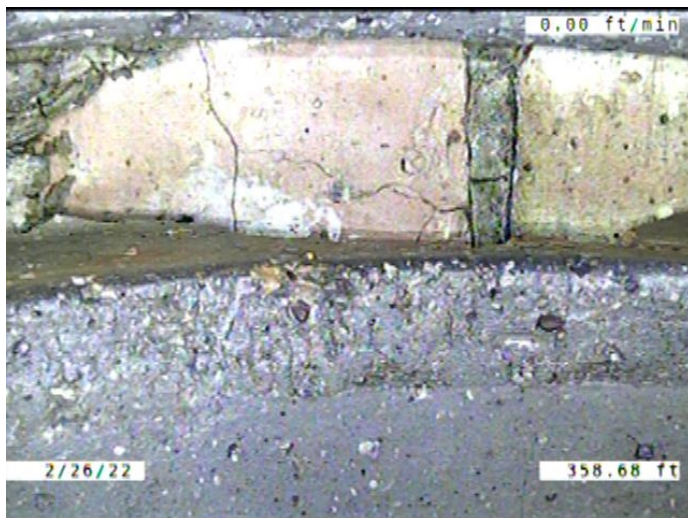
Code: **SMW**
 Description: **Surface Damage Missing Wall**

Distance (ft): **358.7**
 Structural Grade: **5**
 O&M Grade: **0**
 Clock Start/From: **10**
 Clock To: **1**
 1st Value:
 2nd Value:
 Value Percent:
 Continuous Index:
 Within 8" of Joint: **YES**
 Remarks:

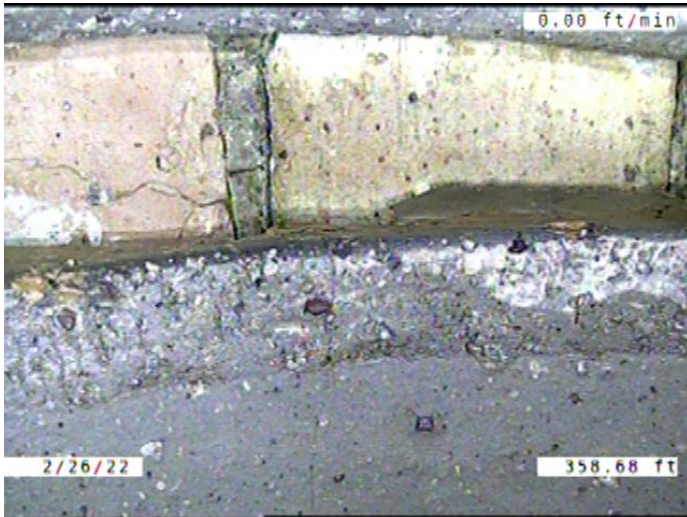
Code: **RPP**
Description: **Point Repair Patch**

Distance (ft): **358.7**
Structural Grade: **0**
O&M Grade: **0**
Clock Start/From: **10**
Clock To: **2**
1st Value:
2nd Value:
Value Percent:
Continuous Index:
Within 8" of Joint: **YES**
Remarks: **BRICK REPAIR**

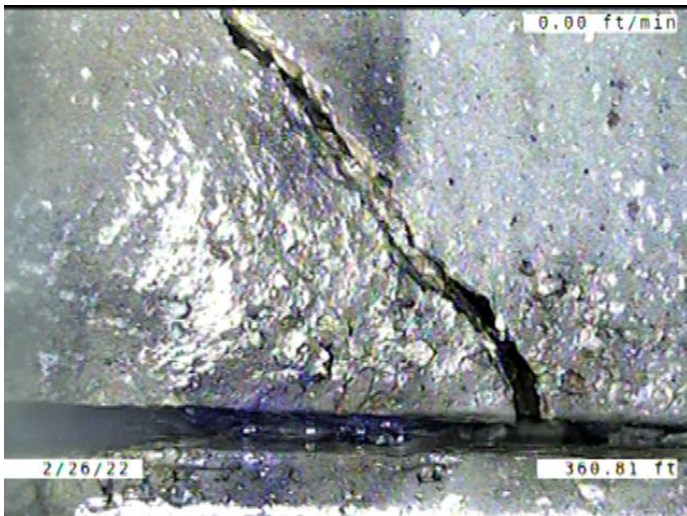
Code: **BSV**
Description: **Broken Soil Visible**

Distance (ft): **360.8**
Structural Grade: **5**
O&M Grade: **0**
Clock Start/From: **4**
Clock To: **8**
1st Value:
2nd Value:
Value Percent:
Continuous Index:
Within 8" of Joint: **YES**
Remarks:

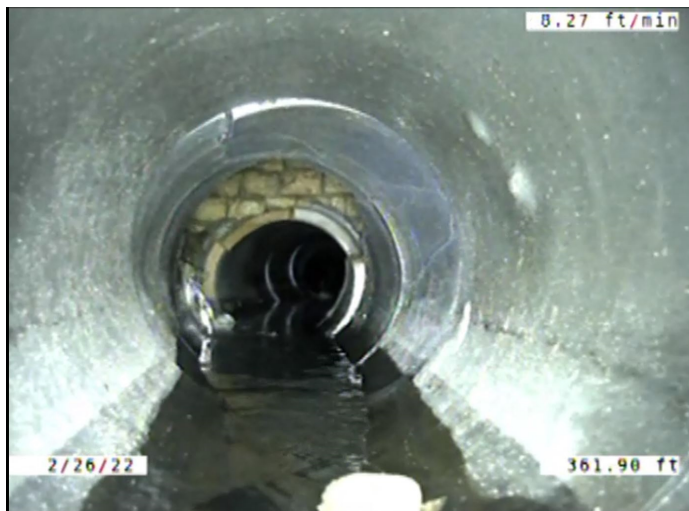
Code: **SZ**
 Description: **Surface Damage Other**

Distance (ft): **361.9**
 Structural Grade: **0**
 O&M Grade: **0**
 Clock Start/From: **2**
 Clock To: **3**
 1st Value:
 2nd Value:
 Value Percent:
 Continuous Index:
 Within 8" of Joint: **NO**
 Remarks: **Indentaions, factory defect**

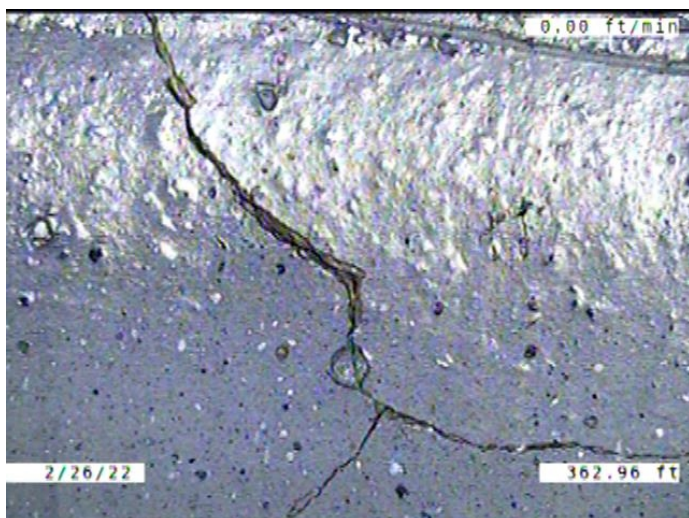
Code: **FM**
 Description: **Fracture Multiple**

Distance (ft): **363.0**
 Structural Grade: **4**
 O&M Grade: **0**
 Clock Start/From: **11**
 Clock To: **4**
 1st Value:
 2nd Value:
 Value Percent:
 Continuous Index:
 Within 8" of Joint: **YES**
 Remarks:

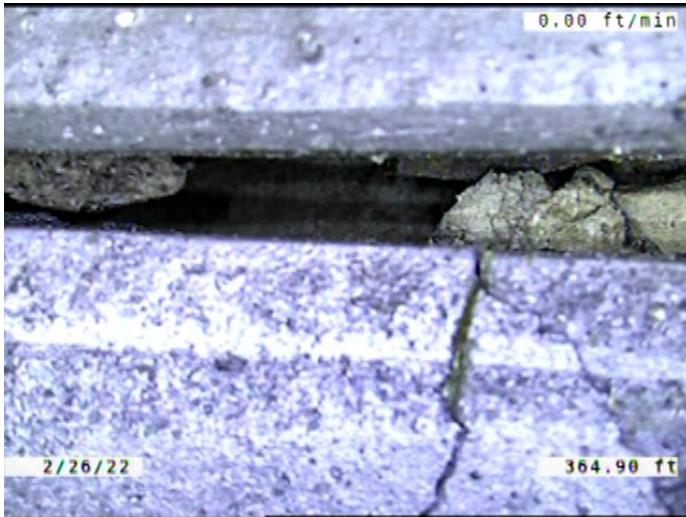
Code: **BVV**
Description: **Broken Void Visible**

Distance (ft): **364.9**
Structural Grade: **5**
O&M Grade: **0**
Clock Start/From: **7**
Clock To: **5**
1st Value:
2nd Value:
Value Percent:
Continuous Index:
Within 8" of Joint: **YES**
Remarks: **SOIL VISIBLE TOO**

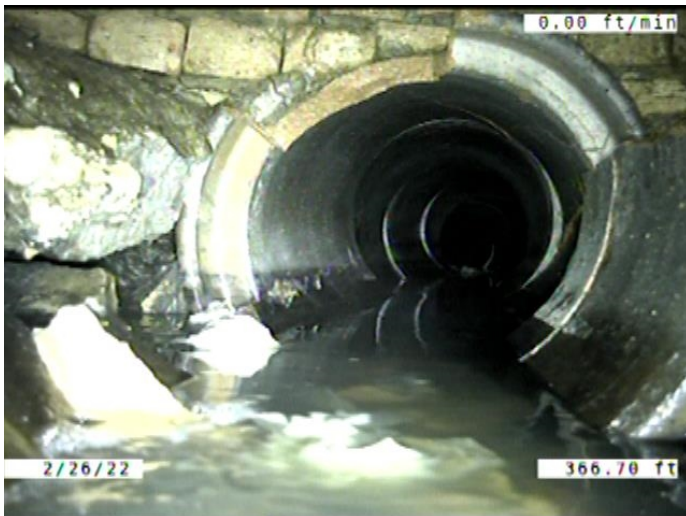
Code: **CM**
Description: **Crack Multiple**
