Profile/Photo Observation Report

Date:	02/26/2022	Weather:		Coding:	PACP 7.0
Pipe Length (ft):	373.0	Owner:	City of Hobart	Pre Clean:	Heavy Cleaning
P.O.#:	YES502259	Surveyor:	S. Bucklin	PSR:	P-806-024-018
Customer:	City of Hobart, IN (Red	Clean Date:	02/22/2022	Shape:	C

Street:	South Main Street	Flow Control:	Not Controlled
City:	Hobart, IN	Year Renewed:	
Location:	Local rural streets with light traffic, t	Tape/Media #:	
Purpose:	Routine Assessment	Dia/Height:	12"
Use:	Sanitary Sewage Pipe	Material:	VCP
Drain Area:		Lining:	None
Category:	NA		
Comment:			
Location Details:		Direction of Survey:	Downstream
US MH:	M-706-018	DS MH:	M-806-024
		Total Length Surveyed (ft):	368.5

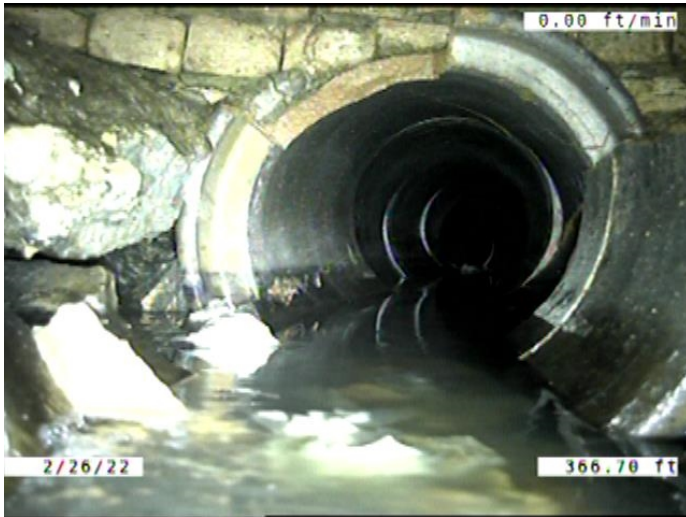
Code: **DSF**
 Description: **Deposits Settled Fine**
