Profile/Photo Observation Report

Date:	04/18/2018	Weather:		Coding:	PACP 6.0
Pipe Length (ft):	257.8	Owner:	NA	Pre Clean:	Not Known
P.O.#:		Surveyor:	Byrd Fitzgerald	PSR:	P-706-018-019
Customer:		Clean Date:	01/01/1900	Shape:	C

Street:	Capitol	Flow Control:	Not Controlled
City:	Hobart, IN	Year Renewed:	
Location:	Light Highway	Tape/Media #:	
Purpose:	Maintenance Related	Dia/Height:	12"
Use:	Sanitary	Material:	VCP
Drain Area:	NA	Lining:	Cured in Place
Category:	NA		
Comment:	Reverse setup. blk silt sludge at 6'.		
Location Details:		Direction of Survey:	Downstream
US MH:	M-706-019	DS MH:	M-706-018
		Total Length Surveyed (ft):	7.5

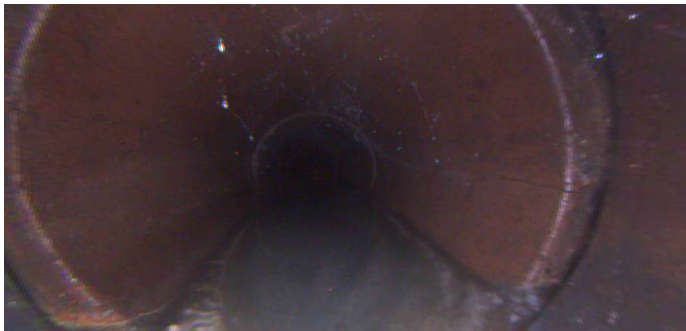
Code: **AMH**
Description: **Manhole**

Distance (ft): **.0**
Structural Grade: **0**
O&M Grade: **0**
Clock Start/From:
Clock To:
1st Value:
2nd Value:
Value Percent:
Continuous Index:
Within 8" of Joint: **NO**
Remarks: **M-706-019**

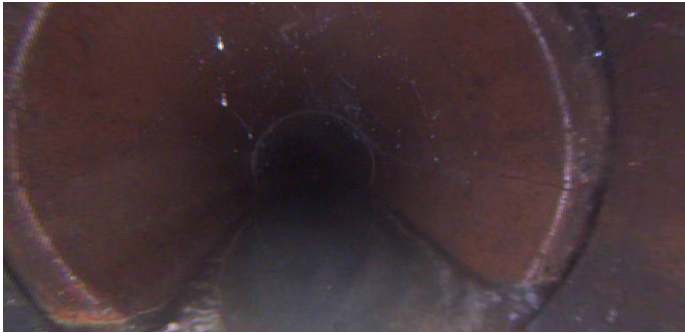
Code:	MWL
Description:	Water Level

Distance (ft):	.0
Structural Grade:	0
O&M Grade:	0
Clock Start/From:	
Clock To:	
1st Value:	
2nd Value:	
Value Percent:	5.000
Continuous Index:	
Within 8" of Joint:	NO
Remarks:

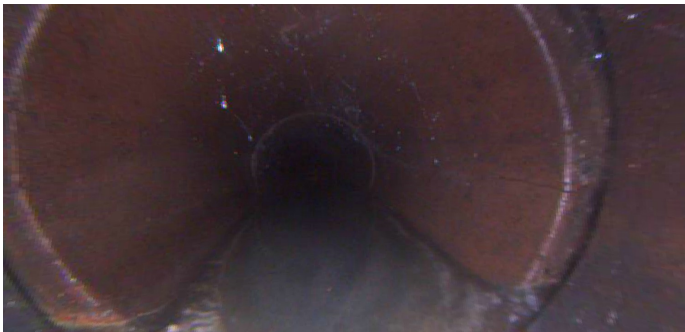
Code:	CL
Description:	Crack Longitudinal

Distance (ft):	.0
Structural Grade:	2
O&M Grade:	0
Clock Start/From:	3
Clock To:	
1st Value:	
2nd Value:	
Value Percent:	
Continuous Index:	
Within 8" of Joint:	YES
Remarks:

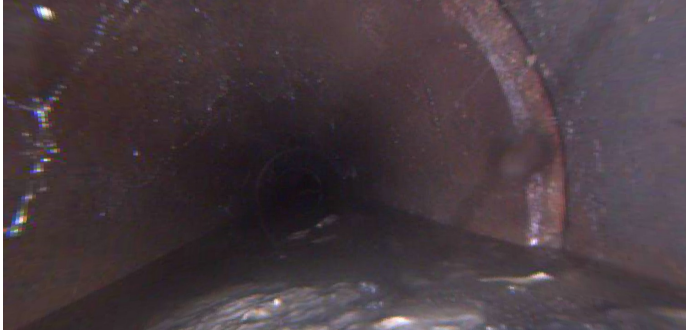
Code: **DSZ**
Description: **Deposits Settled Other**

Distance (ft): **6.0**
Structural Grade: **0**
O&M Grade: **2**
Clock Start/From: **6**
Clock To:
1st Value:
2nd Value:
Value Percent: **10.000**
Continuous Index:
Within 8" of Joint: **NO**
Remarks: **debris**

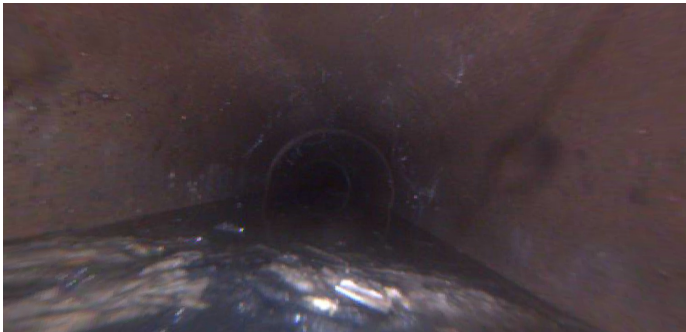
Code: **MSA**
Description: **Abandoned Survey**

Distance (ft): **7.5**
Structural Grade: **0**
O&M Grade: **0**
Clock Start/From:
Clock To:
1st Value:
2nd Value:
Value Percent:
Continuous Index:
Within 8" of Joint: **NO**
Remarks: **debris**
