Profile/Photo Observation Report

Street:	MAIN ST	Flow Control:	Not Controlled
City:	Hobart, IN	Year Renewed:	
Location:	Light Highway	Tape/Media #:	
Purpose:	Maintenance Related	Dia/Height:	12"
Use:	Sanitary	Material:	VCP
Drain Area:	NA	Lining:	Cured in Place
Category:	NA		
Comment:	debris at 62'.

Location Details:		Direction of Survey:	Upstream
US MH:	M-706-019	DS MH:	M-706-018
		Total Length Surveyed (ft):	63.6

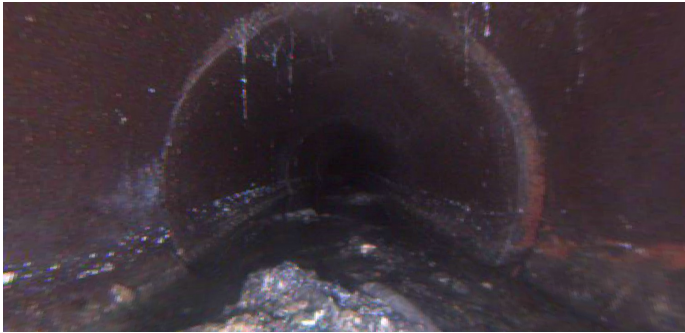
Code:	MWL
Description:	Water Level

Distance (ft):	.0
Structural Grade:	0
O&M Grade:	0
Clock Start/From:	
Clock To:	
1st Value:	
2nd Value:	
Value Percent:	5.000
Continuous Index:	
Within 8" of Joint:	NO
Remarks:

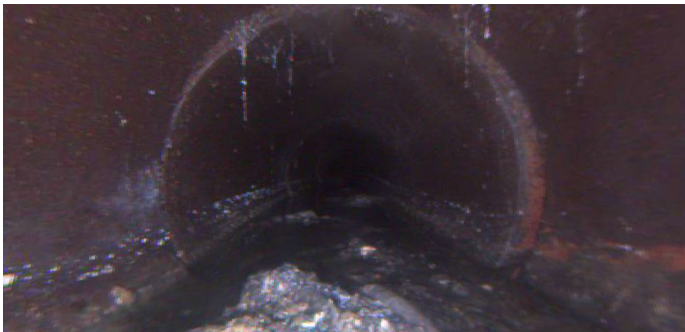
Code:	DSZ
Description:	Deposits Settled Other

Distance (ft):	.0
Structural Grade:	0
O&M Grade:	2
Clock Start/From:	6
Clock To:	
1st Value:	
2nd Value:	
Value Percent:	5.000
Continuous Index:	S01
Within 8" of Joint:	NO
Remarks:	debris

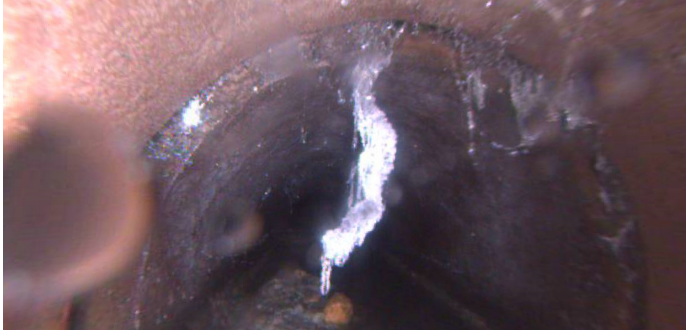
Code: **RMJ**
Description: **Roots Medium Joint**

Distance (ft): **32.7**
Structural Grade: **0**
O&M Grade: **3**
Clock Start/From: **10**
Clock To: **2**
1st Value:
2nd Value:
Value Percent: **5.000**
Continuous Index:
Within 8" of Joint: **YES**
Remarks:

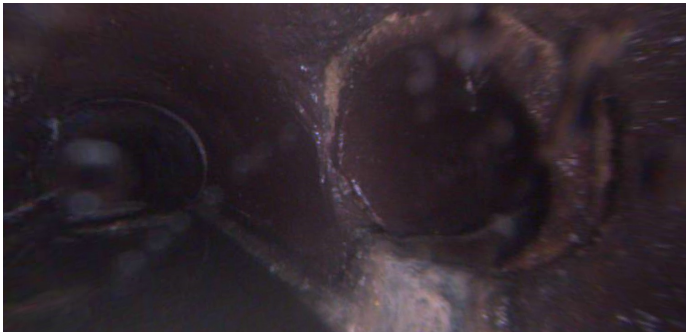
Code: **TBA**
Description: **Tap Break-in Active**

Distance (ft): **49.2**
Structural Grade: **0**
O&M Grade: **0**
Clock Start/From: **3**
Clock To:
1st Value: **4.000**
2nd Value:
Value Percent:
Continuous Index:
Within 8" of Joint:
Remarks:

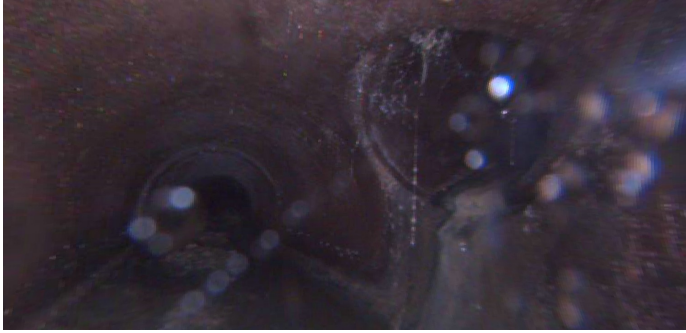
Code: **TB**
Description: **Tap Break-in**

Distance (ft): **63.6**
Structural Grade: **0**
O&M Grade: **0**
Clock Start/From: **2**
Clock To:
1st Value: **4.000**
2nd Value:
Value Percent:
Continuous Index:
Within 8" of Joint:
Remarks:

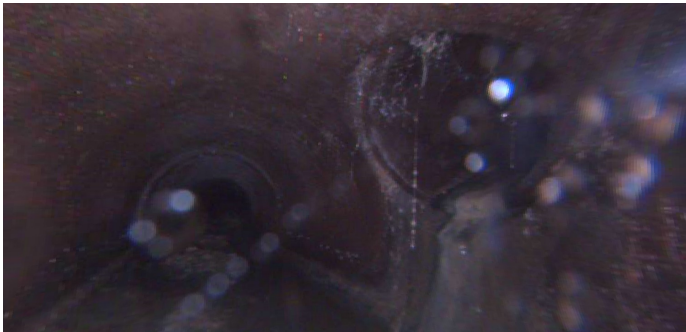
Code: **MSA**
Description: **Abandoned Survey**

Distance (ft): **63.6**
Structural Grade: **0**
O&M Grade: **0**
Clock Start/From:
Clock To:
1st Value:
2nd Value:
Value Percent:
Continuous Index:
Within 8" of Joint: **NO**
Remarks: **debris**

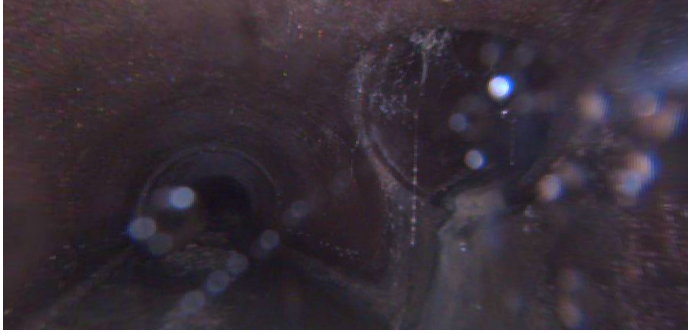
Code:	DSZ
Description:	Deposits Settled Other
Distance (ft):	63.6
Structural Grade:	0
O&M Grade:	2
Clock Start/From:	6
Clock To:	
1st Value:	
2nd Value:	
Value Percent:	5.000
Continuous Index:	F01
Within 8" of Joint:	NO
Remarks:	debris
