Profile/Photo Observation Report

Street:	Capitol	Flow Control:	Not Controlled
City:	Hobart, IN	Year Renewed:	
Location:	Light Highway	Tape/Media #:	
Purpose:	Maintenance Related	Dia/Height:	12"
Use:	Sanitary	Material:	VCP
Drain Area:	NA	Lining:	Cured in Place
Category:	NA		
Comment:	debris at 62'.

Location Details:		Direction of Survey:	Upstream
US MH:	M-706-019	DS MH:	M-706-018
		Total Length Surveyed (ft):	63.6

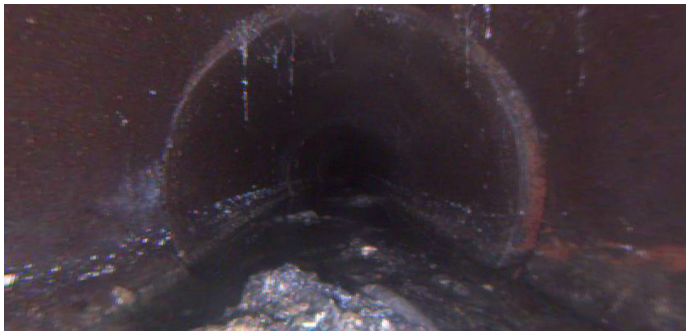
Code: **AMH**
Description: **Manhole**

Distance (ft): **.0**
Structural Grade: **0**
O&M Grade: **0**
Clock Start/From:
Clock To:
1st Value:
2nd Value:
Value Percent:
Continuous Index:
Within 8" of Joint: **NO**
Remarks: **M-706-018**

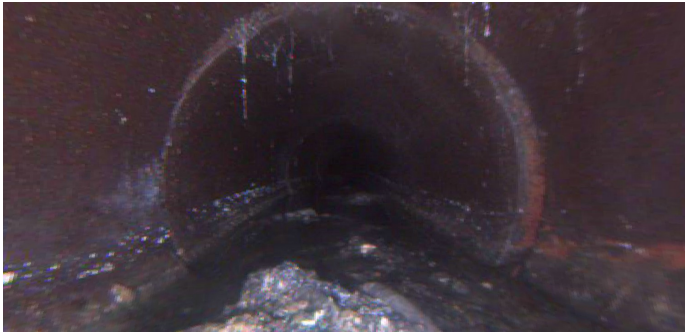
Code:	MWL
Description:	Water Level

Distance (ft):	.0
Structural Grade:	0
O&M Grade:	0
Clock Start/From:	
Clock To:	
1st Value:	
2nd Value:	
Value Percent:	5.000
Continuous Index:	
Within 8" of Joint:	NO
Remarks:

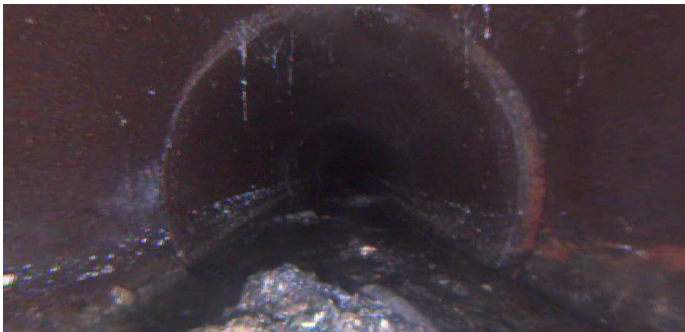
Code:	DSZ
Description:	Deposits Settled Other

Distance (ft):	.0
Structural Grade:	0
O&M Grade:	2
Clock Start/From:	6
Clock To:	
1st Value:	
2nd Value:	
Value Percent:	5.000
Continuous Index:	S01
Within 8" of Joint:	NO
Remarks:	debris

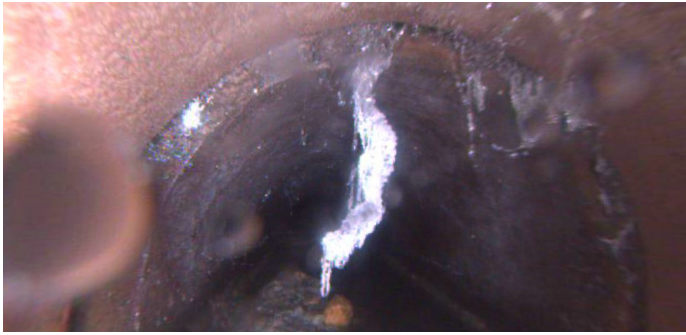
Code: **RMJ**
Description: **Roots Medium Joint**

Distance (ft): **32.7**
Structural Grade: **0**
O&M Grade: **3**
Clock Start/From: **10**
Clock To: **2**
1st Value:
2nd Value:
Value Percent: **5.000**
Continuous Index:
Within 8" of Joint: **YES**
Remarks:

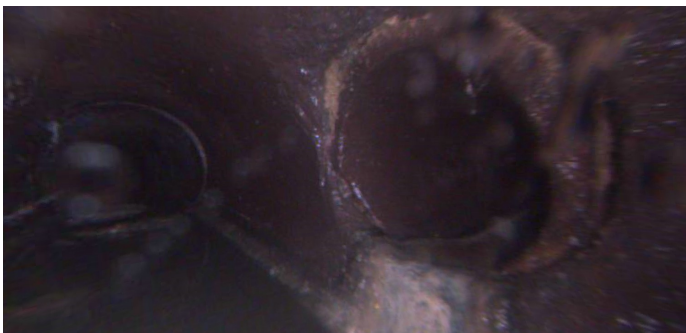
Code: **TBA**
Description: **Tap Break-in Active**

Distance (ft): **49.2**
Structural Grade: **0**
O&M Grade: **0**
Clock Start/From: **3**
Clock To:
1st Value: **4.000**
2nd Value:
Value Percent:
Continuous Index:
Within 8" of Joint:
Remarks:

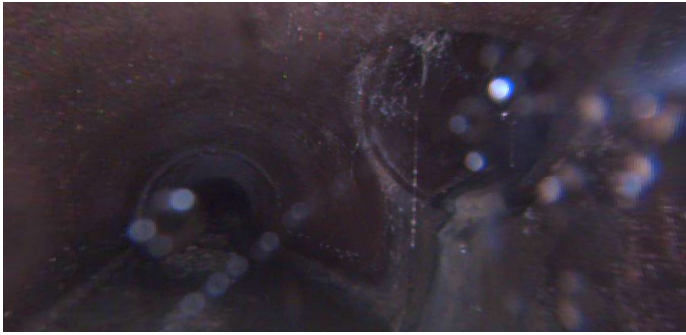
Code: **TB**
Description: **Tap Break-in**

Distance (ft): **63.6**
Structural Grade: **0**
O&M Grade: **0**
Clock Start/From: **2**
Clock To:
1st Value: **4.000**
2nd Value:
Value Percent:
Continuous Index:
Within 8" of Joint:
Remarks:

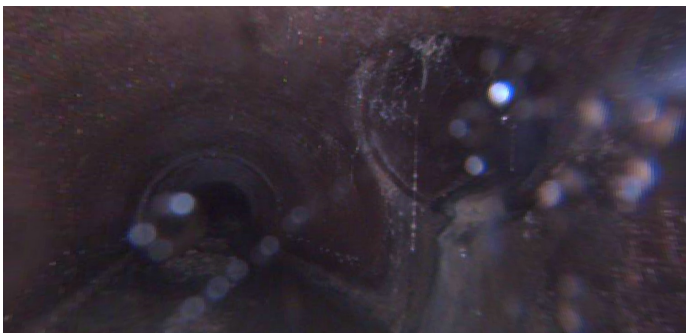
Code: **MSA**
Description: **Abandoned Survey**

Distance (ft): **63.6**
Structural Grade: **0**
O&M Grade: **0**
Clock Start/From:
Clock To:
1st Value:
2nd Value:
Value Percent:
Continuous Index:
Within 8" of Joint: **NO**
Remarks: **debris**

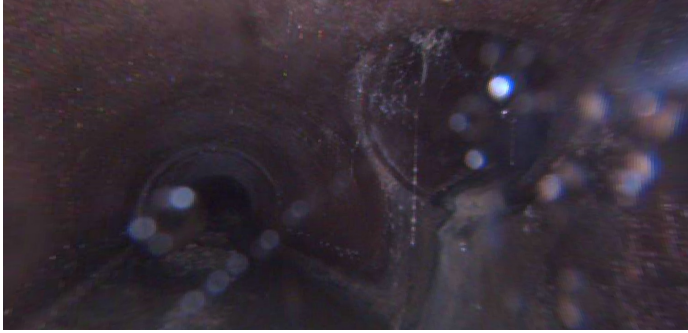
Code:	DSZ
Description:	Deposits Settled Other
Distance (ft):	63.6
Structural Grade:	0
O&M Grade:	2
Clock Start/From:	6
Clock To:	
1st Value:	
2nd Value:	
Value Percent:	5.000
Continuous Index:	F01
Within 8" of Joint:	NO
Remarks:	debris
