Profile/Photo Observation Report

Date:	02/26/2022	Weather:		Coding:	PACP 7.0
Pipe Length (ft):	258.0	Owner:	City of Hobart	Pre Clean:	Heavy Cleaning
P.O.#:	YES502259	Surveyor:	S. Bucklin	PSR:	P-706-018-019
Customer:	City of Hobart, IN (Red	Clean Date:	02/24/2022	Shape:	C

Street:	South Main Street	Flow Control:	Not Controlled
City:	Hobart, IN	Year Renewed:	
Location:	Local rural streets with light traffic, t	Tape/Media #:	
Purpose:	Routine Assessment	Dia/Height:	12"
Use:	Sanitary Sewage Pipe	Material:	VCP
Drain Area:		Lining:	None
Category:	NA		
Comment:			
Location Details:		Direction of Survey:	Downstream
US MH:	M-706-019	DS MH:	M-706-018
		Total Length Surveyed (ft):	259.0

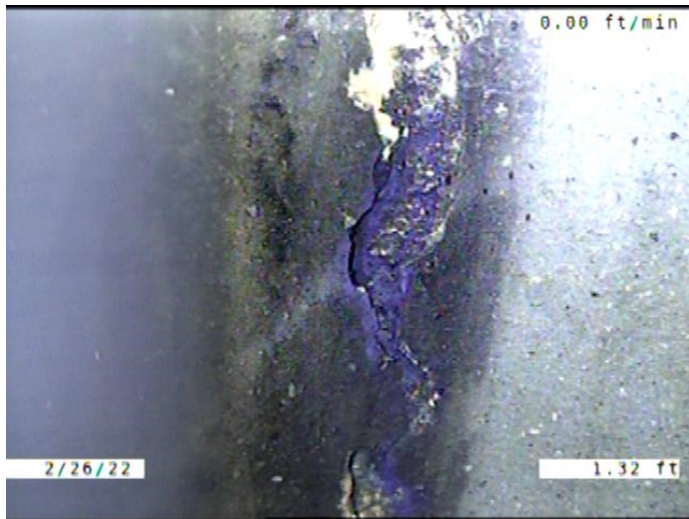
Code: **B**
 Description: **Broken**

Distance (ft): **1.3**
 Structural Grade: **4**
 O&M Grade: **0**
 Clock Start/From: **8**
 Clock To: **4**
 1st Value:
 2nd Value:
 Value Percent:
 Continuous Index:
 Within 8" of Joint: **YES**
 Remarks:

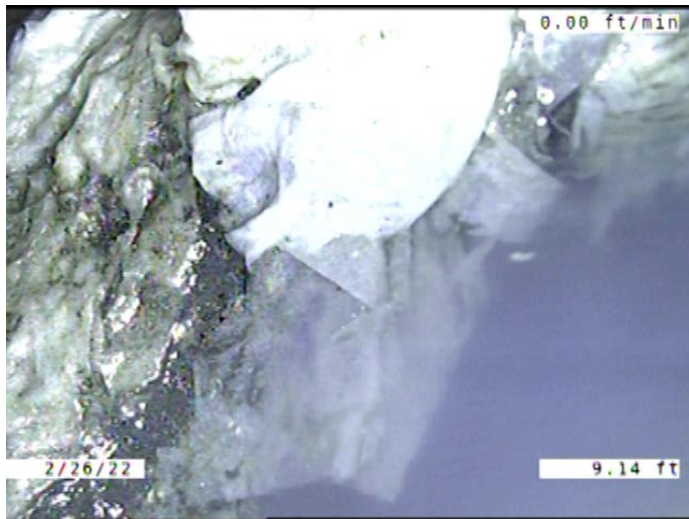
Code: **DAR**
 Description: **Deposits Attached Ragging**

Distance (ft): **9.1**
 Structural Grade: **0**
 O&M Grade: **2**
 Clock Start/From: **7**
 Clock To: **8**
 1st Value:
 2nd Value:
 Value Percent: **5.000**
 Continuous Index:
 Within 8" of Joint: **YES**
 Remarks:

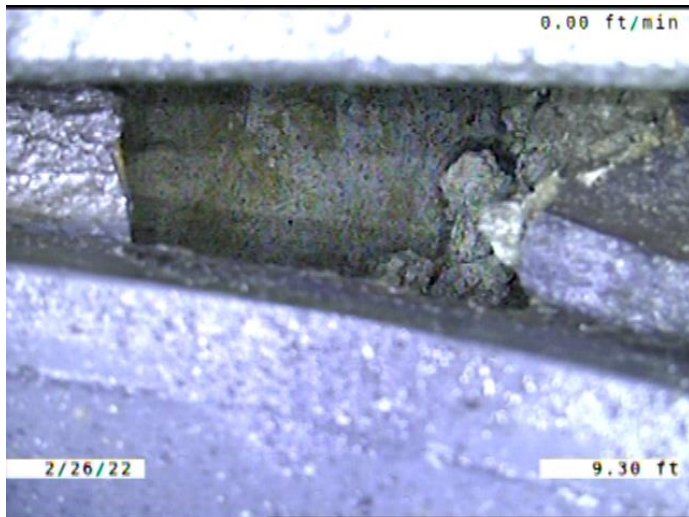
Code: **HVV**
 Description: **Hole Void Visible**

Distance (ft): **9.3**
 Structural Grade: **5**
 O&M Grade: **0**
 Clock Start/From: **1**
 Clock To: **3**
 1st Value:
 2nd Value:
 Value Percent:
 Continuous Index:
 Within 8" of Joint: **YES**
 Remarks:

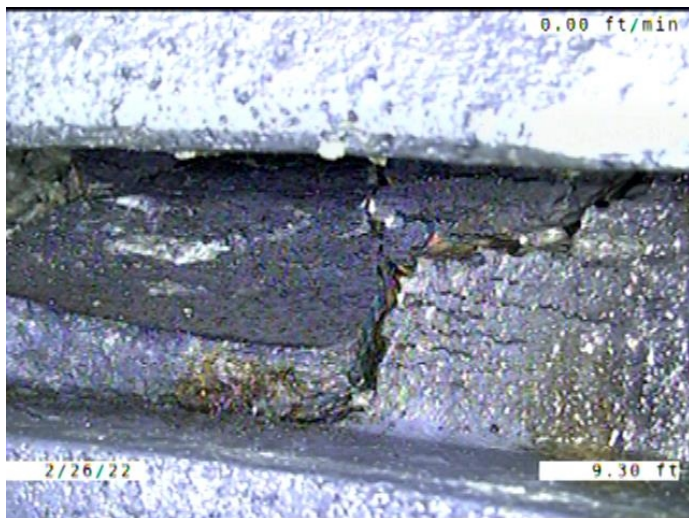
Code: **BVV**
 Description: **Broken Void Visible**

Distance (ft): **9.3**
 Structural Grade: **5**
 O&M Grade: **0**
 Clock Start/From: **3**
 Clock To: **4**
 1st Value:
 2nd Value:
 Value Percent:
 Continuous Index:
 Within 8" of Joint: **YES**
 Remarks:

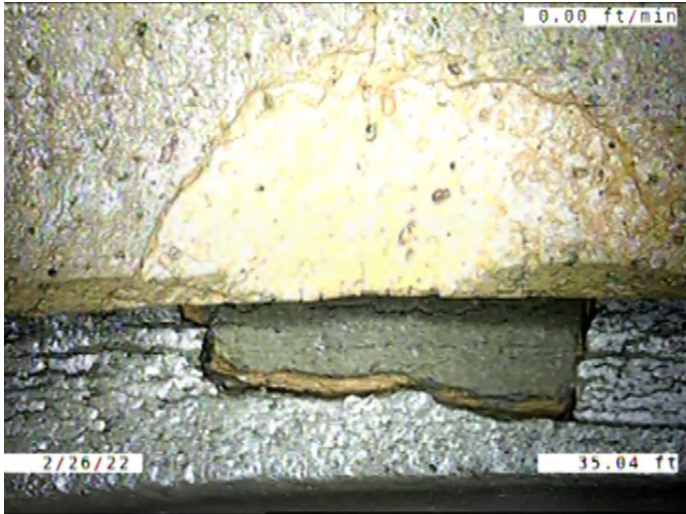
Code: **SSS**
 Description: **Surface Damage Surface Spalling**

Distance (ft): **35.0**
 Structural Grade: **2**
 O&M Grade: **0**
 Clock Start/From: **10**
 Clock To:
 1st Value:
 2nd Value:
 Value Percent:
 Continuous Index:
 Within 8" of Joint: **YES**
 Remarks:

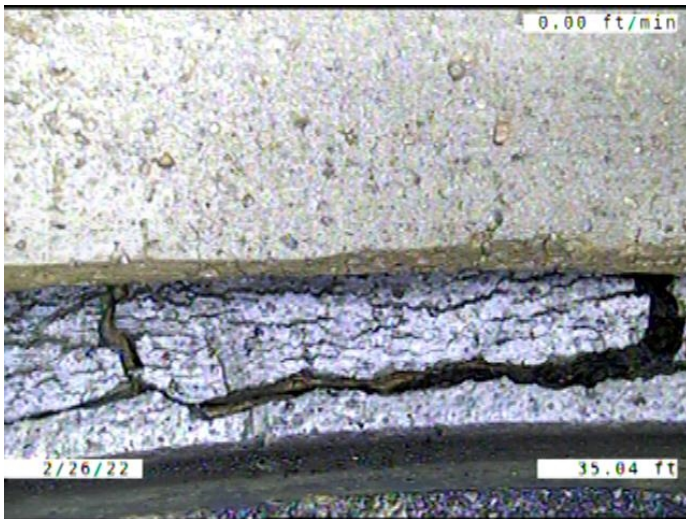
Code: **B**
 Description: **Broken**

Distance (ft): **35.0**
 Structural Grade: **4**
 O&M Grade: **0**
 Clock Start/From: **10**
 Clock To: **3**
 1st Value:
 2nd Value:
 Value Percent:
 Continuous Index:
 Within 8" of Joint: **YES**
 Remarks:

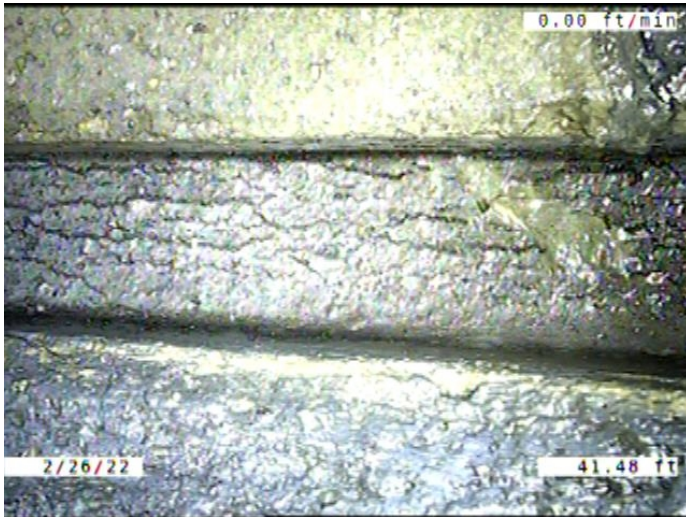
Code: **JAL**
 Description: **Joint Angular Large**

Distance (ft): **41.5**
 Structural Grade: **4**
 O&M Grade: **0**
 Clock Start/From:
 Clock To:
 1st Value:
 2nd Value:
 Value Percent:
 Continuous Index:
 Within 8" of Joint: **NO**
 Remarks:

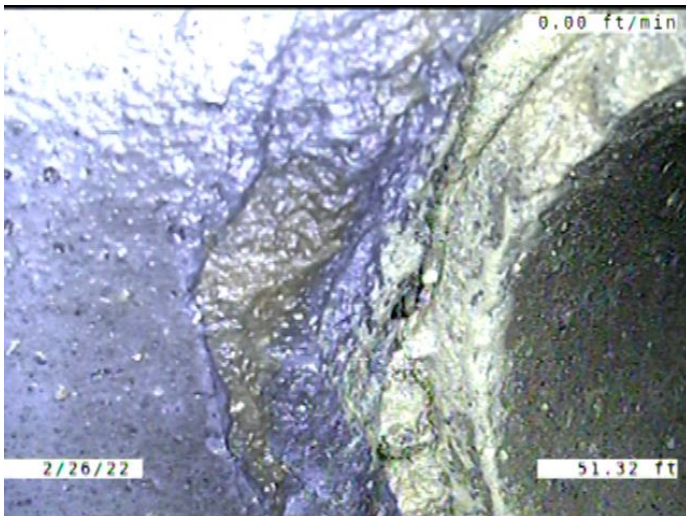
Code: **SSS**
 Description: **Surface Damage Surface Spalling**

Distance (ft): **51.3**
 Structural Grade: **2**
 O&M Grade: **0**
 Clock Start/From: **1**
 Clock To: **4**
 1st Value:
 2nd Value:
 Value Percent:
 Continuous Index:
 Within 8" of Joint: **YES**
 Remarks:

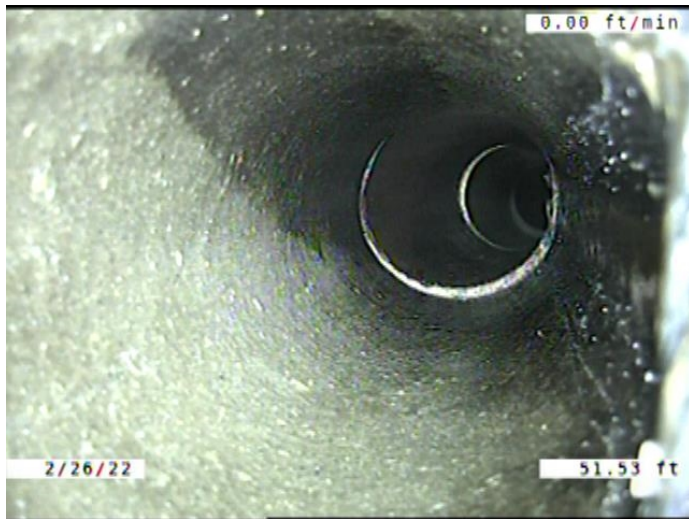
Code:	TB
Description:	Tap Break-in/Hammer
Distance (ft):	51.5
Structural Grade:	0
O&M Grade:	0
Clock Start/From:	3
Clock To:	
1st Value:	6.000
2nd Value:	
Value Percent:	
Continuous Index:	
Within 8" of Joint:	YES
Remarks:	CONSTANTLY RUNNING WATER

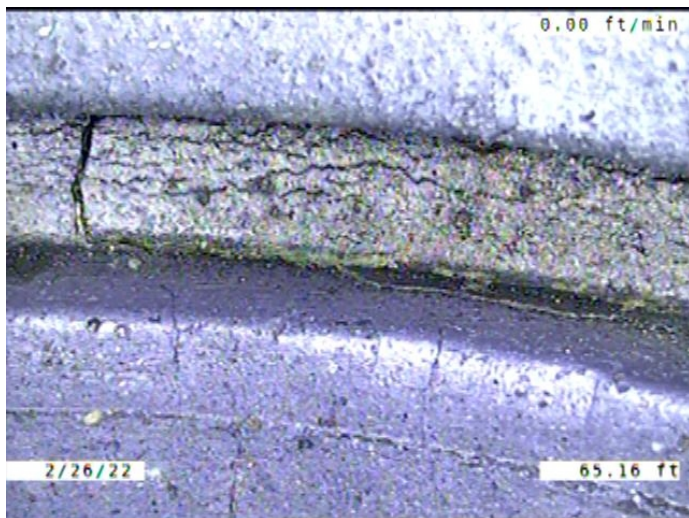
Code:	FM
Description:	Fracture Multiple
Distance (ft):	65.2
Structural Grade:	4
O&M Grade:	0
Clock Start/From:	8
Clock To:	4
1st Value:	
2nd Value:	
Value Percent:	
Continuous Index:	
Within 8" of Joint:	YES
Remarks:

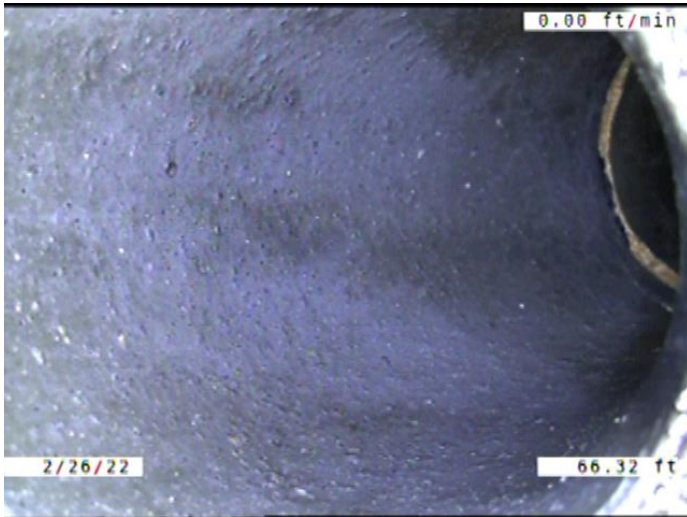
Code:	TFD
Description:	Tap Factory Defective
Distance (ft):	66.3
Structural Grade:	0
O&M Grade:	3
Clock Start/From:	2
Clock To:	
1st Value:	6.000
2nd Value:	
Value Percent:	
Continuous Index:	
Within 8" of Joint:	YES
Remarks:	SOIL VISIBLE BETWEEN SERVICE AND MAIN CONNECTION

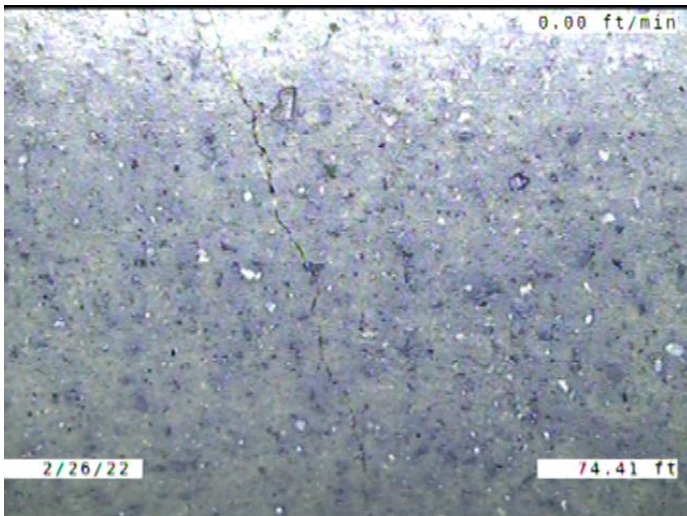
Code:	CM
Description:	Crack Multiple
Distance (ft):	74.4
Structural Grade:	3
O&M Grade:	0
Clock Start/From:	1
Clock To:	2
1st Value:	
2nd Value:	
Value Percent:	
Continuous Index:	
Within 8" of Joint:	YES
Remarks:

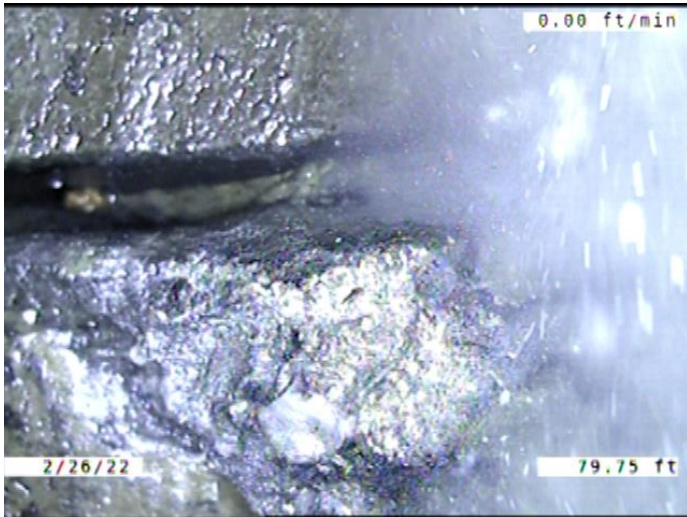
Code:	ISGT
Description:	Intruding Sealing Material Grout
Distance (ft):	79.7
Structural Grade:	0
O&M Grade:	2
Clock Start/From:	7
Clock To:	8
1st Value:	
2nd Value:	
Value Percent:	5.000
Continuous Index:	
Within 8" of Joint:	NO
Remarks:

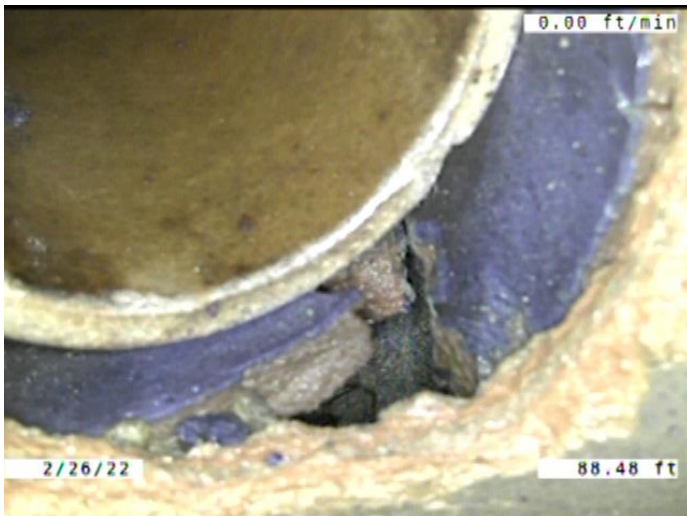
Code:	SSS
Description:	Surface Damage Surface Spalling
Distance (ft):	88.5
Structural Grade:	2
O&M Grade:	0
Clock Start/From:	9
Clock To:	12
1st Value:	
2nd Value:	
Value Percent:	
Continuous Index:	
Within 8" of Joint:	YES
Remarks:

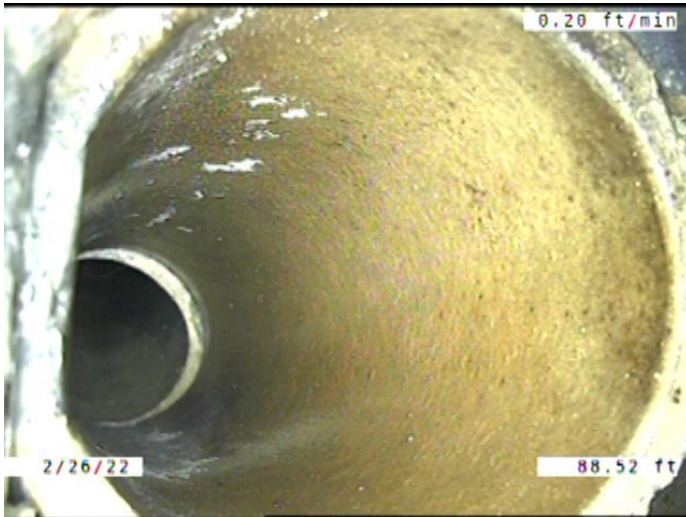
Code:	TBD
Description:	Tap Break-in/Hammer Defective
Distance (ft):	88.5
Structural Grade:	0
O&M Grade:	3
Clock Start/From:	10
Clock To:	
1st Value:	6.000
2nd Value:	
Value Percent:	
Continuous Index:	
Within 8" of Joint:	YES
Remarks:	BVV in tap

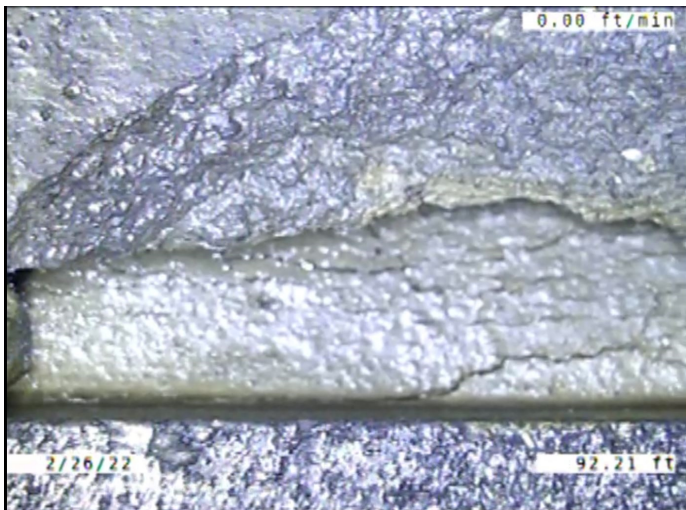
Code:	CM
Description:	Crack Multiple
Distance (ft):	92.2
Structural Grade:	3
O&M Grade:	0
Clock Start/From:	9
Clock To:	10
1st Value:	
2nd Value:	
Value Percent:	
Continuous Index:	
Within 8" of Joint:	YES
Remarks:

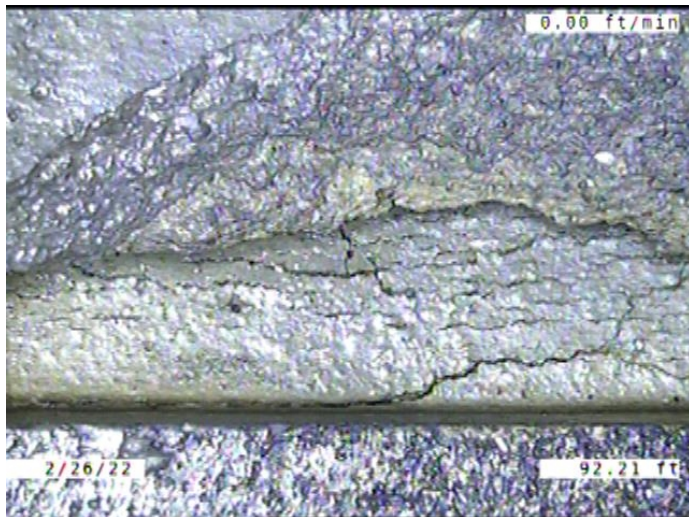
Code: **SMW**
 Description: **Surface Damage Missing Wall**

Distance (ft): **92.2**
 Structural Grade: **5**
 O&M Grade: **0**
 Clock Start/From: **9**
 Clock To: **12**
 1st Value:
 2nd Value:
 Value Percent:
 Continuous Index:
 Within 8" of Joint: **YES**
 Remarks:

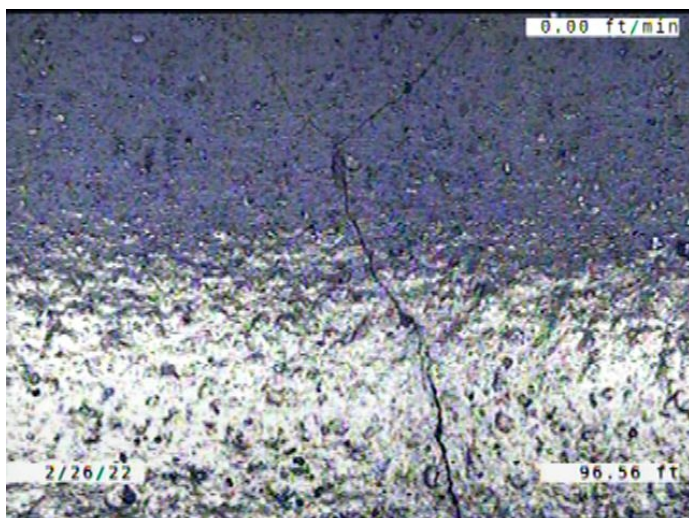
Code: **CM**
 Description: **Crack Multiple**

Distance (ft): **96.6**
 Structural Grade: **3**
 O&M Grade: **0**
 Clock Start/From: **12**
 Clock To: **1**
 1st Value:
 2nd Value:
 Value Percent:
 Continuous Index:
 Within 8" of Joint: **YES**
 Remarks:

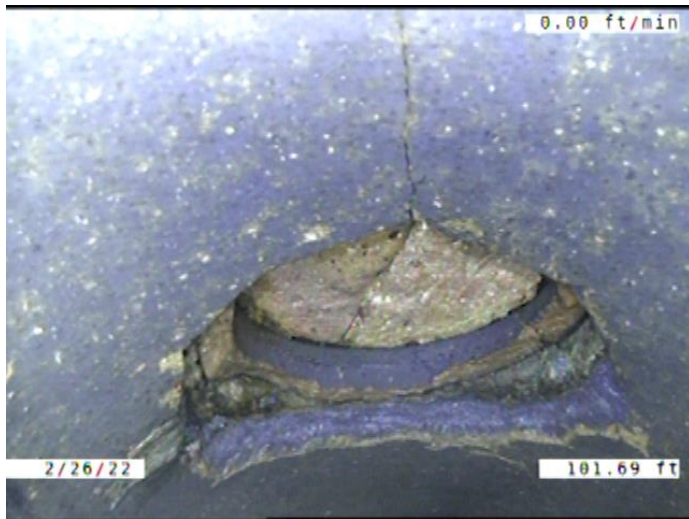
Code: **SSS**
 Description: **Surface Damage Surface Spalling**

Distance (ft): **101.7**
 Structural Grade: **2**
 O&M Grade: **0**
 Clock Start/From: **10**
 Clock To: **12**
 1st Value:
 2nd Value:
 Value Percent:
 Continuous Index:
 Within 8" of Joint: **YES**
 Remarks:

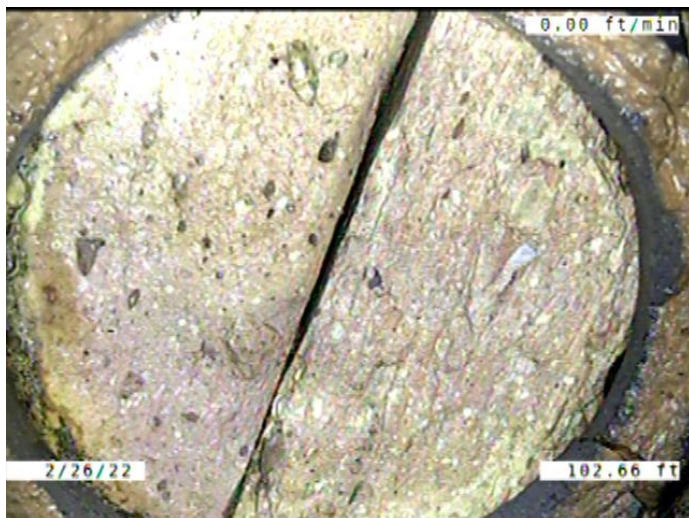
Code: **TBD**
 Description: **Tap Break-in/Hammer Defective**

Distance (ft): **102.7**
 Structural Grade: **0**
 O&M Grade: **3**
 Clock Start/From: **11**
 Clock To:
 1st Value: **6.000**
 2nd Value:
 Value Percent:
 Continuous Index:
 Within 8" of Joint: **NO**
 Remarks: **BRICKED OFF**

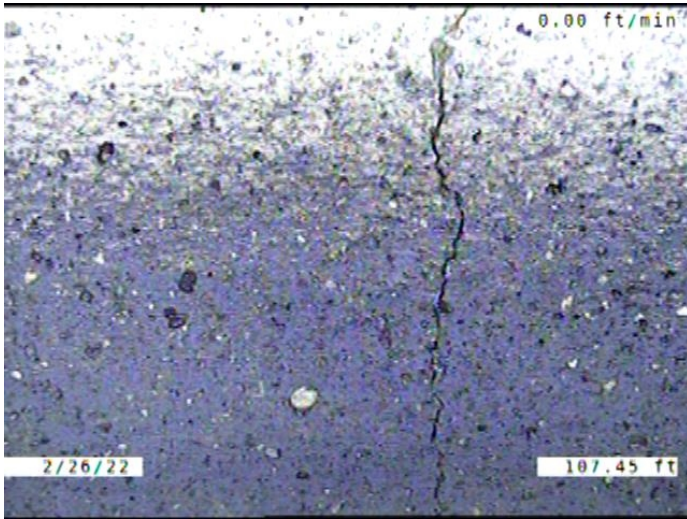
Code: **CM**
Description: **Crack Multiple**

Distance (ft): **107.5**
Structural Grade: **3**
O&M Grade: **0**
Clock Start/From: **12**
Clock To: **1**
1st Value:
2nd Value:
Value Percent:
Continuous Index:
Within 8" of Joint: **YES**
Remarks:

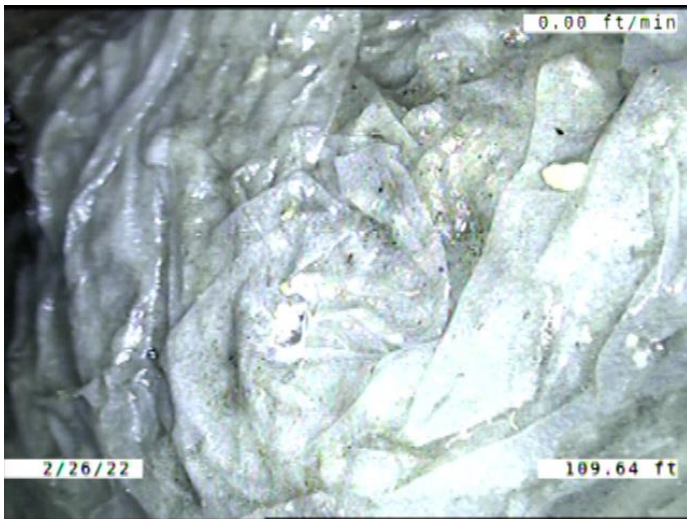
Code: **DAR**
Description: **Deposits Attached Ragging**

Distance (ft): **109.6**
Structural Grade: **0**
O&M Grade: **2**
Clock Start/From: **7**
Clock To: **8**
1st Value:
2nd Value:
Value Percent: **5.000**
Continuous Index:
Within 8" of Joint: **YES**
Remarks: **TP ALSO**

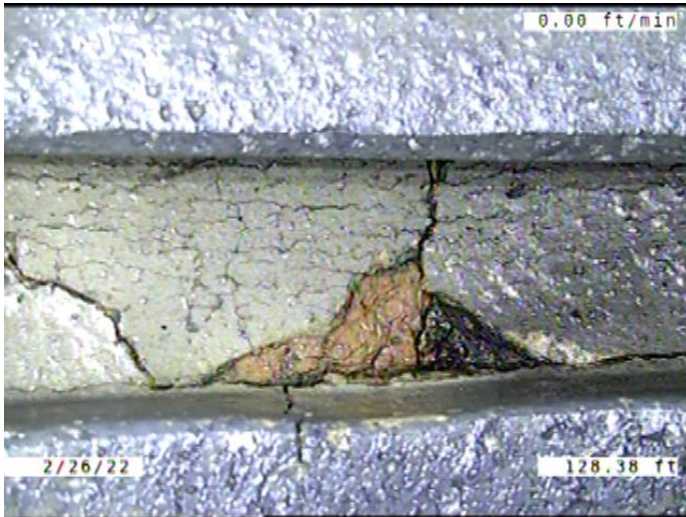
Code: **B**
Description: **Broken**

Distance (ft): **128.4**
Structural Grade: **4**
O&M Grade: **0**
Clock Start/From: **9**
Clock To: **2**
1st Value:
2nd Value:
Value Percent:
Continuous Index:
Within 8" of Joint: **YES**
Remarks:

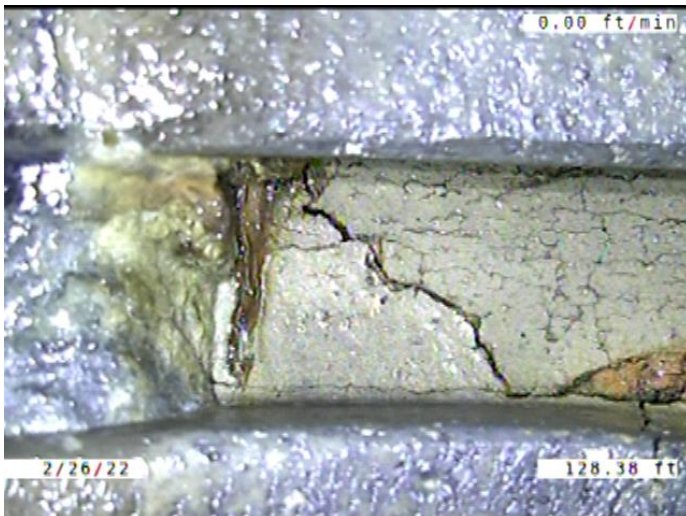
Code: **JAL**
Description: **Joint Angular Large**

Distance (ft): **128.4**
Structural Grade: **4**
O&M Grade: **0**
Clock Start/From:
Clock To:
1st Value:
2nd Value:
Value Percent:
Continuous Index:
Within 8" of Joint: **NO**
Remarks:

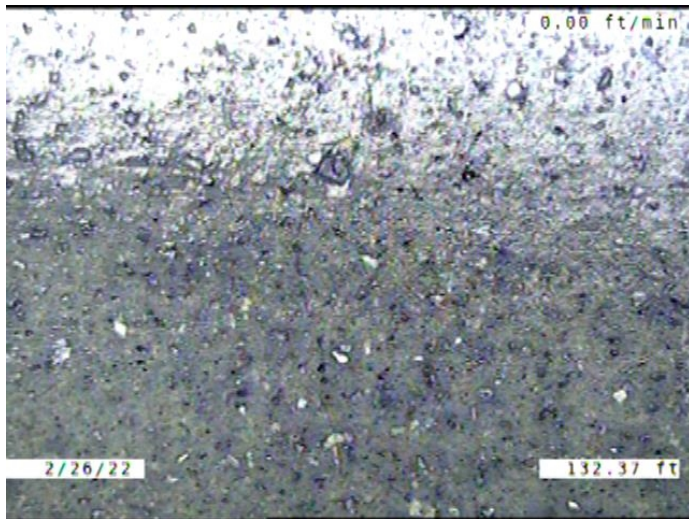
Code: **CM**
 Description: **Crack Multiple**

Distance (ft): **132.4**
 Structural Grade: **3**
 O&M Grade: **0**
 Clock Start/From: **11**
 Clock To: **1**
 1st Value:
 2nd Value:
 Value Percent:
 Continuous Index: **S01**
 Within 8" of Joint: **YES**
 Remarks:

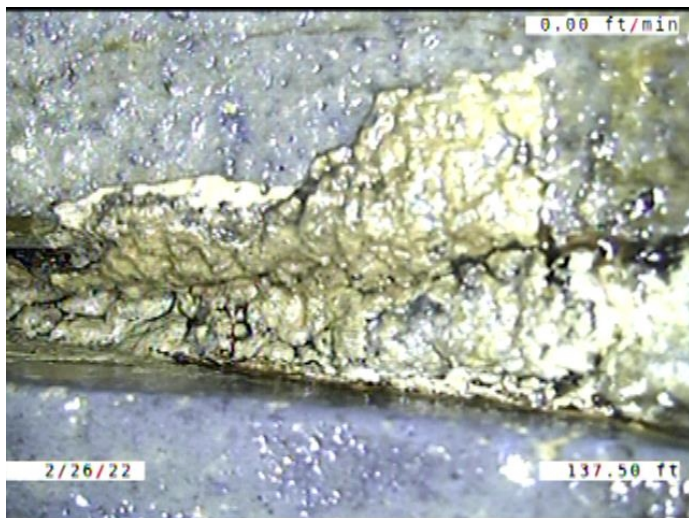
Code: **DAE**
 Description: **Deposits Attached Encrustation**

Distance (ft): **137.5**
 Structural Grade: **0**
 O&M Grade: **2**
 Clock Start/From: **12**
 Clock To: **5**
 1st Value:
 2nd Value:
 Value Percent: **5.000**
 Continuous Index:
 Within 8" of Joint: **YES**
 Remarks:

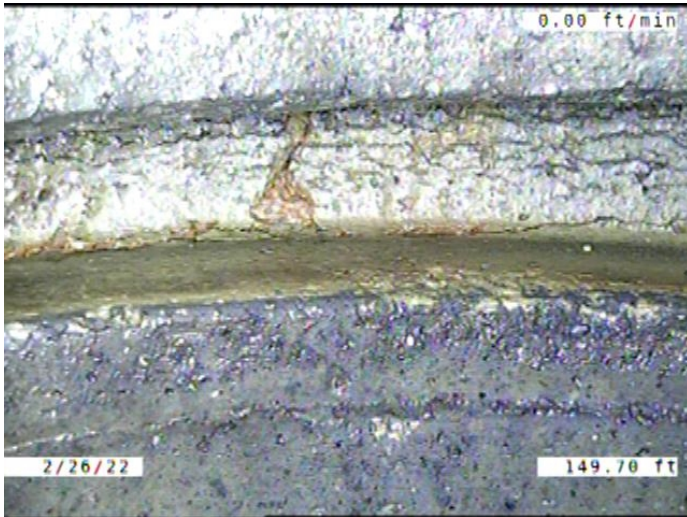
Code: **FM**
 Description: **Fracture Multiple**

Distance (ft): **149.7**
 Structural Grade: **4**
 O&M Grade: **0**
 Clock Start/From: **9**
 Clock To: **3**
 1st Value:
 2nd Value:
 Value Percent:
 Continuous Index:
 Within 8" of Joint: **YES**
 Remarks:

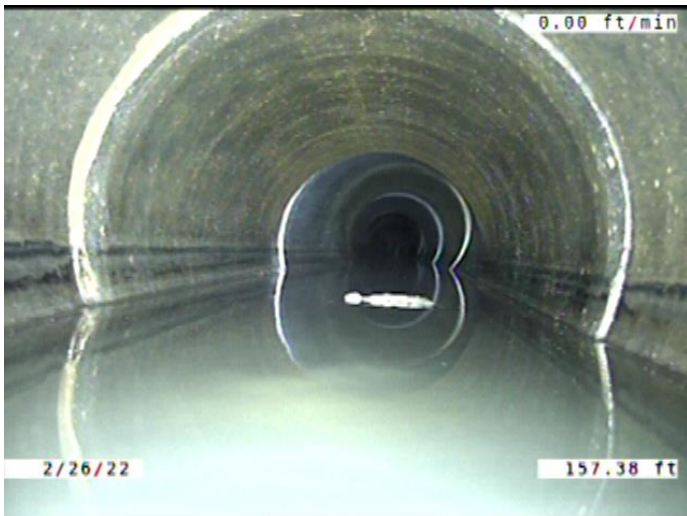
Code: **MWLS**
 Description: **Miscellaneous Water Level Sag**

Distance (ft): **157.4**
 Structural Grade: **2**
 O&M Grade: **0**
 Clock Start/From:
 Clock To:
 1st Value:
 2nd Value:
 Value Percent: **15.000**
 Continuous Index:
 Within 8" of Joint: **NO**
 Remarks:

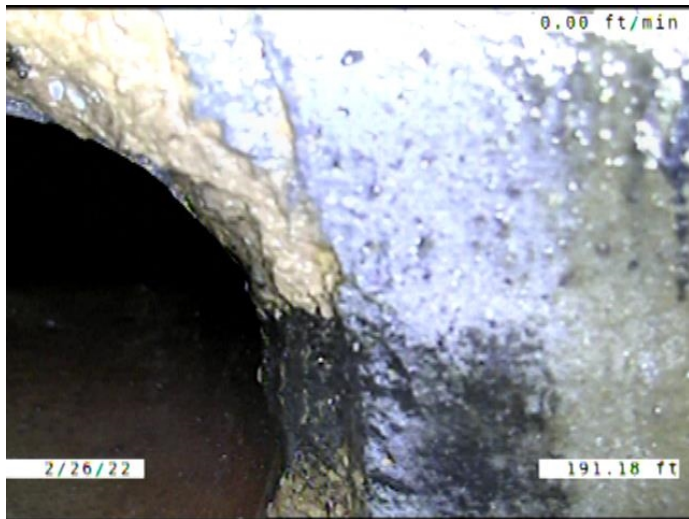
Code:	SSS
Description:	Surface Damage Surface Spalling
Distance (ft):	191.2
Structural Grade:	2
O&M Grade:	0
Clock Start/From:	1
Clock To:	3
1st Value:	
2nd Value:	
Value Percent:	
Continuous Index:	
Within 8" of Joint:	YES
Remarks:

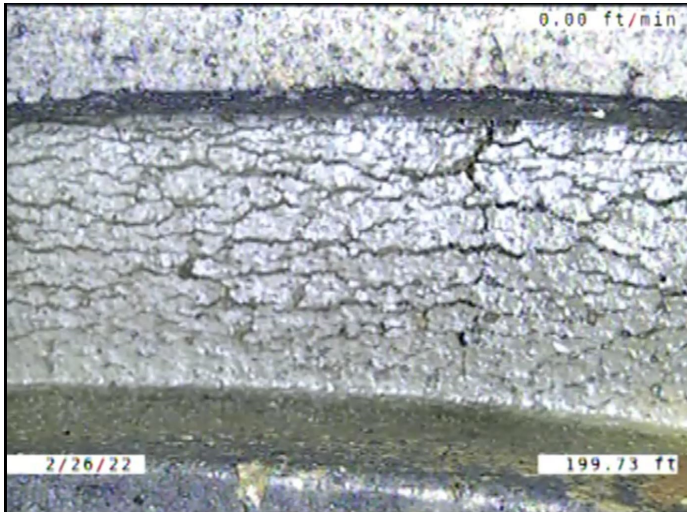
Code: **CM**
 Description: **Crack Multiple**

Distance (ft): **199.7**
 Structural Grade: **3**
 O&M Grade: **0**
 Clock Start/From: **10**
 Clock To: **4**
 1st Value:
 2nd Value:
 Value Percent:
 Continuous Index:
 Within 8" of Joint: **YES**
 Remarks:

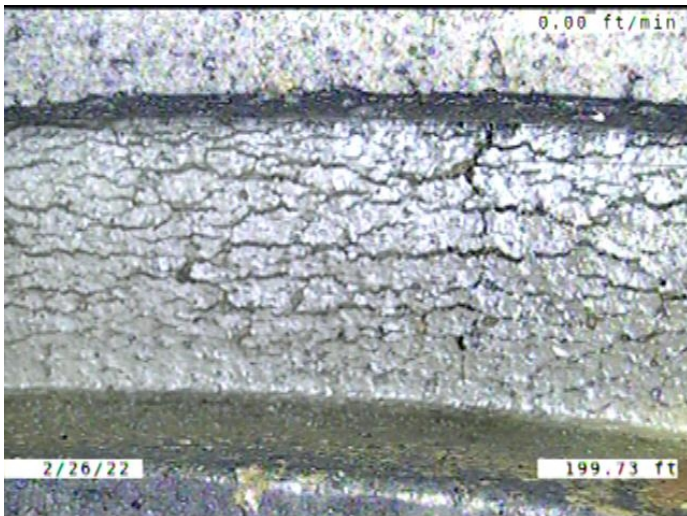
Code: **JAL**
 Description: **Joint Angular Large**

Distance (ft): **199.7**
 Structural Grade: **4**
 O&M Grade: **0**
 Clock Start/From:
 Clock To:
 1st Value:
 2nd Value:
 Value Percent:
 Continuous Index:
 Within 8" of Joint: **NO**
 Remarks:

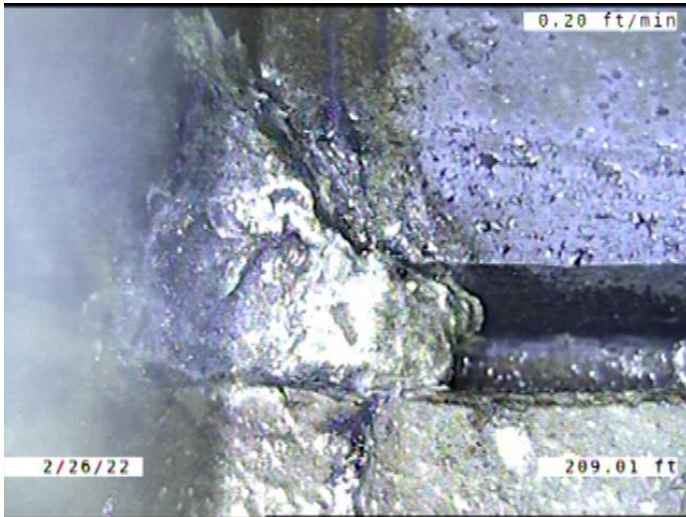
Code: **ISGT**
 Description: **Intruding Sealing Material Grout**

Distance (ft): **209.0**
 Structural Grade: **0**
 O&M Grade: **2**
 Clock Start/From: **4**
 Clock To: **5**
 1st Value:
 2nd Value:
 Value Percent: **5.000**
 Continuous Index:
 Within 8" of Joint: **NO**
 Remarks:

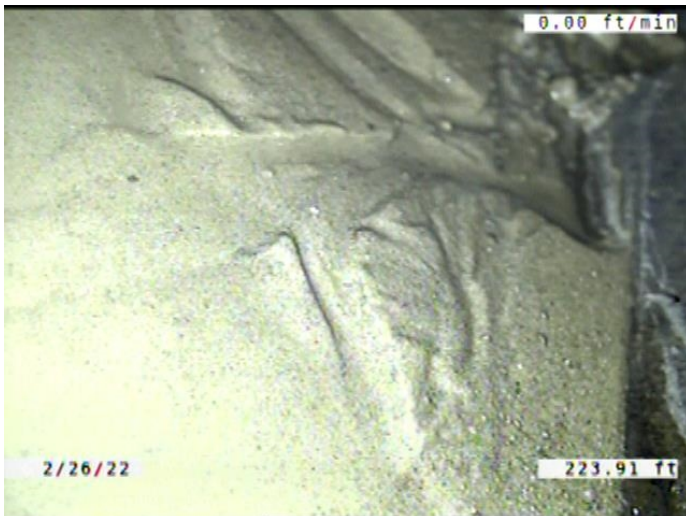
Code: **DSF**
 Description: **Deposits Settled Fine**

Distance (ft): **223.9**
 Structural Grade: **0**
 O&M Grade: **2**
 Clock Start/From: **4**
 Clock To: **7**
 1st Value:
 2nd Value:
 Value Percent: **5.000**
 Continuous Index: **S02**
 Within 8" of Joint: **YES**
 Remarks:

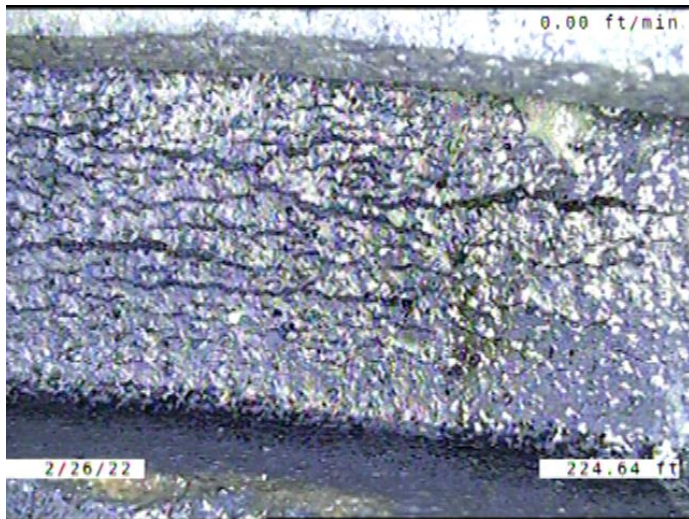
Code: **JAL**
 Description: **Joint Angular Large**

Distance (ft): **224.6**
 Structural Grade: **4**
 O&M Grade: **0**
 Clock Start/From:
 Clock To:
 1st Value:
 2nd Value:
 Value Percent:
 Continuous Index:
 Within 8" of Joint: **NO**
 Remarks:

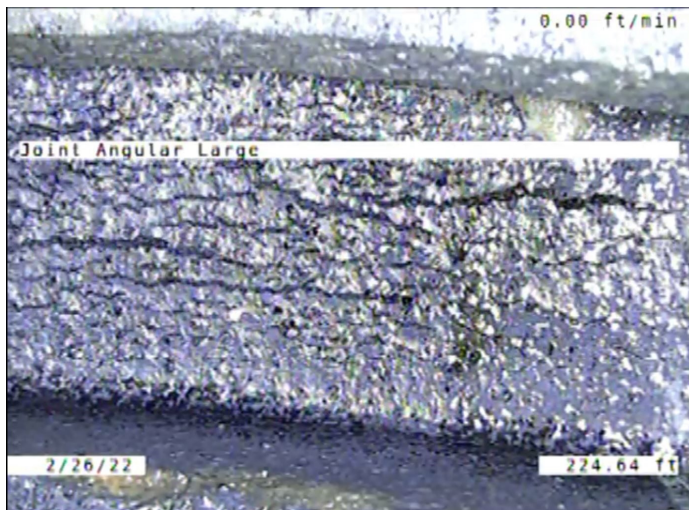
Code: **CM**
 Description: **Crack Multiple**

Distance (ft): **224.6**
 Structural Grade: **3**
 O&M Grade: **0**
 Clock Start/From: **10**
 Clock To: **4**
 1st Value:
 2nd Value:
 Value Percent:
 Continuous Index:
 Within 8" of Joint: **YES**
 Remarks:

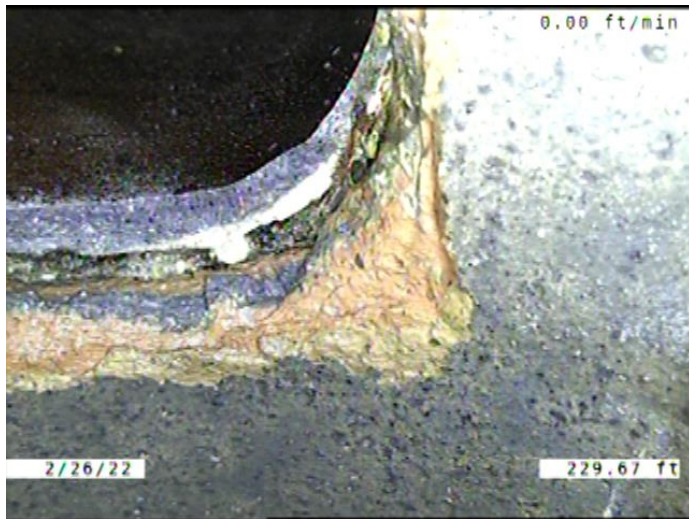
Code: **SSS**
 Description: **Surface Damage Surface Spalling**

Distance (ft): **229.7**
 Structural Grade: **2**
 O&M Grade: **0**
 Clock Start/From: **1**
 Clock To: **3**
 1st Value:
 2nd Value:
 Value Percent:
 Continuous Index:
 Within 8" of Joint: **NO**
 Remarks:

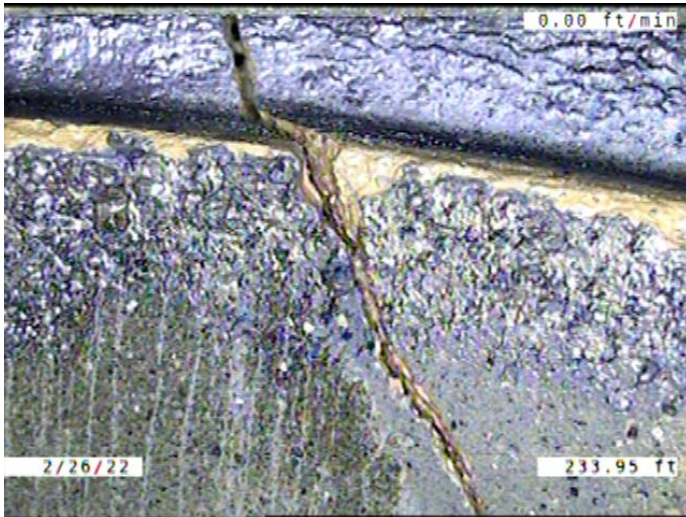
Code: **B**
 Description: **Broken**

Distance (ft): **233.9**
 Structural Grade: **4**
 O&M Grade: **0**
 Clock Start/From: **1**
 Clock To: **4**
 1st Value:
 2nd Value:
 Value Percent:
 Continuous Index:
 Within 8" of Joint: **YES**
 Remarks:

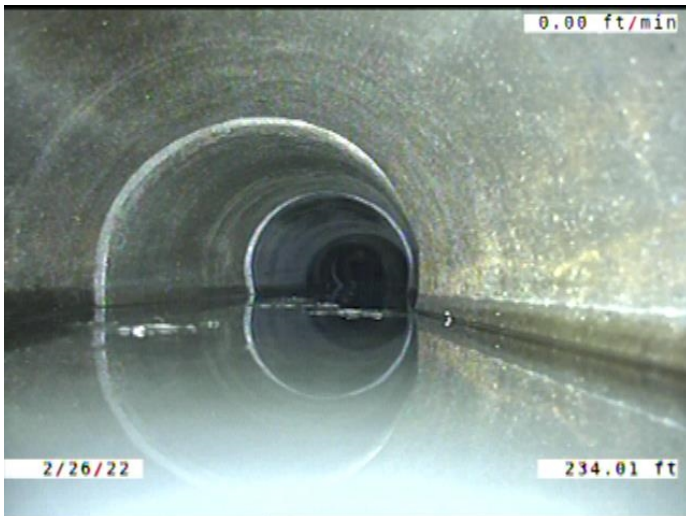
Code: **MWLS**
 Description: **Miscellaneous Water Level Sag**

Distance (ft): **234.0**
 Structural Grade: **2**
 O&M Grade: **0**
 Clock Start/From:
 Clock To:
 1st Value:
 2nd Value:
 Value Percent: **25.000**
 Continuous Index: **S03**
 Within 8" of Joint: **NO**
 Remarks:

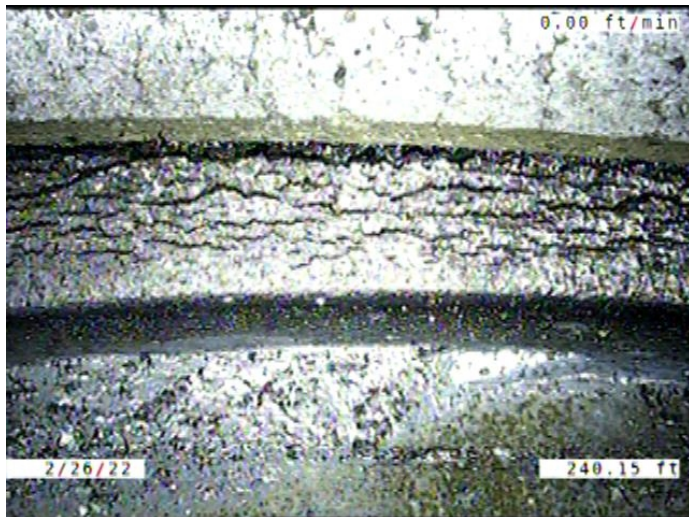
Code: **JSM**
 Description: **Joint Separated Medium**

Distance (ft): **240.1**
 Structural Grade: **3**
 O&M Grade: **0**
 Clock Start/From:
 Clock To:
 1st Value:
 2nd Value:
 Value Percent:
 Continuous Index:
 Within 8" of Joint: **NO**
 Remarks:

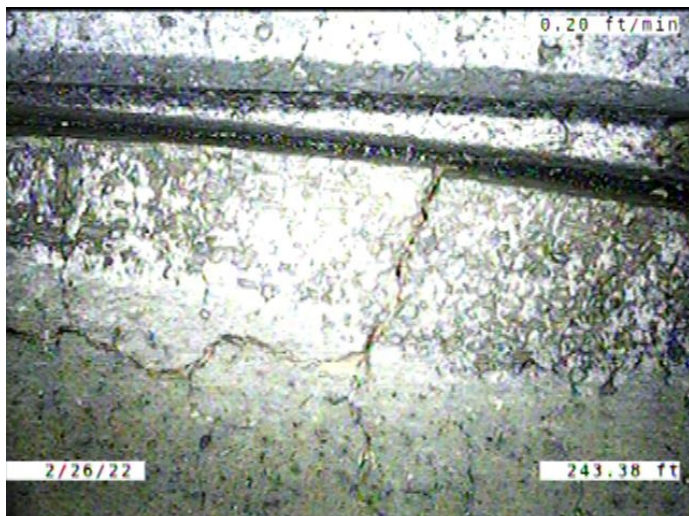
Code: **FM**
 Description: **Fracture Multiple**

Distance (ft): **243.4**
 Structural Grade: **4**
 O&M Grade: **0**
 Clock Start/From: **10**
 Clock To: **1**
 1st Value:
 2nd Value:
 Value Percent:
 Continuous Index: **S04**
 Within 8" of Joint: **YES**
 Remarks:

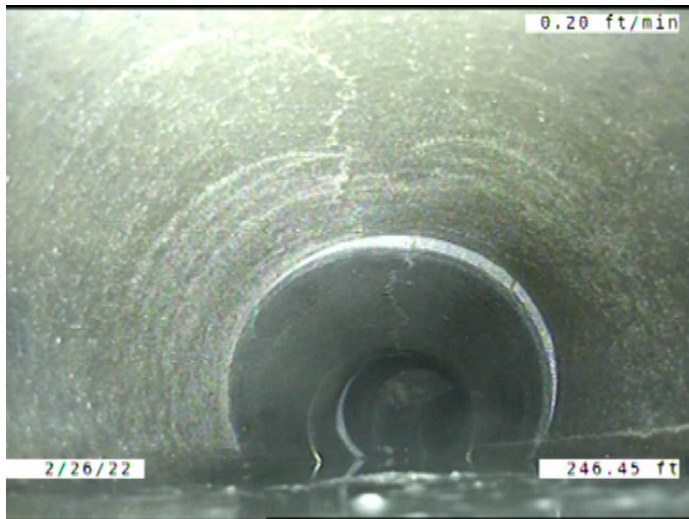
Code: **CM**
Description: **Crack Multiple**

Distance (ft): **246.4**
Structural Grade: **3**
O&M Grade: **0**
Clock Start/From: **11**
Clock To: **1**
1st Value:
2nd Value:
Value Percent:
Continuous Index: **F01**
Within 8" of Joint: **YES**
Remarks:

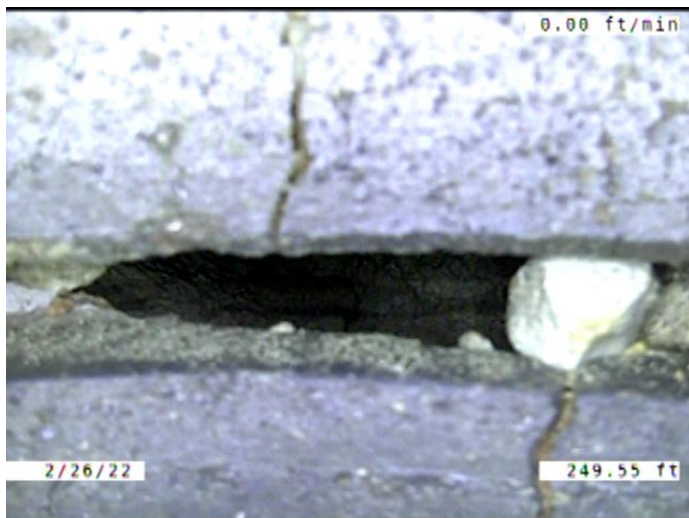
Code: **HVV**
Description: **Hole Void Visible**

Distance (ft): **249.5**
Structural Grade: **5**
O&M Grade: **0**
Clock Start/From: **10**
Clock To: **2**
1st Value:
2nd Value:
Value Percent:
Continuous Index:
Within 8" of Joint: **YES**
Remarks:

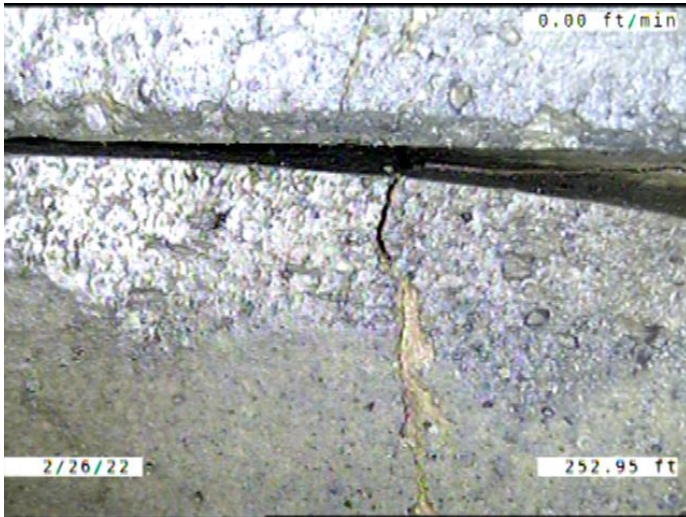
Code: **B**
Description: **Broken**

Distance (ft): **252.9**
Structural Grade: **4**
O&M Grade: **0**
Clock Start/From: **9**
Clock To: **3**
1st Value:
2nd Value:
Value Percent:
Continuous Index:
Within 8" of Joint: **YES**
Remarks:

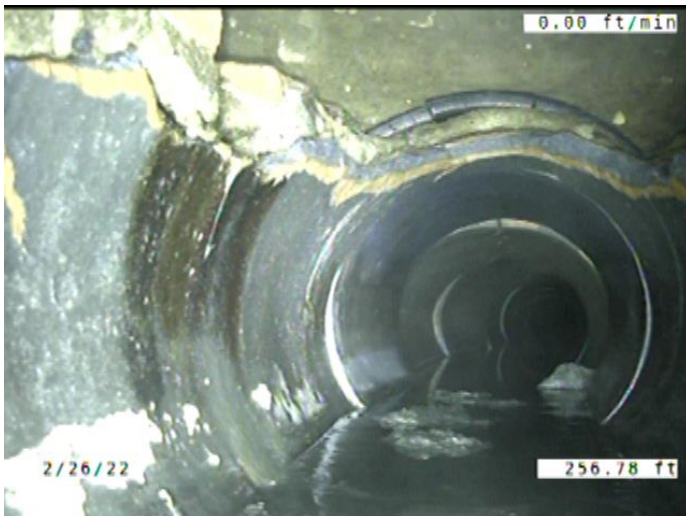
Code: **DSF**
Description: **Deposits Settled Fine**

Distance (ft): **256.8**
Structural Grade: **0**
O&M Grade: **2**
Clock Start/From: **4**
Clock To: **7**
1st Value:
2nd Value:
Value Percent: **5.000**
Continuous Index: **F02**
Within 8" of Joint: **YES**
Remarks:

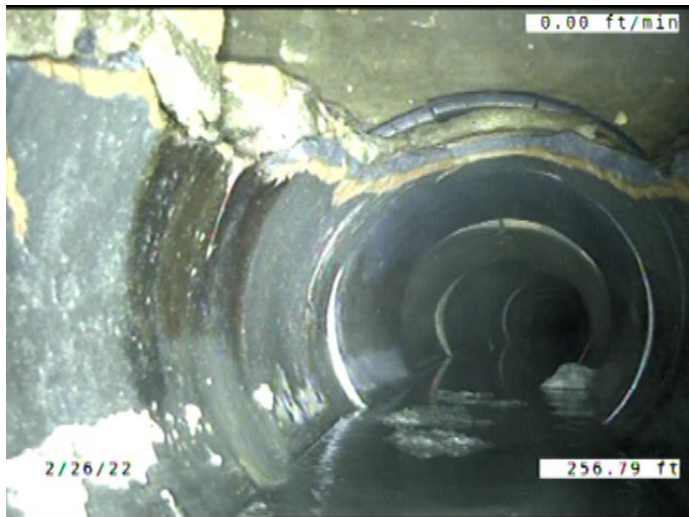
Code: **FM**
 Description: **Fracture Multiple**

Distance (ft): **256.8**
 Structural Grade: **4**
 O&M Grade: **0**
 Clock Start/From: **10**
 Clock To: **1**
 1st Value:
 2nd Value:
 Value Percent:
 Continuous Index: **F04**
 Within 8" of Joint: **YES**
 Remarks:

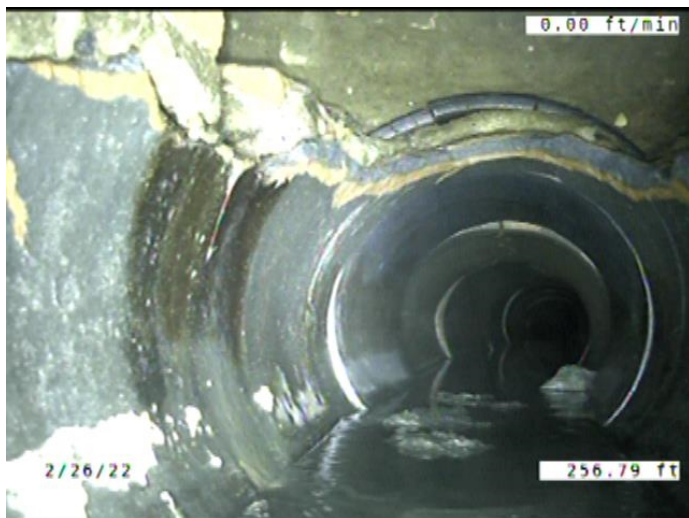
Code: **MWLS**
 Description: **Miscellaneous Water Level Sag**

Distance (ft): **256.8**
 Structural Grade: **2**
 O&M Grade: **0**
 Clock Start/From:
 Clock To:
 1st Value:
 2nd Value:
 Value Percent: **25.000**
 Continuous Index: **F03**
 Within 8" of Joint: **NO**
 Remarks:
