Profile/Photo Observation Report

Date:	05/01/2018	Weather:		Coding:	PACP 6.0
Pipe Length (ft):		Owner:	City of Hobart	Pre Clean:	Not Known
P.O.#:	273	Surveyor:	B. Helbling	PSR:	P-706-019-020
Customer:	City of Hobart	Clean Date:		Shape:	C

Location Details:		Direction of Survey:	Downstream
US MH:	M-706-019	DS MH:	M-706-020
		Total Length Surveyed (ft):	2.1

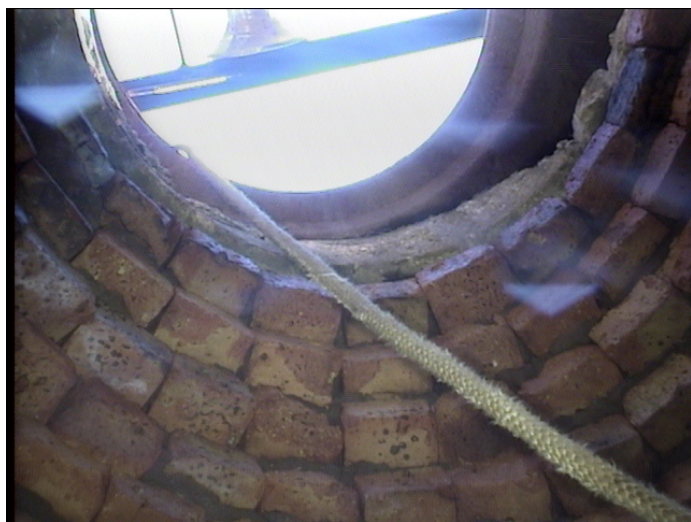
Code: **AMH**
Description: **Manhole**

Distance (ft): **.0**
Structural Grade: **0**
O&M Grade: **0**
Clock Start/From:
Clock To:
1st Value:
2nd Value:
Value Percent:
Continuous Index:
Within 8" of Joint: **NO**
Remarks: **M-706-019**

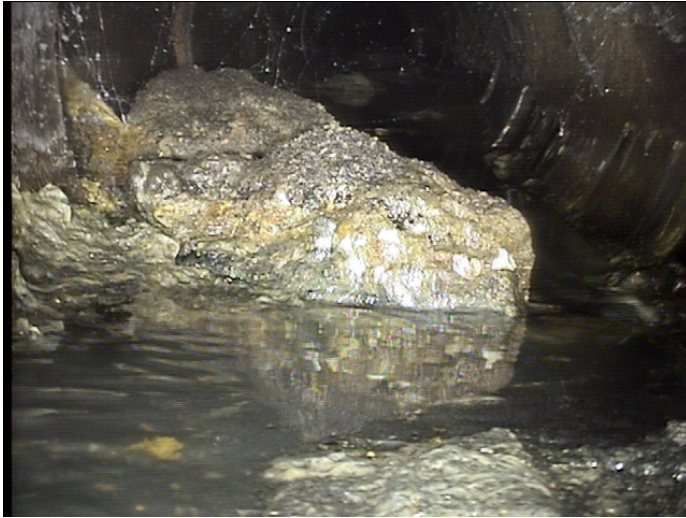
Code: **MWL**
Description: **Water Level**

Distance (ft): **.0**
Structural Grade: **0**
O&M Grade: **0**
Clock Start/From:
Clock To:
1st Value:
2nd Value:
Value Percent: **5.000**
Continuous Index:
Within 8" of Joint: **NO**
Remarks:

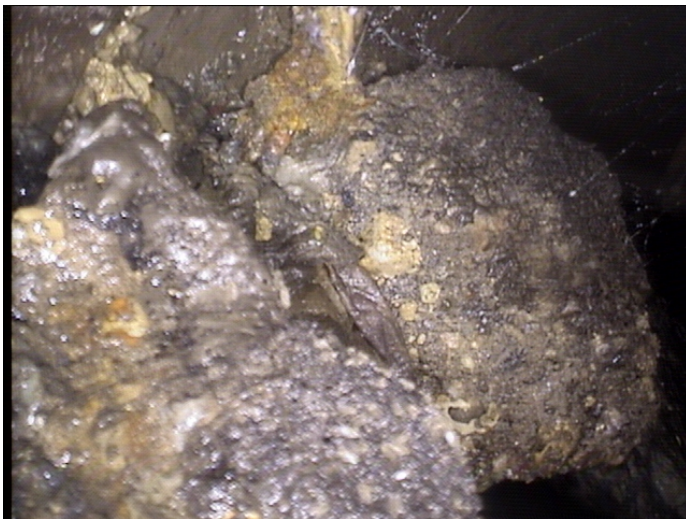
Code: **DSZ**
Description: **Deposits Settled Other**

Distance (ft): **2.0**
Structural Grade: **0**
O&M Grade: **3**
Clock Start/From: **5**
Clock To: **9**
1st Value:
2nd Value:
Value Percent: **20.000**
Continuous Index:
Within 8" of Joint: **NO**
Remarks: **Debris**

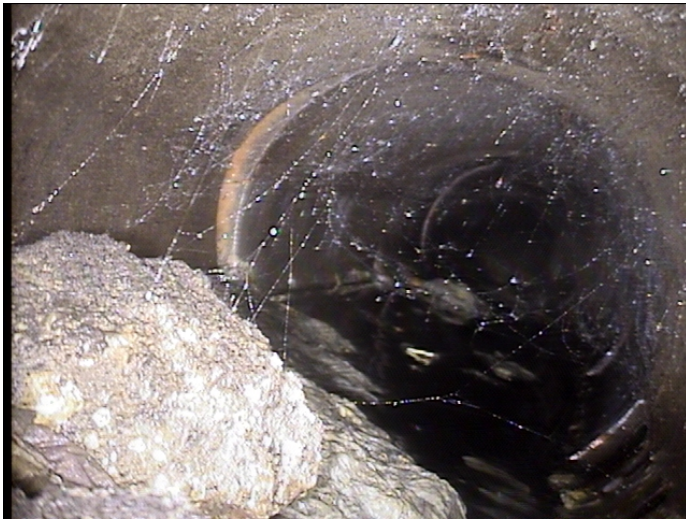
Code:	MSA
Description:	Abandoned Survey
Distance (ft):	2.1
Structural Grade:	0
O&M Grade:	0
Clock Start/From:	
Clock To:	
1st Value:	
2nd Value:	
Value Percent:	
Continuous Index:	
Within 8" of Joint:	NO
Remarks:	Debris/ragging
