Profile/Photo Observation Report

Street:	Lincoln Street	Flow Control:	
City:	Hobart, IN	Year Renewed:	
Location:	Light Highway	Tape/Media #:	934
Purpose:	Routine Assessment	Dia/Height:	10"
Use:	Sanitary	Material:	VCP
Drain Area:		Lining:	
Category:	NA		
Comment:

Location Details:		Direction of Survey:	Downstream
US MH:	M-706-21	DS MH:	M-706-22
		Total Length Surveyed (ft):	18.7

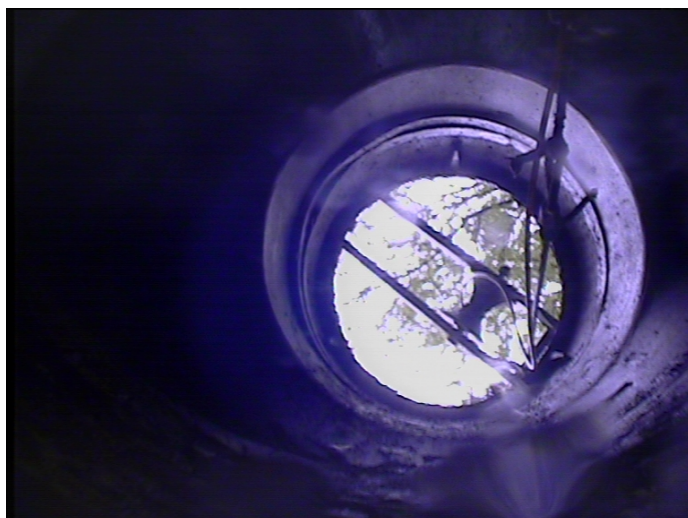
Code: **AMH**
 Description: **Manhole**

Distance (ft): **.0**
 Structural Grade: **0**
 O&M Grade: **0**
 Clock Start/From:
 Clock To:
 1st Value:
 2nd Value:
 Value Percent:
 Continuous Index:
 Within 8" of Joint: **NO**
 Remarks: **M-706-21**

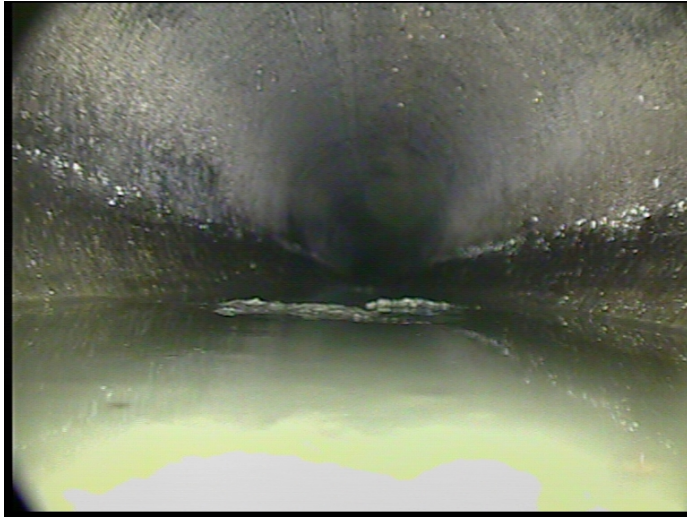
Code:	MWL
Description:	Water Level
Distance (ft):	.0
Structural Grade:	0
O&M Grade:	0
Clock Start/From:	
Clock To:	
1st Value:	
2nd Value:	
Value Percent:	10.000
Continuous Index:	
Within 8" of Joint:	NO
Remarks:

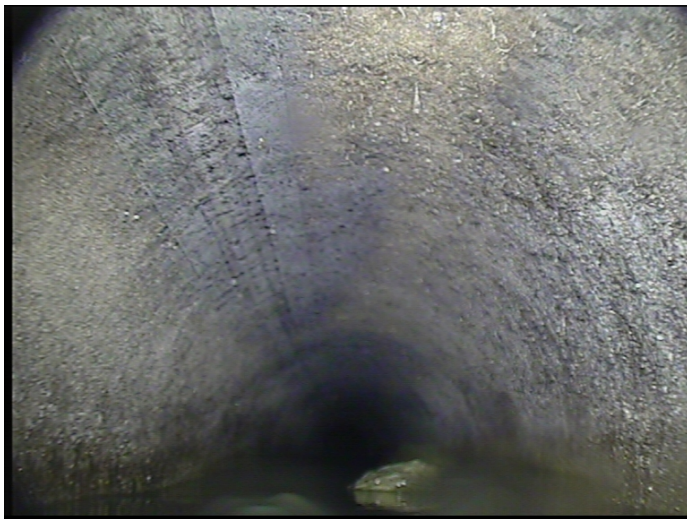
Code:	MWL
Description:	Water Level
Distance (ft):	14.3
Structural Grade:	0
O&M Grade:	0
Clock Start/From:	
Clock To:	
1st Value:	
2nd Value:	
Value Percent:	35.000
Continuous Index:	
Within 8" of Joint:	NO
Remarks:

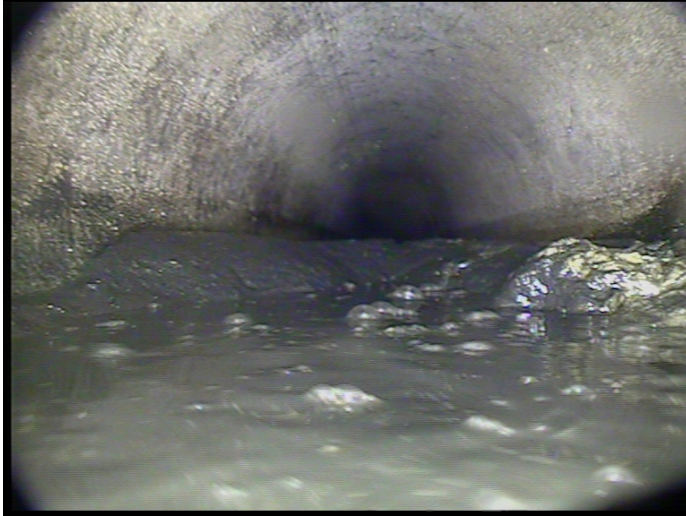
Code: **DSF**
Description: **Deposits Settled Fine**

Distance (ft): **15.7**
Structural Grade: **0**
O&M Grade: **4**
Clock Start/From: **4**
Clock To: **8**
1st Value:
2nd Value:
Value Percent: **25.000**
Continuous Index:
Within 8" of Joint: **NO**
Remarks:

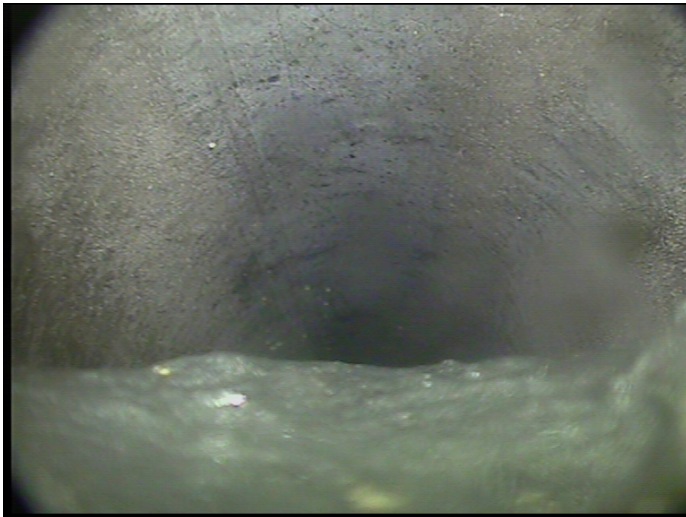
Code: **MSA**
Description: **Abandoned Survey**

Distance (ft): **18.7**
Structural Grade: **0**
O&M Grade: **0**
Clock Start/From:
Clock To:
1st Value:
2nd Value:
Value Percent:
Continuous Index:
Within 8" of Joint: **NO**
Remarks: **deep sediment**
