Profile/Photo Observation Report

Street:	Lincoln Street	Flow Control:	
City:	Hobart, IN	Year Renewed:	
Location:	Light Highway	Tape/Media #:	931
Purpose:	Routine Assessment	Dia/Height:	10"
Use:	Sanitary	Material:	VCP
Drain Area:		Lining:	
Category:	NA		
Comment:

Location Details:		Direction of Survey:	Downstream
US MH:	M-706-22	DS MH:	M-706-23
		Total Length Surveyed (ft):	11.8

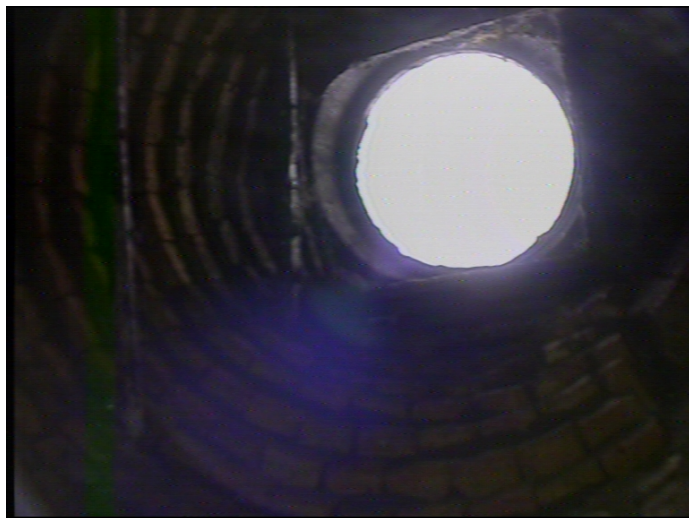
Code: **AMH**
Description: **Manhole**

Distance (ft): **.0**
Structural Grade: **0**
O&M Grade: **0**
Clock Start/From:
Clock To:
1st Value:
2nd Value:
Value Percent:
Continuous Index:
Within 8" of Joint: **NO**
Remarks: **M-706-22**

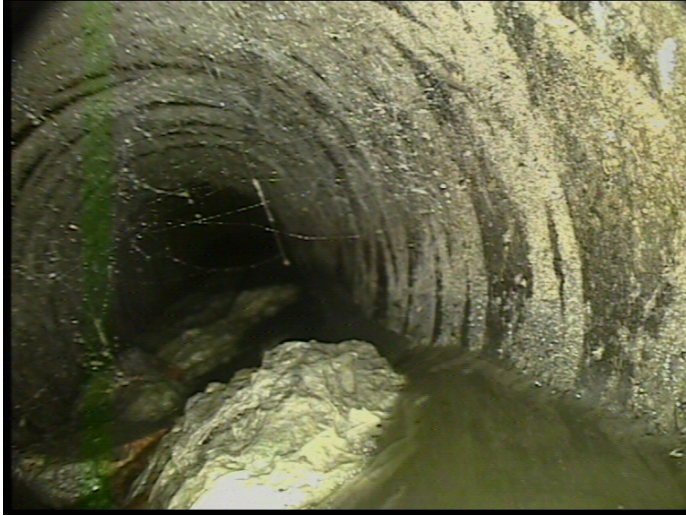
Code:	MWL
Description:	Water Level
Distance (ft):	.0
Structural Grade:	0
O&M Grade:	0
Clock Start/From:	
Clock To:	
1st Value:	
2nd Value:	
Value Percent:	5.000
Continuous Index:	
Within 8" of Joint:	NO
Remarks:

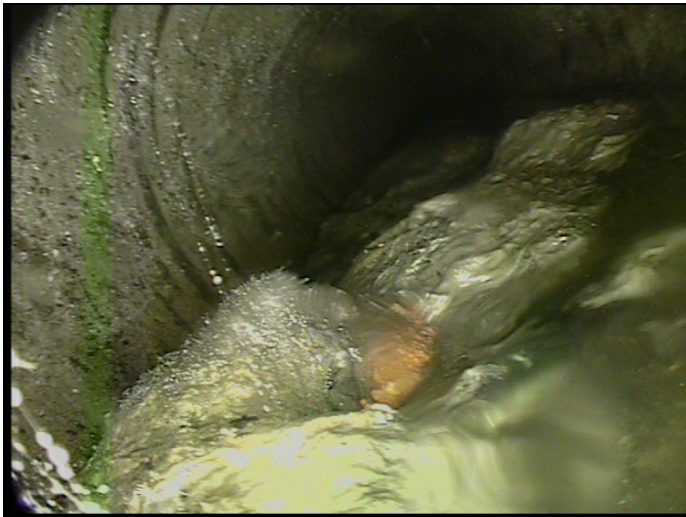
Code:	OBB
Description:	Obstacle Brick
Distance (ft):	2.7
Structural Grade:	0
O&M Grade:	2
Clock Start/From:	6
Clock To:	8
1st Value:	
2nd Value:	
Value Percent:	10.000
Continuous Index:	
Within 8" of Joint:	NO
Remarks:

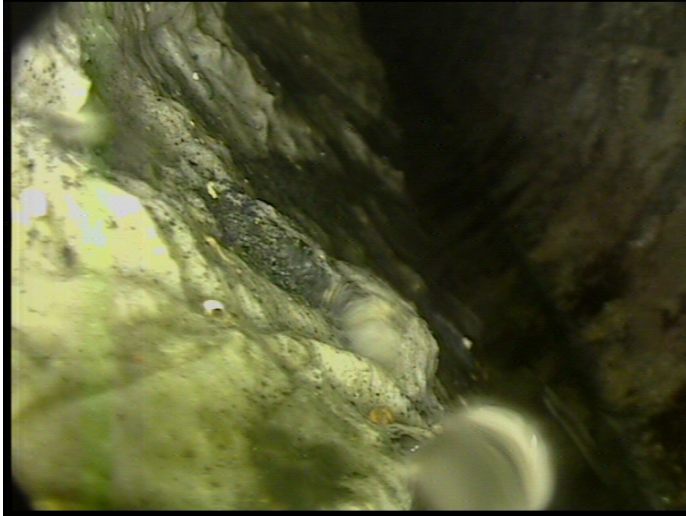
Code:	DSF
Description:	Deposits Settled Fine
Distance (ft):	11.8
Structural Grade:	0
O&M Grade:	3
Clock Start/From:	4
Clock To:	8
1st Value:	
2nd Value:	
Value Percent:	15.000
Continuous Index:	
Within 8" of Joint:	NO
Remarks:

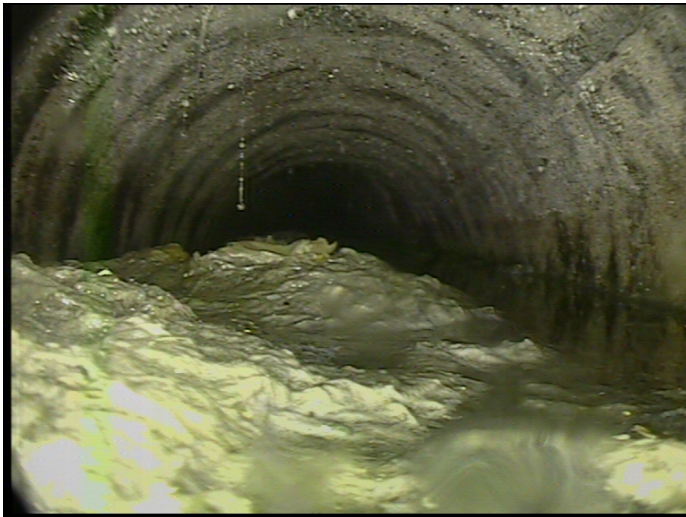
Code:	MSA
Description:	Abandoned Survey
Distance (ft):	11.8
Structural Grade:	0
O&M Grade:	0
Clock Start/From:	
Clock To:	
1st Value:	
2nd Value:	
Value Percent:	
Continuous Index:	
Within 8" of Joint:	NO
Remarks:	Sediment and debris
