Profile/Photo Observation Report

Date:	10/21/2021	Weather:		Coding:	PACP 6.0
Pipe Length (ft):		Owner:	Hobart, IN	Pre Clean:	Not Known
P.O.#:	933_1	Surveyor:	M. Pielacha	PSR:	P-706-023-022
Customer:	Hobart, IN	Clean Date:		Shape:	C

Street:	Lincoln Street	Flow Control:	
City:	Hobart, IN	Year Renewed:	
Location:	Light Highway	Tape/Media #:	933
Purpose:	Reversal	Dia/Height:	10"
Use:	Sanitary	Material:	VCP
Drain Area:		Lining:	
Category:	NA		
Comment:

Location Details:		Direction of Survey:	Upstream
US MH:	M-706-22	DS MH:	M-706-23
		Total Length Surveyed (ft):	61.3

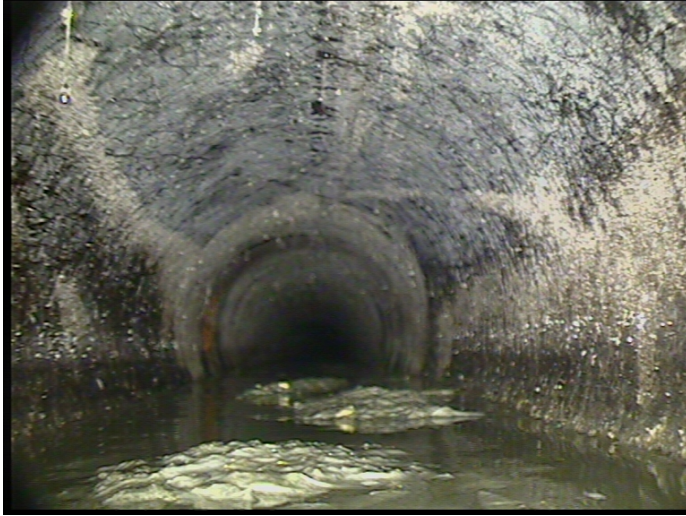
Code: **MWL**
Description: **Water Level**

Distance (ft): **.0**
Structural Grade: **0**
O&M Grade: **0**
Clock Start/From:
Clock To:
1st Value:
2nd Value:
Value Percent: **15.000**
Continuous Index:
Within 8" of Joint: **NO**
Remarks:

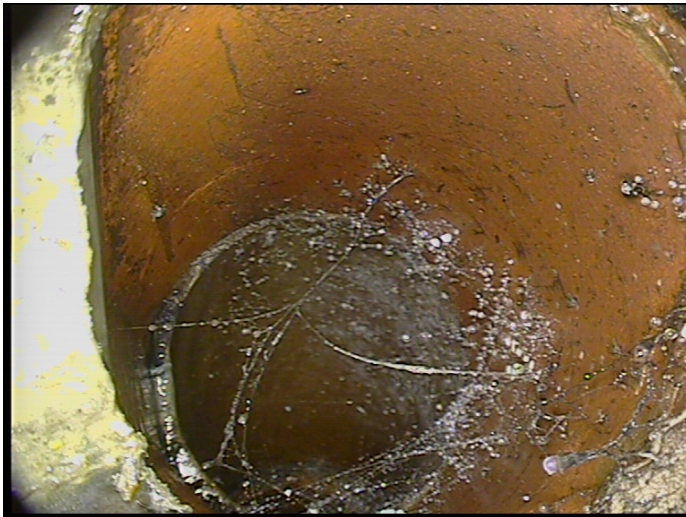
Code: **TBA**
Description: **Tap Break-in Active**

Distance (ft): **5.2**
Structural Grade: **0**
O&M Grade: **0**
Clock Start/From: **9**
Clock To:
1st Value: **4.000**
2nd Value:
Value Percent:
Continuous Index:
Within 8" of Joint: **NO**
Remarks:

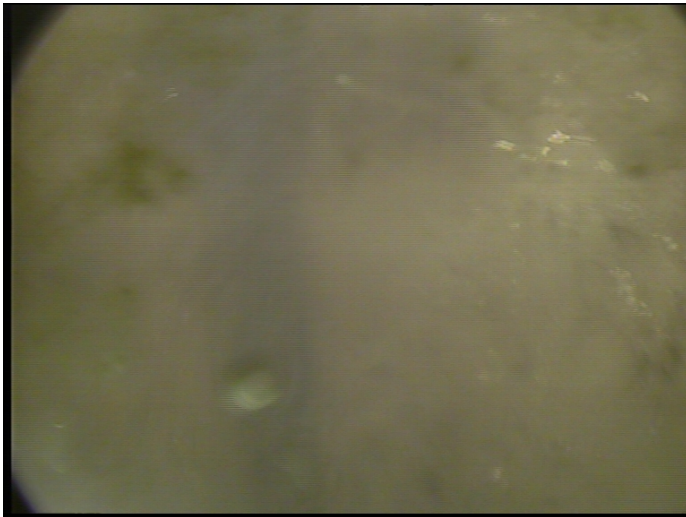
Code:	MWL
Description:	Water Level
Distance (ft):	39.4
Structural Grade:	0
O&M Grade:	0
Clock Start/From:	
Clock To:	
1st Value:	
2nd Value:	
Value Percent:	50.000
Continuous Index:	
Within 8" of Joint:	NO
Remarks:
