Profile/Photo Observation Report

Street:	Lincoln Street	Flow Control:	
City:	Hobart, IN	Year Renewed:	
Location:	Light Highway	Tape/Media #:	932
Purpose:	Routine Assessment	Dia/Height:	10"
Use:	Sanitary	Material:	VCP
Drain Area:		Lining:	
Category:	NA		
Comment:

Location Details:		Direction of Survey:	Upstream
US MH:	M-706-23	DS MH:	M-706-9
		Total Length Surveyed (ft):	126.0

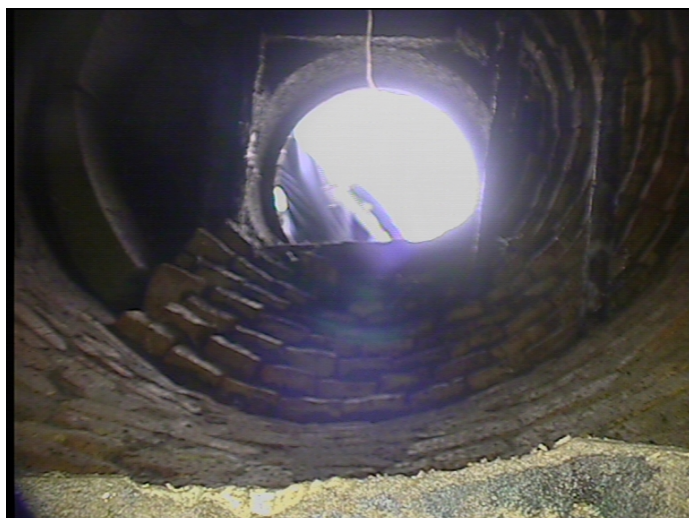
Code: **AMH**
Description: **Manhole**

Distance (ft): **.0**
Structural Grade: **0**
O&M Grade: **0**
Clock Start/From:
Clock To:
1st Value:
2nd Value:
Value Percent:
Continuous Index:
Within 8" of Joint: **NO**
Remarks: **M-706-9**

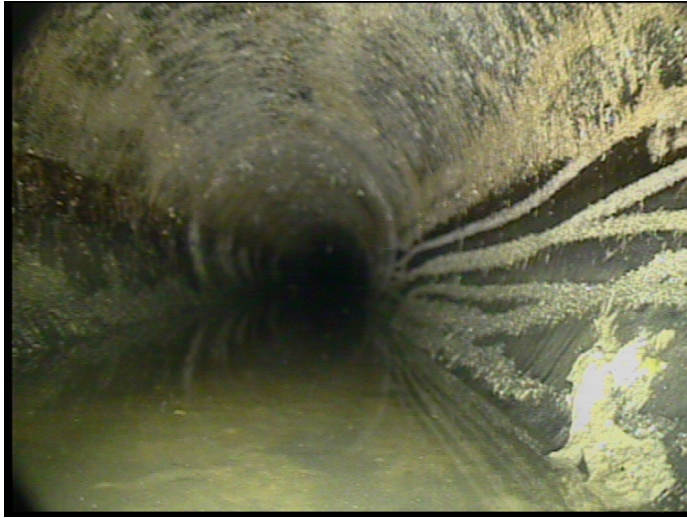
Code:	MWL
Description:	Water Level
Distance (ft):	.0
Structural Grade:	0
O&M Grade:	0
Clock Start/From:	
Clock To:	
1st Value:	
2nd Value:	
Value Percent:	10.000
Continuous Index:	
Within 8" of Joint:	NO
Remarks:

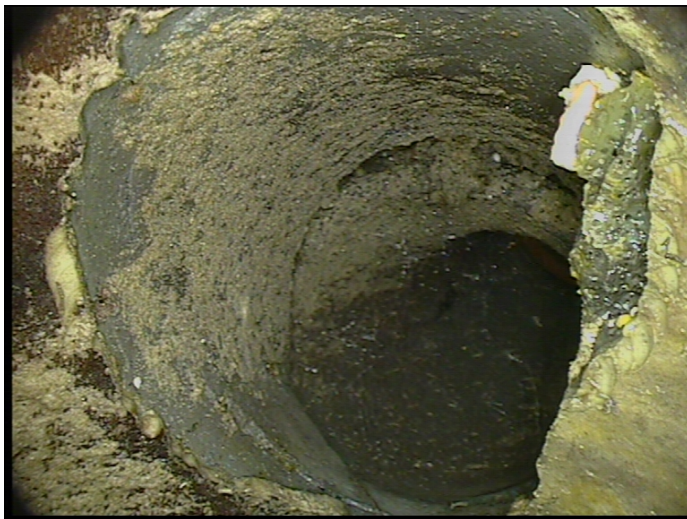
Code:	TF
Description:	Tap Factory
Distance (ft):	14.2
Structural Grade:	0
O&M Grade:	0
Clock Start/From:	2
Clock To:	
1st Value:	4.000
2nd Value:	
Value Percent:	
Continuous Index:	
Within 8" of Joint:	NO
Remarks:

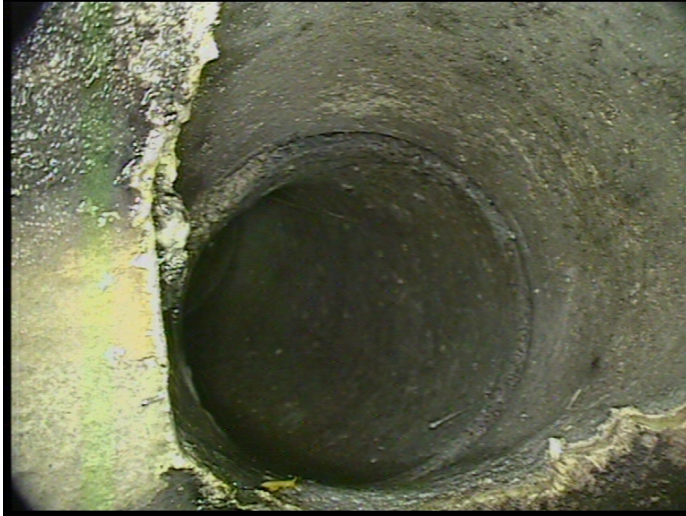
Code: **TF**
Description: **Tap Factory**

Distance (ft): **22.6**
Structural Grade: **0**
O&M Grade: **0**
Clock Start/From: **10**
Clock To:
1st Value: **4.000**
2nd Value:
Value Percent:
Continuous Index:
Within 8" of Joint: **NO**
Remarks:

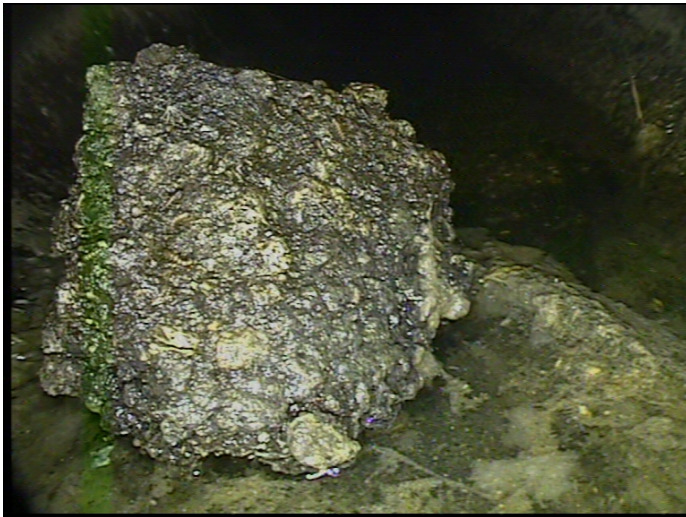
Code: **OBR**
Description: **Obstacle Rocks**

Distance (ft): **49.2**
Structural Grade: **0**
O&M Grade: **2**
Clock Start/From: **6**
Clock To:
1st Value:
2nd Value:
Value Percent: **10.000**
Continuous Index:
Within 8" of Joint: **NO**
Remarks:

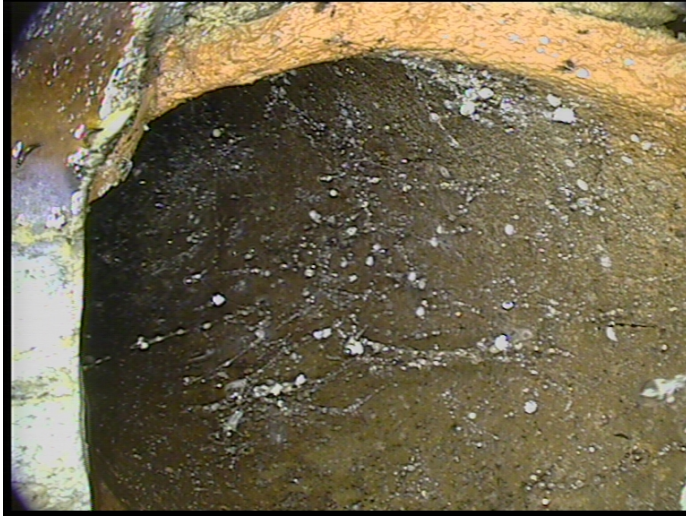
Code: **TBA**
Description: **Tap Break-in Active**

Distance (ft): **51.8**
Structural Grade: **0**
O&M Grade: **0**
Clock Start/From: **10**
Clock To:
1st Value: **4.000**
2nd Value:
Value Percent:
Continuous Index:
Within 8" of Joint: **NO**
Remarks:

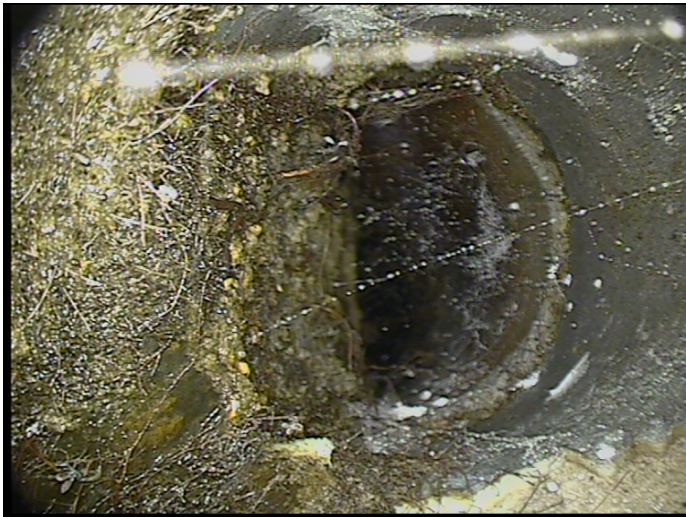
Code: **TFD**
Description: **Tap Factory Defective**

Distance (ft): **91.7**
Structural Grade: **0**
O&M Grade: **2**
Clock Start/From: **9**
Clock To:
1st Value: **4.000**
2nd Value:
Value Percent:
Continuous Index:
Within 8" of Joint: **NO**
Remarks: **roots**

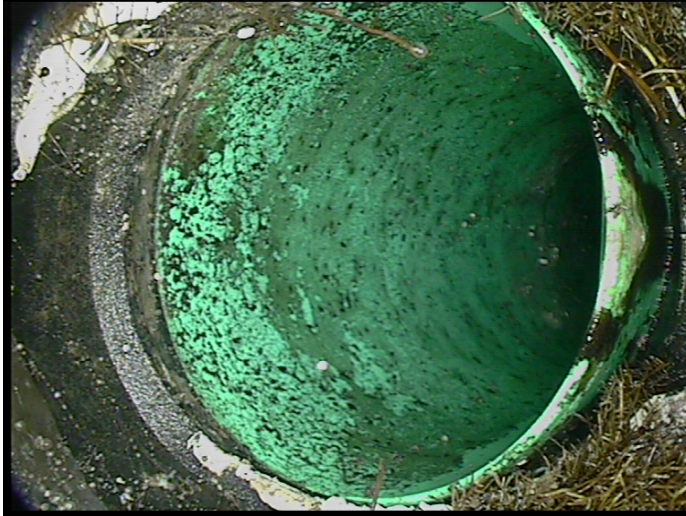
Code:	TBD
Description:	Tap Break-in Defective
Distance (ft):	95.2
Structural Grade:	0
O&M Grade:	3
Clock Start/From:	3
Clock To:	
1st Value:	4.000
2nd Value:	
Value Percent:	
Continuous Index:	
Within 8" of Joint:	NO
Remarks:	roots

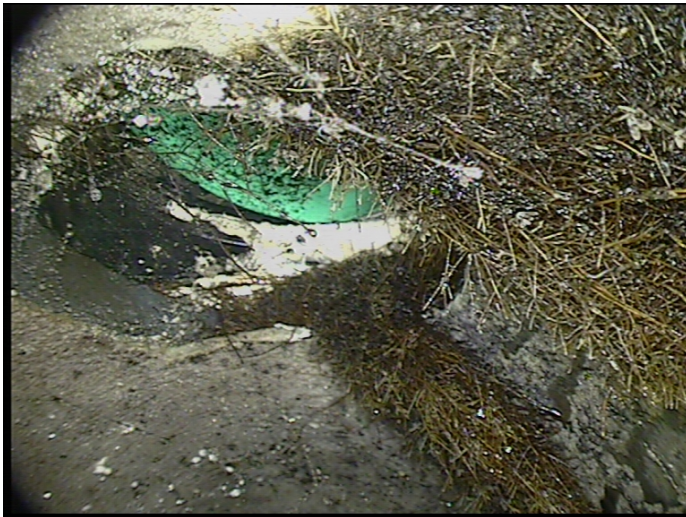
Code:	RML
Description:	Roots Medium Lateral
Distance (ft):	95.2
Structural Grade:	0
O&M Grade:	3
Clock Start/From:	2
Clock To:	5
1st Value:	
2nd Value:	
Value Percent:	5.000
Continuous Index:	
Within 8" of Joint:	NO
Remarks:

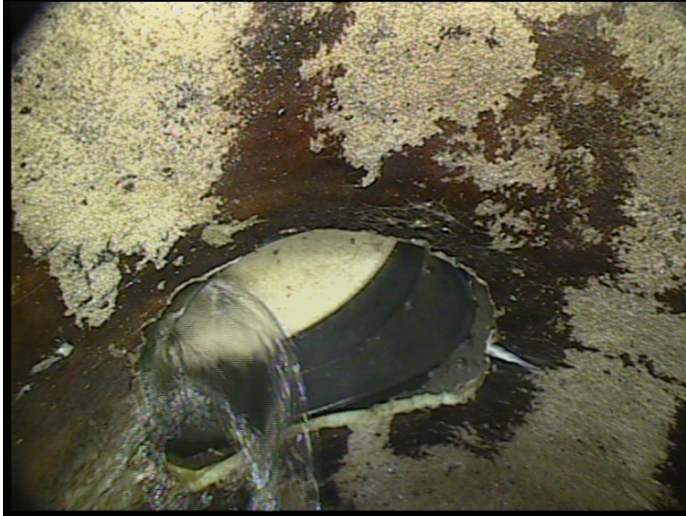
Code: **TBA**
Description: **Tap Break-in Active**

Distance (ft): **115.7**
Structural Grade: **0**
O&M Grade: **0**
Clock Start/From: **10**
Clock To:
1st Value: **4.000**
2nd Value:
Value Percent:
Continuous Index:
Within 8" of Joint: **NO**
Remarks:

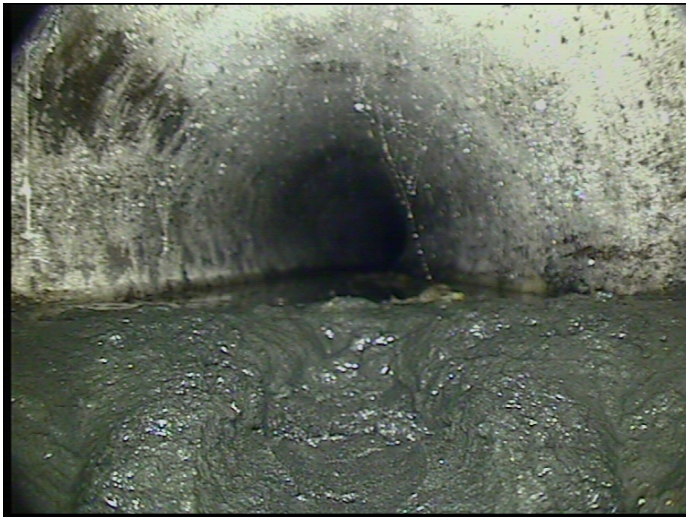
Code: **DSF**
Description: **Deposits Settled Fine**

Distance (ft): **124.2**
Structural Grade: **0**
O&M Grade: **3**
Clock Start/From: **4**
Clock To: **8**
1st Value:
2nd Value:
Value Percent: **15.000**
Continuous Index:
Within 8" of Joint: **YES**
Remarks:

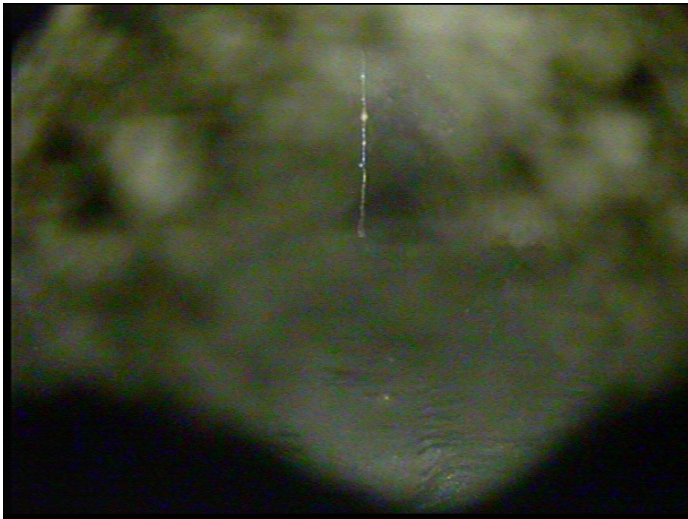
Code:	MSA
Description:	Abandoned Survey
Distance (ft):	126.0
Structural Grade:	0
O&M Grade:	0
Clock Start/From:	
Clock To:	
1st Value:	
2nd Value:	
Value Percent:	
Continuous Index:	
Within 8" of Joint:	NO
Remarks:	deep sediment
