Profile/Photo Observation Report

Street:	Lincoln Street	Flow Control:	
City:	Hobart, IN	Year Renewed:	
Location:	Light Highway	Tape/Media #:	955
Purpose:	Routine Assessment	Dia/Height:	10"
Use:	Sanitary	Material:	VCP
Drain Area:		Lining:	
Category:	NA		
Comment:

Location Details:		Direction of Survey:	Upstream
US MH:	M-706-23	DS MH:	M-706-9
		Total Length Surveyed (ft):	104.6

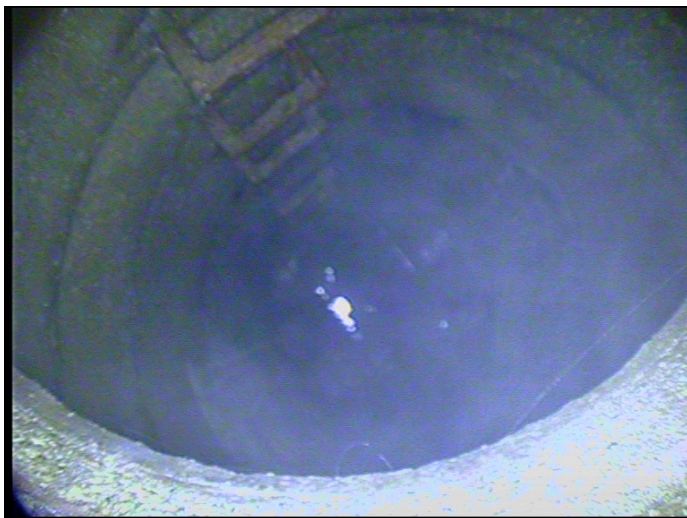
Code:	AMH
Description:	Manhole
Distance (ft):	.0
Structural Grade:	0
O&M Grade:	0
Clock Start/From:	
Clock To:	
1st Value:	
2nd Value:	
Value Percent:	
Continuous Index:	
Within 8" of Joint:	NO
Remarks:	M-706-9

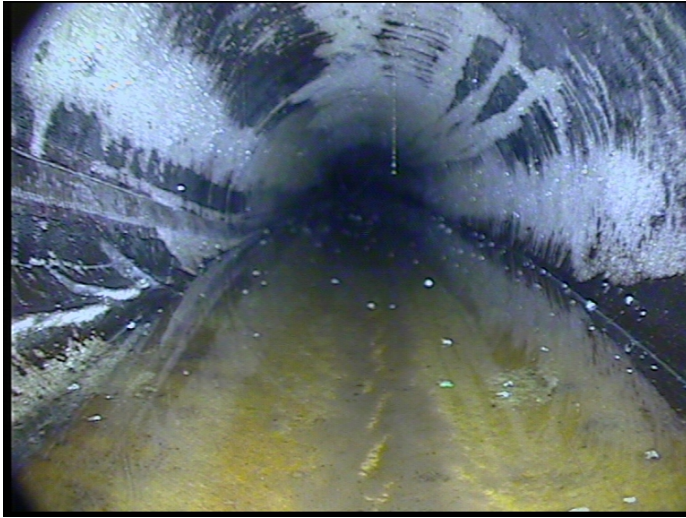
Code: **MWL**
Description: **Water Level**

Distance (ft): **.0**
Structural Grade: **0**
O&M Grade: **0**
Clock Start/From:
Clock To:
1st Value:
2nd Value:
Value Percent: **25.000**
Continuous Index:
Within 8" of Joint: **NO**
Remarks:

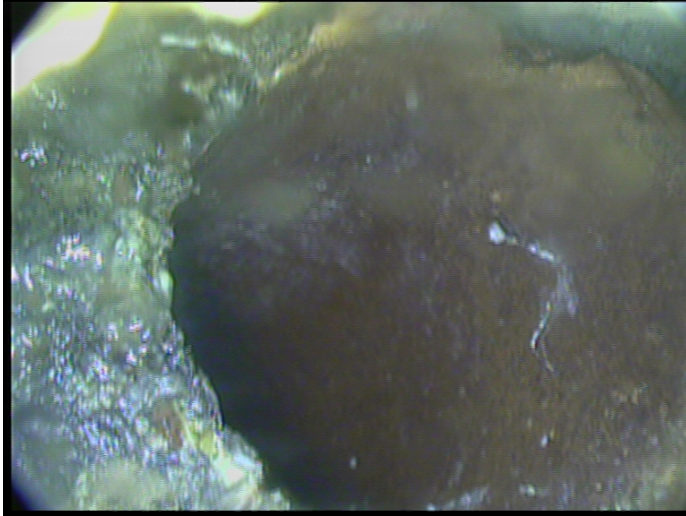
Code: **TB**
Description: **Tap Break-in**

Distance (ft): **77.6**
Structural Grade: **0**
O&M Grade: **0**
Clock Start/From: **10**
Clock To:
1st Value: **4.000**
2nd Value:
Value Percent:
Continuous Index:
Within 8" of Joint: **NO**
Remarks:

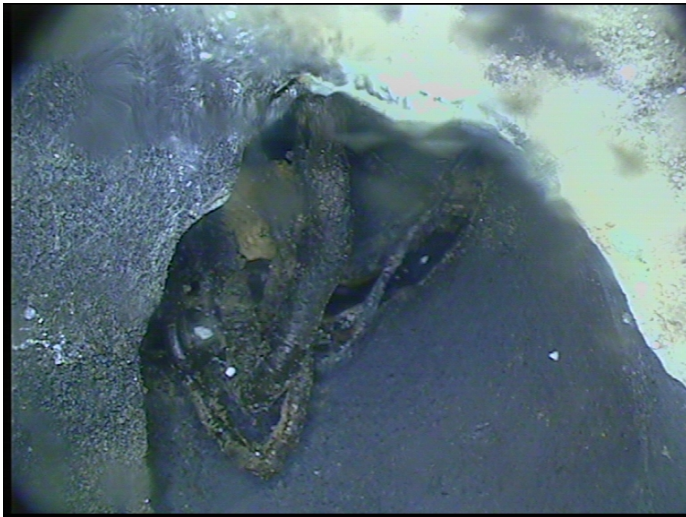
Code: **TFD**
Description: **Tap Factory Defective**

Distance (ft): **79.8**
Structural Grade: **0**
O&M Grade: **2**
Clock Start/From: **10**
Clock To:
1st Value: **4.000**
2nd Value:
Value Percent:
Continuous Index:
Within 8" of Joint: **NO**
Remarks: **roots**

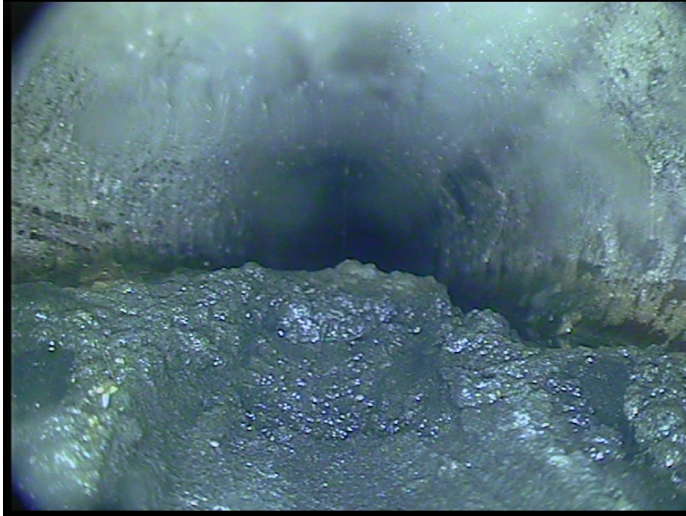
Code: **DSF**
Description: **Deposits Settled Fine**

Distance (ft): **102.9**
Structural Grade: **0**
O&M Grade: **4**
Clock Start/From: **4**
Clock To: **8**
1st Value:
2nd Value:
Value Percent: **25.000**
Continuous Index:
Within 8" of Joint: **NO**
Remarks:

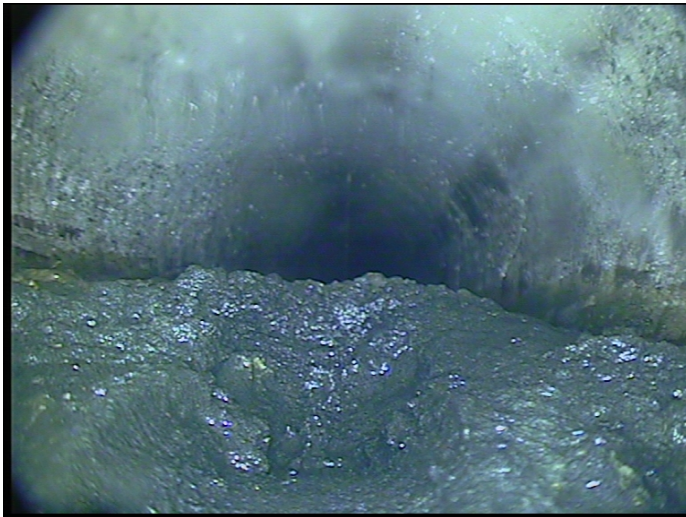
Code: **MSA**
Description: **Abandoned Survey**

Distance (ft): **104.5**
Structural Grade: **0**
O&M Grade: **0**
Clock Start/From:
Clock To:
1st Value:
2nd Value:
Value Percent:
Continuous Index:
Within 8" of Joint: **NO**
Remarks: **Deep sediment**
