Profile/Photo Observation Report

Profile/Photo Observation Report								
Date: Pipe Length (ft) P.O.#: Customer:	10/23/2021): 975_1 Hobart, IN	Weather: Owner: Surveyor: Clean Date:	M. P	art, IN ielacha	Pre Clean: PSR:	PACP 6.0 Not Known P-706-025-024 C		
Street:	Lincoln Street			Control:				
City:	Hobart, IN			enewed:				
Location:	Light Highway			Media #:	975			
Purpose:	Routine Assessment		Dia/H		8"			
Use:	Sanitary		Mater	_	PVC			
Drain Area:	•		Lining	:				
Category:	NA		J					
Comment:								
Location Detail	s:		Direct	ion of Survey	: Upstream			
US MH:	M-706-24	DS MH:	M-706-2	25	Total Length Surveyed (ft):	5.8		
O&M Index:	3.00	O&M Quick:		3100	O&M Rating:	3.00		
Structural Index:	0.00	Structural Qu		0000	Structural Rating:	0.00		
Overall Index:	3.00	Overall Quicl		3100	Overall Rating:	3.00

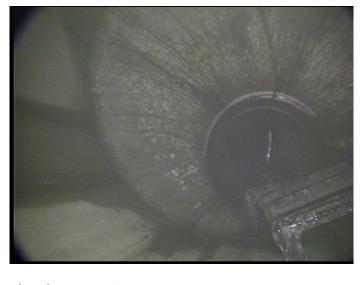
Code: Description:	AMH Manhole
D: 1 (6)	
Distance (ft):	.0
Structural Grade:	0
O&M Grade:	0
Clock Start/From:	
Clock To:	
1st Value:	
2nd Value:	
Value Percent:	
Continuous Index:	
Within 8" of Joint:	NO
Remarks:	M-706-25

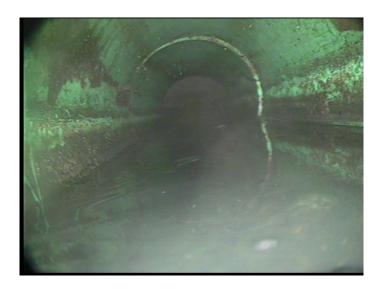
Code: DSF

Description: Deposits Settled Fine

Distance (ft): .0
Structural Grade: 0
O&M Grade: 3
Clock Start/From: 4
Clock To: 8

Value Percent: 20.000
Continuous Index: S01
Within 8" of Joint: YES

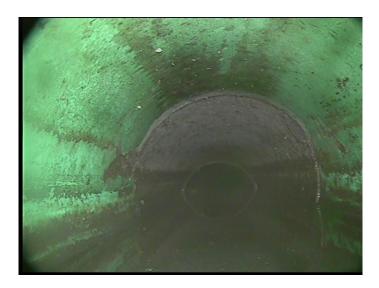
Code: MWL
Description: Water Level

Distance (ft): .0
Structural Grade: 0
O&M Grade: 0
Clock Start/From:

Value Percent: 10.000

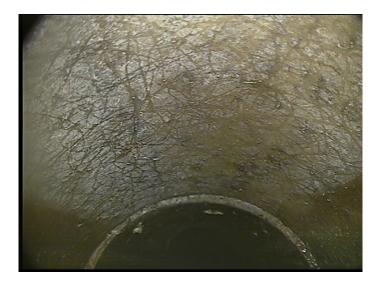
Code: MMC

Description: Material Change

Distance (ft): 4.6
Structural Grade: 0

Within 8" of Joint: NO Remarks: vcp

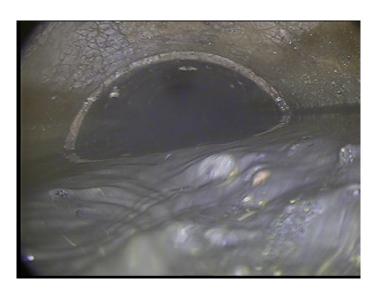
Code: **DSF**

Description: Deposits Settled Fine

Distance (ft): 4.6
Structural Grade: 0
O&M Grade: 4
Clock Start/From: 4
Clock To: 8
1st Value:

2nd Value:
Value Percent:
Continuous Index:
F01

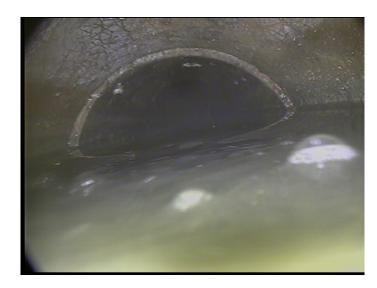
Code: MSA

Description: Abandoned Survey

Distance (ft): 4.6
Structural Grade: 0

Remarks: deep sediment
