## Profile/Photo Observation Report

Street:	<b>Lincoln Street</b>	Flow Control:	
City:	<b>Hobart, IN</b>	Year Renewed:	
Location:	<b>Light Highway</b>	Tape/Media #:	<b>976</b>
Purpose:	<b>Reversal</b>	Dia/Height:	<b>8"</b>
Use:	<b>Sanitary</b>	Material:	<b>VCP</b>
Drain Area:		Lining:	
Category:	<b>NA</b>		
Comment:

Location Details:		Direction of Survey:	<b>Downstream</b>
US MH:	<b>M-706-24</b>	DS MH:	<b>M-706-25</b>
		Total Length Surveyed (ft):	<b>209.9</b>

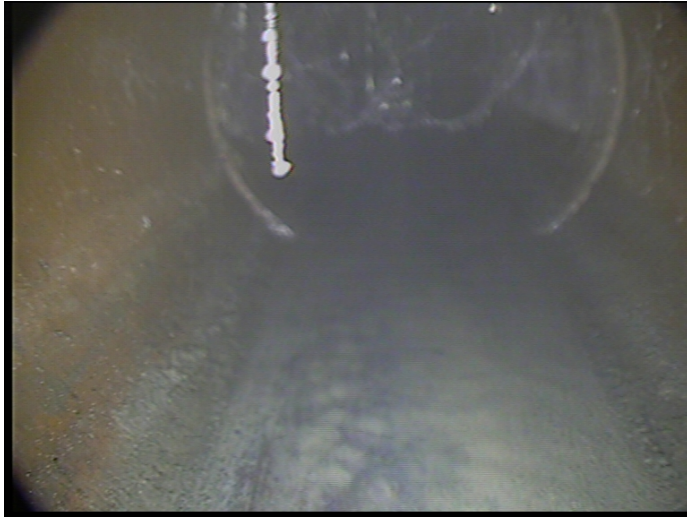
Code:	<b>MWL</b>
Description:	<b>Water Level</b>
Distance (ft):	<b>.0</b>
Structural Grade:	<b>0</b>
O&M Grade:	<b>0</b>
Clock Start/From:	
Clock To:	
1st Value:	
2nd Value:	
Value Percent:	<b>5.000</b>
Continuous Index:	
Within 8" of Joint:	<b>NO</b>
Remarks:

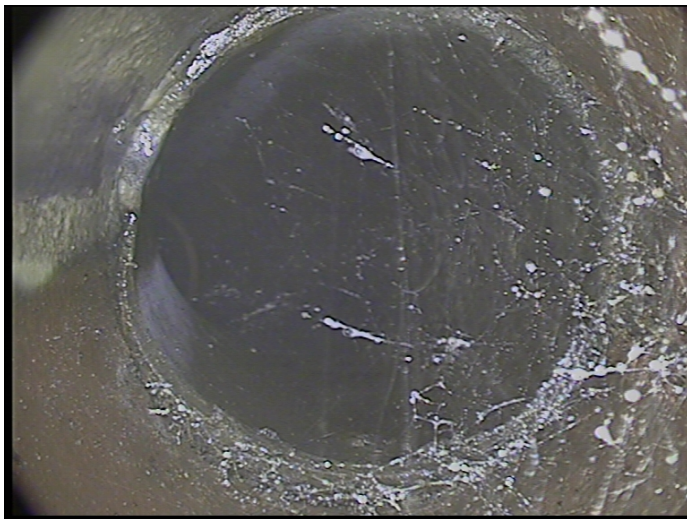
Code:	<b>TF</b>
Description:	<b>Tap Factory</b>
Distance (ft):	<b>25.4</b>
Structural Grade:	<b>0</b>
O&M Grade:	<b>0</b>
Clock Start/From:	<b>10</b>
Clock To:	
1st Value:	<b>4.000</b>
2nd Value:	
Value Percent:	
Continuous Index:	
Within 8" of Joint:	<b>NO</b>
Remarks:

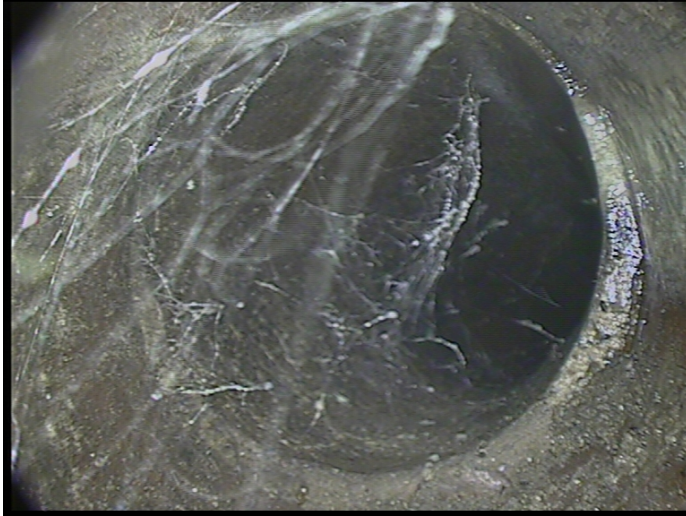
Code: **TF**  
Description: **Tap Factory**

Distance (ft): **27.6**  
Structural Grade: **0**  
O&M Grade: **0**  
Clock Start/From: **3**  
Clock To:  
1st Value: **4.000**  
2nd Value:  
Value Percent:  
Continuous Index:  
Within 8" of Joint: **NO**  
Remarks:

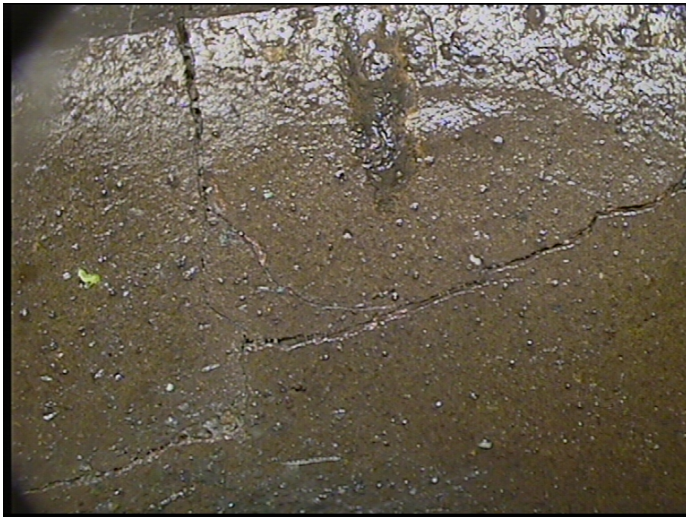
Code: **CM**  
Description: **Crack Multiple**

Distance (ft): **63.6**  
Structural Grade: **3**  
O&M Grade: **0**  
Clock Start/From: **7**  
Clock To: **11**  
1st Value:  
2nd Value:  
Value Percent:  
Continuous Index:  
Within 8" of Joint: **YES**  
Remarks:

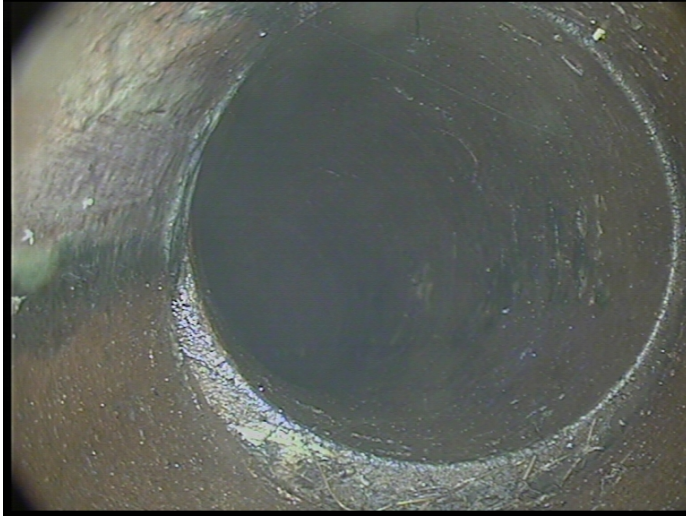
Code:	<b>TF</b>
Description:	<b>Tap Factory</b>
Distance (ft):	<b>64.5</b>
Structural Grade:	<b>0</b>
O&M Grade:	<b>0</b>
Clock Start/From:	<b>10</b>
Clock To:	
1st Value:	<b>4.000</b>
2nd Value:	
Value Percent:	
Continuous Index:	
Within 8" of Joint:	<b>NO</b>
Remarks:

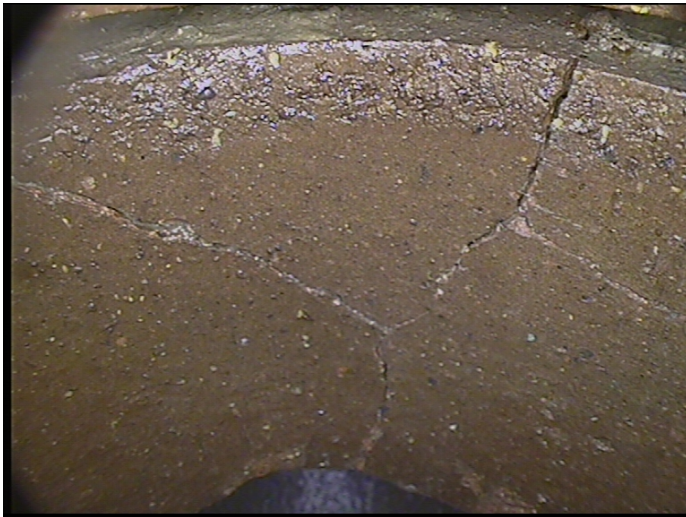
Code:	<b>CM</b>
Description:	<b>Crack Multiple</b>
Distance (ft):	<b>65.9</b>
Structural Grade:	<b>3</b>
O&M Grade:	<b>0</b>
Clock Start/From:	<b>1</b>
Clock To:	<b>5</b>
1st Value:	
2nd Value:	
Value Percent:	
Continuous Index:	
Within 8" of Joint:	<b>YES</b>
Remarks:

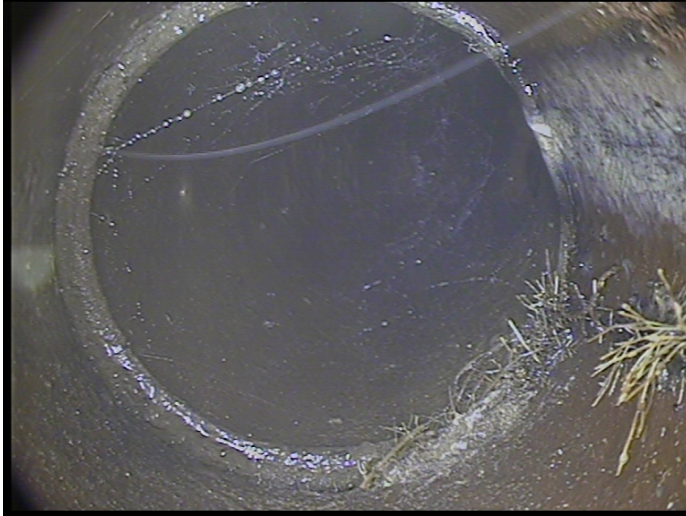
Code:	<b>TFD</b>
Description:	<b>Tap Factory Defective</b>
Distance (ft):	<b>67.0</b>
Structural Grade:	<b>0</b>
O&M Grade:	<b>2</b>
Clock Start/From:	<b>3</b>
Clock To:	
1st Value:	<b>4.000</b>
2nd Value:	
Value Percent:	
Continuous Index:	
Within 8" of Joint:	<b>NO</b>
Remarks:	<b>roots</b>

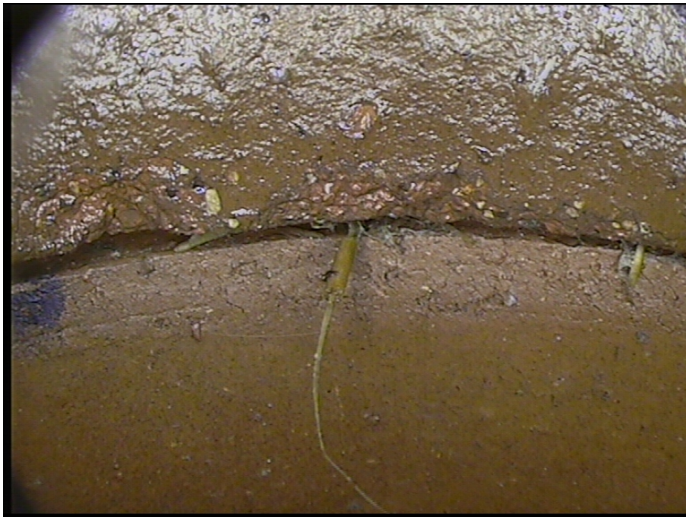
Code:	<b>RFJ</b>
Description:	<b>Roots Fine Joint</b>
Distance (ft):	<b>68.2</b>
Structural Grade:	<b>0</b>
O&M Grade:	<b>1</b>
Clock Start/From:	<b>3</b>
Clock To:	
1st Value:	
2nd Value:	
Value Percent:	
Continuous Index:	
Within 8" of Joint:	<b>YES</b>
Remarks:

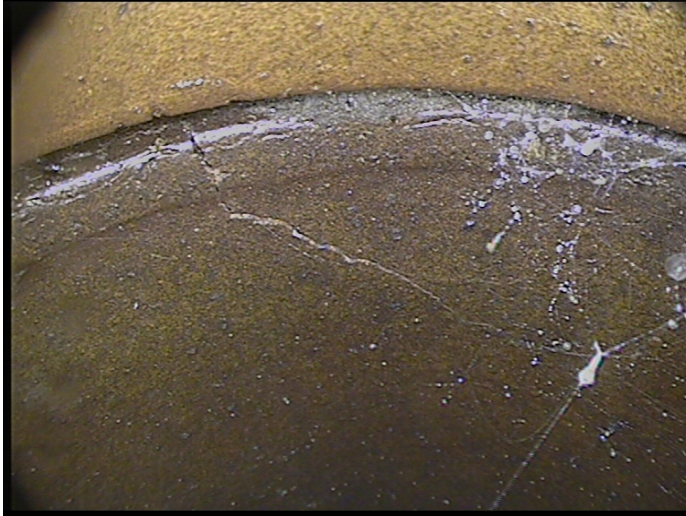
Code:	<b>CC</b>
Description:	<b>Crack Circumferential</b>
Distance (ft):	<b>105.5</b>
Structural Grade:	<b>1</b>
O&M Grade:	<b>0</b>
Clock Start/From:	<b>10</b>
Clock To:	<b>11</b>
1st Value:	
2nd Value:	
Value Percent:	
Continuous Index:	
Within 8" of Joint:	<b>YES</b>
Remarks:

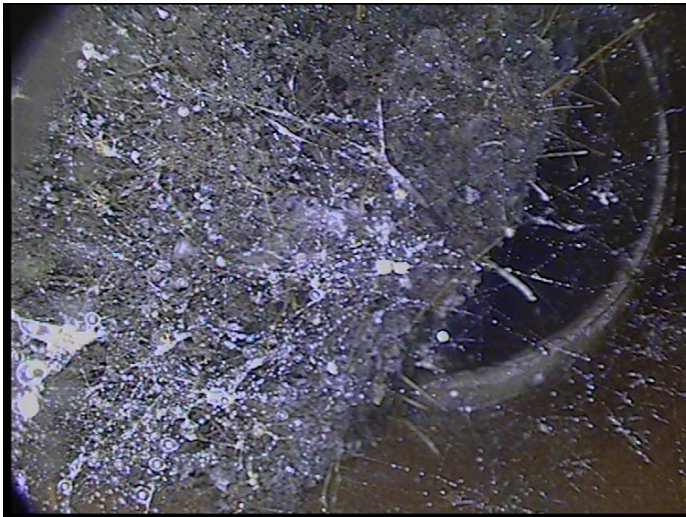
Code:	<b>TFD</b>
Description:	<b>Tap Factory Defective</b>
Distance (ft):	<b>108.9</b>
Structural Grade:	<b>0</b>
O&M Grade:	<b>2</b>
Clock Start/From:	<b>10</b>
Clock To:	
1st Value:	<b>4.000</b>
2nd Value:	
Value Percent:	
Continuous Index:	
Within 8" of Joint:	<b>NO</b>
Remarks:	<b>roots</b>

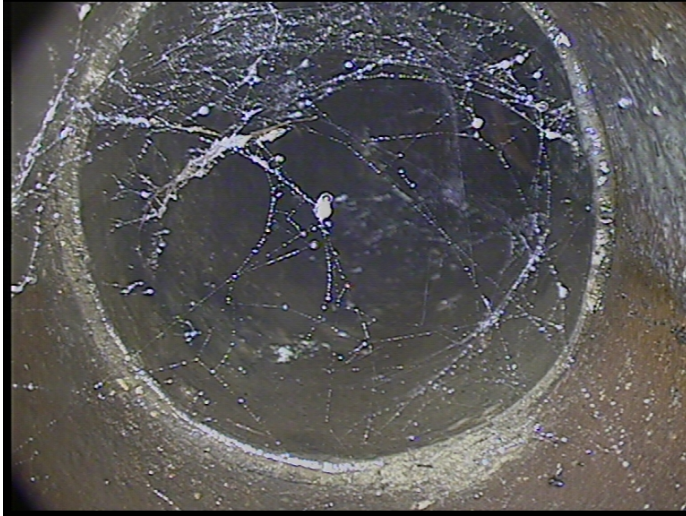
Code: **TF**  
Description: **Tap Factory**

Distance (ft): **109.0**  
Structural Grade: **0**  
O&M Grade: **0**  
Clock Start/From: **3**  
Clock To:  
1st Value: **4.000**  
2nd Value:  
Value Percent:  
Continuous Index:  
Within 8" of Joint: **NO**  
Remarks:

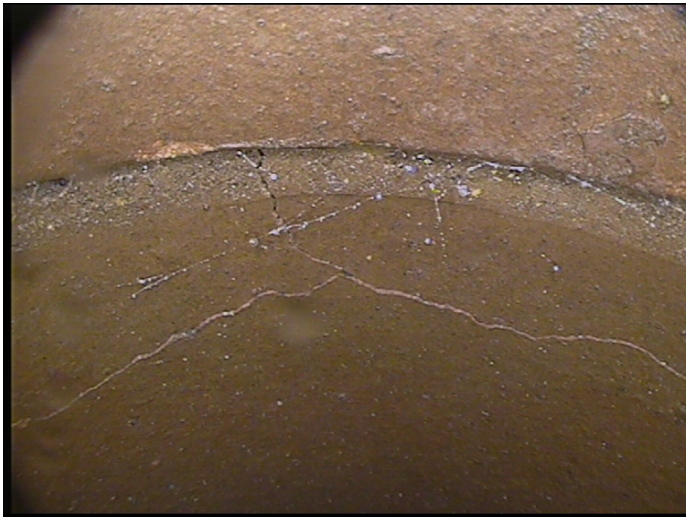
Code: **CM**  
Description: **Crack Multiple**

Distance (ft): **123.4**  
Structural Grade: **3**  
O&M Grade: **0**  
Clock Start/From: **10**  
Clock To: **3**  
1st Value:  
2nd Value:  
Value Percent:  
Continuous Index:  
Within 8" of Joint: **YES**  
Remarks:

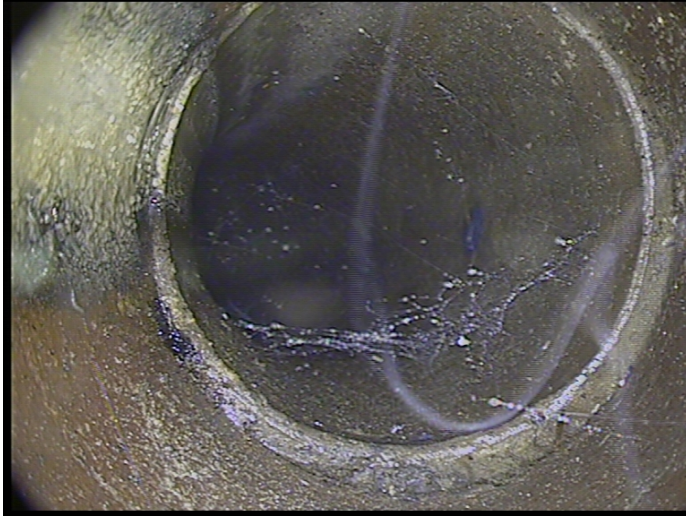
Code: **TF**  
Description: **Tap Factory**

Distance (ft): **144.4**  
Structural Grade: **0**  
O&M Grade: **0**  
Clock Start/From: **9**  
Clock To:  
1st Value: **4.000**  
2nd Value:  
Value Percent:  
Continuous Index:  
Within 8" of Joint: **NO**  
Remarks:

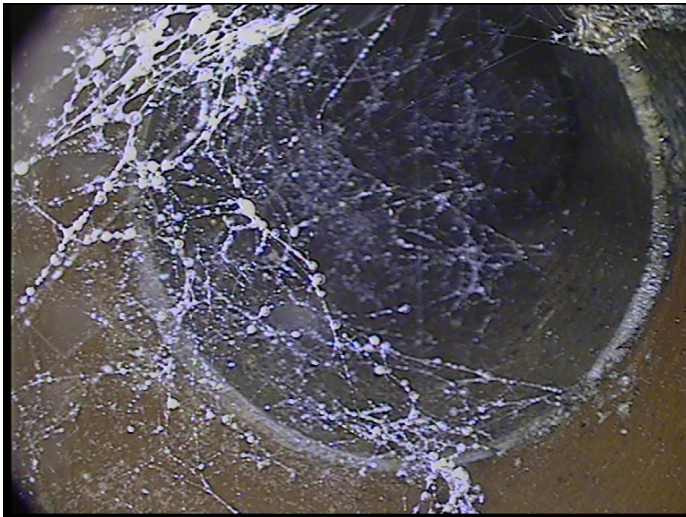
Code: **TF**  
Description: **Tap Factory**

Distance (ft): **146.4**  
Structural Grade: **0**  
O&M Grade: **0**  
Clock Start/From: **3**  
Clock To:  
1st Value: **4.000**  
2nd Value:  
Value Percent:  
Continuous Index:  
Within 8" of Joint: **NO**  
Remarks:

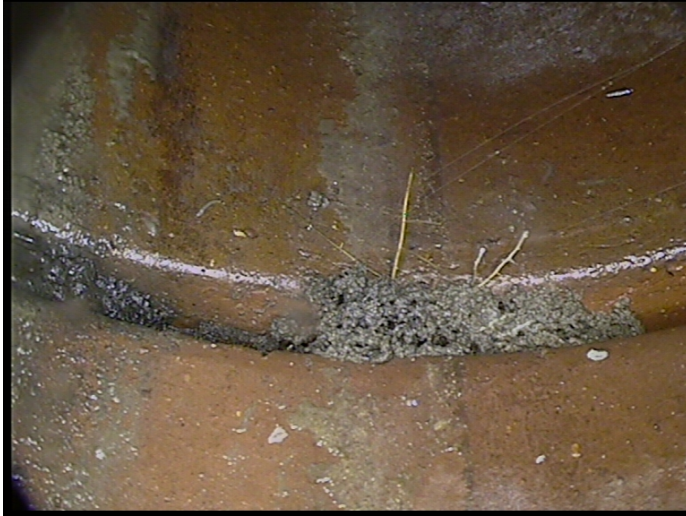
Code: **RFJ**  
Description: **Roots Fine Joint**

Distance (ft): **174.2**  
Structural Grade: **0**  
O&M Grade: **1**  
Clock Start/From: **4**  
Clock To:  
1st Value:  
2nd Value:  
Value Percent:  
Continuous Index:  
Within 8" of Joint: **YES**  
Remarks:

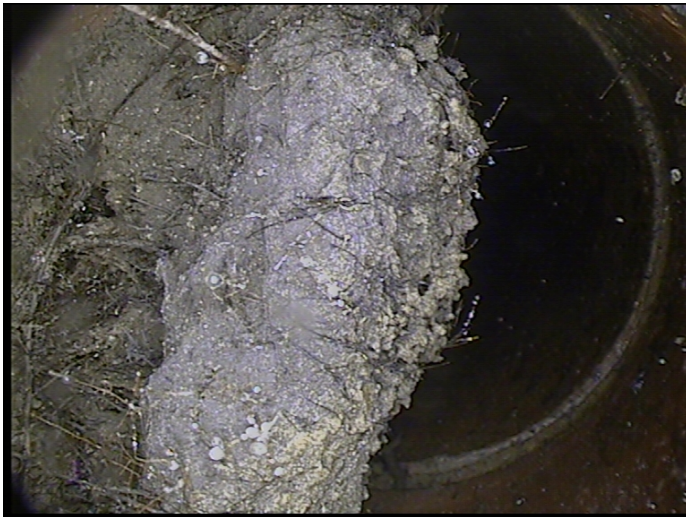
Code: **TFD**  
Description: **Tap Factory Defective**

Distance (ft): **177.4**  
Structural Grade: **0**  
O&M Grade: **2**  
Clock Start/From: **9**  
Clock To:  
1st Value: **4.000**  
2nd Value:  
Value Percent:  
Continuous Index:  
Within 8" of Joint: **NO**  
Remarks: **roots**

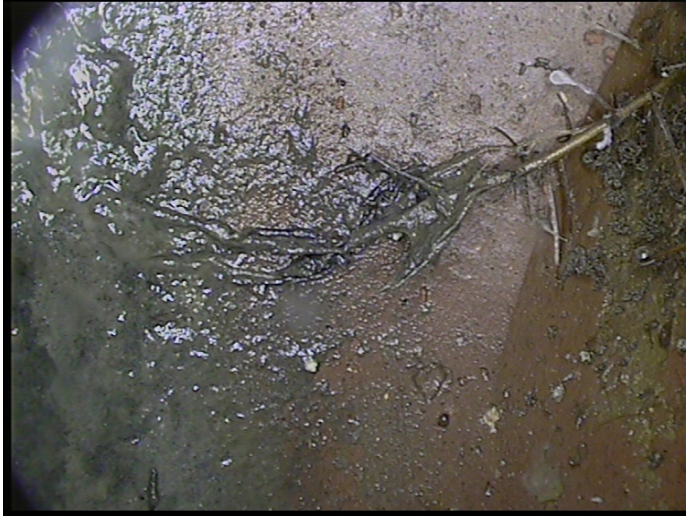
Code: **RFL**  
Description: **Roots Fine Lateral**

Distance (ft): **177.4**  
Structural Grade: **0**  
O&M Grade: **1**  
Clock Start/From: **8**  
Clock To:  
1st Value:  
2nd Value:  
Value Percent:  
Continuous Index:  
Within 8" of Joint: **NO**  
Remarks:

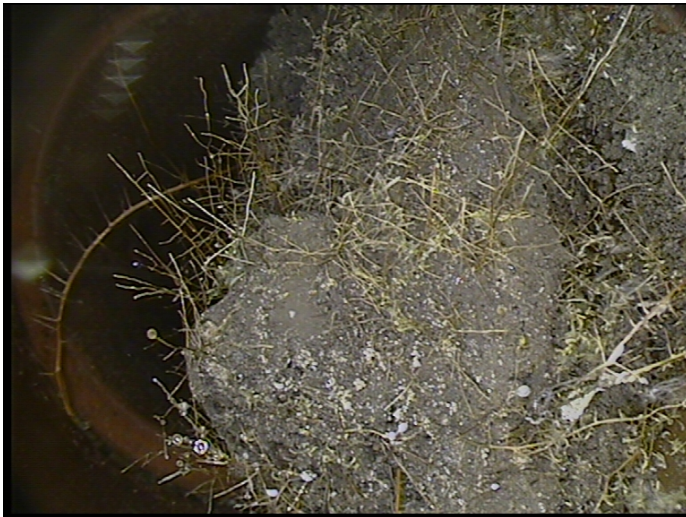
Code: **TFD**  
Description: **Tap Factory Defective**

Distance (ft): **179.6**  
Structural Grade: **0**  
O&M Grade: **2**  
Clock Start/From: **3**  
Clock To:  
1st Value: **4.000**  
2nd Value:  
Value Percent:  
Continuous Index:  
Within 8" of Joint: **NO**  
Remarks: **roots**

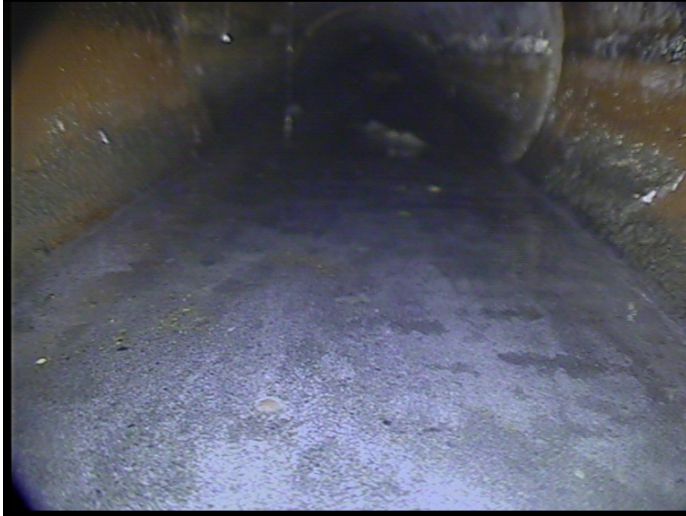
Code: **DSF**  
Description: **Deposits Settled Fine**

Distance (ft): **205.2**  
Structural Grade: **0**  
O&M Grade: **3**  
Clock Start/From: **4**  
Clock To: **8**  
1st Value:  
2nd Value:  
Value Percent: **15.000**  
Continuous Index: **S01**  
Within 8" of Joint: **YES**  
Remarks:

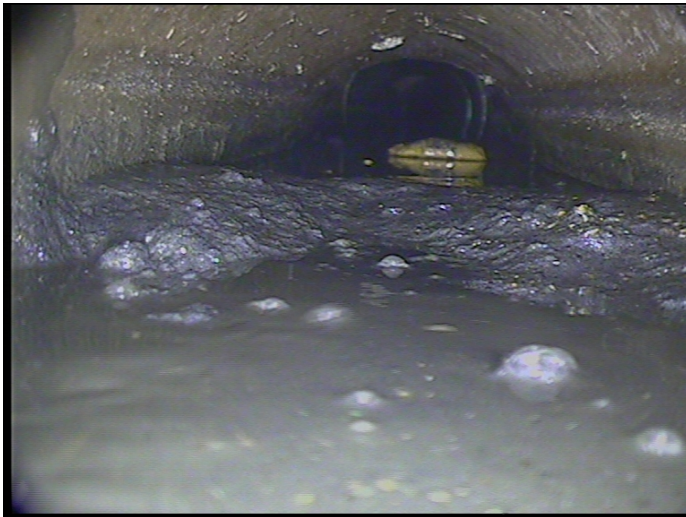
Code: **DSF**  
Description: **Deposits Settled Fine**

Distance (ft): **209.6**  
Structural Grade: **0**  
O&M Grade: **3**  
Clock Start/From: **4**  
Clock To: **8**  
1st Value:  
2nd Value:  
Value Percent: **20.000**  
Continuous Index: **F01**  
Within 8" of Joint: **NO**  
Remarks:

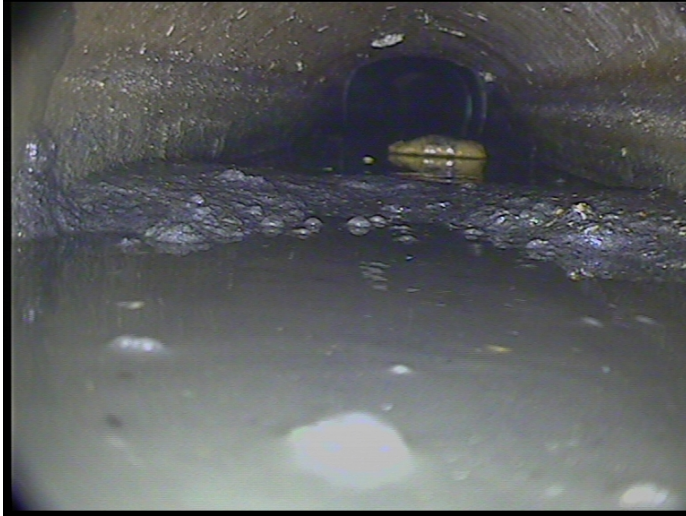
Code:	<b>MSA</b>
Description:	<b>Abandoned Survey</b>
Distance (ft):	<b>209.6</b>
Structural Grade:	<b>0</b>
O&M Grade:	<b>0</b>
Clock Start/From:	
Clock To:	
1st Value:	
2nd Value:	
Value Percent:	
Continuous Index:	
Within 8" of Joint:	<b>NO</b>
Remarks:	<b>reverse Complete</b>
