Profile/Photo Observation Report

Street:	Lincoln Street	Flow Control:	
City:	Hobart, IN	Year Renewed:	
Location:	Light Highway	Tape/Media #:	977
Purpose:	Routine Assessment	Dia/Height:	8"
Use:	Sanitary	Material:	VCP
Drain Area:		Lining:	
Category:	NA		
Comment:

Location Details:		Direction of Survey:	Upstream
US MH:	M-706-25	DS MH:	M-706-26
		Total Length Surveyed (ft):	12.4

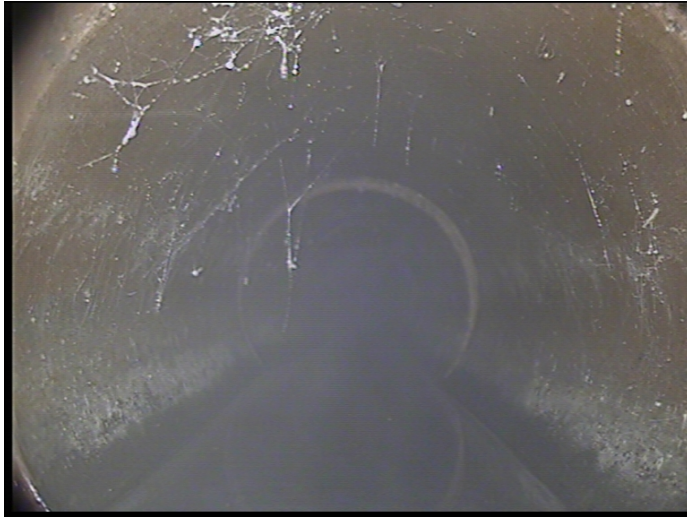
Code:	MWL
Description:	Water Level
Distance (ft):	.0
Structural Grade:	0
O&M Grade:	0
Clock Start/From:	
Clock To:	
1st Value:	
2nd Value:	
Value Percent:	5.000
Continuous Index:	
Within 8" of Joint:	NO
Remarks:

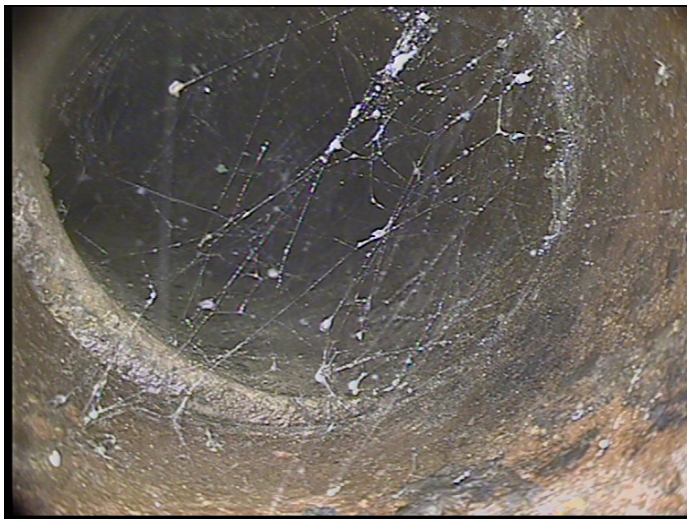
Code:	TF
Description:	Tap Factory
Distance (ft):	9.9
Structural Grade:	0
O&M Grade:	0
Clock Start/From:	10
Clock To:	
1st Value:	4.000
2nd Value:	
Value Percent:	
Continuous Index:	
Within 8" of Joint:	NO
Remarks:

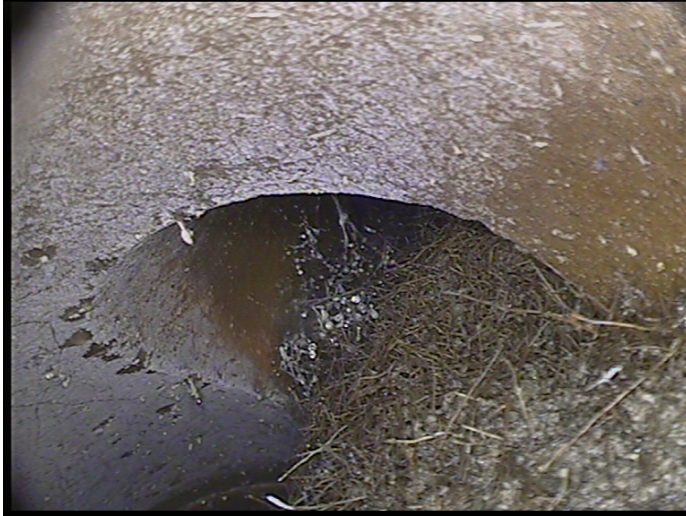
Code:	TFD
Description:	Tap Factory Defective
Distance (ft):	11.5
Structural Grade:	0
O&M Grade:	2
Clock Start/From:	2
Clock To:	
1st Value:	4.000
2nd Value:	
Value Percent:	
Continuous Index:	
Within 8" of Joint:	NO
Remarks:	roots

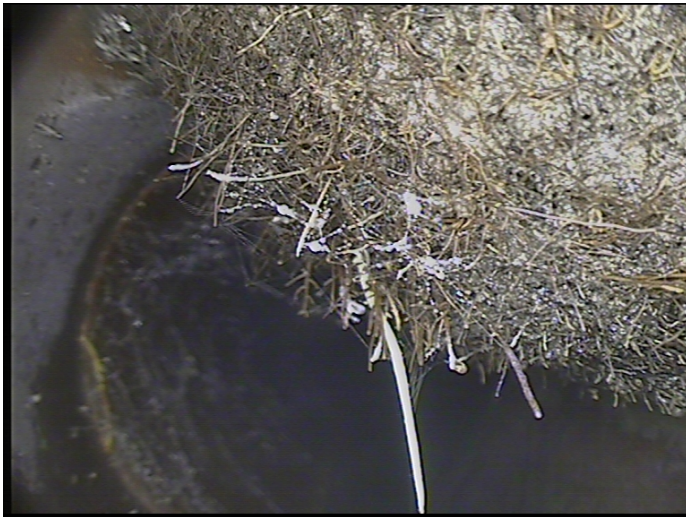
Code:	RML
Description:	Roots Medium Lateral
Distance (ft):	11.5
Structural Grade:	0
O&M Grade:	3
Clock Start/From:	2
Clock To:	6
1st Value:	
2nd Value:	
Value Percent:	30.000
Continuous Index:	
Within 8" of Joint:	NO
Remarks:

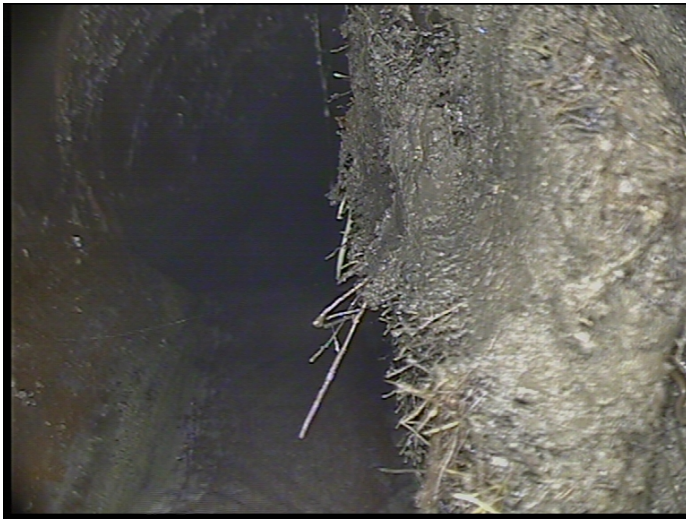
Code:	MSA
Description:	Abandoned Survey
Distance (ft):	11.8
Structural Grade:	0
O&M Grade:	0
Clock Start/From:	
Clock To:	
1st Value:	
2nd Value:	
Value Percent:	
Continuous Index:	
Within 8" of Joint:	NO
Remarks:	large roots
