Profile/Photo Observation Report

Date:	10/21/2021	Weather:		Coding:	PACP 6.0
Pipe Length (ft):		Owner:	Hobart, IN	Pre Clean:	Not Known
P.O.#:	943_1	Surveyor:	M. Pielacha	PSR:	P-707-033-027
Customer:	Hobart, IN	Clean Date:		Shape:	C

Street:	Lincoln Street	Flow Control:	
City:	Hobart, IN	Year Renewed:	
Location:	Light Highway	Tape/Media #:	943
Purpose:	Routine Assessment	Dia/Height:	8"
Use:	Sanitary	Material:	VCP
Drain Area:		Lining:	
Category:	NA		
Comment:

Location Details:		Direction of Survey:	Downstream
US MH:	M-706-27	DS MH:	M-707-33
		Total Length Surveyed (ft):	22.4

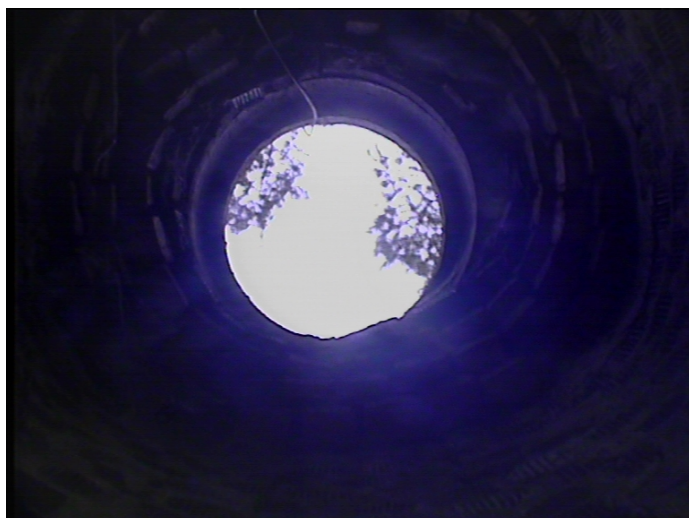
Code: **AMH**
Description: **Manhole**

Distance (ft): **.0**
Structural Grade: **0**
O&M Grade: **0**
Clock Start/From:
Clock To:
1st Value:
2nd Value:
Value Percent:
Continuous Index:
Within 8" of Joint: **NO**
Remarks: **M-706-27**

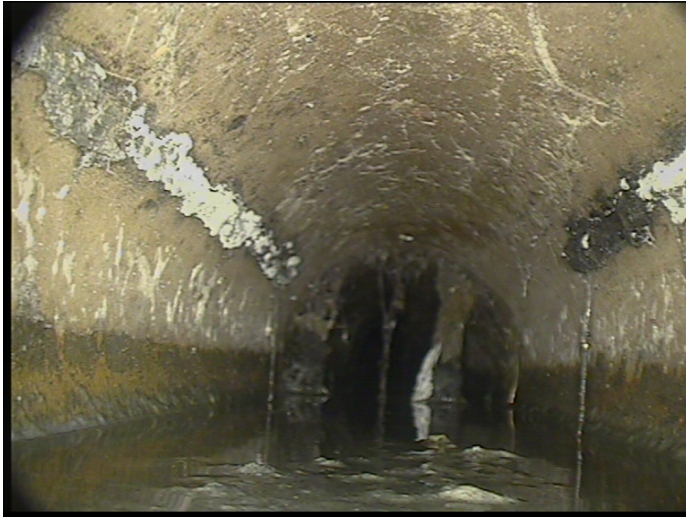
Code: **MWL**
Description: **Water Level**

Distance (ft): **.0**
Structural Grade: **0**
O&M Grade: **0**
Clock Start/From:
Clock To:
1st Value:
2nd Value:
Value Percent: **10.000**
Continuous Index:
Within 8" of Joint: **NO**
Remarks:

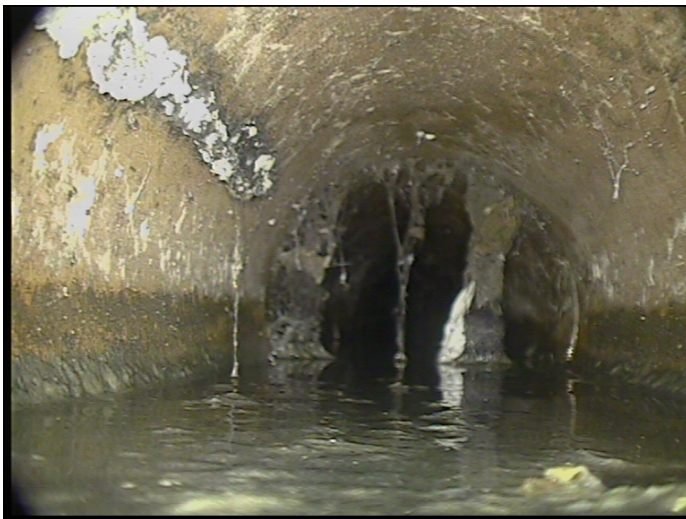
Code: **DSF**
Description: **Deposits Settled Fine**

Distance (ft): **3.3**
Structural Grade: **0**
O&M Grade: **2**
Clock Start/From: **4**
Clock To: **8**
1st Value:
2nd Value:
Value Percent: **10.000**
Continuous Index: **S01**
Within 8" of Joint: **YES**
Remarks:

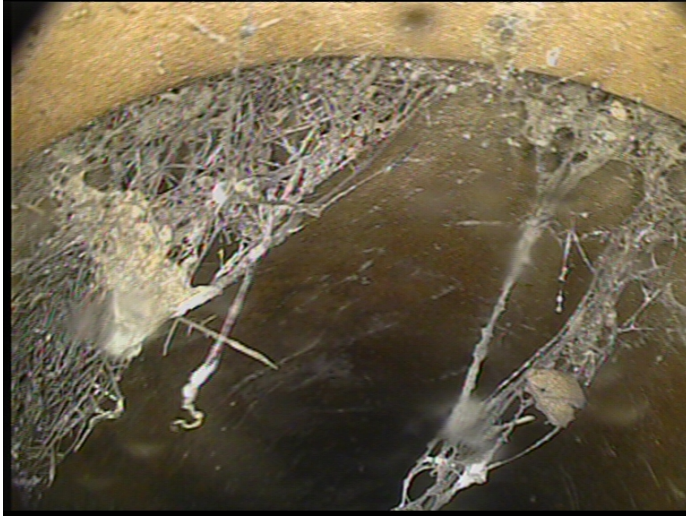
Code: **RMJ**
Description: **Roots Medium Joint**

Distance (ft): **3.9**
Structural Grade: **0**
O&M Grade: **3**
Clock Start/From: **9**
Clock To: **3**
1st Value:
2nd Value:
Value Percent: **10.000**
Continuous Index: **S02**
Within 8" of Joint: **YES**
Remarks:

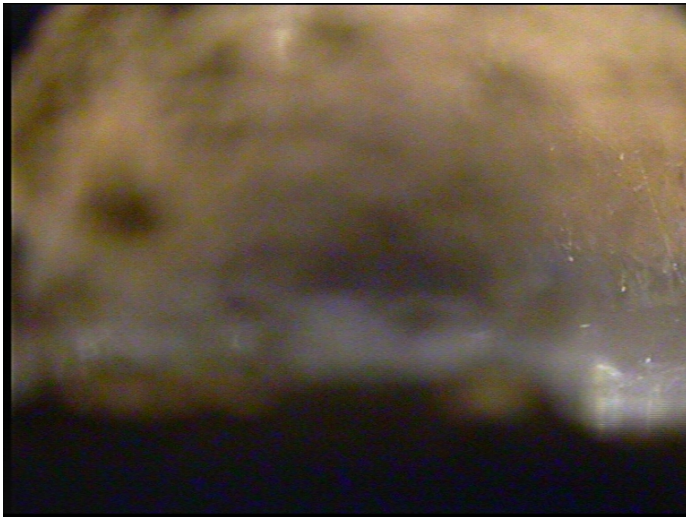
Code: **DSF**
Description: **Deposits Settled Fine**

Distance (ft): **22.4**
Structural Grade: **0**
O&M Grade: **2**
Clock Start/From: **4**
Clock To: **8**
1st Value:
2nd Value:
Value Percent: **10.000**
Continuous Index: **F01**
Within 8" of Joint: **NO**
Remarks:

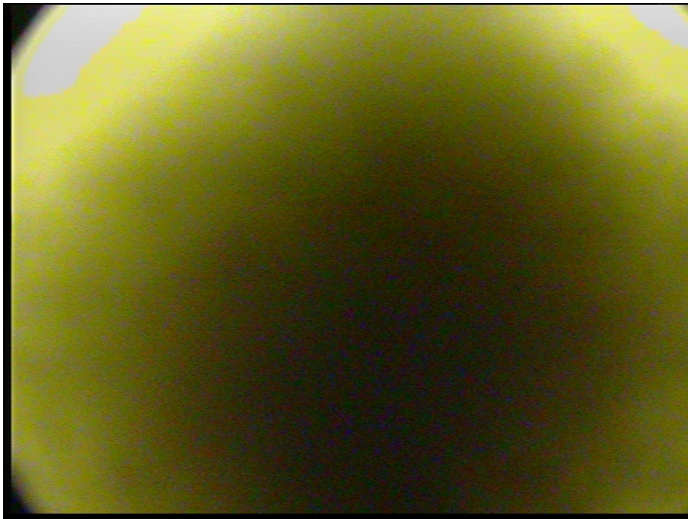
Code: **MSA**
Description: **Abandoned Survey**

Distance (ft): **22.4**
Structural Grade: **0**
O&M Grade: **0**
Clock Start/From:
Clock To:
1st Value:
2nd Value:
Value Percent:
Continuous Index:
Within 8" of Joint: **NO**
Remarks: **deep sediment**
