Profile/Photo Observation Report

Street:	10th Street	Flow Control:	
City:	Hobart, IN	Year Renewed:	
Location:	Light Highway	Tape/Media #:	944
Purpose:	Routine Assessment	Dia/Height:	21"
Use:	Sanitary	Material:	PVC
Drain Area:		Lining:

US MH: **M-706-28** DS MH: **M-706-1** Total Length Surveyed (ft): **3.4**

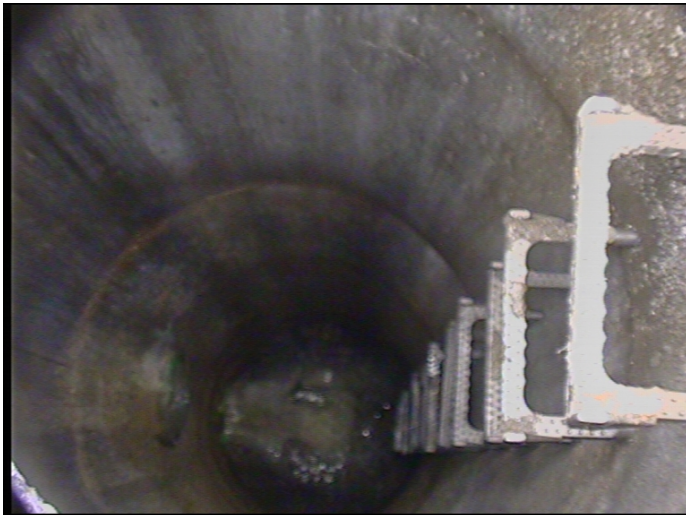
Code:	AMH
Description:	Manhole
Distance (ft):	.0
Structural Grade:	0
O&M Grade:	0
Clock Start/From:	
Clock To:	
1st Value:	
2nd Value:	
Value Percent:	
Continuous Index:	
Within 8" of Joint:	NO
Remarks:	M-706-1

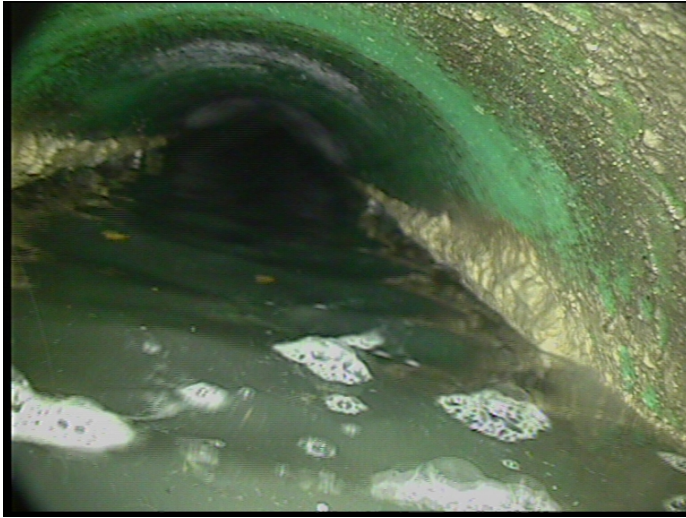
Code: **MWL**
Description: **Water Level**

Distance (ft): **.0**
Structural Grade: **0**
O&M Grade: **0**
Clock Start/From:
Clock To:
1st Value:
2nd Value:
Value Percent: **60.000**
Continuous Index:
Within 8" of Joint: **NO**
Remarks:

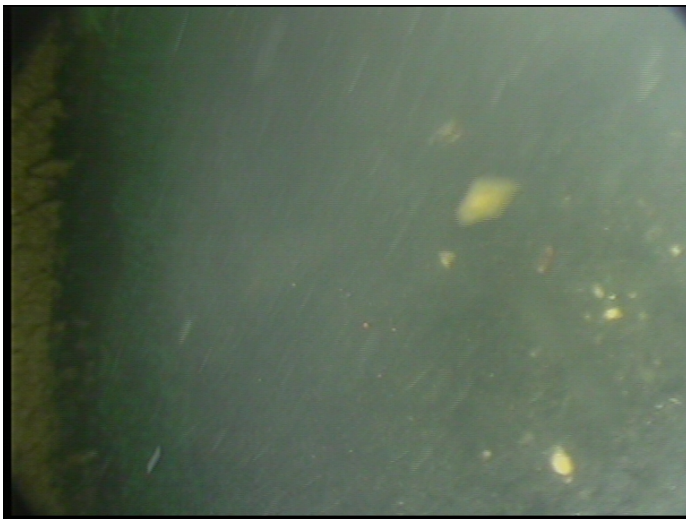
Code: **DSF**
Description: **Deposits Settled Fine**

Distance (ft): **3.4**
Structural Grade: **0**
O&M Grade: **4**
Clock Start/From: **4**
Clock To: **8**
1st Value:
2nd Value:
Value Percent: **30.000**
Continuous Index:
Within 8" of Joint: **NO**
Remarks:

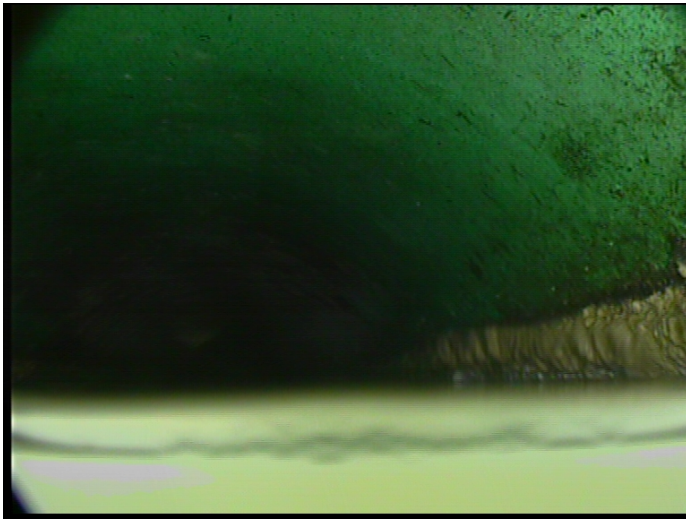
Code:	MSA
Description:	Abandoned Survey
Distance (ft):	3.4
Structural Grade:	0
O&M Grade:	0
Clock Start/From:	
Clock To:	
1st Value:	
2nd Value:	
Value Percent:	
Continuous Index:	
Within 8" of Joint:	NO
Remarks:	deep sediment
