## Profile/Photo Observation Report

Street:	<b>STATE ST</b>	Flow Control:	<b>Not Controlled</b>
City:	<b>Hobart, IN</b>	Year Renewed:	
Location:	<b>Light Highway</b>	Tape/Media #:	
Purpose:	<b>Maintenance Related</b>	Dia/Height:	<b>8"</b>
Use:	<b>Sanitary</b>	Material:	<b>VCP</b>
Drain Area:	<b>NA</b>	Lining:	<b>Cured in Place</b>
Category:	<b>NA</b>		
Comment:	<b>tap broke bell at 1'.</b>		
Location Details:		Direction of Survey:	<b>Downstream</b>
US MH:	<b>M-706-029</b>	DS MH:	<b>M-706-030</b>
		Total Length Surveyed (ft):	<b>2.7</b>

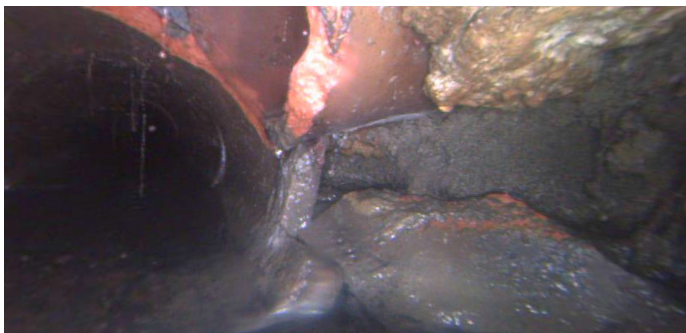
Code: **HVV**  
Description: **Hole Void Visible**

Distance (ft): **.0**  
Structural Grade: **5**  
O&M Grade: **0**  
Clock Start/From: **3**  
Clock To:  
1st Value:  
2nd Value:  
Value Percent:  
Continuous Index:  
Within 8" of Joint:  
Remarks:

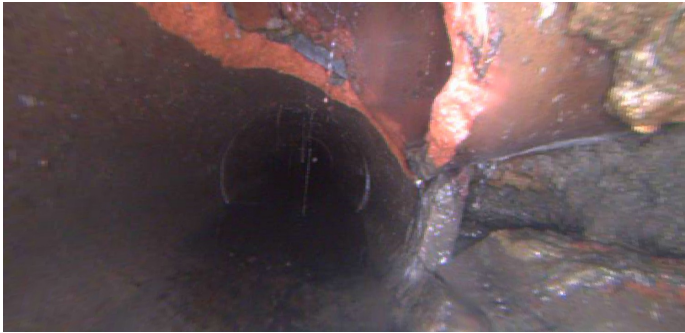
Code:	<b>AMH</b>
Description:	<b>Manhole</b>

Distance (ft):	<b>.0</b>
Structural Grade:	<b>0</b>
O&M Grade:	<b>0</b>
Clock Start/From:	
Clock To:	
1st Value:	
2nd Value:	
Value Percent:	
Continuous Index:	
Within 8" of Joint:	<b>NO</b>
Remarks:	<b>M-706-029</b>

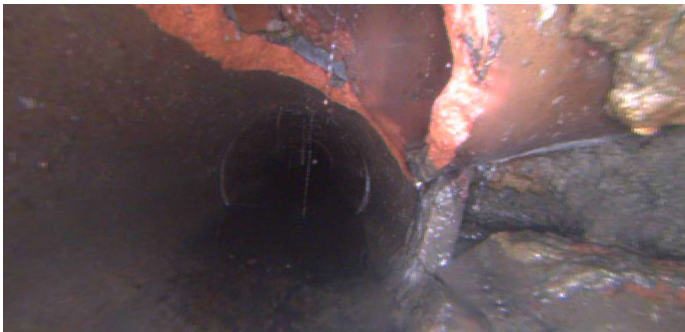
Code:	<b>MWL</b>
Description:	<b>Water Level</b>

Distance (ft):	<b>.0</b>
Structural Grade:	<b>0</b>
O&M Grade:	<b>0</b>
Clock Start/From:	
Clock To:	
1st Value:	
2nd Value:	
Value Percent:	<b>5.000</b>
Continuous Index:	
Within 8" of Joint:	<b>NO</b>
Remarks:

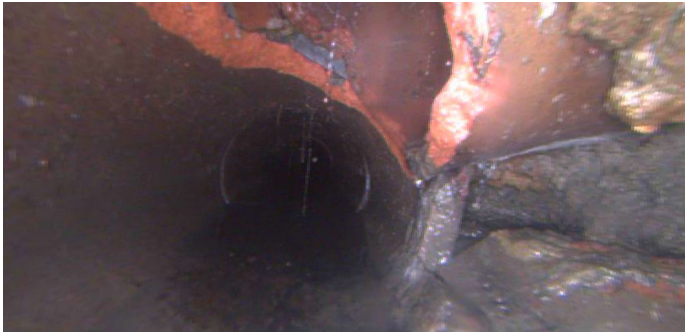
Code: **TBI**  
Description: **Tap Break-in Intruding**

Distance (ft): **.0**  
Structural Grade: **0**  
O&M Grade: **2**  
Clock Start/From: **2**  
Clock To:  
1st Value: **4.000**  
2nd Value: **2.000**  
Value Percent:  
Continuous Index:  
Within 8" of Joint:  
Remarks:

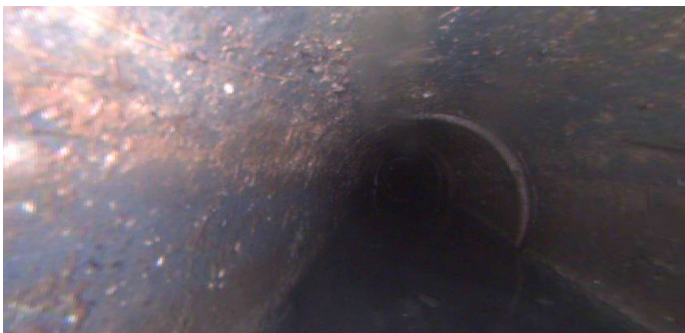
Code: **MSA**  
Description: **Abandoned Survey**

Distance (ft): **2.7**  
Structural Grade: **0**  
O&M Grade: **0**  
Clock Start/From:  
Clock To:  
1st Value:  
2nd Value:  
Value Percent:  
Continuous Index:  
Within 8" of Joint: **NO**  
Remarks: **wedged by tbi**
