Profile/Photo Observation Report

Street:	Capitol	Flow Control:	Not Controlled
City:	Hobart, IN	Year Renewed:	
Location:	Light Highway	Tape/Media #:	
Purpose:	Maintenance Related	Dia/Height:	8"
Use:	Sanitary	Material:	VCP
Drain Area:	NA	Lining:	Cured in Place
Category:	NA		
Comment:	tap broke bell at 1'.		
Location Details:		Direction of Survey:	Downstream
US MH:	M-706-029	DS MH:	M-706-030
		Total Length Surveyed (ft):	2.7

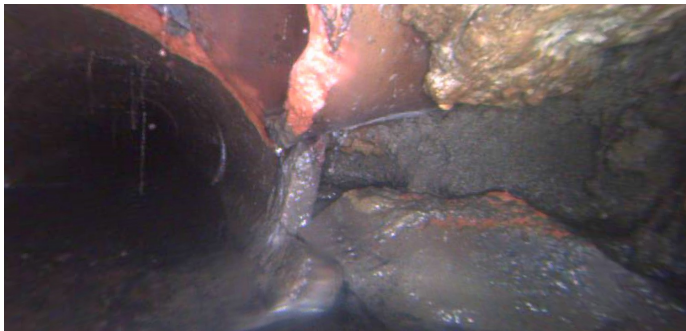
Code: **HVV**
Description: **Hole Void Visible**

Distance (ft): **.0**
Structural Grade: **5**
O&M Grade: **0**
Clock Start/From: **3**
Clock To:
1st Value:
2nd Value:
Value Percent:
Continuous Index:
Within 8" of Joint:
Remarks:

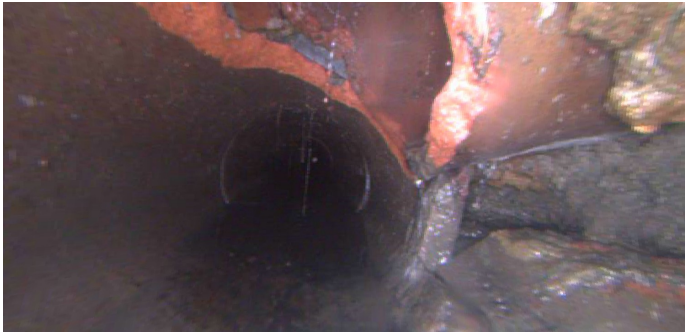
Code: **AMH**
Description: **Manhole**

Distance (ft): **.0**
Structural Grade: **0**
O&M Grade: **0**
Clock Start/From:
Clock To:
1st Value:
2nd Value:
Value Percent:
Continuous Index:
Within 8" of Joint: **NO**
Remarks: **M-706-029**

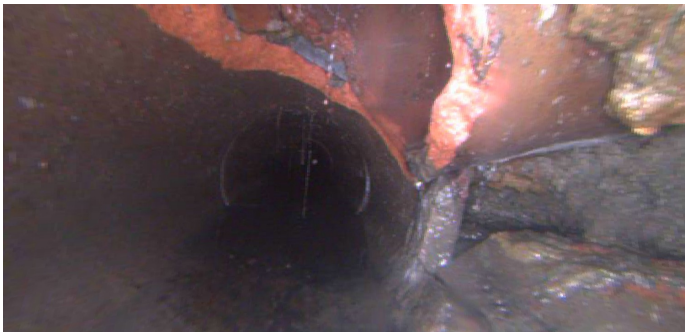
Code: **MWL**
Description: **Water Level**

Distance (ft): **.0**
Structural Grade: **0**
O&M Grade: **0**
Clock Start/From:
Clock To:
1st Value:
2nd Value:
Value Percent: **5.000**
Continuous Index:
Within 8" of Joint: **NO**
Remarks:

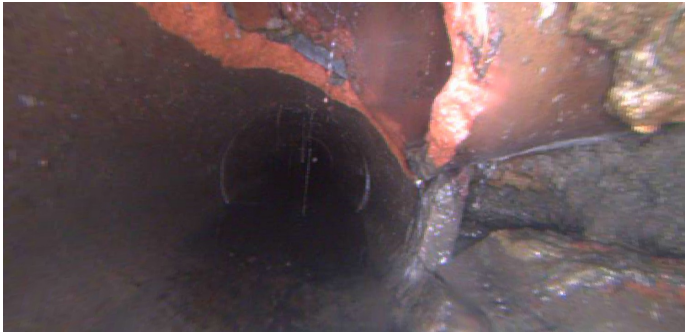
Code: **TBI**
Description: **Tap Break-in Intruding**

Distance (ft): **.0**
Structural Grade: **0**
O&M Grade: **2**
Clock Start/From: **2**
Clock To:
1st Value: **4.000**
2nd Value: **2.000**
Value Percent:
Continuous Index:
Within 8" of Joint:
Remarks:

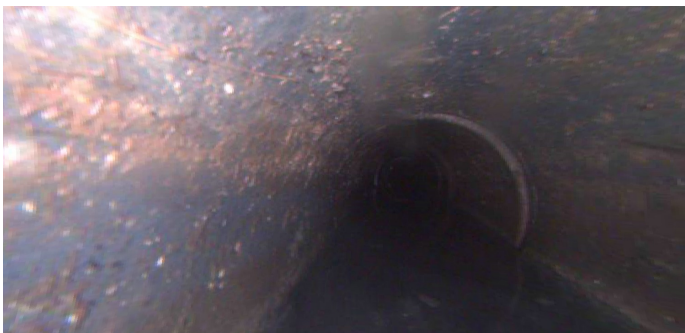
Code: **MSA**
Description: **Abandoned Survey**

Distance (ft): **2.7**
Structural Grade: **0**
O&M Grade: **0**
Clock Start/From:
Clock To:
1st Value:
2nd Value:
Value Percent:
Continuous Index:
Within 8" of Joint: **NO**
Remarks: **wedged by tbi**
