## Profile/Photo Observation Report

| Street: | <b>STATE ST</b> | Flow Control: | <b>Not Controlled</b> |
| City: | <b>Hobart, IN</b> | Year Renewed: | |
| US MH: | <b>M-706-029</b> | DS MH: | <b>M-706-030</b> |

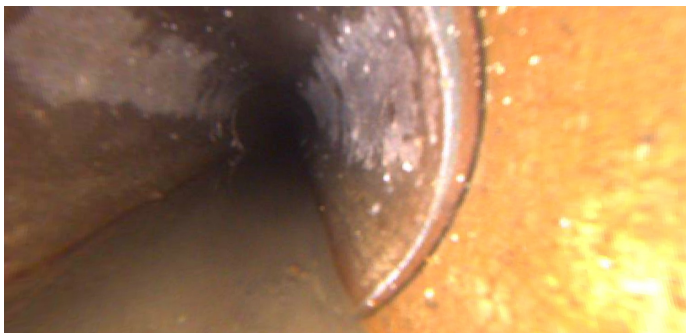
Code: **AMH**  
Description: **Manhole**

Distance (ft): **.0**  
Structural Grade: **0**  
O&M Grade: **0**  
Clock Start/From:  
Clock To:  
1st Value:  
2nd Value:  
Value Percent:  
Continuous Index:  
Within 8" of Joint: **NO**  
Remarks: **M-706-030**

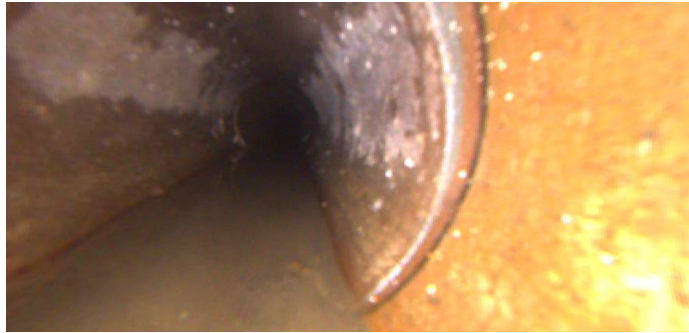
Code: **MWL**  
Description: **Water Level**

Distance (ft): **.0**  
Structural Grade: **0**  
O&M Grade: **0**  
Clock Start/From:  
Clock To:  
1st Value:  
2nd Value:  
Value Percent: **5.000**  
Continuous Index:  
Within 8" of Joint: **NO**  
Remarks:

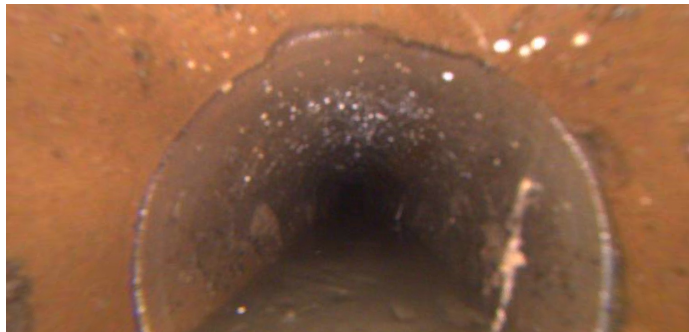
Code: **RFJ**  
Description: **Roots Fine Joint**

Distance (ft): **11.2**  
Structural Grade: **0**  
O&M Grade: **1**  
Clock Start/From: **2**  
Clock To:  
1st Value:  
2nd Value:  
Value Percent:  
Continuous Index:  
Within 8" of Joint: **YES**  
Remarks:

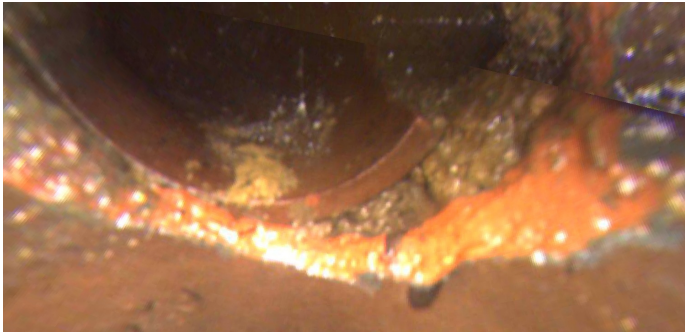
Code: **TB**  
Description: **Tap Break-in**

Distance (ft): **20.5**  
Structural Grade: **0**  
O&M Grade: **0**  
Clock Start/From: **12**  
Clock To:  
1st Value: **4.000**  
2nd Value:  
Value Percent:  
Continuous Index:  
Within 8" of Joint:  
Remarks:

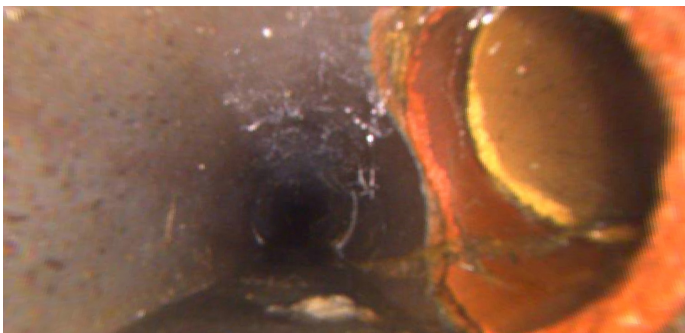
Code: **TBI**  
Description: **Tap Break-in Intruding**

Distance (ft): **22.1**  
Structural Grade: **0**  
O&M Grade: **2**  
Clock Start/From: **3**  
Clock To:  
1st Value: **4.000**  
2nd Value: **1.000**  
Value Percent:  
Continuous Index:  
Within 8" of Joint:  
Remarks:

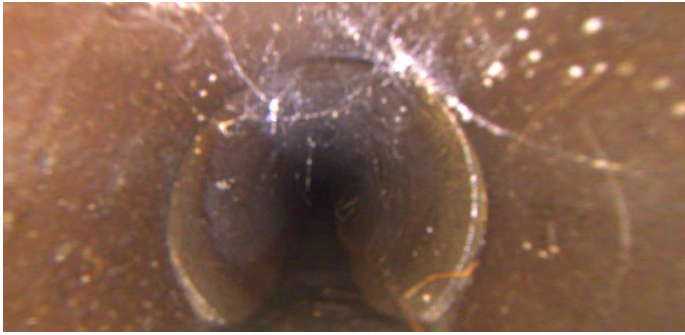
Code: **RFJ**  
Description: **Roots Fine Joint**

Distance (ft): **23.3**  
Structural Grade: **0**  
O&M Grade: **1**  
Clock Start/From: **3**  
Clock To:  
1st Value:  
2nd Value:  
Value Percent:  
Continuous Index:  
Within 8" of Joint: **YES**  
Remarks:

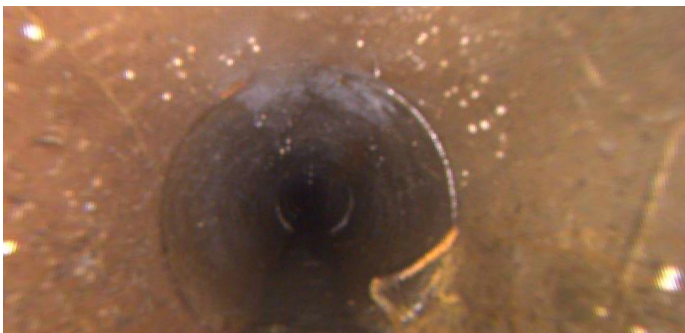
Code: **RFJ**  
Description: **Roots Fine Joint**

Distance (ft): **25.3**  
Structural Grade: **0**  
O&M Grade: **1**  
Clock Start/From: **4**  
Clock To:  
1st Value:  
2nd Value:  
Value Percent:  
Continuous Index:  
Within 8" of Joint: **YES**  
Remarks:

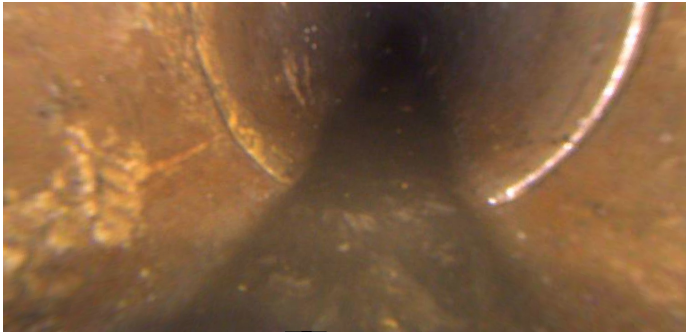
Code: **CL**  
Description: **Crack Longitudinal**

Distance (ft): **35.8**  
Structural Grade: **2**  
O&M Grade: **0**  
Clock Start/From: **8**  
Clock To:  
1st Value:  
2nd Value:  
Value Percent:  
Continuous Index:  
Within 8" of Joint: **YES**  
Remarks:

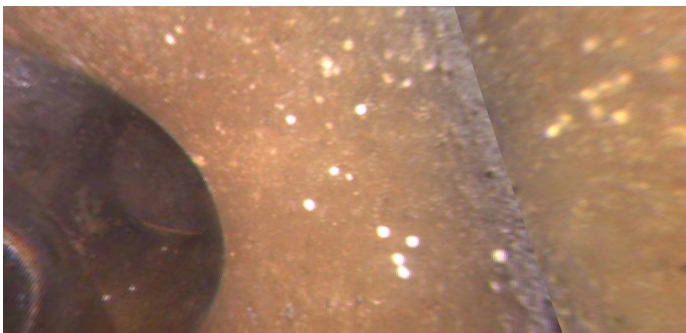
Code: **TFC**  
Description: **Tap Factory Capped**

Distance (ft): **35.8**  
Structural Grade: **0**  
O&M Grade: **0**  
Clock Start/From: **10**  
Clock To:  
1st Value: **4.000**  
2nd Value:  
Value Percent:  
Continuous Index:  
Within 8" of Joint: **YES**  
Remarks:

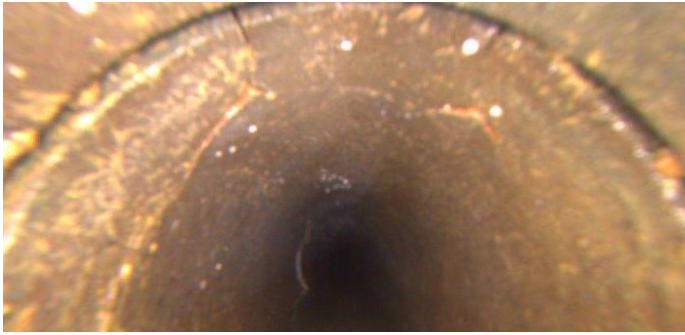
Code: **FM**  
Description: **Fracture Multiple**

Distance (ft): **44.2**  
Structural Grade: **4**  
O&M Grade: **0**  
Clock Start/From: **8**  
Clock To: **4**  
1st Value:  
2nd Value:  
Value Percent:  
Continuous Index:  
Within 8" of Joint: **YES**  
Remarks:

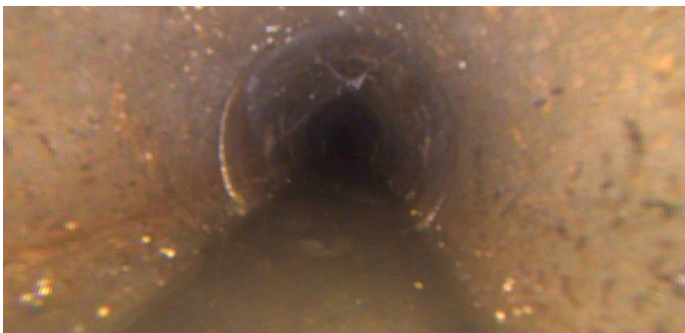
Code: **MSA**  
Description: **Abandoned Survey**

Distance (ft): **49.9**  
Structural Grade: **0**  
O&M Grade: **0**  
Clock Start/From:  
Clock To:  
1st Value:  
2nd Value:  
Value Percent:  
Continuous Index:  
Within 8" of Joint: **NO**  
Remarks: **Debris under water**
