## Profile/Photo Observation Report

Date:	<b>04/18/2018</b>	Weather:		Coding:	<b>PACP 6.0</b>
Pipe Length (ft):	<b>329.6</b>	Owner:	<b>NA</b>	Pre Clean:	<b>Not Known</b>
P.O.#:		Surveyor:	<b>Byrd Fitzgerald</b>	PSR:	<b>P-706-030-029</b>
Customer:		Clean Date:	<b>01/01/1900</b>	Shape:	<b>C</b>

Street:	<b>Capitol</b>	Flow Control:	<b>Not Controlled</b>
City:	<b>Hobart, IN</b>	Year Renewed:	
Location:	<b>Light Highway</b>	Tape/Media #:	
Purpose:	<b>Maintenance Related</b>	Dia/Height:	<b>8"</b>
Use:	<b>Sanitary</b>	Material:	<b>VCP</b>
Drain Area:	<b>NA</b>	Lining:	<b>Cured in Place</b>
Category:	<b>NA</b>		
Comment:	<b>Reverse setup. sediment at 48'.</b>		
Location Details:		Direction of Survey:	<b>Upstream</b>
US MH:	<b>M-706-029</b>	DS MH:	<b>M-706-030</b>
		Total Length Surveyed (ft):	<b>49.9</b>

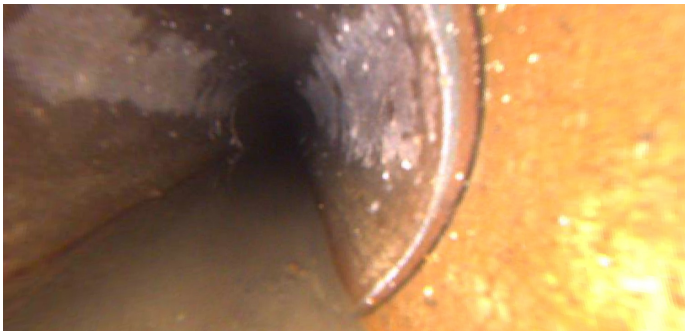
Code: **AMH**  
Description: **Manhole**

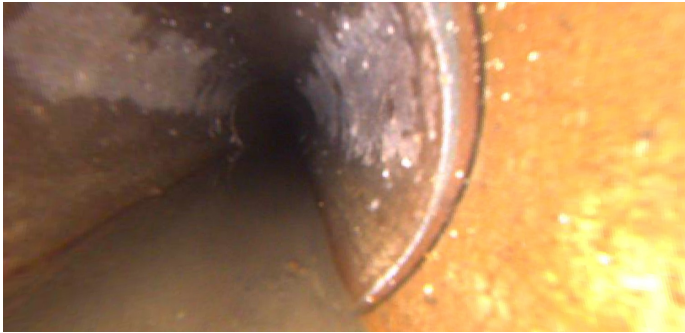
Code:	<b>MWL</b>
Description:	<b>Water Level</b>

Distance (ft):	<b>.0</b>
Structural Grade:	<b>0</b>
O&M Grade:	<b>0</b>
Clock Start/From:	
Clock To:	
1st Value:	
2nd Value:	
Value Percent:	<b>5.000</b>
Continuous Index:	
Within 8" of Joint:	<b>NO</b>
Remarks:

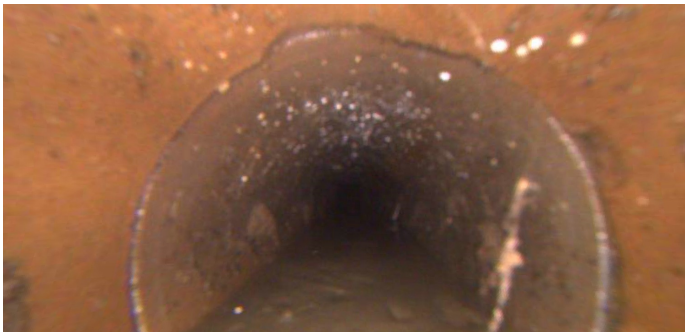
Code:	<b>RFJ</b>
Description:	<b>Roots Fine Joint</b>

Distance (ft):	<b>11.2</b>
Structural Grade:	<b>0</b>
O&M Grade:	<b>1</b>
Clock Start/From:	<b>2</b>
Clock To:	
1st Value:	
2nd Value:	
Value Percent:	
Continuous Index:	
Within 8" of Joint:	<b>YES</b>
Remarks:

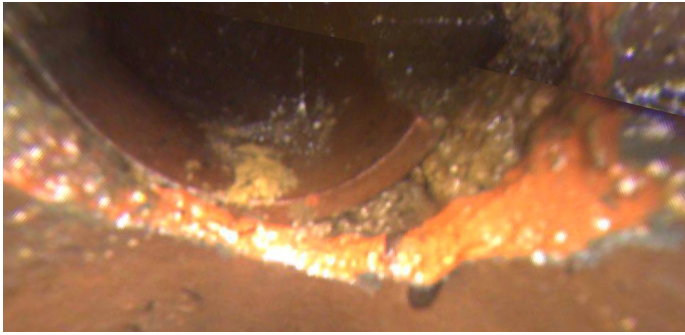
Code: **TB**  
Description: **Tap Break-in**

Distance (ft): **20.5**  
Structural Grade: **0**  
O&M Grade: **0**  
Clock Start/From: **12**  
Clock To:  
1st Value: **4.000**  
2nd Value:  
Value Percent:  
Continuous Index:  
Within 8" of Joint:  
Remarks:

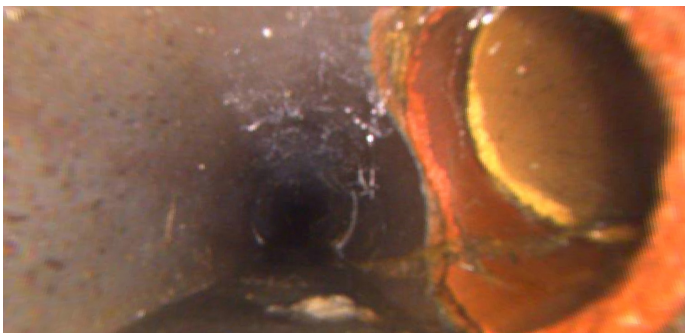
Code: **TBI**  
Description: **Tap Break-in Intruding**

Distance (ft): **22.1**  
Structural Grade: **0**  
O&M Grade: **2**  
Clock Start/From: **3**  
Clock To:  
1st Value: **4.000**  
2nd Value: **1.000**  
Value Percent:  
Continuous Index:  
Within 8" of Joint:  
Remarks:

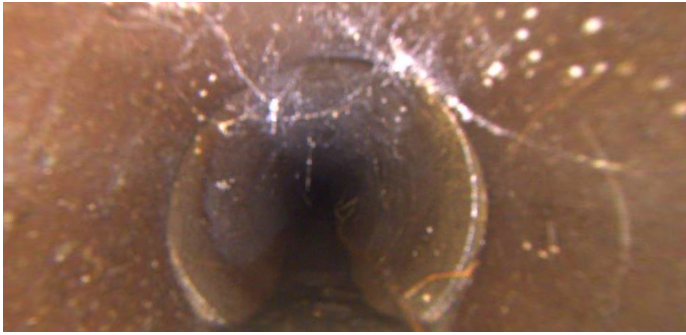
Code: **RFJ**  
Description: **Roots Fine Joint**

Distance (ft): **23.3**  
Structural Grade: **0**  
O&M Grade: **1**  
Clock Start/From: **3**  
Clock To:  
1st Value:  
2nd Value:  
Value Percent:  
Continuous Index:  
Within 8" of Joint: **YES**  
Remarks:

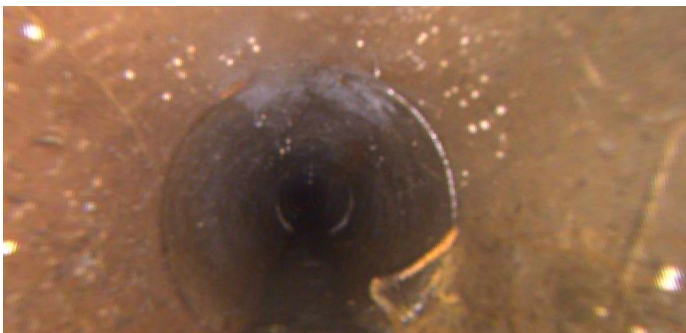
Code: **RFJ**  
Description: **Roots Fine Joint**

Distance (ft): **25.3**  
Structural Grade: **0**  
O&M Grade: **1**  
Clock Start/From: **4**  
Clock To:  
1st Value:  
2nd Value:  
Value Percent:  
Continuous Index:  
Within 8" of Joint: **YES**  
Remarks:

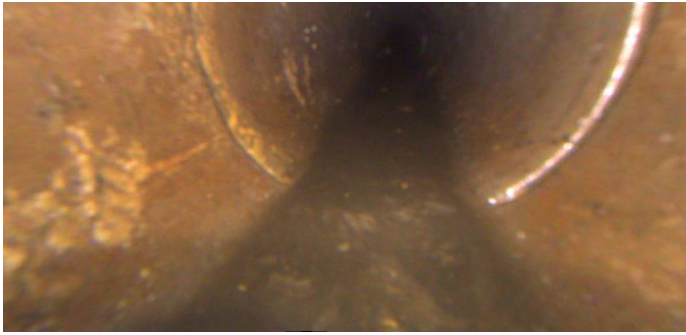
Code: **CL**  
Description: **Crack Longitudinal**

Distance (ft): **35.8**  
Structural Grade: **2**  
O&M Grade: **0**  
Clock Start/From: **8**  
Clock To:  
1st Value:  
2nd Value:  
Value Percent:  
Continuous Index:  
Within 8" of Joint: **YES**  
Remarks:

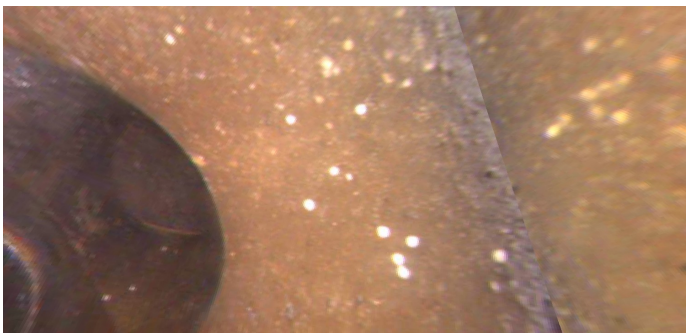
Code: **TFC**  
Description: **Tap Factory Capped**

Distance (ft): **35.8**  
Structural Grade: **0**  
O&M Grade: **0**  
Clock Start/From: **10**  
Clock To:  
1st Value: **4.000**  
2nd Value:  
Value Percent:  
Continuous Index:  
Within 8" of Joint: **YES**  
Remarks:

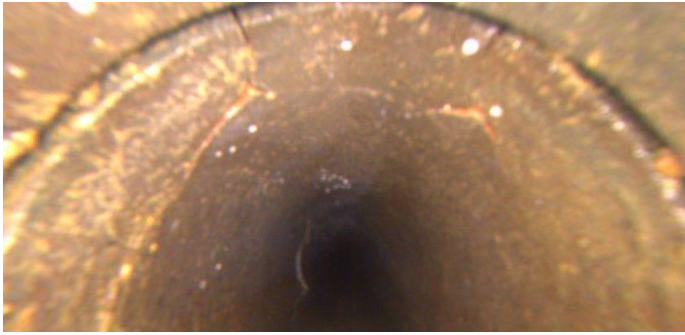
Code: **FM**  
Description: **Fracture Multiple**

Distance (ft): **44.2**  
Structural Grade: **4**  
O&M Grade: **0**  
Clock Start/From: **8**  
Clock To: **4**  
1st Value:  
2nd Value:  
Value Percent:  
Continuous Index:  
Within 8" of Joint: **YES**  
Remarks:

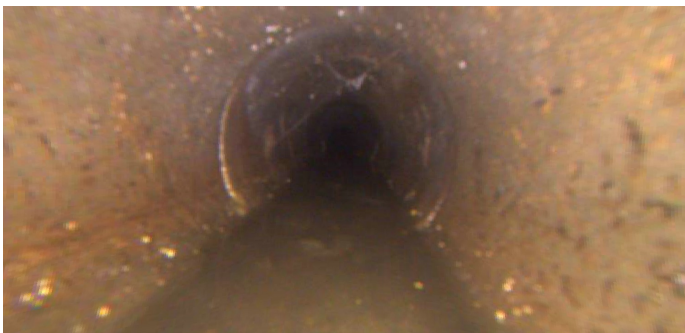
Code: **MSA**  
Description: **Abandoned Survey**

Distance (ft): **49.9**  
Structural Grade: **0**  
O&M Grade: **0**  
Clock Start/From:  
Clock To:  
1st Value:  
2nd Value:  
Value Percent:  
Continuous Index:  
Within 8" of Joint: **NO**  
Remarks: **Debris under water**
