Profile/Photo Observation Report

Date:	04/20/2018	Weather:		Coding:	PACP 6.0
Pipe Length (ft):	177.1	Owner:	NA	Pre Clean:	Not Known
P.O.#:		Surveyor:	Jen Costello	PSR:	P-706-033-032
Customer:		Clean Date:	01/01/1900	Shape:	C

Location Details:		Direction of Survey:	Downstream
US MH:	M-706-032	DS MH:	M-706-033
		Total Length Surveyed (ft):	5.7

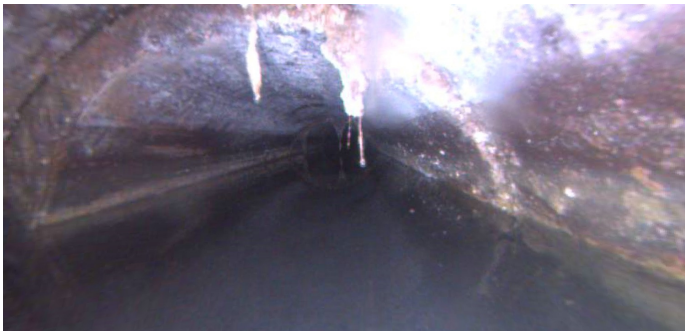
Code: **AMH**
Description: **Manhole**

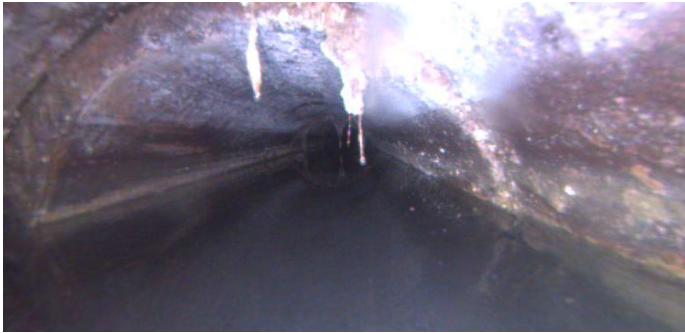
Code:	MWL
Description:	Water Level

Distance (ft):	.0
Structural Grade:	0
O&M Grade:	0
Clock Start/From:	
Clock To:	
1st Value:	
2nd Value:	
Value Percent:	30.000
Continuous Index:	
Within 8" of Joint:	NO
Remarks:

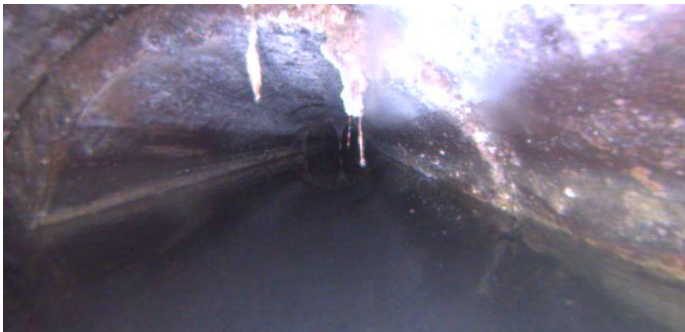
Code:	DAGS
Description:	Deposits Attached Grease

Distance (ft):	.0
Structural Grade:	0
O&M Grade:	2
Clock Start/From:	8
Clock To:	4
1st Value:	
2nd Value:	
Value Percent:	5.000
Continuous Index:	S01
Within 8" of Joint:	NO
Remarks:

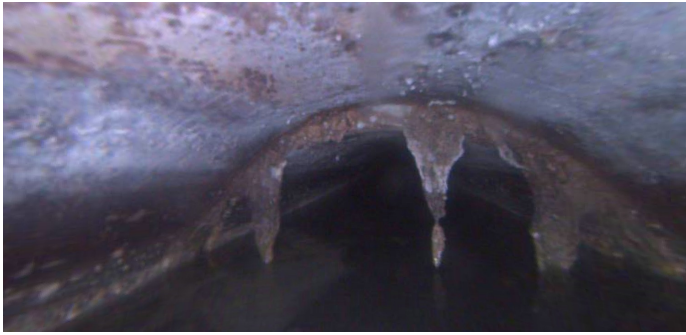
Code: **DAR**
Description: **Deposits Attached Ragging**

Distance (ft): **2.8**
Structural Grade: **0**
O&M Grade: **2**
Clock Start/From: **10**
Clock To: **2**
1st Value:
2nd Value:
Value Percent: **5.000**
Continuous Index:
Within 8" of Joint: **YES**
Remarks:

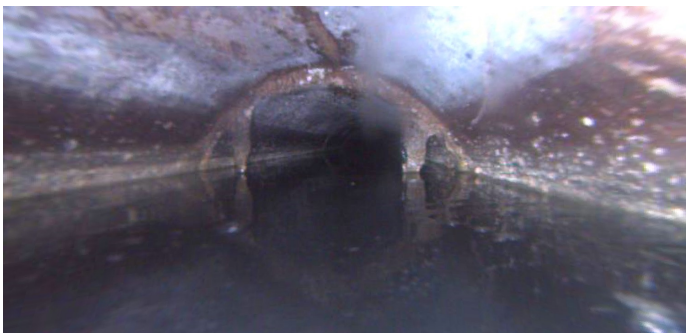
Code: **MSA**
Description: **Abandoned Survey**

Distance (ft): **5.7**
Structural Grade: **0**
O&M Grade: **0**
Clock Start/From:
Clock To:
1st Value:
2nd Value:
Value Percent:
Continuous Index:
Within 8" of Joint: **NO**
Remarks: **DEBRIS UNDER WATER**

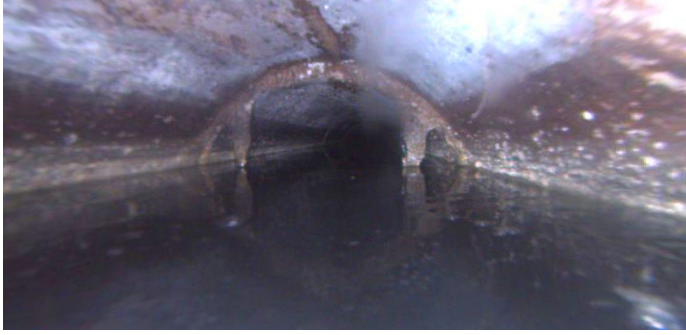
Code:	DAGS
Description:	Deposits Attached Grease
Distance (ft):	5.7
Structural Grade:	0
O&M Grade:	2
Clock Start/From:	8
Clock To:	4
1st Value:	
2nd Value:	
Value Percent:	5.000
Continuous Index:	F01
Within 8" of Joint:	NO
Remarks:
