# Profile/Photo Observation Report

Date:	<b>03/09/2022</b>	Weather:		Coding:	<b>PACP 7.0</b>
Pipe Length (ft):	<b>177.0</b>	Owner:	<b>City of Hobart</b>	Pre Clean:	<b>Heavy Cleaning</b>
P.O.#:	<b>YES502259</b>	Surveyor:	<b>S. Bucklin</b>	PSR:	<b>P-706-033-032</b>
Customer:	<b>City of Hobart, IN (Red</b>	Clean Date:	<b>03/04/2022</b>	Shape:	<b>C</b>

Street:	<b>South Lake Street</b>	Flow Control:	<b>Not Controlled</b>
City:	<b>Hobart, IN</b>	Year Renewed:	
Location:	<b>Local rural streets with light traffic, t</b>	Tape/Media #:	
Purpose:	<b>Routine Assessment</b>	Dia/Height:	<b>10"</b>
Use:	<b>Sanitary Sewage Pipe</b>	Material:	<b>VCP</b>
Drain Area:		Lining:	<b>None</b>
Category:	<b>NA</b>		
Comment:			
Location Details:		Direction of Survey:	<b>Downstream</b>
US MH:	<b>M-706-032</b>	DS MH:	<b>M-706-033</b>
		Total Length Surveyed (ft):	<b>175.4</b>

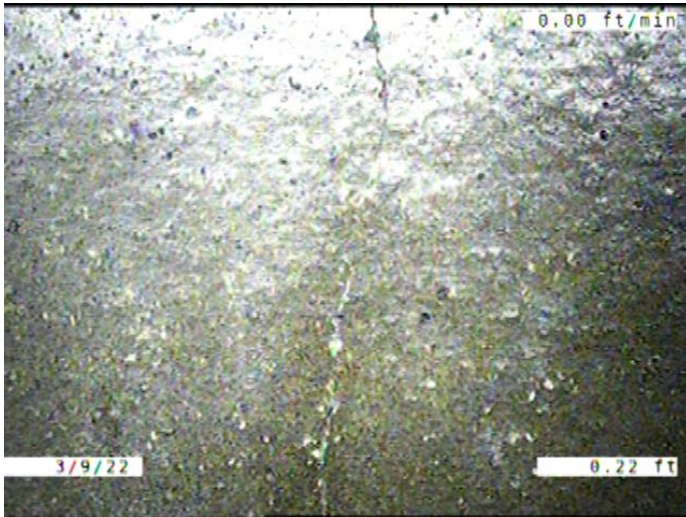
Code: **CL**  
Description: **Crack Longitudinal**

Distance (ft): **.2**  
Structural Grade: **2**  
O&M Grade: **0**  
Clock Start/From: **12**  
Clock To:  
1st Value:  
2nd Value:  
Value Percent:  
Continuous Index:  
Within 8" of Joint: **YES**  
Remarks:

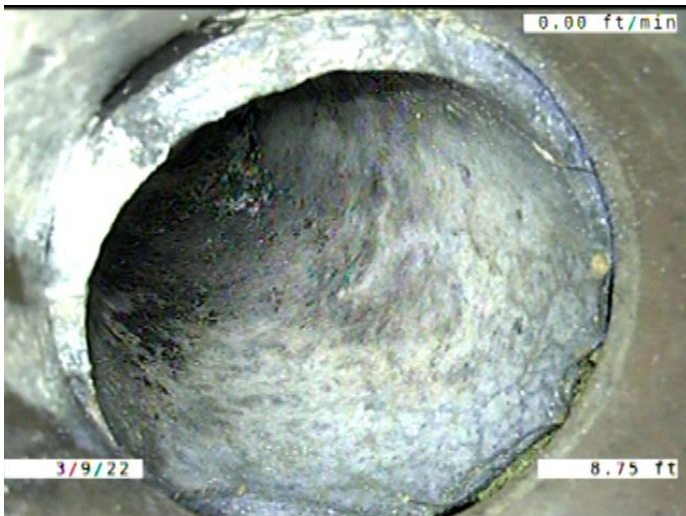
Code: **TF**  
Description: **Tap Factory**

Distance (ft): **8.7**  
Structural Grade: **0**  
O&M Grade: **0**  
Clock Start/From: **10**  
Clock To:  
1st Value: **6.000**  
2nd Value:  
Value Percent:  
Continuous Index:  
Within 8" of Joint: **YES**  
Remarks: **SERVICE TO MAIN CONNECTION  
BROKEN AND SOIL VISIBLE. CONSTA**

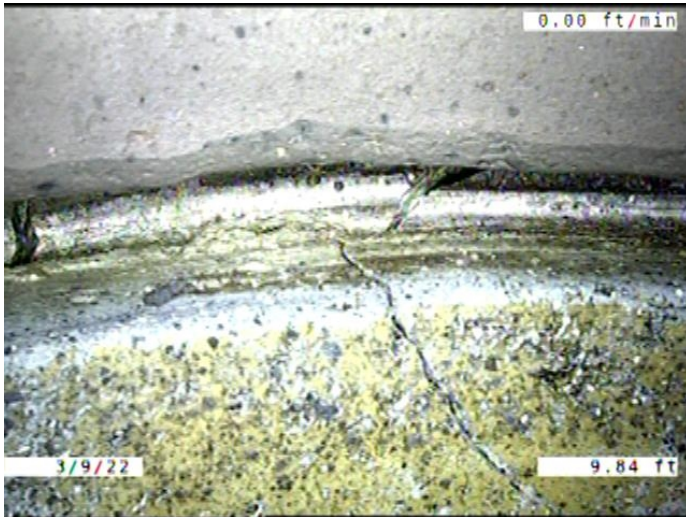
Code: **FM**  
 Description: **Fracture Multiple**

Distance (ft): **9.8**  
 Structural Grade: **4**  
 O&M Grade: **0**  
 Clock Start/From: **8**  
 Clock To: **12**  
 1st Value:  
 2nd Value:  
 Value Percent:  
 Continuous Index:  
 Within 8" of Joint: **YES**  
 Remarks:

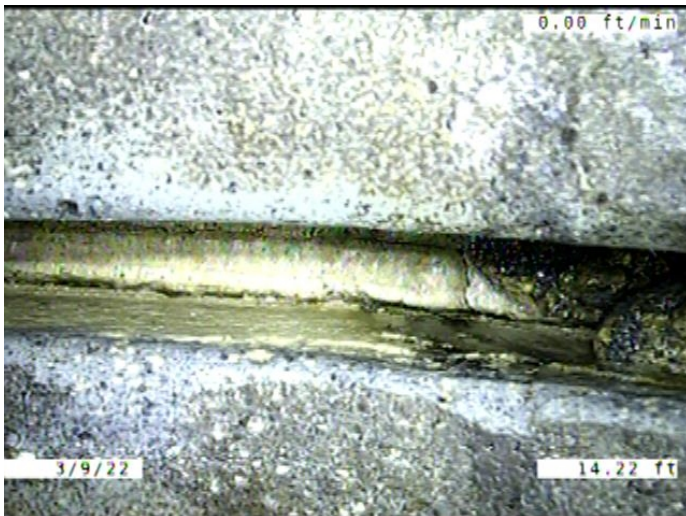
Code: **B**  
 Description: **Broken**

Distance (ft): **14.2**  
 Structural Grade: **4**  
 O&M Grade: **0**  
 Clock Start/From: **9**  
 Clock To: **4**  
 1st Value:  
 2nd Value:  
 Value Percent:  
 Continuous Index:  
 Within 8" of Joint: **YES**  
 Remarks:

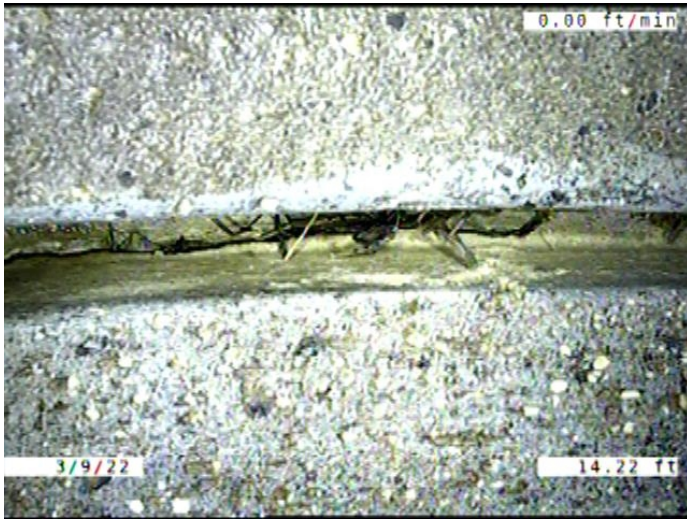
Code: **RFJ**  
 Description: **Roots Fine Joint**

Distance (ft): **14.2**  
 Structural Grade: **0**  
 O&M Grade: **1**  
 Clock Start/From: **11**  
 Clock To: **1**  
 1st Value:  
 2nd Value:  
 Value Percent:  
 Continuous Index:  
 Within 8" of Joint: **YES**  
 Remarks:

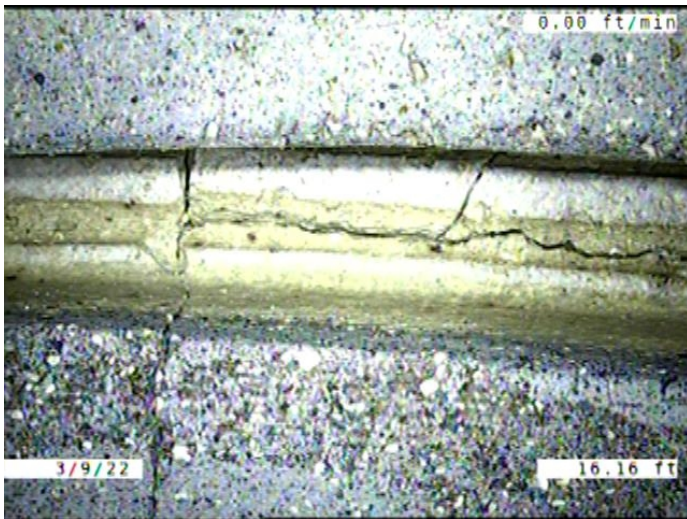
Code: **B**  
 Description: **Broken**

Distance (ft): **16.2**  
 Structural Grade: **4**  
 O&M Grade: **0**  
 Clock Start/From: **9**  
 Clock To: **4**  
 1st Value:  
 2nd Value:  
 Value Percent:  
 Continuous Index:  
 Within 8" of Joint: **YES**  
 Remarks:

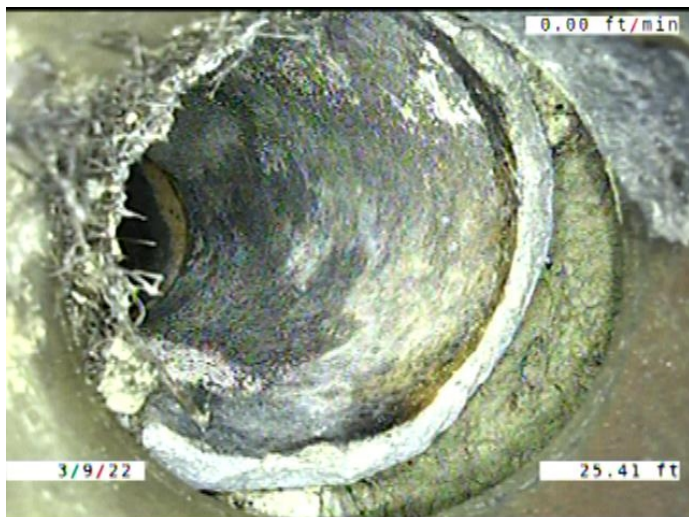
Code: **TF**  
Description: **Tap Factory**

Distance (ft): **25.4**  
Structural Grade: **0**  
O&M Grade: **0**  
Clock Start/From: **10**  
Clock To:  
1st Value: **6.000**  
2nd Value:  
Value Percent:  
Continuous Index:  
Within 8" of Joint: **YES**  
Remarks: **SERVICE TO MAIN CONNECTION  
BROKEN, OFFSET, AND SOIL VISIBLE.**

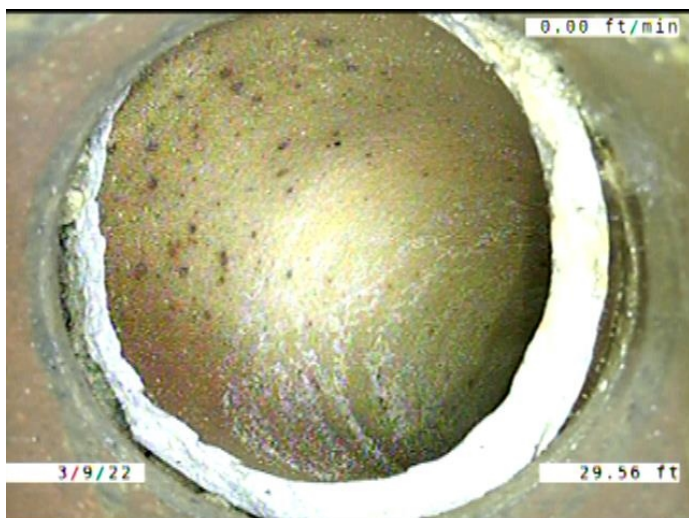
Code: **TF**  
Description: **Tap Factory**

Distance (ft): **29.6**  
Structural Grade: **0**  
O&M Grade: **0**  
Clock Start/From: **2**  
Clock To:  
1st Value: **6.000**  
2nd Value:  
Value Percent:  
Continuous Index:  
Within 8" of Joint: **YES**  
Remarks: **SERVICE TO MAIN CONNECTION  
BROKEN AND SOIL VISIBLE.**

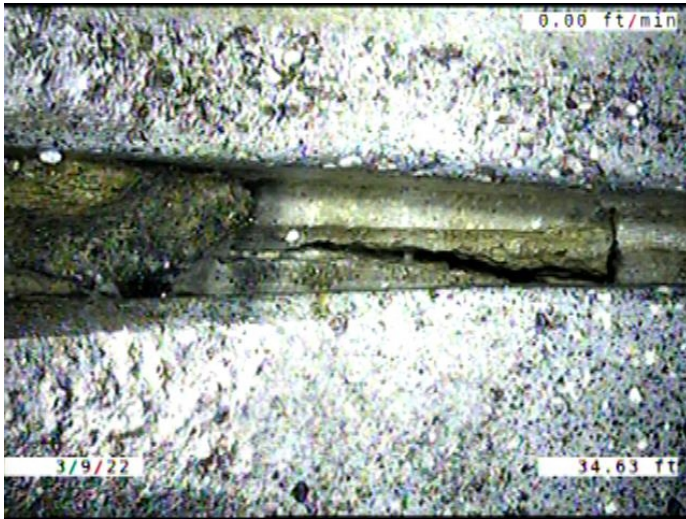
Code: **IDJ**  
Description: **Infiltration Dripper Joint**

Distance (ft): **34.6**  
Structural Grade: **0**  
O&M Grade: **3**  
Clock Start/From: **3**  
Clock To:  
1st Value:  
2nd Value:  
Value Percent:  
Continuous Index:  
Within 8" of Joint: **YES**  
Remarks:

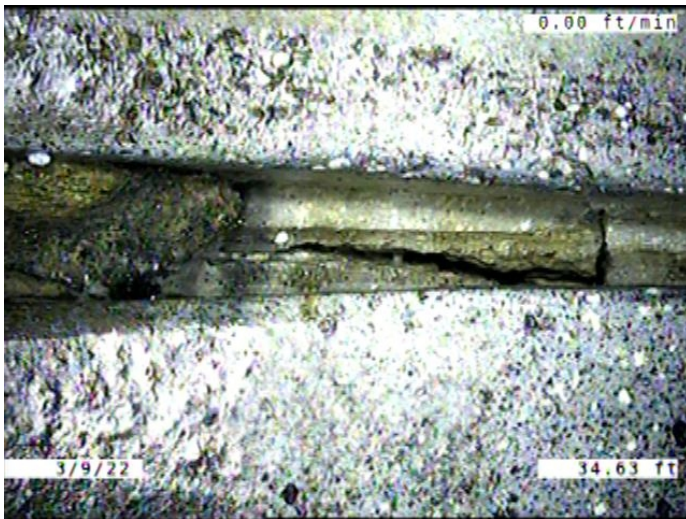
Code: **B**  
Description: **Broken**

Distance (ft): **34.6**  
Structural Grade: **4**  
O&M Grade: **0**  
Clock Start/From: **9**  
Clock To: **3**  
1st Value:  
2nd Value:  
Value Percent:  
Continuous Index:  
Within 8" of Joint: **YES**  
Remarks:

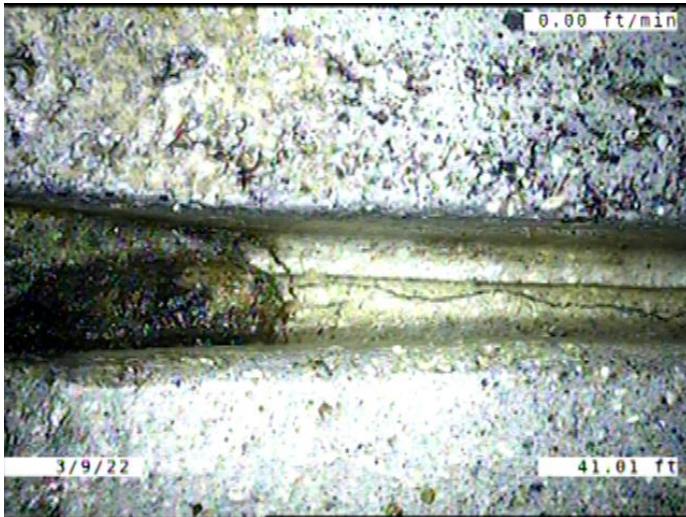
Code: **FM**  
Description: **Fracture Multiple**

Distance (ft): **41.0**  
Structural Grade: **4**  
O&M Grade: **0**  
Clock Start/From: **11**  
Clock To: **3**  
1st Value:  
2nd Value:  
Value Percent:  
Continuous Index:  
Within 8" of Joint: **YES**  
Remarks:

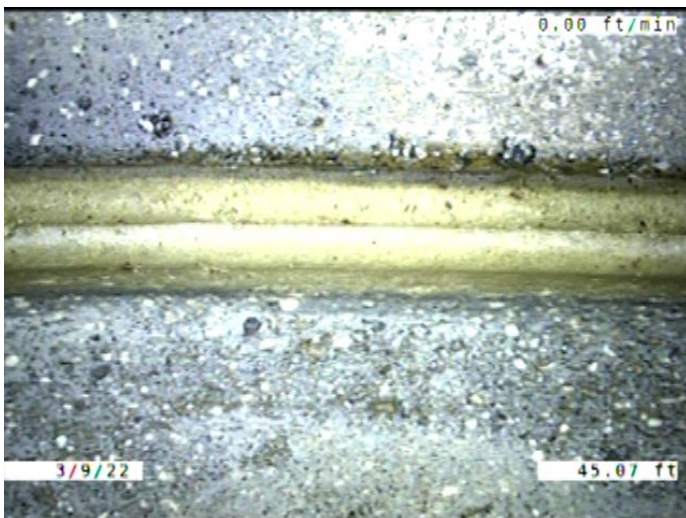
Code: **JAM**  
Description: **Joint Angular Medium**

Distance (ft): **45.1**  
Structural Grade: **3**  
O&M Grade: **0**  
Clock Start/From:  
Clock To:  
1st Value:  
2nd Value:  
Value Percent:  
Continuous Index:  
Within 8" of Joint: **NO**  
Remarks:

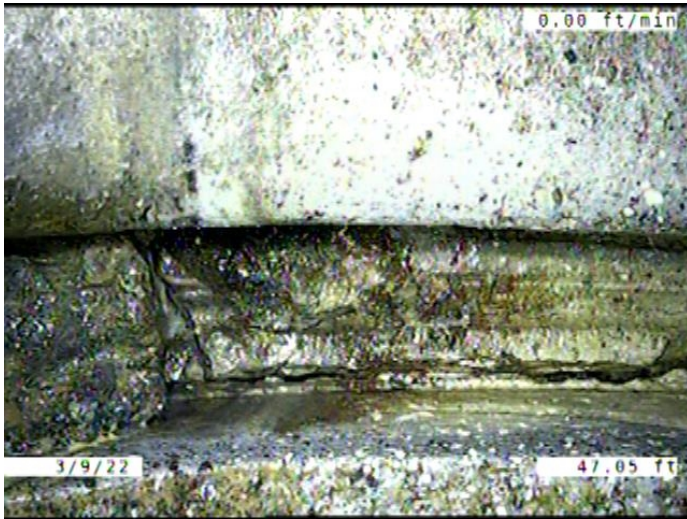
Code: **JAL**  
Description: **Joint Angular Large**

Distance (ft): **47.0**  
Structural Grade: **4**  
O&M Grade: **0**  
Clock Start/From:  
Clock To:  
1st Value:  
2nd Value:  
Value Percent:  
Continuous Index:  
Within 8" of Joint: **NO**  
Remarks:

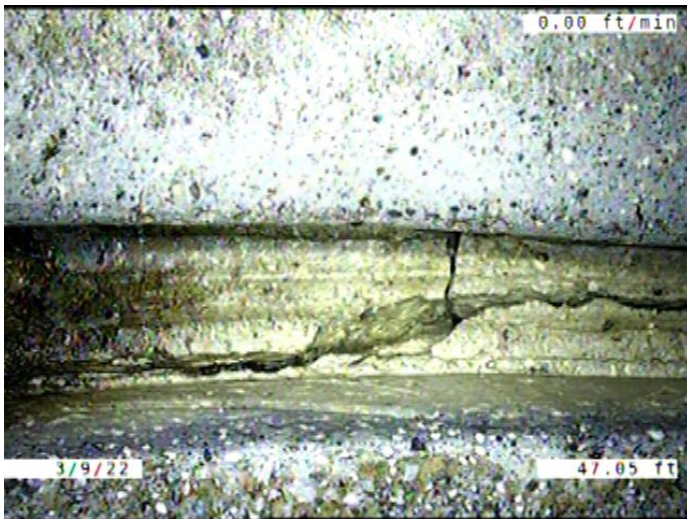
Code: **BSV**  
Description: **Broken Soil Visible**

Distance (ft): **47.0**  
Structural Grade: **5**  
O&M Grade: **0**  
Clock Start/From: **8**  
Clock To: **4**  
1st Value:  
2nd Value:  
Value Percent:  
Continuous Index:  
Within 8" of Joint: **YES**  
Remarks:

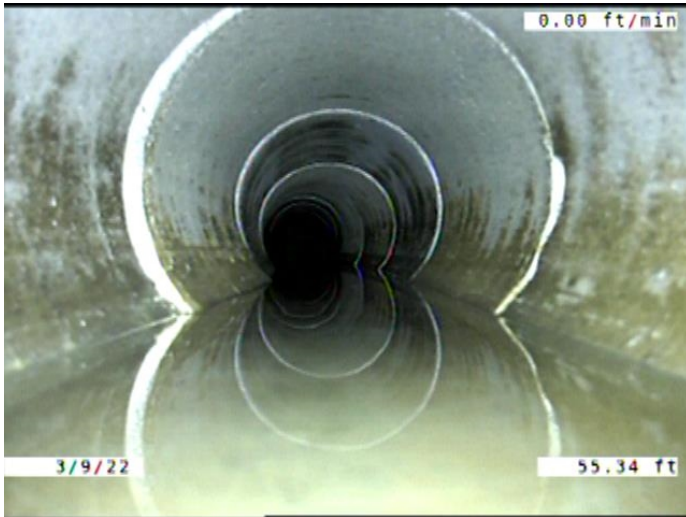
Code: **MWLS**  
 Description: **Miscellaneous Water Level Sag**

Distance (ft): **55.3**  
 Structural Grade: **2**  
 O&M Grade: **0**  
 Clock Start/From:  
 Clock To:  
 1st Value:  
 2nd Value:  
 Value Percent: **10.000**  
 Continuous Index:  
 Within 8" of Joint: **NO**  
 Remarks:

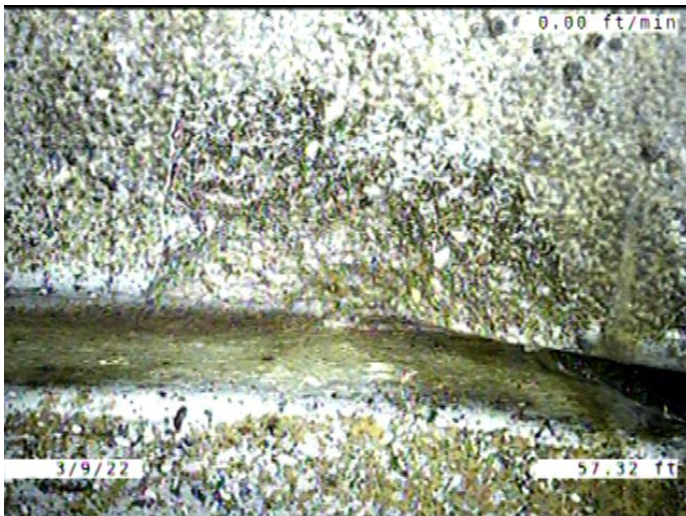
Code: **SZ**  
 Description: **Surface Damage Other**

Distance (ft): **57.3**  
 Structural Grade: **0**  
 O&M Grade: **0**  
 Clock Start/From: **3**  
 Clock To:  
 1st Value:  
 2nd Value:  
 Value Percent:  
 Continuous Index:  
 Within 8" of Joint: **YES**  
 Remarks: **A PIECE CHIPPED AWAY FROM THE JOINT.**

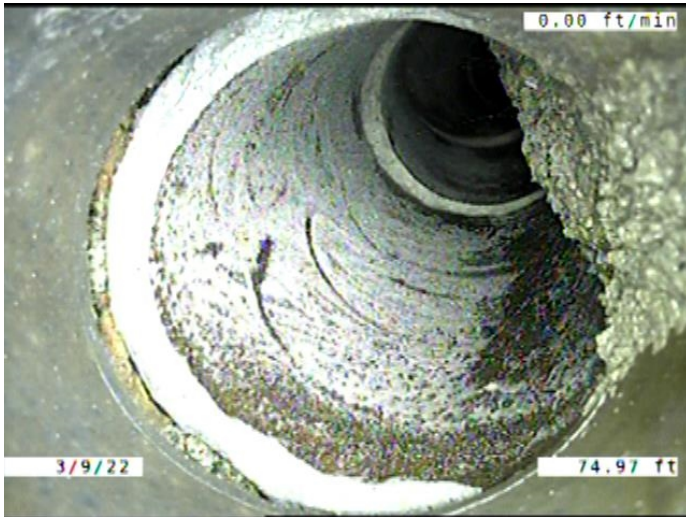
Code: **TF**  
 Description: **Tap Factory**

Distance (ft): **75.0**  
 Structural Grade: **0**  
 O&M Grade: **0**  
 Clock Start/From: **2**  
 Clock To:  
 1st Value: **6.000**  
 2nd Value:  
 Value Percent:  
 Continuous Index:  
 Within 8" of Joint: **YES**  
 Remarks: **SERVICE TO MAIN CONNECTION  
 BROKEN AND SOIL VISIBLE.**

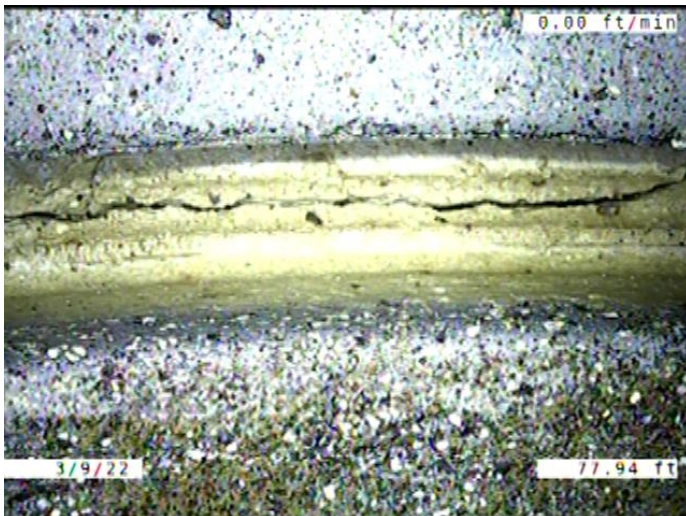
Code: **FM**  
 Description: **Fracture Multiple**

Distance (ft): **77.9**  
 Structural Grade: **4**  
 O&M Grade: **0**  
 Clock Start/From: **8**  
 Clock To: **11**  
 1st Value:  
 2nd Value:  
 Value Percent:  
 Continuous Index:  
 Within 8" of Joint: **YES**  
 Remarks:

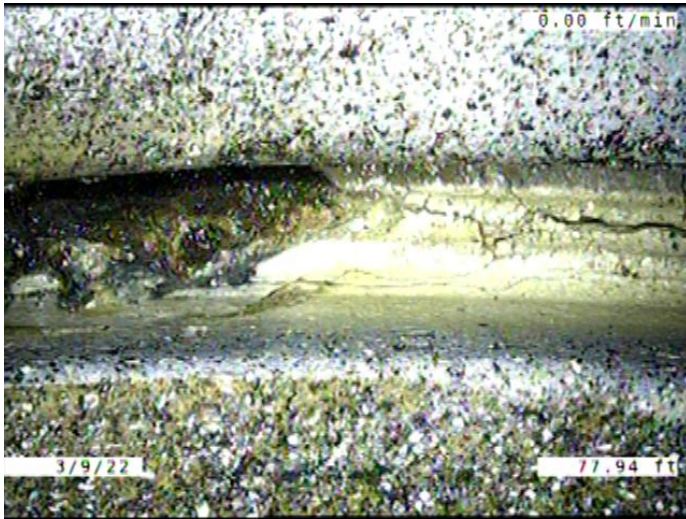
Code: **JAM**  
Description: **Joint Angular Medium**

Distance (ft): **77.9**  
Structural Grade: **3**  
O&M Grade: **0**  
Clock Start/From:  
Clock To:  
1st Value:  
2nd Value:  
Value Percent:  
Continuous Index:  
Within 8" of Joint: **NO**  
Remarks:

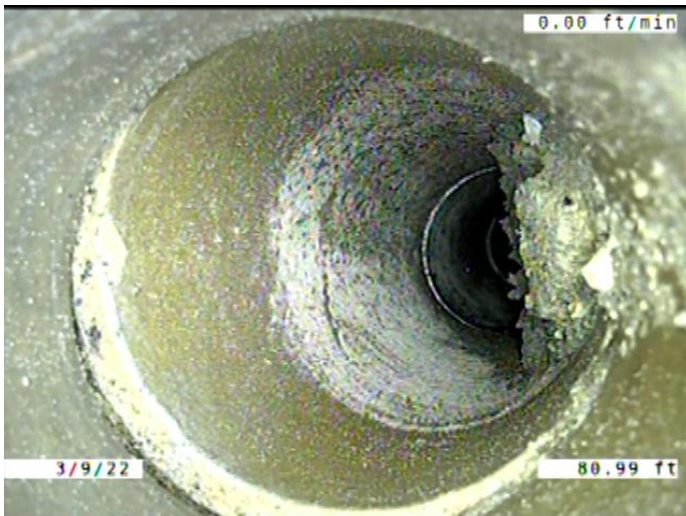
Code: **TFD**  
Description: **Tap Factory Defective**

Distance (ft): **81.0**  
Structural Grade: **0**  
O&M Grade: **3**  
Clock Start/From: **2**  
Clock To:  
1st Value: **6.000**  
2nd Value:  
Value Percent:  
Continuous Index:  
Within 8" of Joint: **YES**  
Remarks: **TAP BROKEN. SERVICE TO MAIN CONNECTION BROKEN AND SOIL VIS**

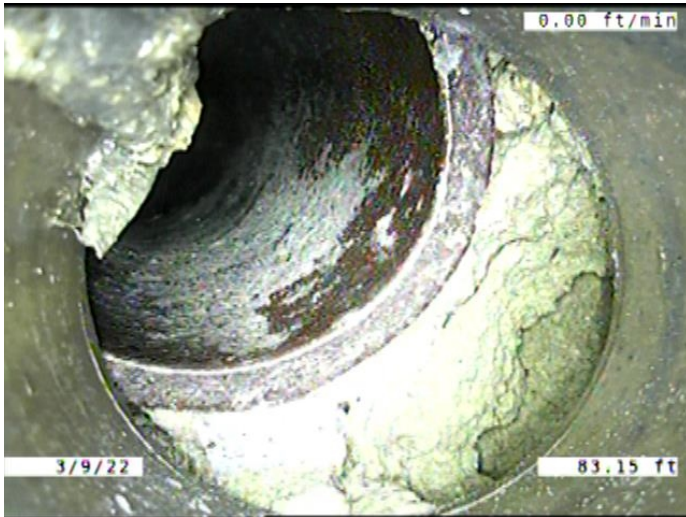
Code: **TF**  
Description: **Tap Factory**

Distance (ft): **83.1**  
Structural Grade: **0**  
O&M Grade: **0**  
Clock Start/From: **10**  
Clock To:  
1st Value: **6.000**

**YES**  
**SERVICE TO MAIN CONNECTION  
BROKEN, LARGE OFFSET, AND SOIL V**

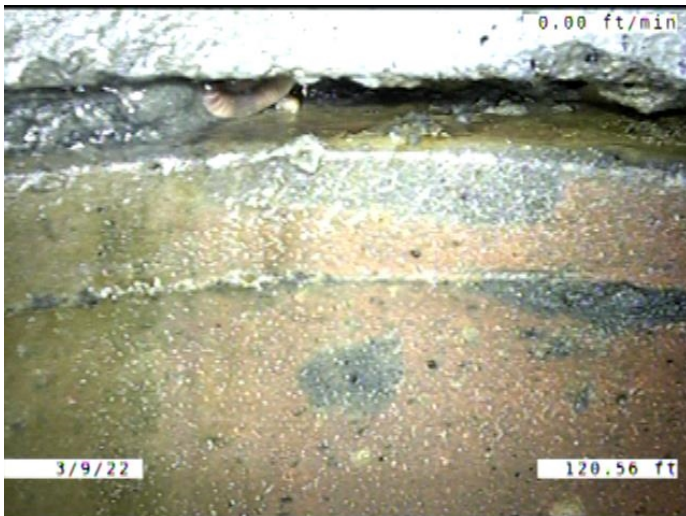
Code: **IDJ**  
Description: **Infiltration Dripper Joint**

Distance (ft): **120.6**  
Structural Grade: **0**  
O&M Grade: **3**  
Clock Start/From: **9**

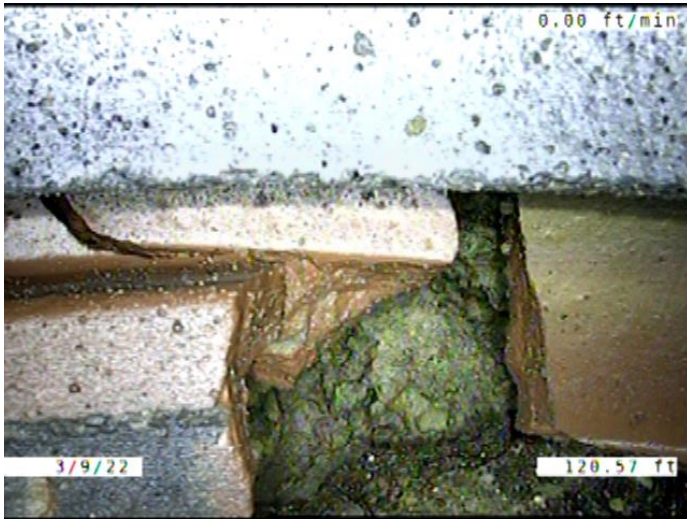
Code: **BSV**  
Description: **Broken Soil Visible**

Distance (ft): **120.6**  
Structural Grade: **5**  
O&M Grade: **0**  
Clock Start/From: **10**  
Clock To: **5**  
1st Value:  
2nd Value:  
Value Percent:  
Continuous Index:  
Within 8" of Joint: **YES**  
Remarks:

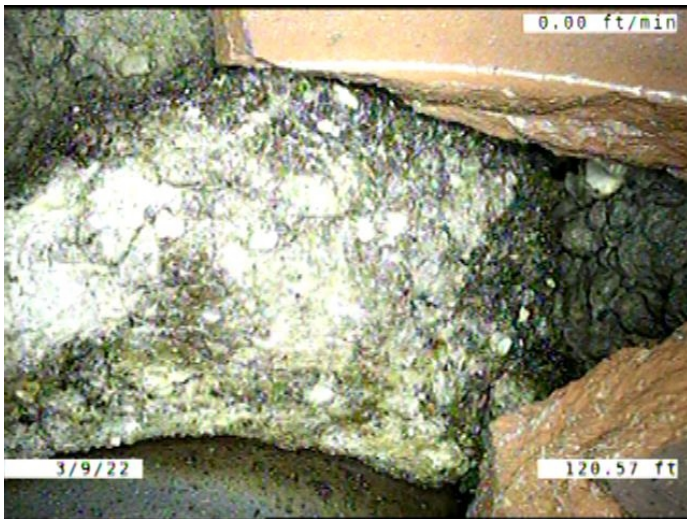
Code: **SMW**  
Description: **Surface Damage Missing Wall**

Distance (ft): **120.6**  
Structural Grade: **5**  
O&M Grade: **0**  
Clock Start/From: **2**  
Clock To: **3**  
1st Value:  
2nd Value:  
Value Percent:  
Continuous Index:  
Within 8" of Joint: **YES**  
Remarks:

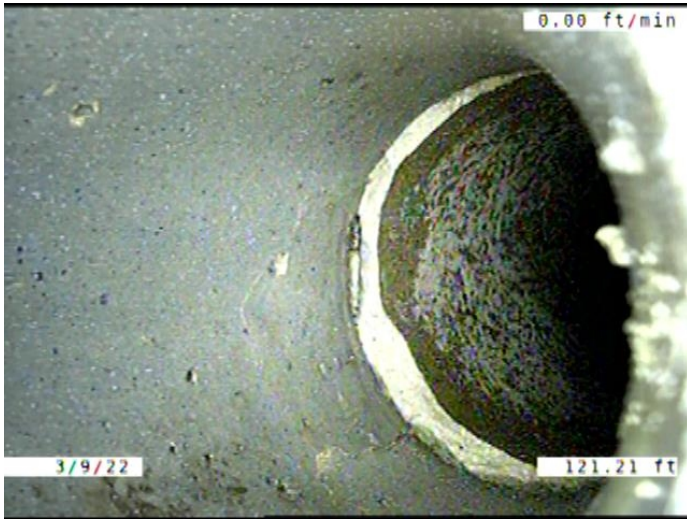
Code: **TBI**  
 Description: **Tap Break-in Intruding**

Distance (ft): **121.2**  
 Structural Grade: **0**  
 O&M Grade: **2**  
 Clock Start/From: **2**  
 Clock To:  
 1st Value: **6.000**  
 2nd Value: **1.000**  
 Value Percent:  
 Continuous Index:  
 Within 8" of Joint: **YES**  
 Remarks:

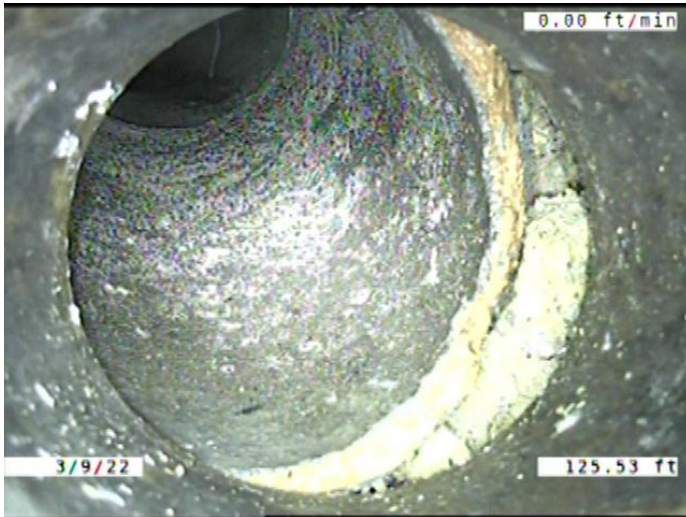
Code: **TF**  
Description: **Tap Factory**

Distance (ft): **125.5**  
Structural Grade: **0**  
O&M Grade: **0**  
Clock Start/From: **11**  
Clock To:  
1st Value: **6.000**  
2nd Value:  
Value Percent:  
Continuous Index:  
Within 8" of Joint: **YES**  
Remarks: **SERVICE TO MAIN CONNECTION  
BROKEN, OFFSET, AND SOIL VISIBLE.**

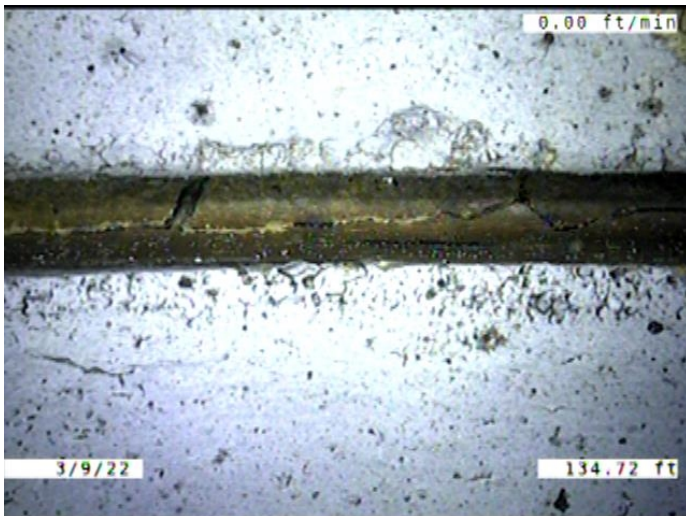
Code: **B**  
Description: **Broken**

Distance (ft): **134.7**  
Structural Grade: **4**  
O&M Grade: **0**  
Clock Start/From: **10**  
Clock To: **3**  
1st Value:  
2nd Value:  
Value Percent:  
Continuous Index:  
Within 8" of Joint: **YES**  
Remarks:

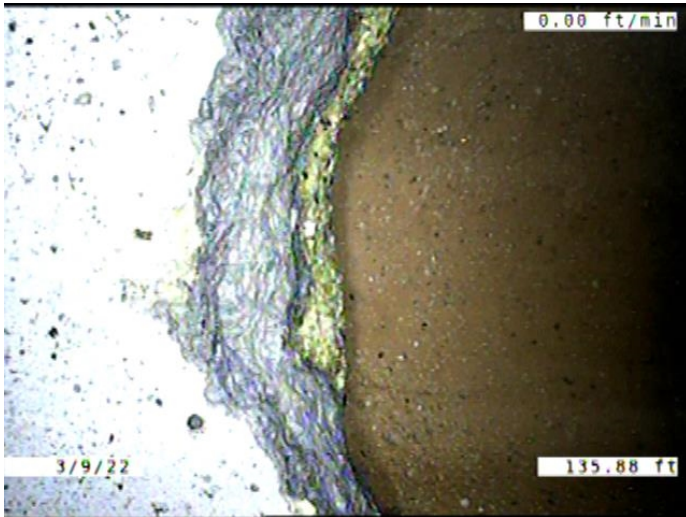
Code: **SSS**  
 Description: **Surface Damage Surface Spalling**

Distance (ft): **135.9**  
 Structural Grade: **2**  
 O&M Grade: **0**  
 Clock Start/From: **12**  
 Clock To: **3**  
 1st Value:  
 2nd Value:  
 Value Percent:  
 Continuous Index:  
 Within 8" of Joint: **YES**  
 Remarks:

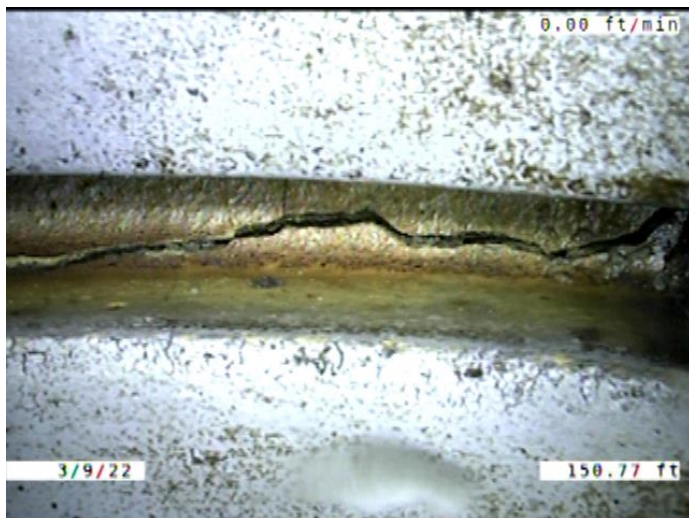
Code: **B**  
 Description: **Broken**

Distance (ft): **150.8**  
 Structural Grade: **4**  
 O&M Grade: **0**  
 Clock Start/From: **9**  
 Clock To: **3**  
 1st Value:  
 2nd Value:  
 Value Percent:  
 Continuous Index:  
 Within 8" of Joint: **YES**  
 Remarks:

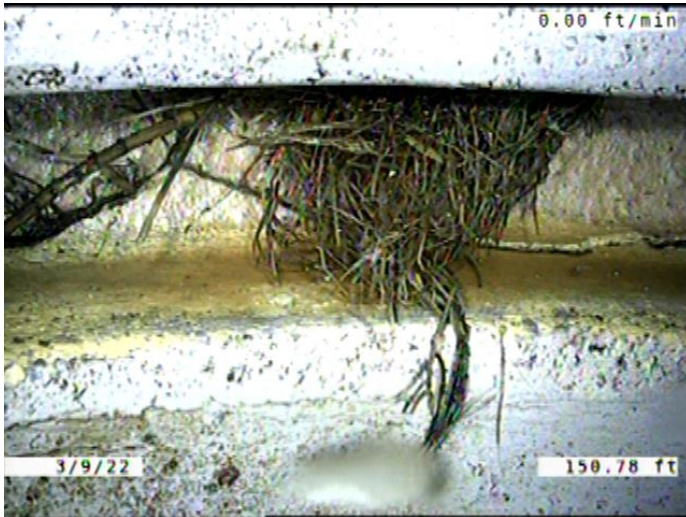
Code: **RFJ**  
 Description: **Roots Fine Joint**

Distance (ft): **150.8**  
 Structural Grade: **0**  
 O&M Grade: **1**  
 Clock Start/From: **9**  
 Clock To: **10**  
 1st Value:  
 2nd Value:  
 Value Percent:  
 Continuous Index:  
 Within 8" of Joint: **YES**  
 Remarks:

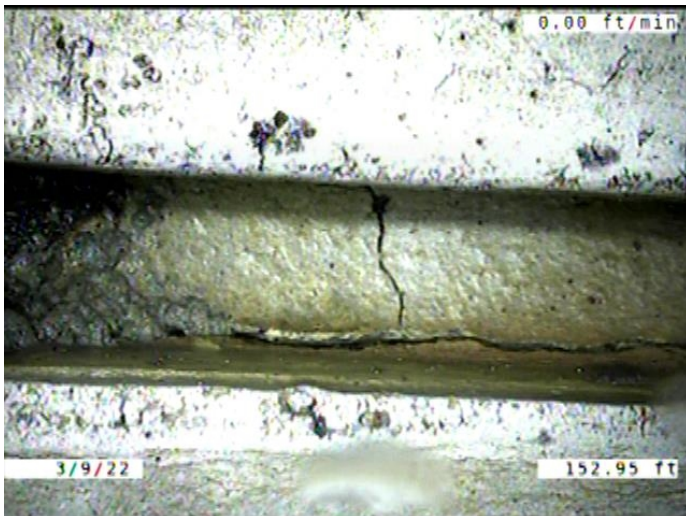
Code: **BSV**  
 Description: **Broken Soil Visible**

Distance (ft): **153.0**  
 Structural Grade: **5**  
 O&M Grade: **0**  
 Clock Start/From: **9**  
 Clock To: **3**  
 1st Value:  
 2nd Value:  
 Value Percent:  
 Continuous Index:  
 Within 8" of Joint: **YES**  
 Remarks:

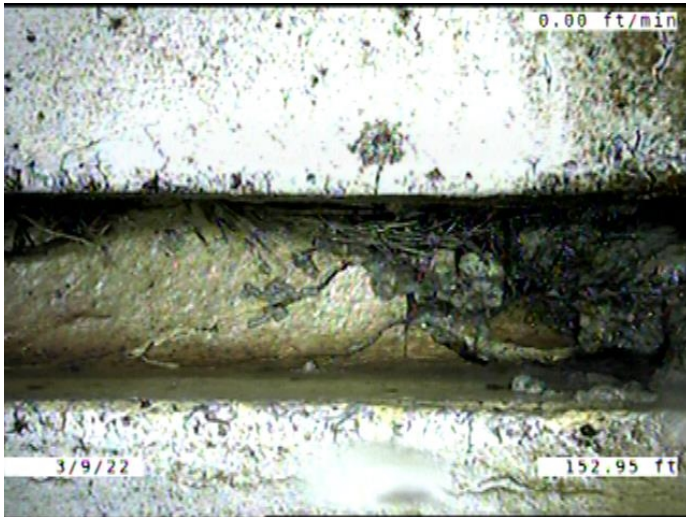
Code: **RFJ**  
 Description: **Roots Fine Joint**

Distance (ft): **153.0**  
 Structural Grade: **0**  
 O&M Grade: **1**  
 Clock Start/From: **2**  
 Clock To: **3**  
 1st Value:  
 2nd Value:  
 Value Percent:  
 Continuous Index:  
 Within 8" of Joint: **YES**  
 Remarks:

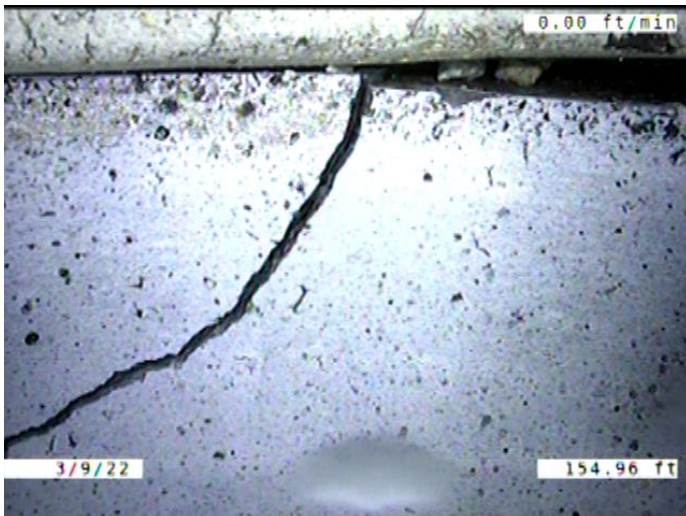
Code: **B**  
 Description: **Broken**

Distance (ft): **155.0**  
 Structural Grade: **4**  
 O&M Grade: **0**  
 Clock Start/From: **9**  
 Clock To: **3**  
 1st Value:  
 2nd Value:  
 Value Percent:  
 Continuous Index:  
 Within 8" of Joint: **YES**  
 Remarks:

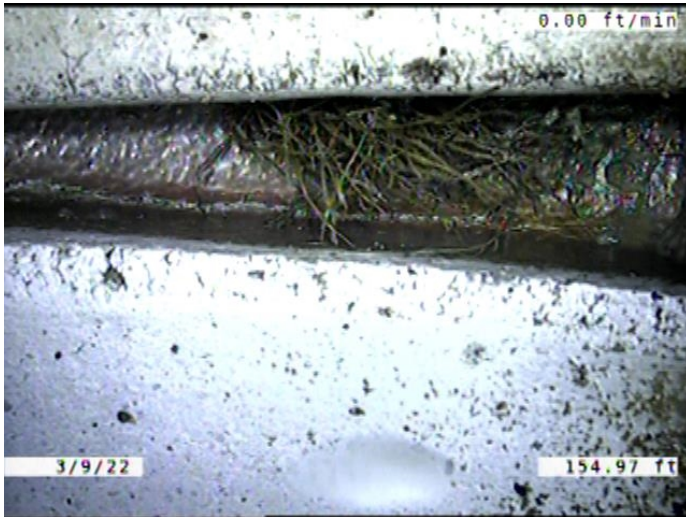
Code: **RFJ**  
 Description: **Roots Fine Joint**

Distance (ft): **155.0**  
 Structural Grade: **0**  
 O&M Grade: **1**  
 Clock Start/From: **2**  
 Clock To: **3**  
 1st Value:  
 2nd Value:  
 Value Percent:  
 Continuous Index:  
 Within 8" of Joint: **YES**  
 Remarks:

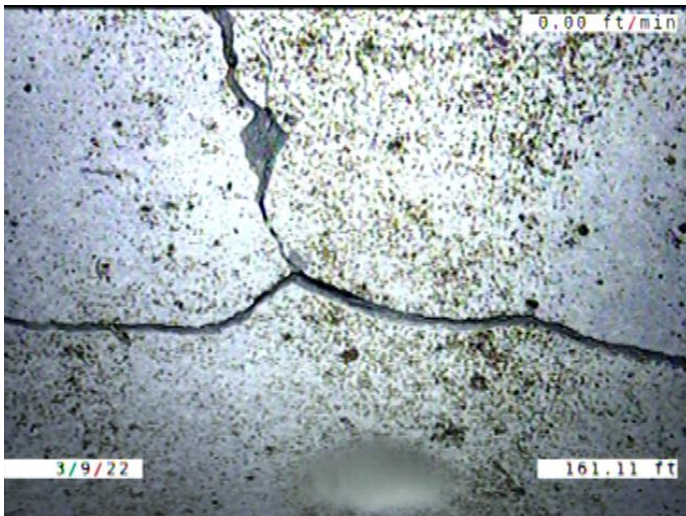
Code: **B**  
 Description: **Broken**

Distance (ft): **161.1**  
 Structural Grade: **4**  
 O&M Grade: **0**  
 Clock Start/From: **9**  
 Clock To: **4**  
 1st Value:  
 2nd Value:  
 Value Percent:  
 Continuous Index:  
 Within 8" of Joint: **YES**  
 Remarks:

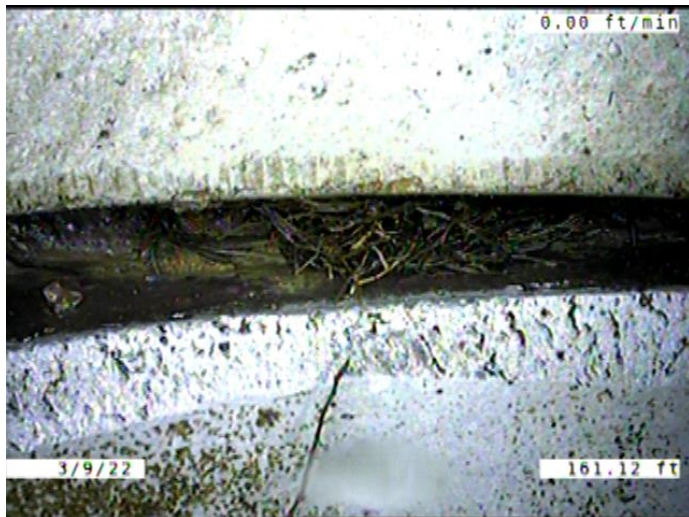
Code: **RFJ**  
 Description: **Roots Fine Joint**

Distance (ft): **161.1**  
 Structural Grade: **0**  
 O&M Grade: **1**  
 Clock Start/From: **10**  
 Clock To:  
 1st Value:  
 2nd Value:  
 Value Percent:  
 Continuous Index:  
 Within 8" of Joint: **YES**  
 Remarks:

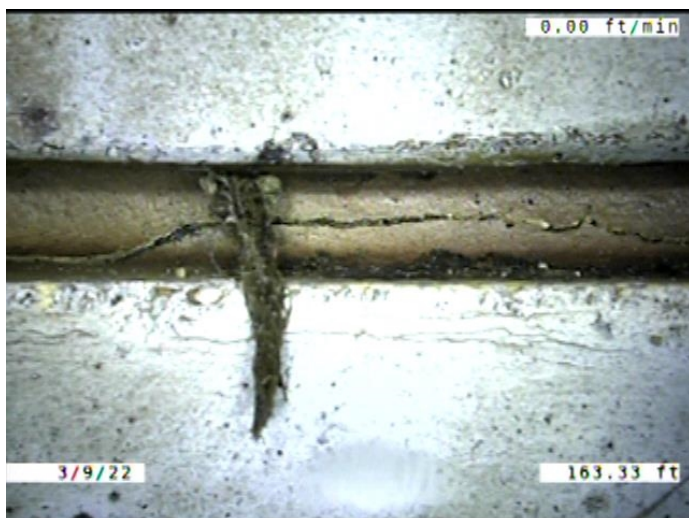
Code: **RFJ**  
 Description: **Roots Fine Joint**

Distance (ft): **163.3**  
 Structural Grade: **0**  
 O&M Grade: **1**  
 Clock Start/From: **9**  
 Clock To: **3**  
 1st Value:  
 2nd Value:  
 Value Percent:  
 Continuous Index: **S01**  
 Within 8" of Joint: **YES**  
 Remarks:

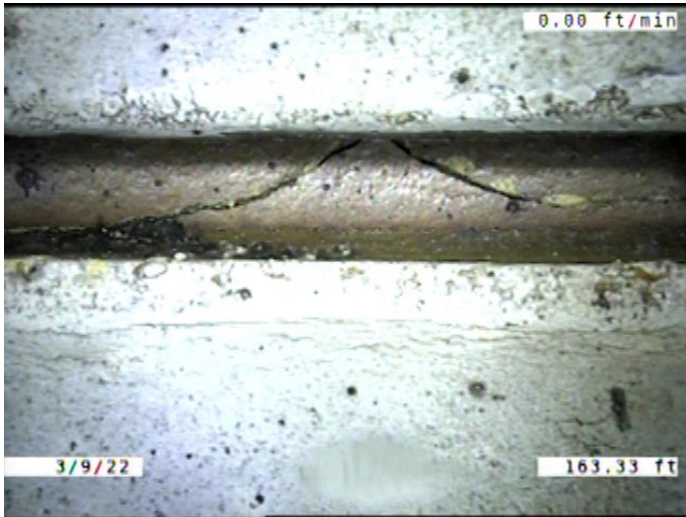
Code: **B**  
 Description: **Broken**

Distance (ft): **163.3**  
 Structural Grade: **4**  
 O&M Grade: **0**  
 Clock Start/From: **9**  
 Clock To: **2**  
 1st Value:  
 2nd Value:  
 Value Percent:  
 Continuous Index:  
 Within 8" of Joint: **YES**  
 Remarks:

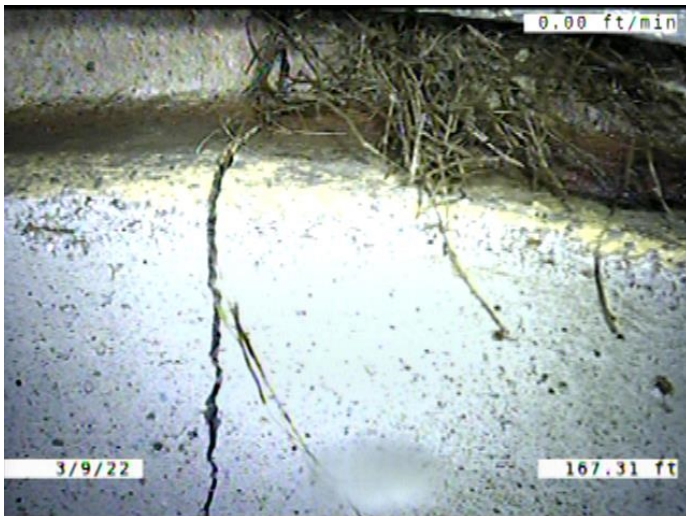
Code: **B**  
 Description: **Broken**

Distance (ft): **167.3**  
 Structural Grade: **4**  
 O&M Grade: **0**  
 Clock Start/From: **8**  
 Clock To: **2**  
 1st Value:  
 2nd Value:  
 Value Percent:  
 Continuous Index:  
 Within 8" of Joint: **YES**  
 Remarks:

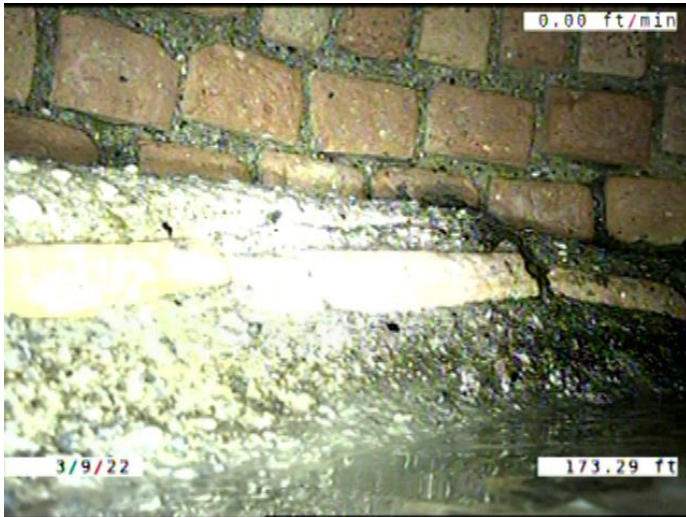
Code: **RFJ**  
 Description: **Roots Fine Joint**

Distance (ft): **173.3**  
 Structural Grade: **0**  
 O&M Grade: **1**  
 Clock Start/From: **9**  
 Clock To: **3**  
 1st Value:  
 2nd Value:  
 Value Percent:  
 Continuous Index: **F01**  
 Within 8" of Joint: **YES**  
 Remarks:
