Profile/Photo Observation Report

Date:	03/08/2022	Weather:		Coding:	PACP 7.0
Pipe Length (ft):	168.0	Owner:	City of Hobart	Pre Clean:	Heavy Cleaning
P.O.#:	YES502259	Surveyor:	S. Bucklin	PSR:	P-706-034-033
Customer:	City of Hobart, IN (Red	Clean Date:	03/04/2022	Shape:	C

Street:	South Lake Street	Flow Control:	Not Controlled
City:	Hobart, IN	Year Renewed:	
Location:	Local rural streets with light traffic, t	Tape/Media #:	
Purpose:	Routine Assessment	Dia/Height:	10"
Use:	Sanitary Sewage Pipe	Material:	VCP
Drain Area:		Lining:	None
Category:	NA		
Comment:			
Location Details:		Direction of Survey:	Downstream
US MH:	M-706-033	DS MH:	M-706-034
		Total Length Surveyed (ft):	157.1

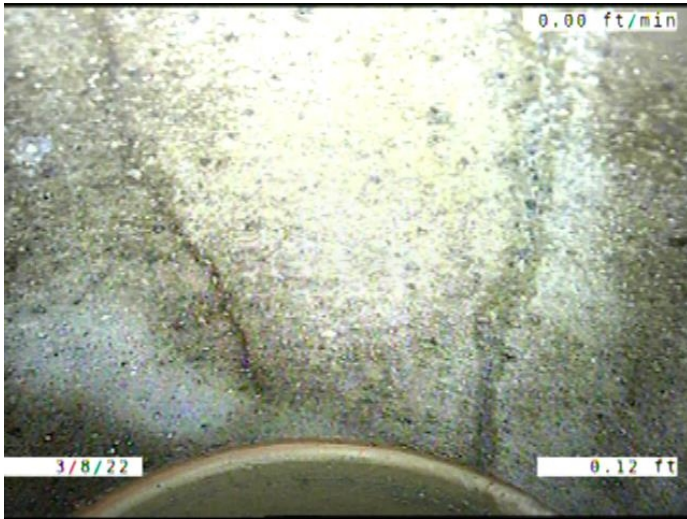
Code: **CM**
Description: **Crack Multiple**

Distance (ft): **.1**
Structural Grade: **3**
O&M Grade: **0**
Clock Start/From: **10**
Clock To: **2**
1st Value:
2nd Value:
Value Percent:
Continuous Index:
Within 8" of Joint: **YES**
Remarks:

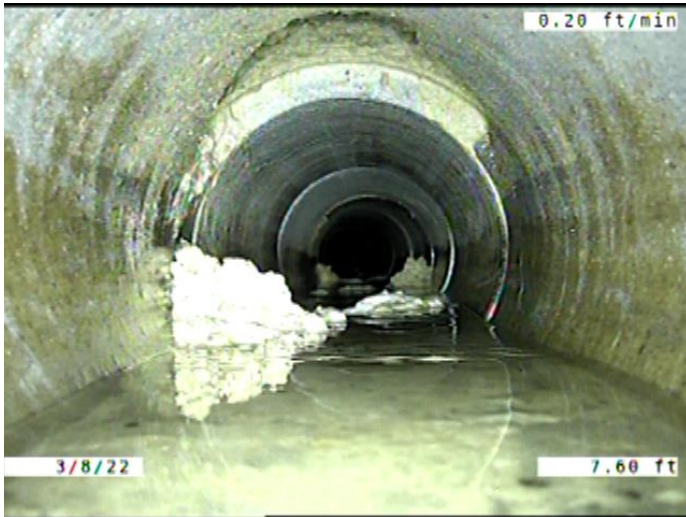
Code: **DSF**
 Description: **Deposits Settled Fine**

Distance (ft): **7.6**
 Structural Grade: **0**
 O&M Grade: **2**
 Clock Start/From: **3**
 Clock To: **9**
 1st Value:
 2nd Value:
 Value Percent: **10.000**
 Continuous Index: **S01**
 Within 8" of Joint: **YES**
 Remarks:

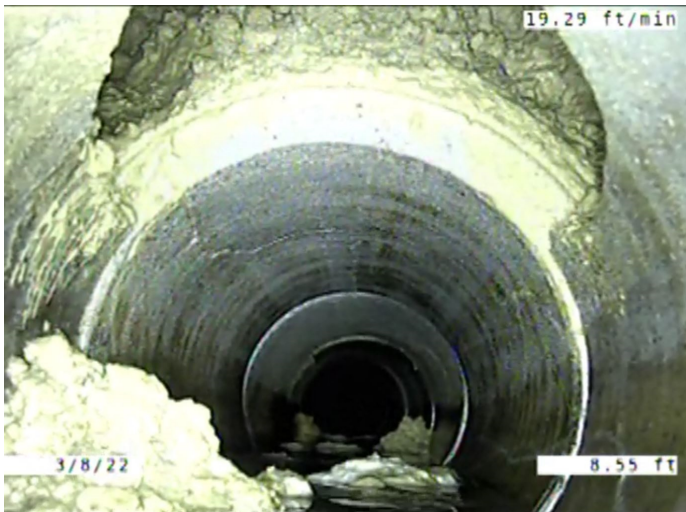
Code: **FM**
 Description: **Fracture Multiple**

Distance (ft): **8.6**
 Structural Grade: **4**
 O&M Grade: **0**
 Clock Start/From: **10**
 Clock To: **5**
 1st Value:
 2nd Value:
 Value Percent:
 Continuous Index:
 Within 8" of Joint: **NO**
 Remarks:

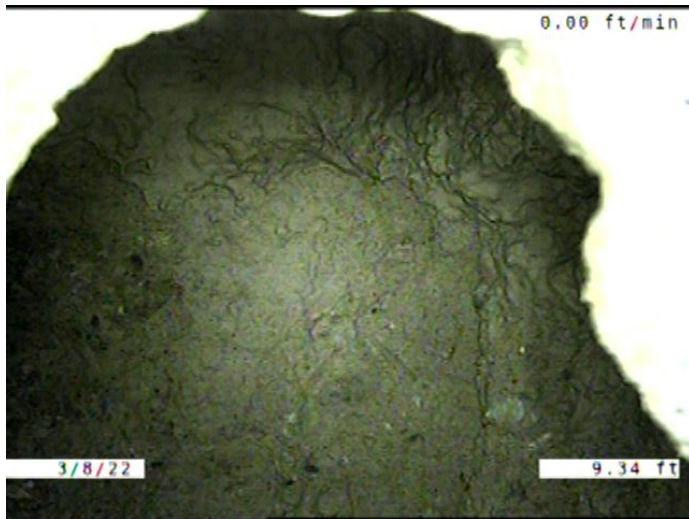
Code: **HVV**
Description: **Hole Void Visible**

Distance (ft): **9.3**
Structural Grade: **5**
O&M Grade: **0**
Clock Start/From: **10**
Clock To: **2**
1st Value:
2nd Value:
Value Percent:
Continuous Index:
Within 8" of Joint: **YES**
Remarks:

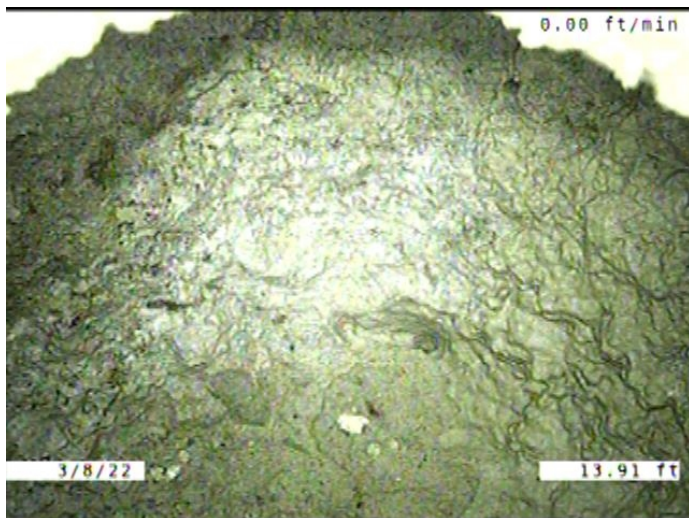
Code: **HVV**
Description: **Hole Void Visible**

Distance (ft): **13.9**
Structural Grade: **5**
O&M Grade: **0**
Clock Start/From: **10**
Clock To: **1**
1st Value:
2nd Value:
Value Percent:
Continuous Index:
Within 8" of Joint: **YES**
Remarks:

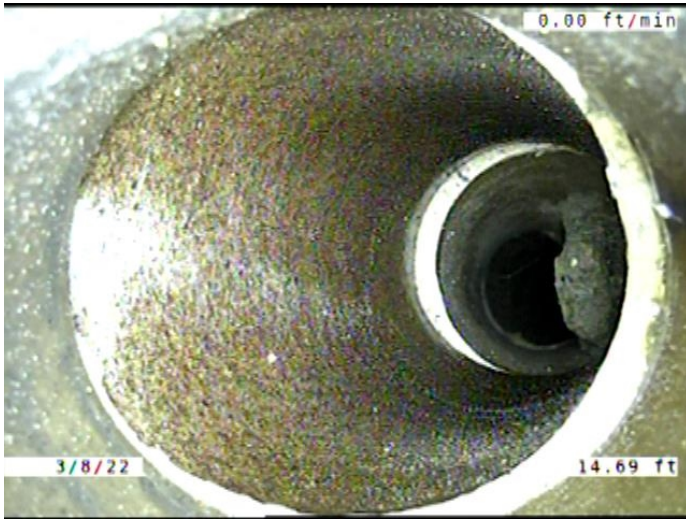
Code:	TF
Description:	Tap Factory
Distance (ft):	14.7
Structural Grade:	0
O&M Grade:	0
Clock Start/From:	2
Clock To:	
1st Value:	6.000
2nd Value:	
Value Percent:	
Continuous Index:	
Within 8" of Joint:	YES
Remarks:	SERVICE TO MAIN CONNECNTION BROKEN

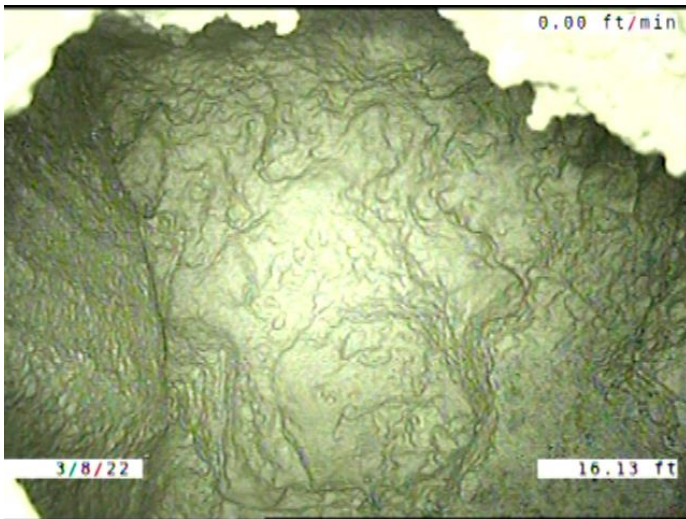
Code:	HVV
Description:	Hole Void Visible
Distance (ft):	16.1
Structural Grade:	5
O&M Grade:	0
Clock Start/From:	10
Clock To:	1
1st Value:	
2nd Value:	
Value Percent:	
Continuous Index:	
Within 8" of Joint:	YES
Remarks:

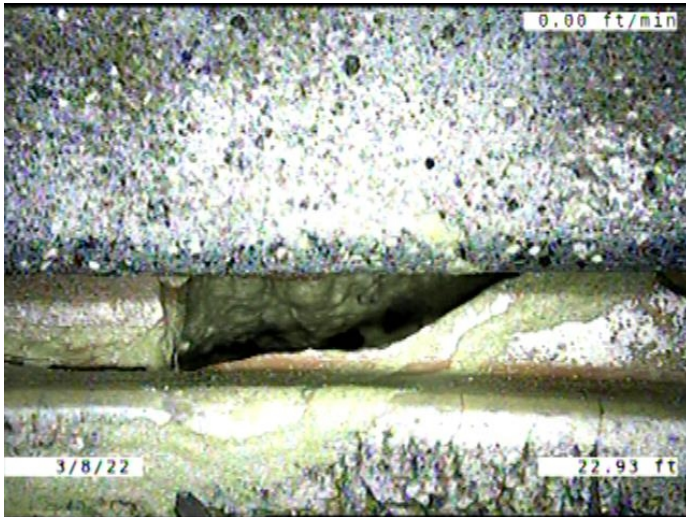
Code: **BVV**
 Description: **Broken Void Visible**

Distance (ft): **22.9**
 Structural Grade: **5**
 O&M Grade: **0**
 Clock Start/From: **11**
 Clock To: **1**
 1st Value:
 2nd Value:
 Value Percent:
 Continuous Index:
 Within 8" of Joint: **YES**
 Remarks:

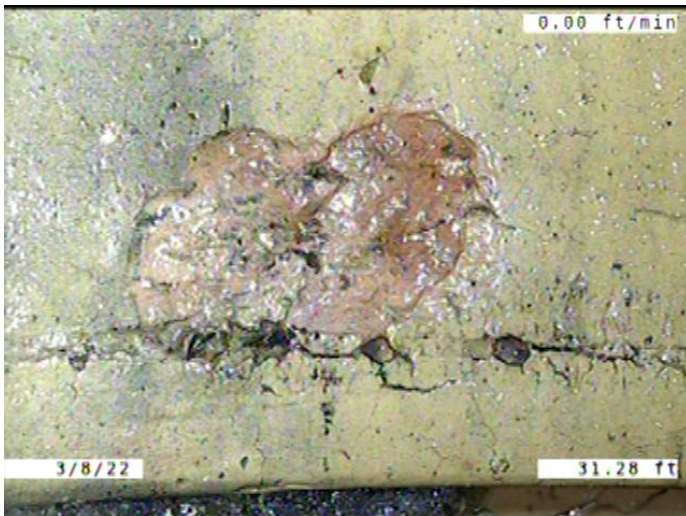
Code: **SSS**
 Description: **Surface Damage Surface Spalling**

Distance (ft): **31.3**
 Structural Grade: **2**
 O&M Grade: **0**
 Clock Start/From: **3**
 Clock To:
 1st Value:
 2nd Value:
 Value Percent:
 Continuous Index:
 Within 8" of Joint: **YES**
 Remarks:

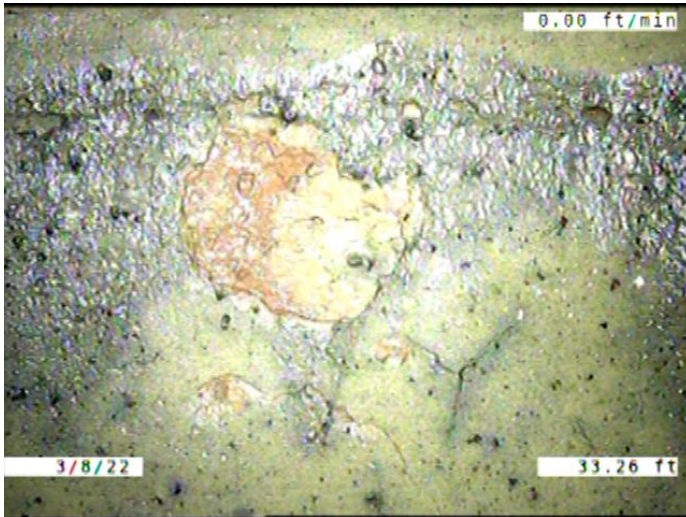
Code: **SSS**
 Description: **Surface Damage Surface Spalling**

Distance (ft): **33.3**
 Structural Grade: **2**
 O&M Grade: **0**
 Clock Start/From: **2**
 Clock To:
 1st Value:
 2nd Value:
 Value Percent:
 Continuous Index:
 Within 8" of Joint: **YES**
 Remarks:

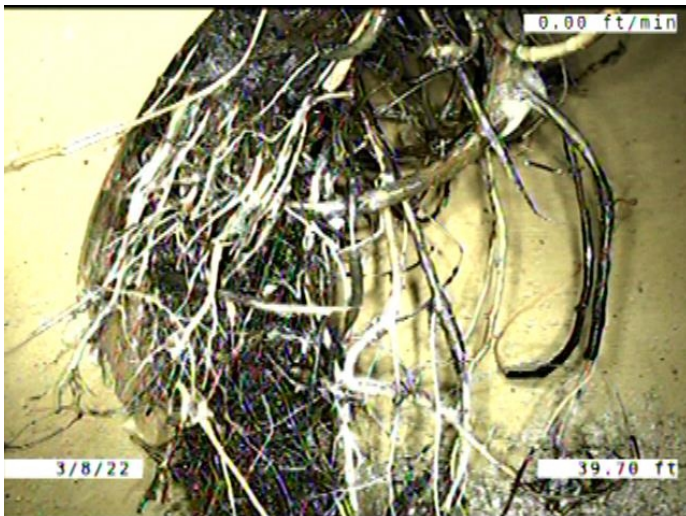
Code: **RFL**
 Description: **Roots Fine Lateral**

Distance (ft): **39.7**
 Structural Grade: **0**
 O&M Grade: **1**
 Clock Start/From: **10**
 Clock To:
 1st Value:
 2nd Value:
 Value Percent:
 Continuous Index:
 Within 8" of Joint: **NO**
 Remarks:

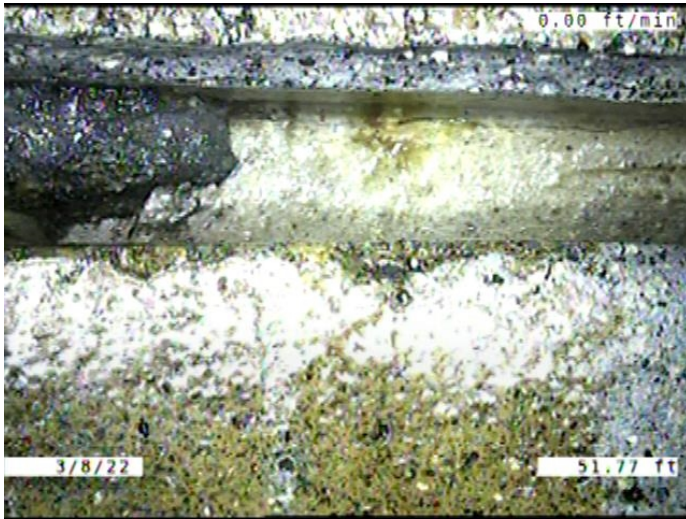
Code: **JAM**
Description: **Joint Angular Medium**

Distance (ft): **51.8**
Structural Grade: **3**
O&M Grade: **0**
Clock Start/From:
Clock To:
1st Value:
2nd Value:
Value Percent:
Continuous Index:
Within 8" of Joint: **NO**
Remarks:

Code: **TF**
Description: **Tap Factory**

Distance (ft): **54.6**
Structural Grade: **0**
O&M Grade: **0**
Clock Start/From: **2**
Clock To:
1st Value: **6.000**
2nd Value:
Value Percent:
Continuous Index:
Within 8" of Joint: **YES**
Remarks: **SERVICE LINE BROKEN AND OFFSET.
SOIL VISIBLE.**

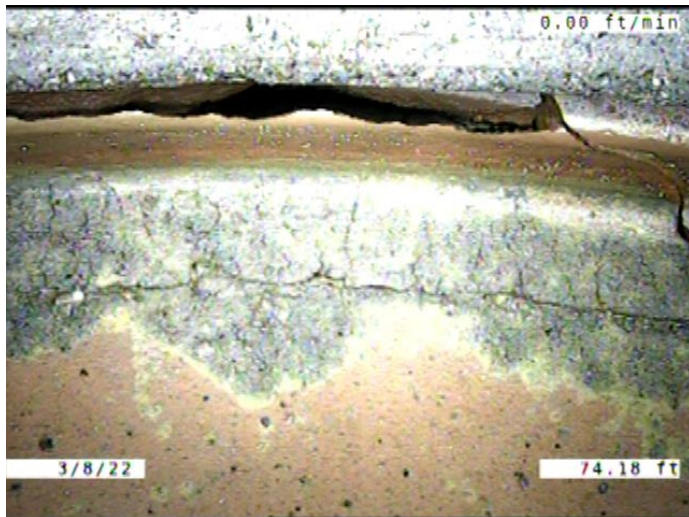
Code: **BVV**
 Description: **Broken Void Visible**

Distance (ft): **74.2**
 Structural Grade: **5**
 O&M Grade: **0**
 Clock Start/From: **8**
 Clock To: **4**
 1st Value:
 2nd Value:
 Value Percent:
 Continuous Index:
 Within 8" of Joint: **YES**
 Remarks: **SOIL VISIBLE TOO**

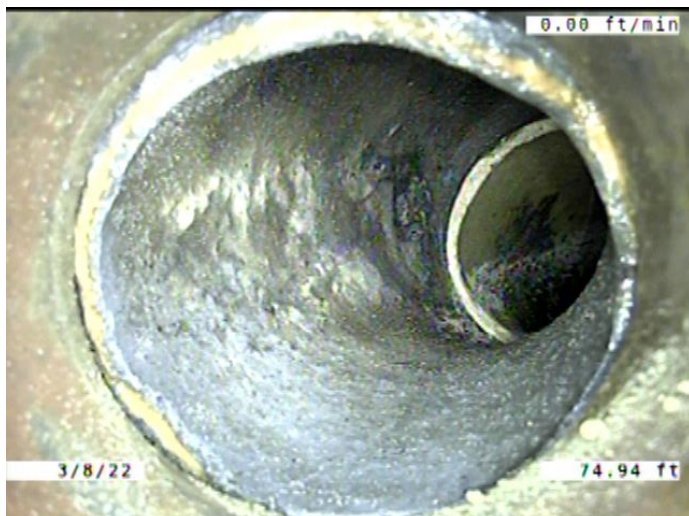
Code: **TF**
 Description: **Tap Factory**

Distance (ft): **74.9**
 Structural Grade: **0**
 O&M Grade: **0**
 Clock Start/From: **2**
 Clock To:
 1st Value: **6.000**
 2nd Value:
 Value Percent:
 Continuous Index:
 Within 8" of Joint: **YES**
 Remarks: **SERVICIE TO MAIN CONNECTION
BROKEN. SOIL VISIBLE**

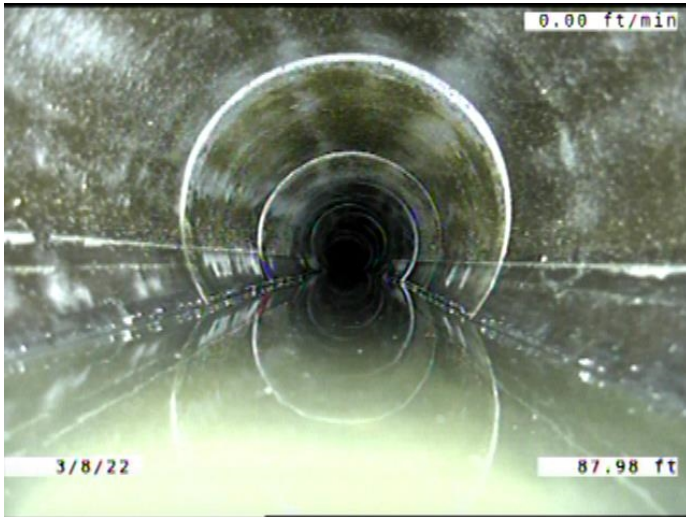
Code: **MWLS**
Description: **Miscellaneous Water Level Sag**

Distance (ft): **88.0**
Structural Grade: **2**
O&M Grade: **0**
Clock Start/From:
Clock To:
1st Value:
2nd Value:
Value Percent: **10.000**
Continuous Index: **S03**
Within 8" of Joint: **NO**
Remarks:

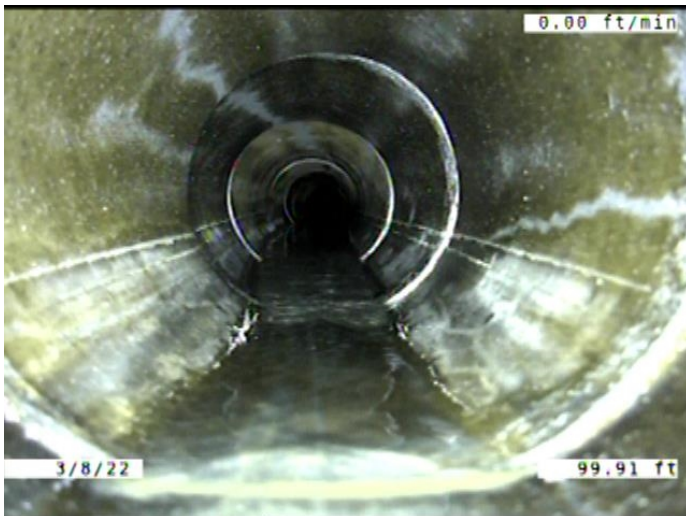
Code: **MWLS**
Description: **Miscellaneous Water Level Sag**

Distance (ft): **99.9**
Structural Grade: **2**
O&M Grade: **0**
Clock Start/From:
Clock To:
1st Value:
2nd Value:
Value Percent: **10.000**
Continuous Index: **F03**
Within 8" of Joint: **NO**
Remarks:

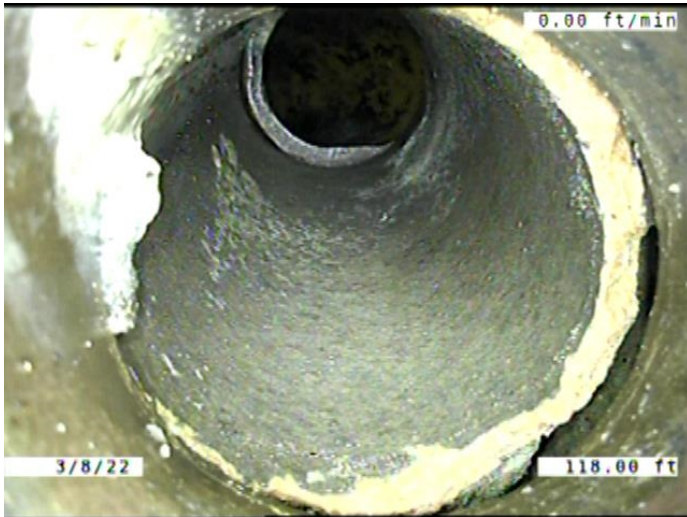
Code: **TF**
Description: **Tap Factory**

Distance (ft): **118.0**
Structural Grade: **0**
O&M Grade: **0**
Clock Start/From: **10**
Clock To:
1st Value: **6.000**

2nd Value:
Value Percent:
Continuous Index:
Within 8" of Joint: **YES**
Remarks: **SERVICE TO MAIN CONNECTION
BROKEN AND SOIL VISIBLE.**

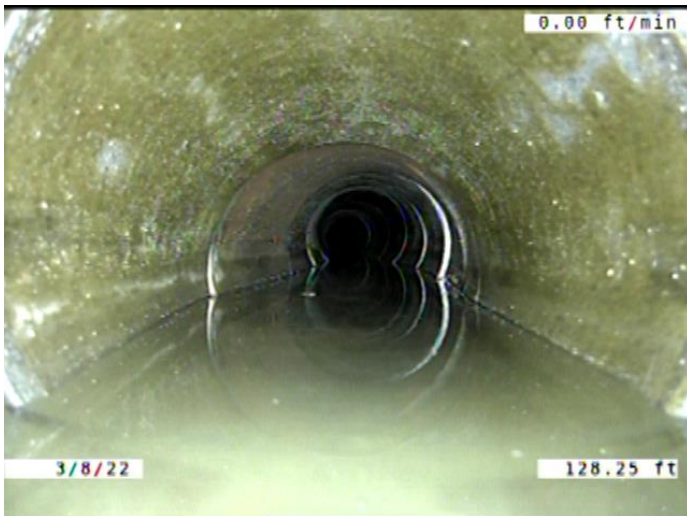
Code: **MWLS**
Description: **Miscellaneous Water Level Sag**

Distance (ft): **128.3**
Structural Grade: **2**
O&M Grade: **0**
Clock Start/From:
Clock To:
1st Value:
2nd Value:
Value Percent: **15.000**

Continuous Index: **S04**
Within 8" of Joint: **NO**
Remarks:

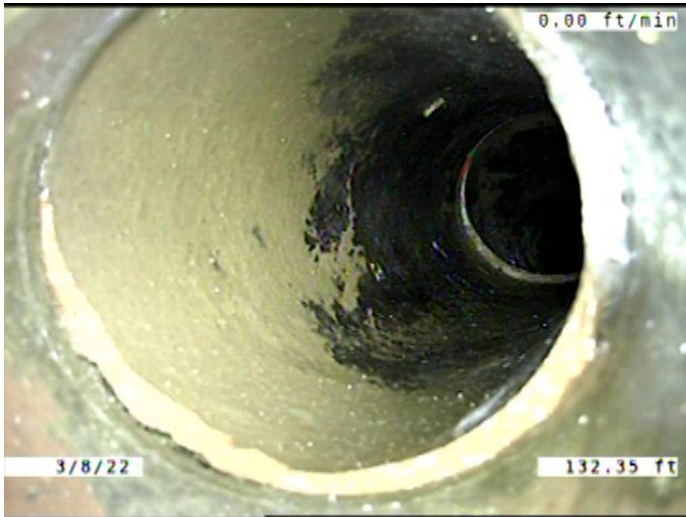
Code: **TF**
Description: **Tap Factory**

Distance (ft): **132.3**
Structural Grade: **0**
O&M Grade: **0**
Clock Start/From: **2**
Clock To:
1st Value: **6.000**
2nd Value:
Value Percent:
Continuous Index:
Within 8" of Joint: **YES**
Remarks: **SERVICE TO MAIN CONNECNTION
BROKEN AND SOIL VISIBLE. WATER**

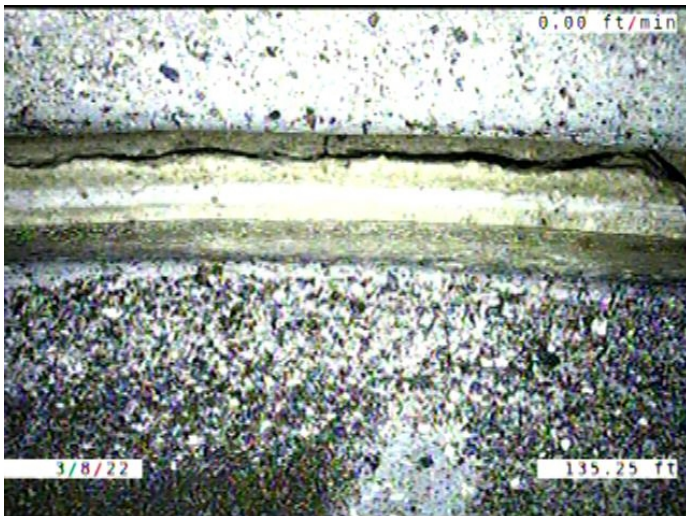
Code: **B**
Description: **Broken**

Distance (ft): **135.2**
Structural Grade: **4**
O&M Grade: **0**
Clock Start/From: **9**
Clock To: **3**
1st Value:
2nd Value:
Value Percent:
Continuous Index:
Within 8" of Joint: **YES**
Remarks:

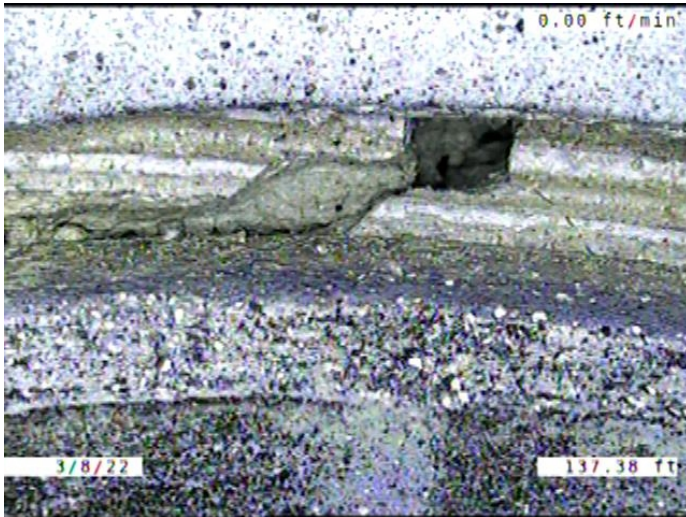
Code: **BSV**
 Description: **Broken Soil Visible**

Distance (ft): **137.4**
 Structural Grade: **5**
 O&M Grade: **0**
 Clock Start/From: **9**
 Clock To: **12**
 1st Value:
 2nd Value:
 Value Percent:
 Continuous Index:
 Within 8" of Joint: **YES**
 Remarks:

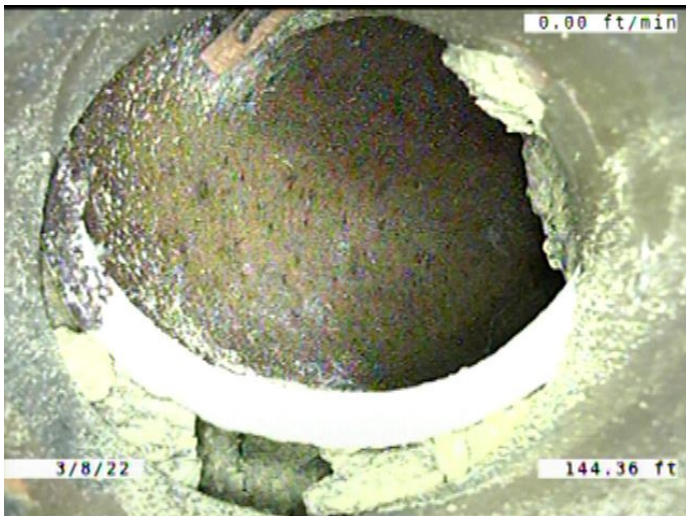
Code: **TFD**
 Description: **Tap Factory Defective**

Distance (ft): **144.4**
 Structural Grade: **0**
 O&M Grade: **3**
 Clock Start/From: **1**
 Clock To:
 1st Value: **6.000**
 2nd Value:
 Value Percent:
 Continuous Index:
 Within 8" of Joint: **YES**
 Remarks: **BROKEN. SERVICE TO MAIN
 CONNECNTION BROKEN, OFFSET, A**

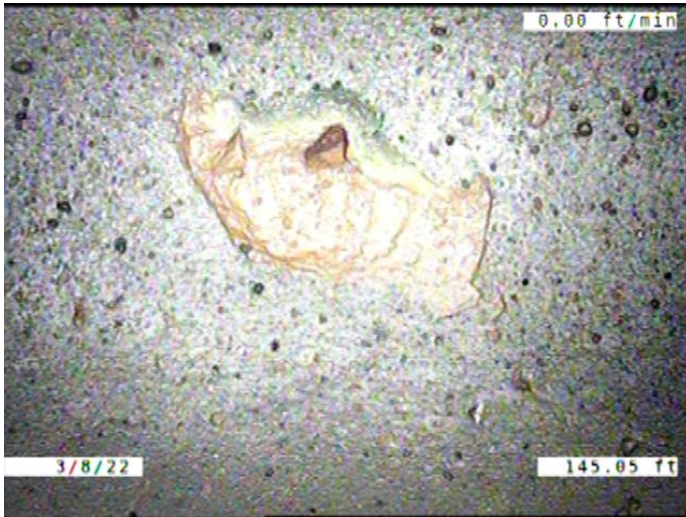
Code: **SSS**
 Description: **Surface Damage Surface Spalling**

Distance (ft): **145.0**
 Structural Grade: **2**
 O&M Grade: **0**
 Clock Start/From: **12**
 Clock To: **1**
 1st Value:
 2nd Value:
 Value Percent:
 Continuous Index:
 Within 8" of Joint: **YES**
 Remarks:

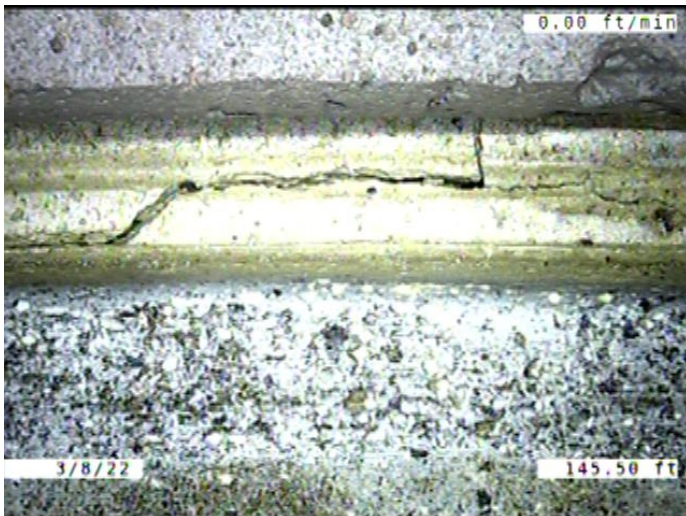
Code: **BSV**
 Description: **Broken Soil Visible**

Distance (ft): **145.5**
 Structural Grade: **5**
 O&M Grade: **0**
 Clock Start/From: **8**
 Clock To: **12**
 1st Value:
 2nd Value:
 Value Percent:
 Continuous Index:
 Within 8" of Joint: **YES**
 Remarks:

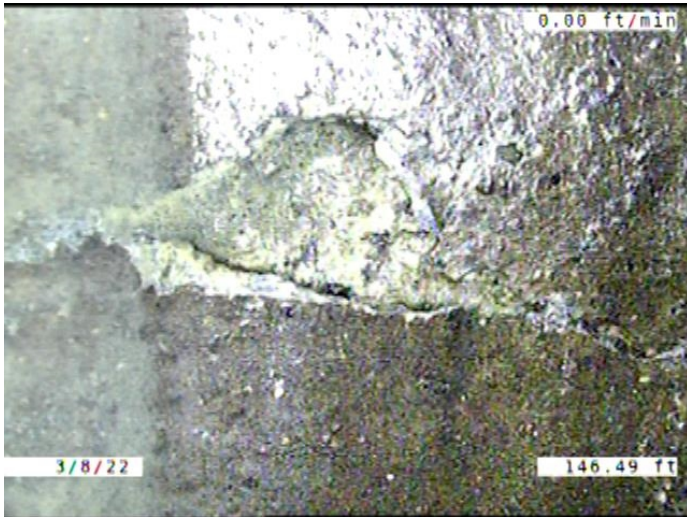
Code: **HSV**
 Description: **Hole Soil Visible**

Distance (ft): **146.5**
 Structural Grade: **5**
 O&M Grade: **0**
 Clock Start/From: **8**
 Clock To: **9**
 1st Value:
 2nd Value:
 Value Percent:
 Continuous Index:
 Within 8" of Joint: **NO**
 Remarks:

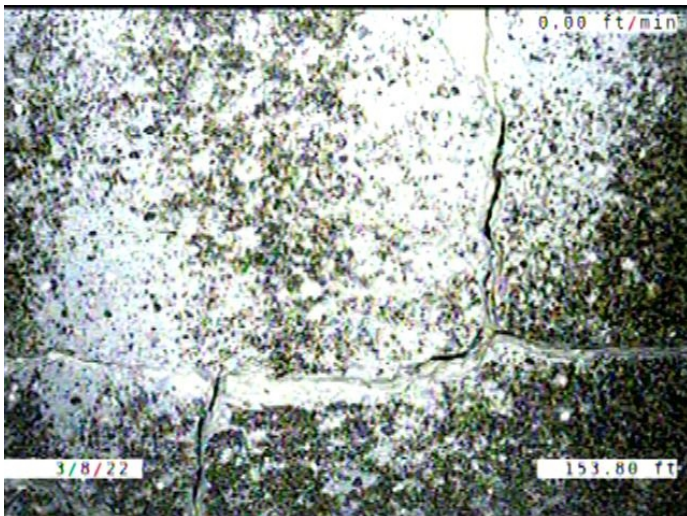
Code: **B**
 Description: **Broken**

Distance (ft): **153.8**
 Structural Grade: **4**
 O&M Grade: **0**
 Clock Start/From: **10**
 Clock To: **3**
 1st Value:
 2nd Value:
 Value Percent:
 Continuous Index:
 Within 8" of Joint: **YES**
 Remarks:

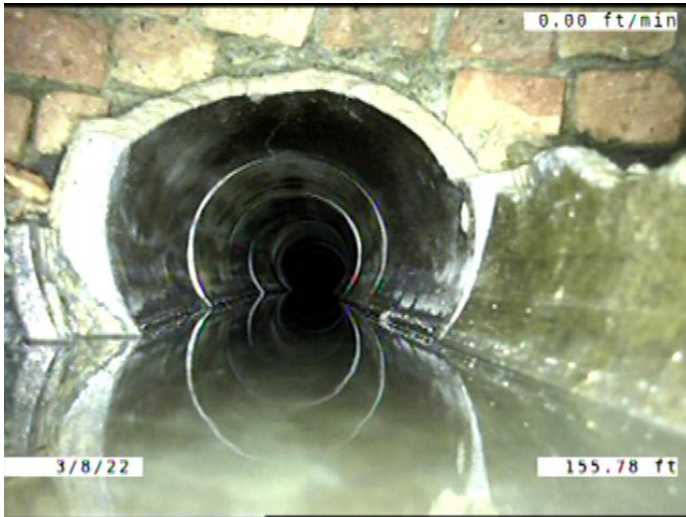
Code: **DSF**
Description: **Deposits Settled Fine**

Distance (ft): **155.8**
Structural Grade: **0**
O&M Grade: **2**
Clock Start/From: **3**
Clock To: **9**
1st Value:
2nd Value:
Value Percent: **10.000**
Continuous Index: **F01**
Within 8" of Joint: **YES**
Remarks:

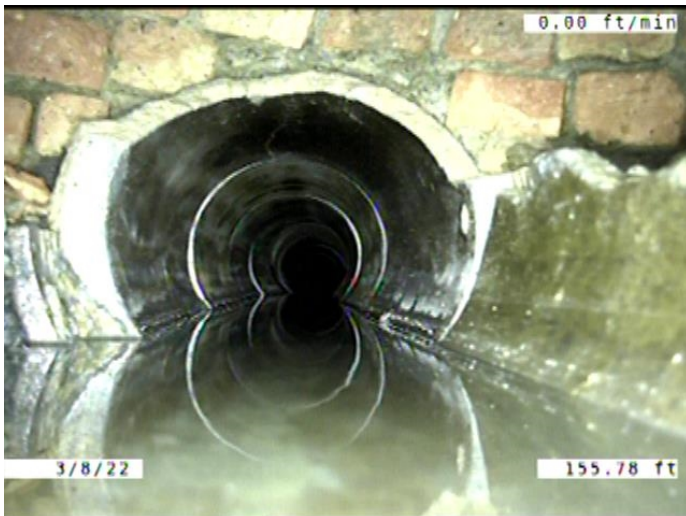
Code: **MWLS**
Description: **Miscellaneous Water Level Sag**

Distance (ft): **155.8**
Structural Grade: **2**
O&M Grade: **0**
Clock Start/From:
Clock To:
1st Value:
2nd Value:
Value Percent: **15.000**
Continuous Index: **F04**
Within 8" of Joint: **NO**
Remarks:
