## Profile/Photo Observation Report

| Street: | <b>LAKE ST &amp; E 7TH ST</b> | Flow Control: | <b>Not Controlled</b> |
| City: | <b>Hobart, IN</b> | Year Renewed: | |

| US MH: | <b>M-706-034</b> | DS MH: | <b>M-706-035</b> |

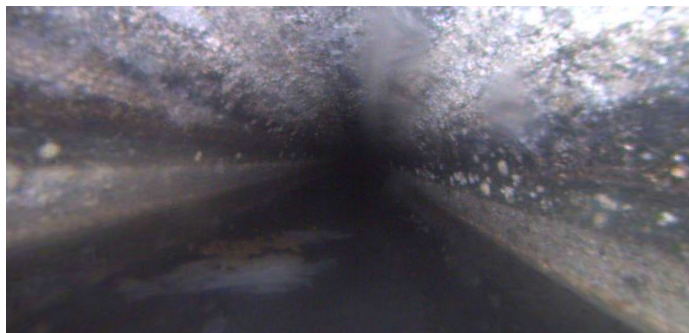
Code: **AMH**  
Description: **Manhole**

Distance (ft): **.0**  
Structural Grade: **0**  
O&M Grade: **0**  
Clock Start/From:  
Clock To:  
1st Value:  
2nd Value:  
Value Percent:  
Continuous Index:  
Within 8" of Joint: **NO**  
Remarks: **M-706-034**

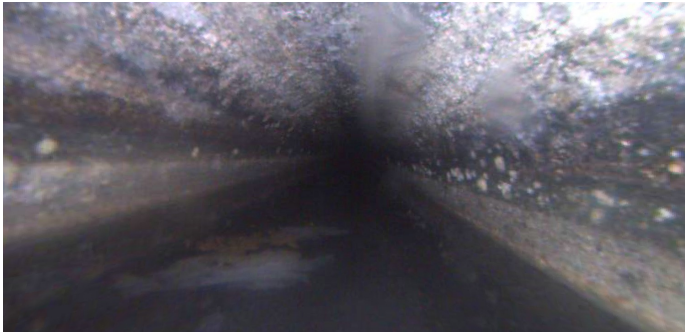
| Code: | <b>MWL</b> |
| Description: | <b>Water Level</b> |

| Value Percent: | <b>30.000</b> |

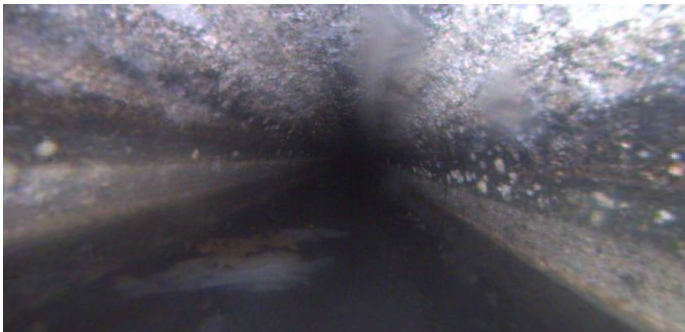
| Code: | <b>DAGS</b> |
| Description: | <b>Deposits Attached Grease</b> |

| O&M Grade: | <b>2</b> |
| Clock Start/From: | <b>8</b> |
| Clock To: | <b>4</b> |
| Value Percent: | <b>10.000</b> |

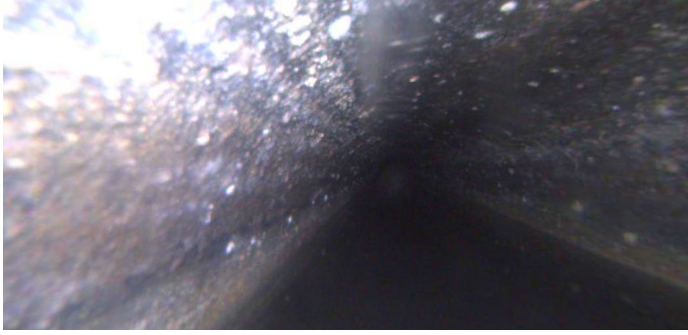
| Code: | <b>MSA</b> |
| Description: | <b>Abandoned Survey</b> |
| Distance (ft): | <b>8.3</b> |
| Remarks: | <b>debris under water</b> |
