Profile/Photo Observation Report

Street:	Capitol	Flow Control:	Not Controlled
City:	Hobart, IN	Year Renewed:	
Location:	Light Highway	Tape/Media #:	
Purpose:	Maintenance Related	Dia/Height:	10"
Use:	Sanitary	Material:	VCP
Drain Area:	NA	Lining:	Cured in Place
Category:	NA		
Comment:	heavy silt at 7'.

Location Details:		Direction of Survey:	Downstream
US MH:	M-706-034	DS MH:	M-706-035
		Total Length Surveyed (ft):	8.3

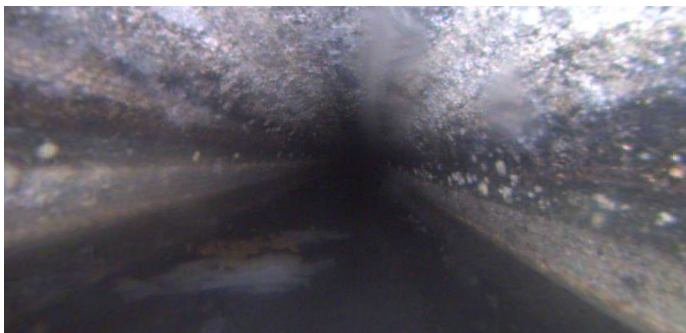
Code: **AMH**
Description: **Manhole**

Distance (ft): **.0**
Structural Grade: **0**
O&M Grade: **0**
Clock Start/From:
Clock To:
1st Value:
2nd Value:
Value Percent:
Continuous Index:
Within 8" of Joint: **NO**
Remarks: **M-706-034**

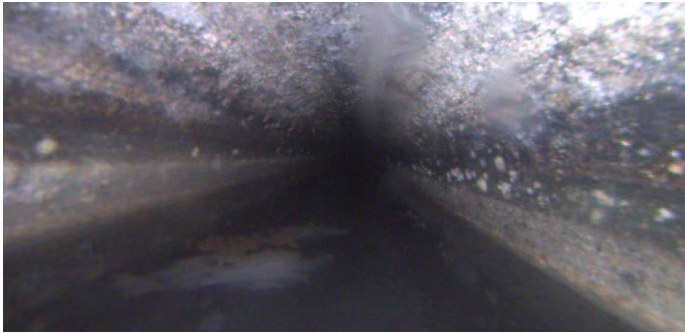
Code:	MWL
Description:	Water Level

Distance (ft):	.0
Structural Grade:	0
O&M Grade:	0
Clock Start/From:	
Clock To:	
1st Value:	
2nd Value:	
Value Percent:	30.000
Continuous Index:	
Within 8" of Joint:	NO
Remarks:

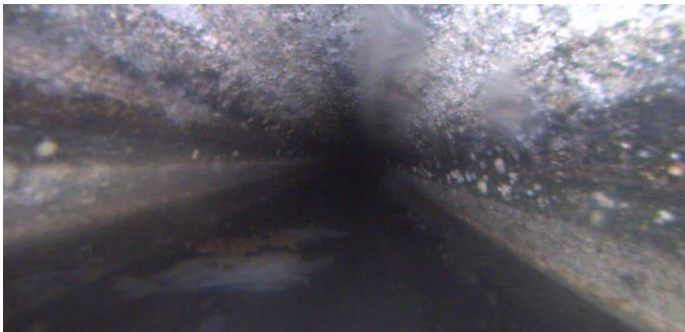
Code:	DAGS
Description:	Deposits Attached Grease

Distance (ft):	.0
Structural Grade:	0
O&M Grade:	2
Clock Start/From:	8
Clock To:	4
1st Value:	
2nd Value:	
Value Percent:	10.000
Continuous Index:	
Within 8" of Joint:	NO
Remarks:

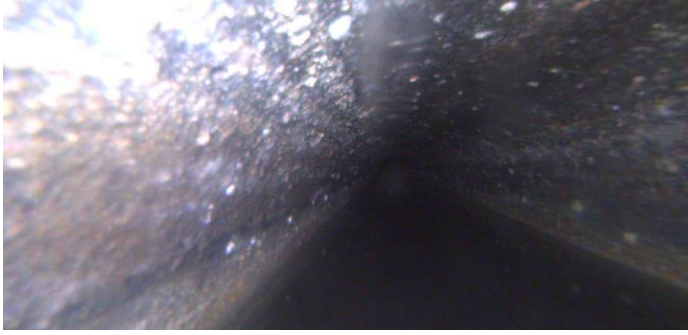
Code:	MSA
Description:	Abandoned Survey
Distance (ft):	8.3
Structural Grade:	0
O&M Grade:	0
Clock Start/From:	
Clock To:	
1st Value:	
2nd Value:	
Value Percent:	
Continuous Index:	
Within 8" of Joint:	NO
Remarks:	debris under water
