Profile/Photo Observation Report

Date:	04/20/2018	Weather:		Coding:	PACP 6.0
Pipe Length (ft):	142.5	Owner:	NA	Pre Clean:	Not Known
P.O.#:		Surveyor:	Byrd Fitzgerald	PSR:	P-706-035.5-035
Customer:		Clean Date:	01/01/1900	Shape:	C

Location Details:		Direction of Survey:	Upstream
US MH:	M-706-035	DS MH:	M-706-035.5
		Total Length Surveyed (ft):	78.0

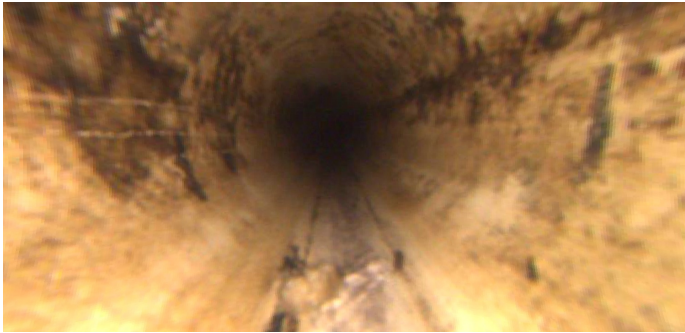
Code:	MWL
Description:	Water Level

Distance (ft):	.0
Structural Grade:	0
O&M Grade:	0
Clock Start/From:	
Clock To:	
1st Value:	
2nd Value:	
Value Percent:	5.000
Continuous Index:	
Within 8" of Joint:	NO
Remarks:

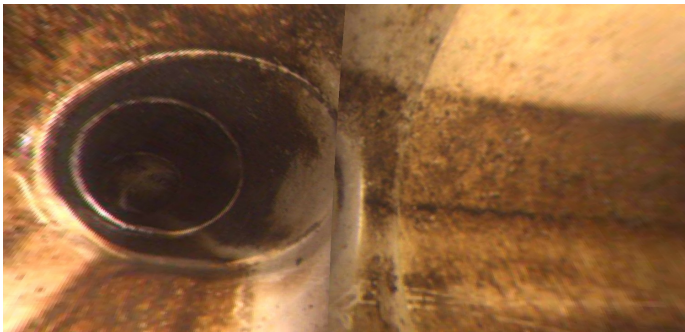
Code:	TF
Description:	Tap Factory

Distance (ft):	65.1
Structural Grade:	0
O&M Grade:	0
Clock Start/From:	10
Clock To:	
1st Value:	4.000
2nd Value:	
Value Percent:	
Continuous Index:	
Within 8" of Joint:	YES
Remarks:

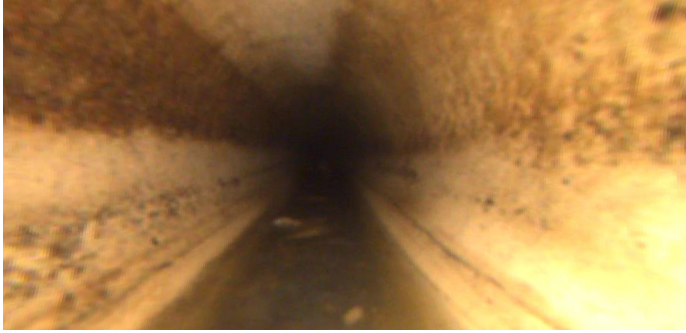
Code:	MSA
Description:	Abandoned Survey
Distance (ft):	78.0
Structural Grade:	0
O&M Grade:	0
Clock Start/From:	
Clock To:	
1st Value:	
2nd Value:	
Value Percent:	
Continuous Index:	
Within 8" of Joint:	NO
Remarks:	no blockage
