## Profile/Photo Observation Report

Street:	<b>WATER ST</b>	Flow Control:	<b>Not Controlled</b>
City:	<b>Hobart, IN</b>	Year Renewed:	
Location:	<b>Light Highway</b>	Tape/Media #:	
Purpose:	<b>Maintenance Related</b>	Dia/Height:	<b>12"</b>
Use:	<b>Sanitary</b>	Material:	<b>PVC</b>
Drain Area:	<b>NA</b>	Lining:	<b>Cured in Place</b>
Category:	<b>NA</b>		
Comment:	<b>Debris at 106'.</b>

Location Details:		Direction of Survey:	<b>Downstream</b>
US MH:	<b>M-706-040</b>	DS MH:	<b>M-706-041</b>
		Total Length Surveyed (ft):	<b>107.2</b>

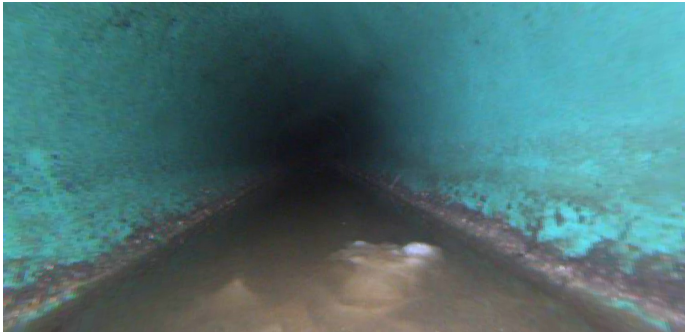
Code:	<b>MWL</b>
Description:	<b>Water Level</b>

Distance (ft):	<b>.0</b>
Structural Grade:	<b>0</b>
O&M Grade:	<b>0</b>
Clock Start/From:	
Clock To:	
1st Value:	
2nd Value:	
Value Percent:	<b>5.000</b>
Continuous Index:	
Within 8" of Joint:	<b>NO</b>
Remarks:

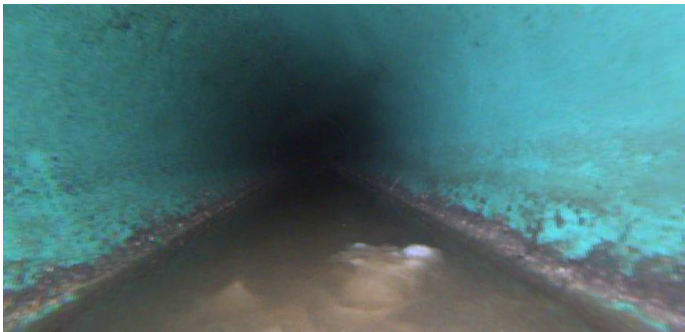
Code:	<b>DSZ</b>
Description:	<b>Deposits Settled Other</b>

Distance (ft):	<b>.0</b>
Structural Grade:	<b>0</b>
O&M Grade:	<b>2</b>
Clock Start/From:	<b>6</b>
Clock To:	
1st Value:	
2nd Value:	
Value Percent:	<b>5.000</b>
Continuous Index:	<b>S01</b>
Within 8" of Joint:	<b>NO</b>
Remarks:	<b>tissue/debris</b>

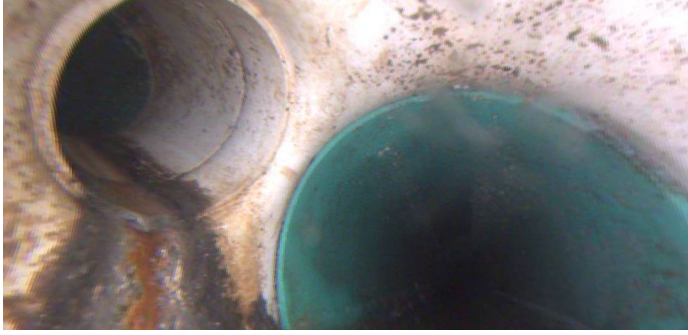
Code: **TF**  
Description: **Tap Factory**

Distance (ft): **33.2**  
Structural Grade: **0**  
O&M Grade: **0**  
Clock Start/From: **11**  
Clock To:  
1st Value: **4.000**  
2nd Value:  
Value Percent:  
Continuous Index:  
Within 8" of Joint: **YES**  
Remarks:

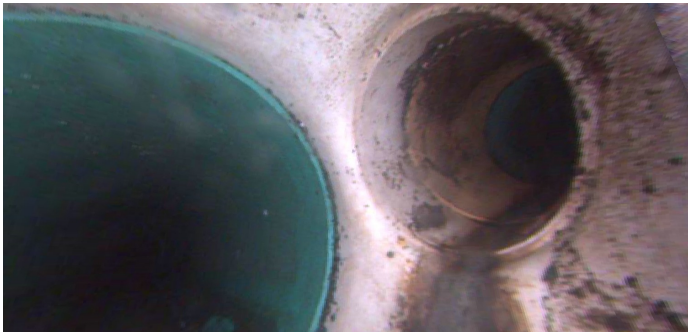
Code: **TF**  
Description: **Tap Factory**

Distance (ft): **56.4**  
Structural Grade: **0**  
O&M Grade: **0**  
Clock Start/From: **2**  
Clock To:  
1st Value: **4.000**  
2nd Value:  
Value Percent:  
Continuous Index:  
Within 8" of Joint: **YES**  
Remarks:

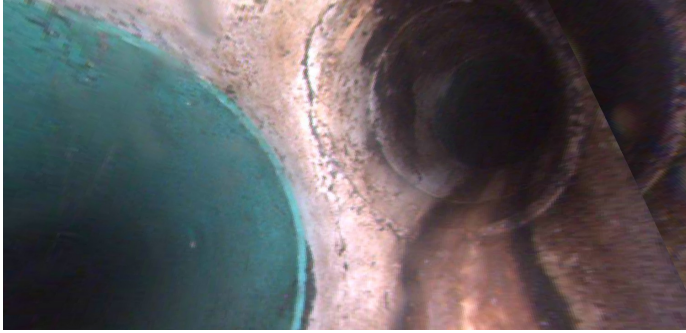
Code: **TF**  
Description: **Tap Factory**

Distance (ft): **63.7**  
Structural Grade: **0**  
O&M Grade: **0**  
Clock Start/From: **2**  
Clock To:  
1st Value: **4.000**  
2nd Value:  
Value Percent:  
Continuous Index:  
Within 8" of Joint: **YES**  
Remarks:

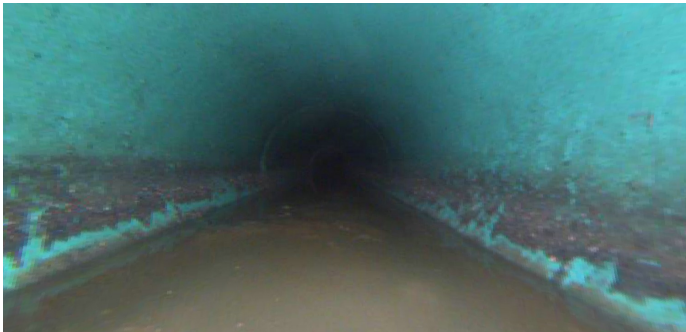
Code: **MSA**  
Description: **Abandoned Survey**

Distance (ft): **107.2**  
Structural Grade: **0**  
O&M Grade: **0**  
Clock Start/From:  
Clock To:  
1st Value:  
2nd Value:  
Value Percent:  
Continuous Index:  
Within 8" of Joint: **NO**  
Remarks: **no blockage**

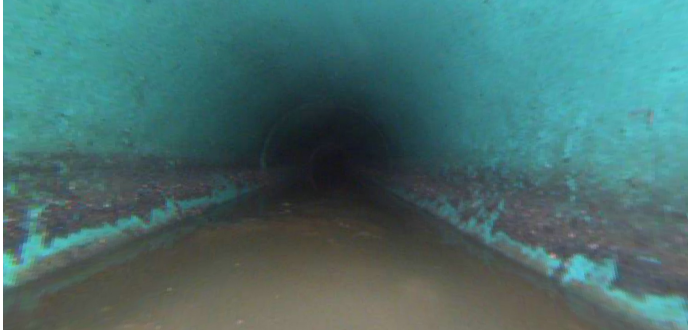
Code:	<b>DSZ</b>
Description:	<b>Deposits Settled Other</b>
Distance (ft):	<b>107.2</b>
Structural Grade:	<b>0</b>
O&M Grade:	<b>2</b>
Clock Start/From:	<b>6</b>
Clock To:	
1st Value:	
2nd Value:	
Value Percent:	<b>5.000</b>
Continuous Index:	<b>F01</b>
Within 8" of Joint:	<b>NO</b>
Remarks:	<b>tissue/debris</b>
