Profile/Photo Observation Report

Date:	04/19/2018	Weather:		Coding:	PACP 6.0
Pipe Length (ft):	164.6	Owner:	NA	Pre Clean:	Not Known
P.O.#:		Surveyor:	Byrd Fitzgerald	PSR:	P-706-041-040
Customer:		Clean Date:	01/01/1900	Shape:	C

Street:	Capitol	Flow Control:	Not Controlled
City:	Hobart, IN	Year Renewed:	
Location:	Light Highway	Tape/Media #:	
Purpose:	Maintenance Related	Dia/Height:	12"
Use:	Sanitary	Material:	PVC
Drain Area:	NA	Lining:	Cured in Place
Category:	NA		
Comment:	Debris at 106'.

Location Details:		Direction of Survey:	Downstream
US MH:	M-706-040	DS MH:	M-706-041
		Total Length Surveyed (ft):	107.2

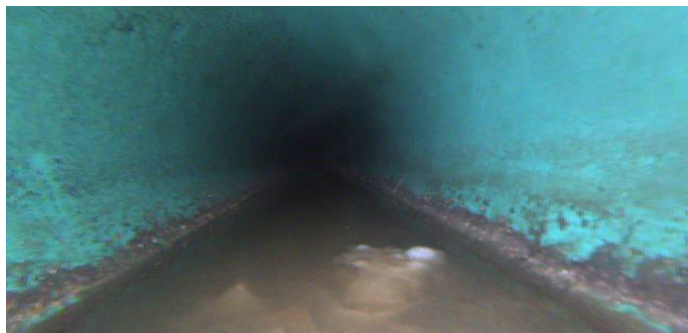
Code: **AMH**
 Description: **Manhole**
 Distance (ft): **.0**
 Structural Grade: **0**
 O&M Grade: **0**
 Clock Start/From:
 Clock To:
 1st Value:
 2nd Value:
 Value Percent:
 Continuous Index:
 Within 8" of Joint: **NO**
 Remarks: **M-706-040**

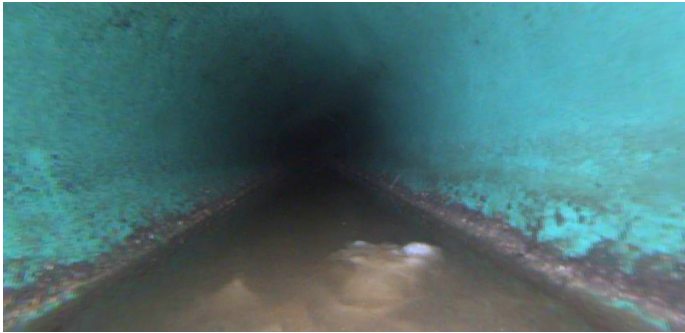
Code:	MWL
Description:	Water Level

Distance (ft):	.0
Structural Grade:	0
O&M Grade:	0
Clock Start/From:	
Clock To:	
1st Value:	
2nd Value:	
Value Percent:	5.000
Continuous Index:	
Within 8" of Joint:	NO
Remarks:

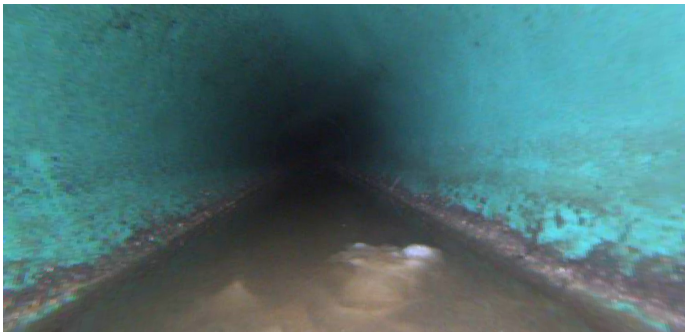
Code:	DSZ
Description:	Deposits Settled Other

Distance (ft):	.0
Structural Grade:	0
O&M Grade:	2
Clock Start/From:	6
Clock To:	
1st Value:	
2nd Value:	
Value Percent:	5.000
Continuous Index:	S01
Within 8" of Joint:	NO
Remarks:	tissue/debris

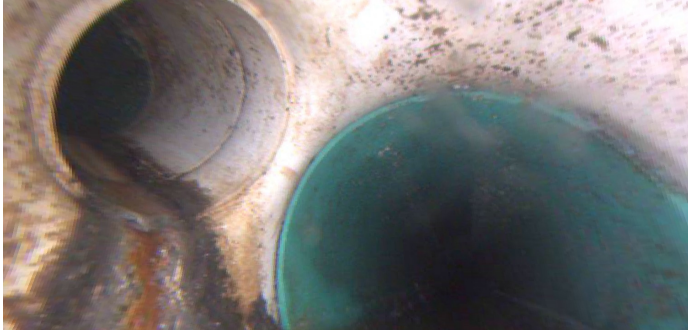
Code: **TF**
Description: **Tap Factory**

Distance (ft): **33.2**
Structural Grade: **0**
O&M Grade: **0**
Clock Start/From: **11**
Clock To:
1st Value: **4.000**
2nd Value:
Value Percent:
Continuous Index:
Within 8" of Joint: **YES**
Remarks:

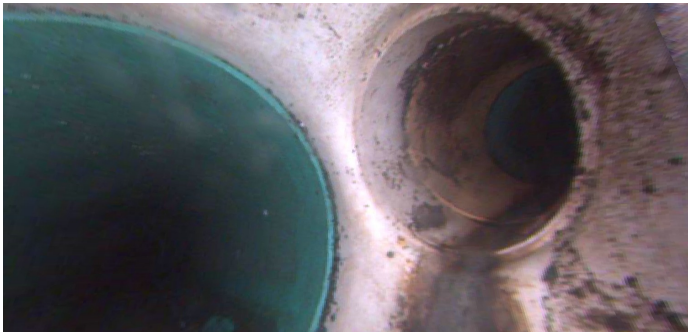
Code: **TF**
Description: **Tap Factory**

Distance (ft): **56.4**
Structural Grade: **0**
O&M Grade: **0**
Clock Start/From: **2**
Clock To:
1st Value: **4.000**
2nd Value:
Value Percent:
Continuous Index:
Within 8" of Joint: **YES**
Remarks:

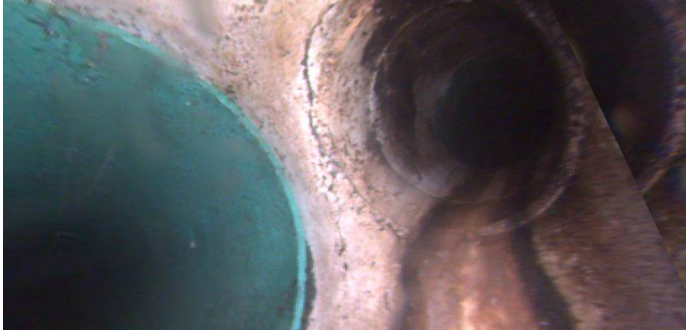
Code: **TF**
Description: **Tap Factory**

Distance (ft): **63.7**
Structural Grade: **0**
O&M Grade: **0**
Clock Start/From: **2**
Clock To:
1st Value: **4.000**
2nd Value:
Value Percent:
Continuous Index:
Within 8" of Joint: **YES**
Remarks:

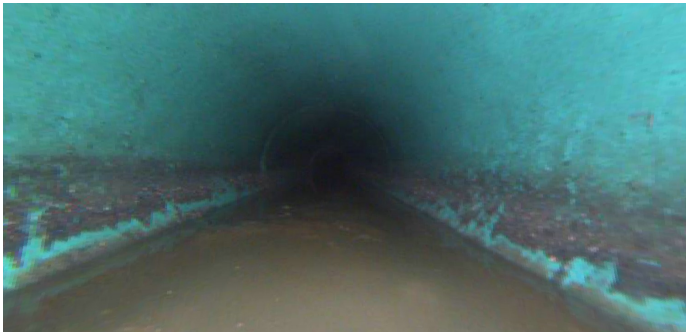
Code: **MSA**
Description: **Abandoned Survey**

Distance (ft): **107.2**
Structural Grade: **0**
O&M Grade: **0**
Clock Start/From:
Clock To:
1st Value:
2nd Value:
Value Percent:
Continuous Index:
Within 8" of Joint: **NO**
Remarks: **no blockage**

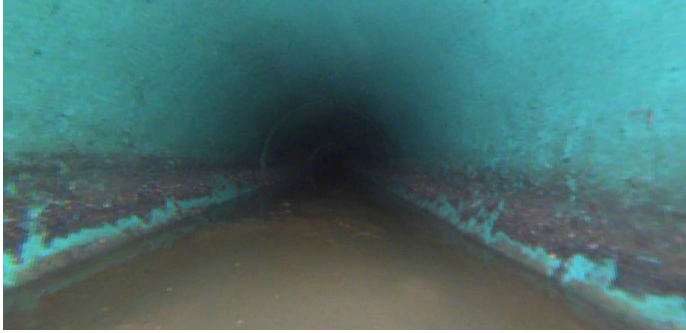
Code:	DSZ
Description:	Deposits Settled Other
Distance (ft):	107.2
Structural Grade:	0
O&M Grade:	2
Clock Start/From:	6
Clock To:	
1st Value:	
2nd Value:	
Value Percent:	5.000
Continuous Index:	F01
Within 8" of Joint:	NO
Remarks:	tissue/debris
