## Profile/Photo Observation Report

Street:	<b>WATER ST &amp; E 7TH ST</b>	Flow Control:	<b>Not Controlled</b>
City:	<b>Hobart, IN</b>	Year Renewed:	
Location:	<b>Light Highway</b>	Tape/Media #:	
Purpose:	<b>Maintenance Related</b>	Dia/Height:	<b>12"</b>
Use:	<b>Sanitary</b>	Material:	<b>VCP</b>
Drain Area:	<b>NA</b>	Lining:	<b>Cured in Place</b>
Category:	<b>NA</b>		
Comment:	<b>Reverse setup. debris rollover at 4'.</b>		
Location Details:		Direction of Survey:	<b>Downstream</b>
US MH:	<b>M-706-042</b>	DS MH:	<b>M-706-042.1</b>
		Total Length Surveyed (ft):	<b>5.0</b>

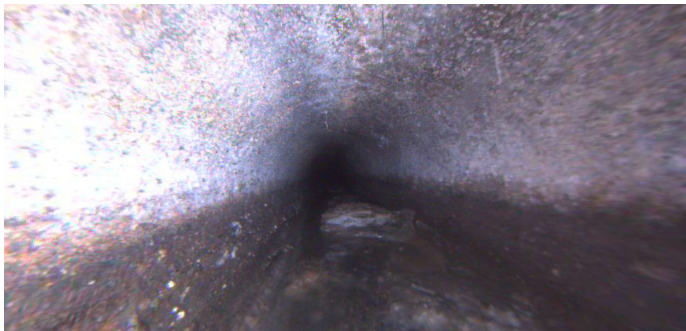
Code: **AMH**  
Description: **Manhole**

Distance (ft): **.0**  
Structural Grade: **0**  
O&M Grade: **0**  
Clock Start/From:  
Clock To:  
1st Value:  
2nd Value:  
Value Percent:  
Continuous Index:  
Within 8" of Joint: **NO**  
Remarks: **M-706-042**

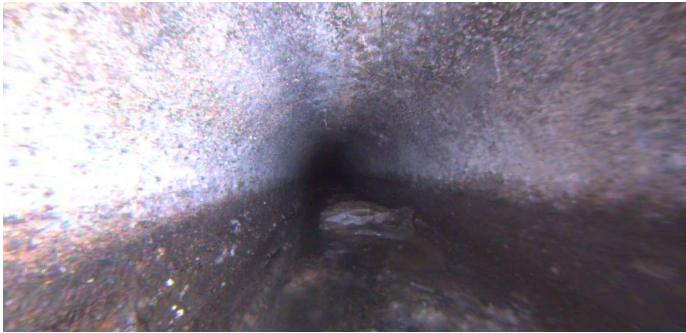
Code:	<b>MWL</b>
Description:	<b>Water Level</b>

Distance (ft):	<b>.0</b>
Structural Grade:	<b>0</b>
O&M Grade:	<b>0</b>
Clock Start/From:	
Clock To:	
1st Value:	
2nd Value:	
Value Percent:	<b>10.000</b>
Continuous Index:	
Within 8" of Joint:	<b>NO</b>
Remarks:

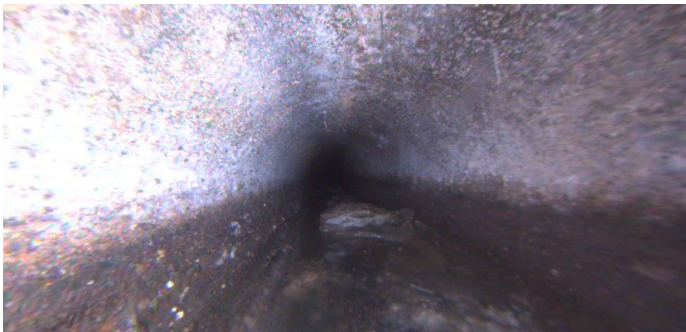
Code:	<b>DAE</b>
Description:	<b>Deposits Attached Encrustation</b>

Distance (ft):	<b>.0</b>
Structural Grade:	<b>0</b>
O&M Grade:	<b>2</b>
Clock Start/From:	<b>8</b>
Clock To:	<b>4</b>
1st Value:	
2nd Value:	
Value Percent:	<b>5.000</b>
Continuous Index:	
Within 8" of Joint:	<b>NO</b>
Remarks:

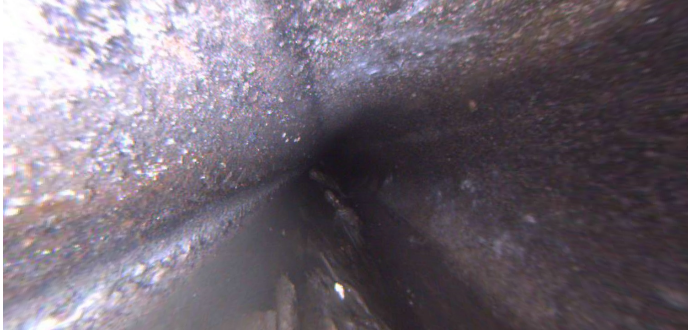
Code:	<b>MSA</b>
Description:	<b>Abandoned Survey</b>
Distance (ft):	<b>5.0</b>
Structural Grade:	<b>0</b>
O&M Grade:	<b>0</b>
Clock Start/From:	
Clock To:	
1st Value:	
2nd Value:	
Value Percent:	
Continuous Index:	
Within 8" of Joint:	<b>NO</b>
Remarks:	<b>overturned</b>
