Profile/Photo Observation Report

Street:	Capitol	Flow Control:	Not Controlled
City:	Hobart, IN	Year Renewed:	
Location:	Light Highway	Tape/Media #:	
Purpose:	Maintenance Related	Dia/Height:	12"
Use:	Sanitary	Material:	VCP
Drain Area:	NA	Lining:	Cured in Place
Category:	NA		
Comment:	Reverse setup. debris rollover at 4'.		
Location Details:		Direction of Survey:	Downstream
US MH:	M-706-042	DS MH:	M-706-042.1
		Total Length Surveyed (ft):	5.0

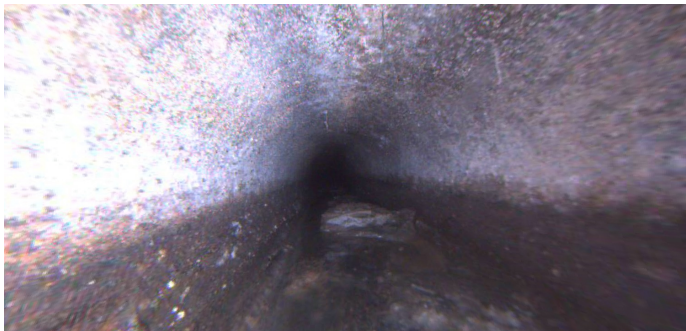
Code: **AMH**
Description: **Manhole**

Distance (ft): **.0**
Structural Grade: **0**
O&M Grade: **0**
Clock Start/From:
Clock To:
1st Value:
2nd Value:
Value Percent:
Continuous Index:
Within 8" of Joint: **NO**
Remarks: **M-706-042**

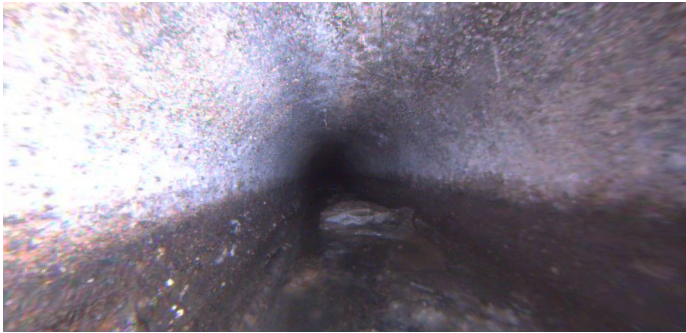
Code:	MWL
Description:	Water Level

Distance (ft):	.0
Structural Grade:	0
O&M Grade:	0
Clock Start/From:	
Clock To:	
1st Value:	
2nd Value:	
Value Percent:	10.000
Continuous Index:	
Within 8" of Joint:	NO
Remarks:

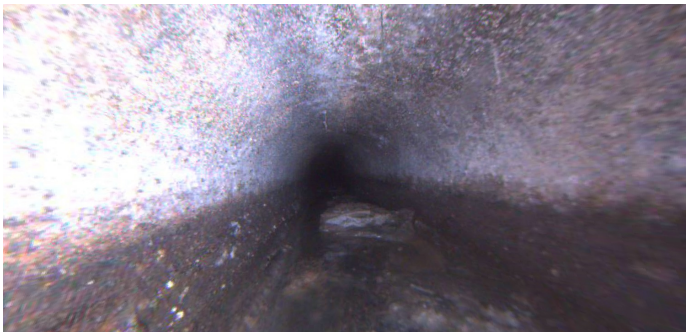
Code:	DAE
Description:	Deposits Attached Encrustation

Distance (ft):	.0
Structural Grade:	0
O&M Grade:	2
Clock Start/From:	8
Clock To:	4
1st Value:	
2nd Value:	
Value Percent:	5.000
Continuous Index:	
Within 8" of Joint:	NO
Remarks:

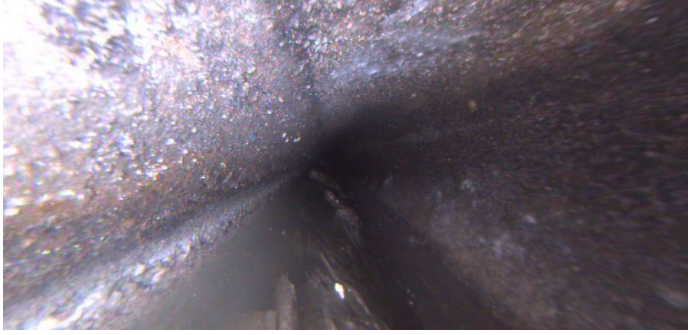
Code:	MSA
Description:	Abandoned Survey
Distance (ft):	5.0
Structural Grade:	0
O&M Grade:	0
Clock Start/From:	
Clock To:	
1st Value:	
2nd Value:	
Value Percent:	
Continuous Index:	
Within 8" of Joint:	NO
Remarks:	overturned
