Profile/Photo Observation Report

Street:	WATER ST & E 7TH ST	Flow Control:	Not Controlled
City:	Hobart, IN	Year Renewed:	
Location:	Alley	Tape/Media #:	
Purpose:	Maintenance Related	Dia/Height:	8"
Use:	Sanitary	Material:	PVC
Drain Area:	NA	Lining:	Cured in Place
Category:	NA		
Comment:	heavy silt at 11'.

Location Details:		Direction of Survey:	Upstream
US MH:	M-706-042	DS MH:	M-706-043
		Total Length Surveyed (ft):	12.5

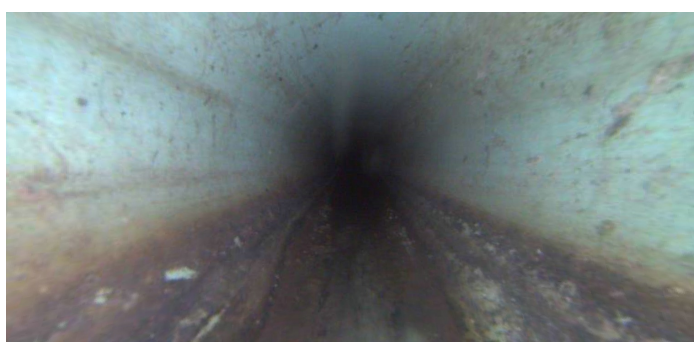
Code: **AMH**
Description: **Manhole**

Distance (ft): **.0**
Structural Grade: **0**
O&M Grade: **0**
Clock Start/From:
Clock To:
1st Value:
2nd Value:
Value Percent:
Continuous Index:
Within 8" of Joint: **NO**
Remarks: **M-706-043**

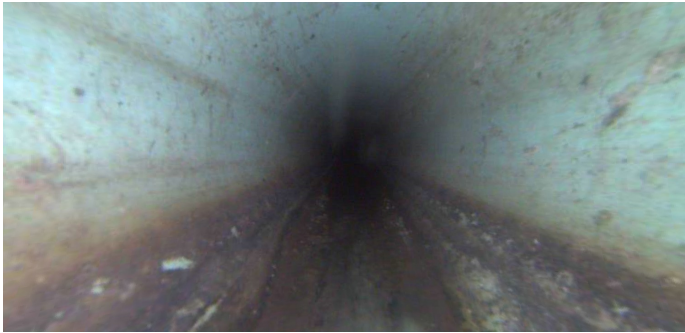
Code:	MWL
Description:	Water Level

Distance (ft):	.0
Structural Grade:	0
O&M Grade:	0
Clock Start/From:	
Clock To:	
1st Value:	
2nd Value:	
Value Percent:	5.000
Continuous Index:	
Within 8" of Joint:	NO
Remarks:

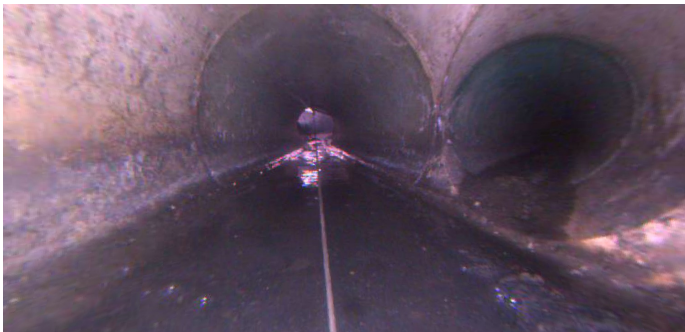
Code:	TF
Description:	Tap Factory

Distance (ft):	5.9
Structural Grade:	0
O&M Grade:	0
Clock Start/From:	9
Clock To:	
1st Value:	4.000
2nd Value:	
Value Percent:	
Continuous Index:	
Within 8" of Joint:	
Remarks:

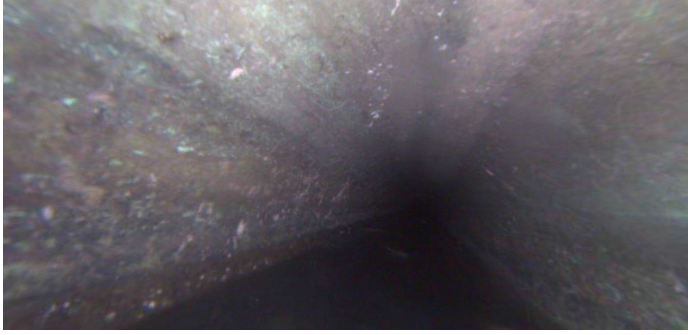
Code:	MSA
Description:	Abandoned Survey
Distance (ft):	12.5
Structural Grade:	0
O&M Grade:	0
Clock Start/From:	
Clock To:	
1st Value:	
2nd Value:	
Value Percent:	
Continuous Index:	
Within 8" of Joint:	NO
Remarks:	DEBRIS UNDER WATER
