## Profile/Photo Observation Report

Date:	<b>04/19/2018</b>	Weather:		Coding:	<b>PACP 6.0</b>
Pipe Length (ft):	<b>168.5</b>	Owner:	<b>NA</b>	Pre Clean:	<b>Not Known</b>
P.O.#:		Surveyor:	<b>Curtis Montgomery</b>	PSR:	<b>P-706-044-043</b>
Customer:		Clean Date:	<b>01/01/1900</b>	Shape:	<b>C</b>

Street:	<b>Capitol</b>	Flow Control:	<b>Not Controlled</b>
City:	<b>Hobart, IN</b>	Year Renewed:	
Location:	<b>Alley</b>	Tape/Media #:	
Purpose:	<b>Maintenance Related</b>	Dia/Height:	<b>8"</b>
Use:	<b>Sanitary</b>	Material:	<b>VCP</b>
Drain Area:	<b>NA</b>	Lining:	<b>Cured in Place</b>
Category:	<b>NA</b>		
Comment:	<b>blk rocks stuck in wheels at 72'.</b>		
Location Details:		Direction of Survey:	<b>Upstream</b>
US MH:	<b>M-706-043</b>	DS MH:	<b>M-706-044</b>
		Total Length Surveyed (ft):	<b>74.0</b>

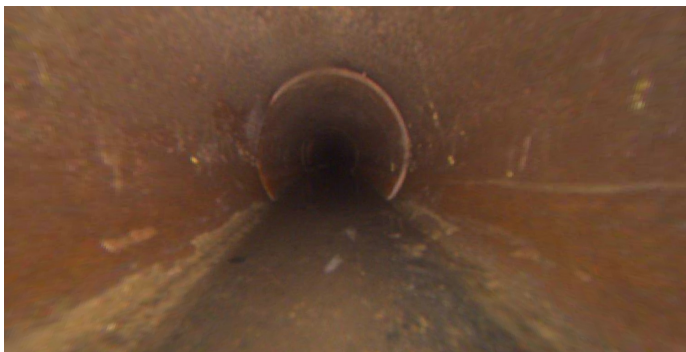
Code: **AMH**  
Description: **Manhole**

Distance (ft): **.0**  
Structural Grade: **0**  
O&M Grade: **0**  
Clock Start/From:  
Clock To:  
1st Value:  
2nd Value:  
Value Percent:  
Continuous Index:  
Within 8" of Joint: **NO**  
Remarks: **M-706-044**

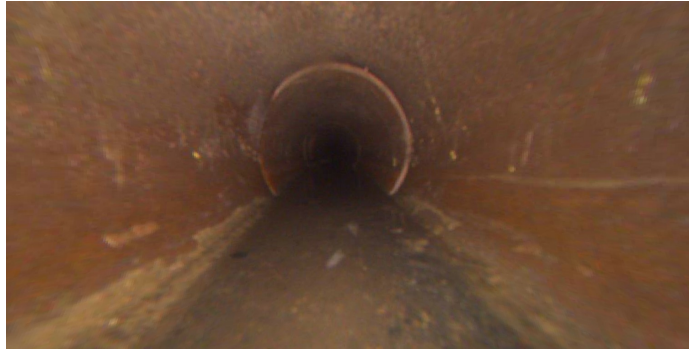
Code:	<b>MWL</b>
Description:	<b>Water Level</b>
Distance (ft):	<b>.0</b>
Structural Grade:	<b>0</b>
O&M Grade:	<b>0</b>
Clock Start/From:	
Clock To:	
1st Value:	
2nd Value:	
Value Percent:	<b>5.000</b>
Continuous Index:	
Within 8" of Joint:	<b>NO</b>
Remarks:

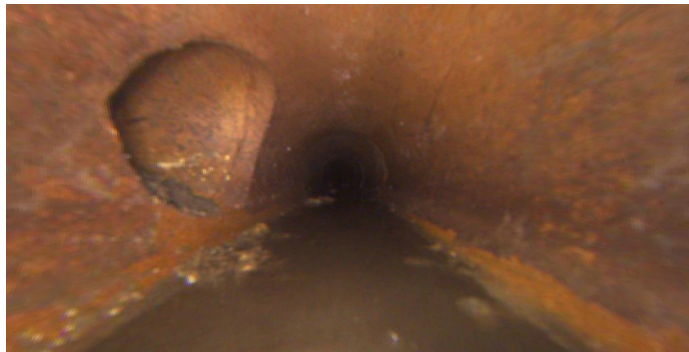
Code:	<b>TF</b>
Description:	<b>Tap Factory</b>
Distance (ft):	<b>4.4</b>
Structural Grade:	<b>0</b>
O&M Grade:	<b>0</b>
Clock Start/From:	<b>9</b>
Clock To:	
1st Value:	<b>6.000</b>
2nd Value:	
Value Percent:	
Continuous Index:	
Within 8" of Joint:	
Remarks:

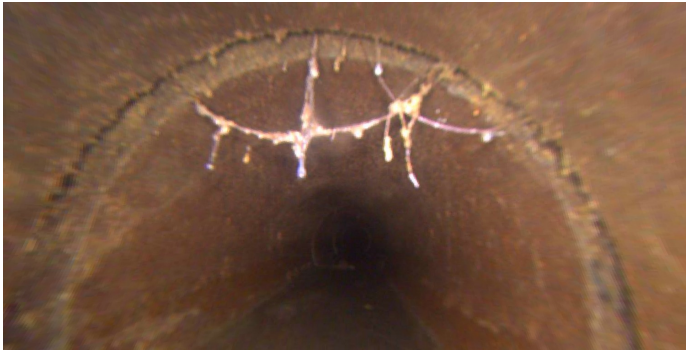
Code: **RFJ**  
Description: **Roots Fine Joint**

Distance (ft): **14.2**  
Structural Grade: **0**  
O&M Grade: **1**  
Clock Start/From: **11**  
Clock To: **2**  
1st Value:  
2nd Value:  
Value Percent:  
Continuous Index:  
Within 8" of Joint: **YES**  
Remarks:

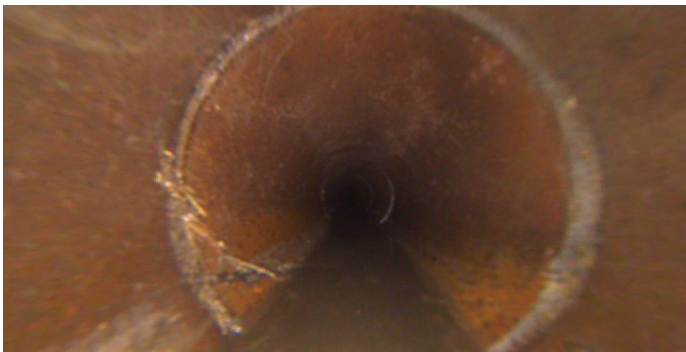
Code: **RFJ**  
Description: **Roots Fine Joint**

Distance (ft): **24.4**  
Structural Grade: **0**  
O&M Grade: **1**  
Clock Start/From: **8**  
Clock To: **9**  
1st Value:  
2nd Value:  
Value Percent:  
Continuous Index:  
Within 8" of Joint: **YES**  
Remarks:

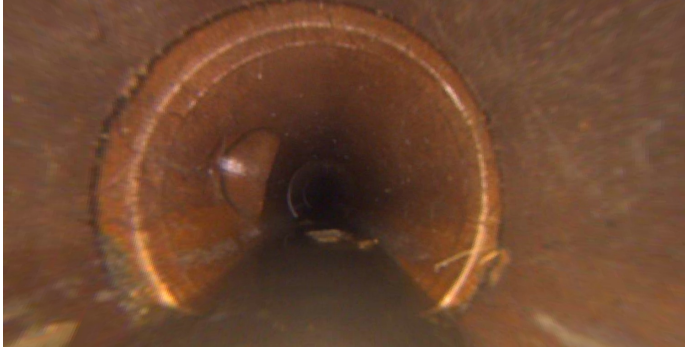
Code: **RFB**  
Description: **Roots Fine Barrel**

Distance (ft): **32.5**  
Structural Grade: **0**  
O&M Grade: **2**  
Clock Start/From: **4**  
Clock To:  
1st Value:  
2nd Value:  
Value Percent:  
Continuous Index:  
Within 8" of Joint: **NO**  
Remarks:

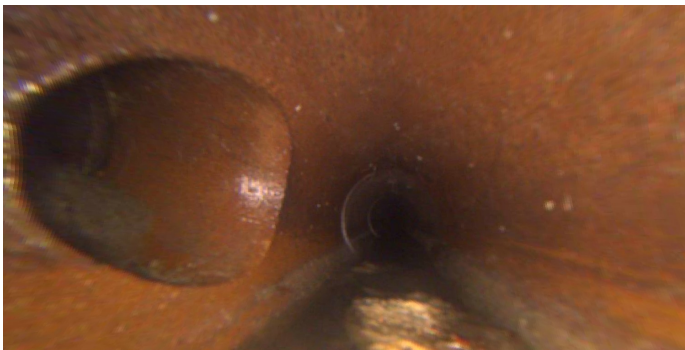
Code: **TFD**  
Description: **Tap Factory Defective**

Distance (ft): **33.3**  
Structural Grade: **0**  
O&M Grade: **2**  
Clock Start/From: **9**  
Clock To:  
1st Value: **6.000**  
2nd Value:  
Value Percent:  
Continuous Index:  
Within 8" of Joint:  
Remarks: **DSZ 10% in wye**

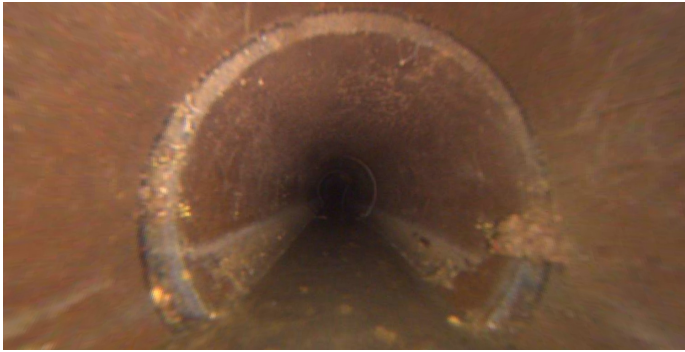
Code: **DAZ**  
Description: **Deposits Attached Other**

Distance (ft): **44.9**  
Structural Grade: **0**  
O&M Grade: **2**  
Clock Start/From: **4**  
Clock To:  
1st Value:  
2nd Value:  
Value Percent: **5.000**  
Continuous Index:  
Within 8" of Joint: **NO**  
Remarks:

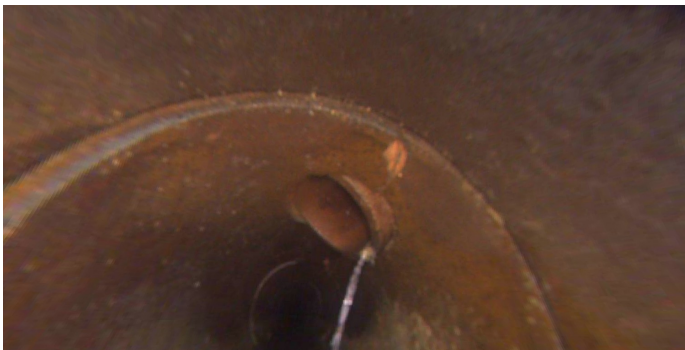
Code: **CL**  
Description: **Crack Longitudinal**

Distance (ft): **49.2**  
Structural Grade: **2**  
O&M Grade: **0**  
Clock Start/From: **1**  
Clock To:  
1st Value:  
2nd Value:  
Value Percent:  
Continuous Index:  
Within 8" of Joint: **YES**  
Remarks:

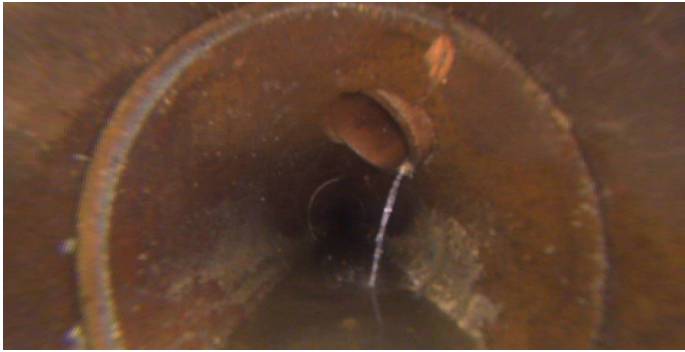
Code: **TBI**  
Description: **Tap Break-in Intruding**

Distance (ft): **49.2**  
Structural Grade: **0**  
O&M Grade: **2**  
Clock Start/From: **1**  
Clock To:  
1st Value: **6.000**  
2nd Value: **2.000**  
Value Percent:  
Continuous Index:  
Within 8" of Joint:  
Remarks: **TBI is active**

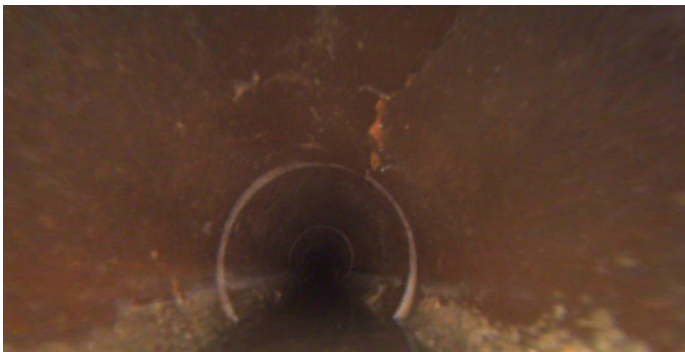
Code: **CL**  
Description: **Crack Longitudinal**

Distance (ft): **50.6**  
Structural Grade: **2**  
O&M Grade: **0**  
Clock Start/From: **1**  
Clock To:  
1st Value:  
2nd Value:  
Value Percent:  
Continuous Index:  
Within 8" of Joint:  
Remarks:

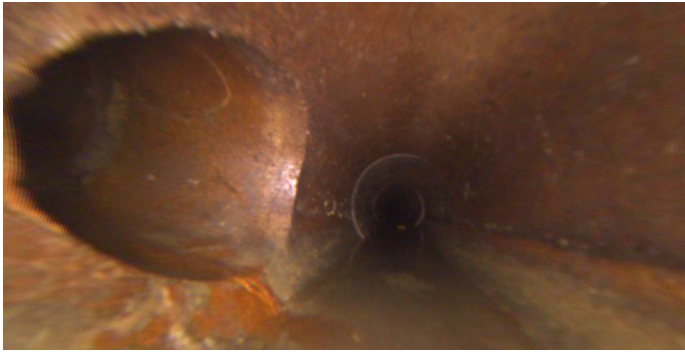
Code: **TF**  
Description: **Tap Factory**

Distance (ft): **72.5**  
Structural Grade: **0**  
O&M Grade: **0**  
Clock Start/From: **9**  
Clock To:  
1st Value: **6.000**  
2nd Value:  
Value Percent:  
Continuous Index:  
Within 8" of Joint:  
Remarks:

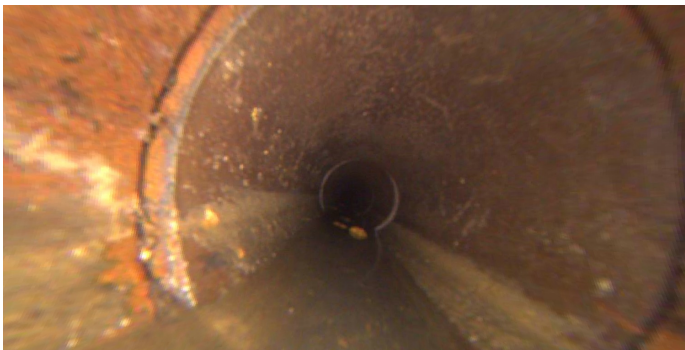
Code: **MSA**  
Description: **Abandoned Survey**

Distance (ft): **74.0**  
Structural Grade: **0**  
O&M Grade: **0**  
Clock Start/From:  
Clock To:  
1st Value:  
2nd Value:  
Value Percent:  
Continuous Index:  
Within 8" of Joint: **NO**  
Remarks: **debris**
