Profile/Photo Observation Report

Street:	Capitol	Flow Control:	Not Controlled
City:	Hobart, IN	Year Renewed:	
Location:	Alley	Tape/Media #:	
Purpose:	Maintenance Related	Dia/Height:	8"
Use:	Sanitary	Material:	VCP
Drain Area:	NA	Lining:	Cured in Place
Category:	NA		
Comment:	Reverse setup. debris at 15'.		
Location Details:		Direction of Survey:	Downstream
US MH:	M-706-043	DS MH:	M-706-044
		Total Length Surveyed (ft):	16.8

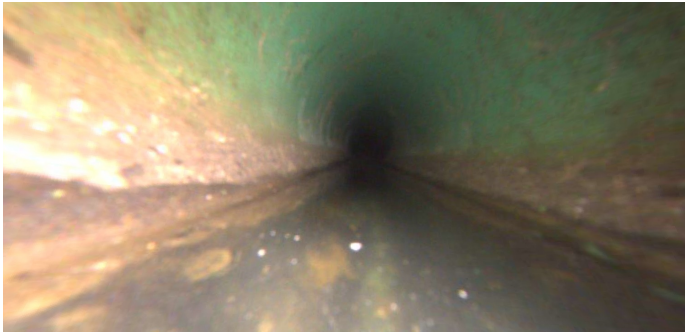
Code:	MWL
Description:	Water Level

Distance (ft):	.0
Structural Grade:	0
O&M Grade:	0
Clock Start/From:	
Clock To:	
1st Value:	
2nd Value:	
Value Percent:	20.000
Continuous Index:	
Within 8" of Joint:	NO
Remarks:

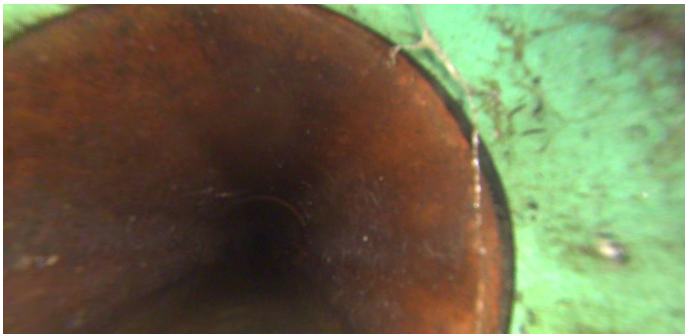
Code:	MMC
Description:	Material Change

Distance (ft):	6.1
Structural Grade:	0
O&M Grade:	0
Clock Start/From:	
Clock To:	
1st Value:	
2nd Value:	
Value Percent:	
Continuous Index:	
Within 8" of Joint:	NO
Remarks:	vcp

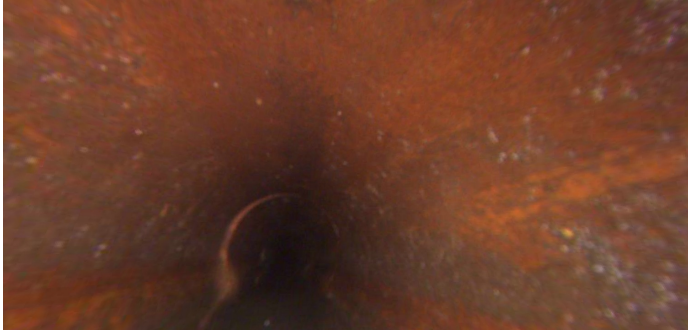
Code:	MSA
Description:	Abandoned Survey
Distance (ft):	16.8
Structural Grade:	0
O&M Grade:	0
Clock Start/From:	
Clock To:	
1st Value:	
2nd Value:	
Value Percent:	
Continuous Index:	
Within 8" of Joint:	NO
Remarks:	debris
