Profile/Photo Observation Report

Date:	03/05/2022	Weather:		Coding:	PACP 7.0
Pipe Length (ft):	169.0	Owner:	City of Hobart	Pre Clean:	Heavy Cleaning
P.O.#:	YES502259	Surveyor:	S. Bucklin	PSR:	P-706-044-043
Customer:	City of Hobart, IN (Red	Clean Date:	02/27/2022	Shape:	C

Street:	Fleming Street	Flow Control:	Not Controlled
City:	Hobart, IN	Year Renewed:	
Location:	Alley	Tape/Media #:	
Purpose:	Routine Assessment	Dia/Height:	10"
Use:	Sanitary Sewage Pipe	Material:	VCP
Drain Area:		Lining:	None
Category:	NA		
Comment:			
Location Details:		Direction of Survey:	Upstream
US MH:	M-706-043	DS MH:	M-706-044
		Total Length Surveyed (ft):	191.4

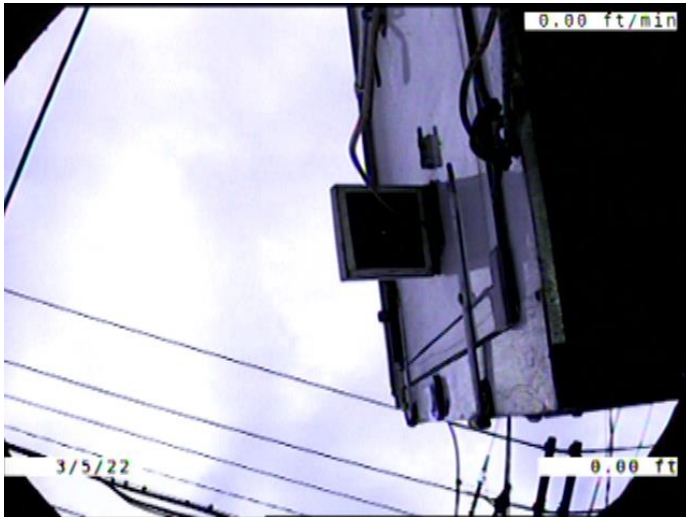
Code: **AMH**
 Description: **Manhole**

Distance (ft): **.0**
 Structural Grade: **0**
 O&M Grade: **0**
 Clock Start/From:
 Clock To:
 1st Value:
 2nd Value:
 Value Percent:
 Continuous Index:
 Within 8" of Joint: **NO**
 Remarks: **M-706-044**

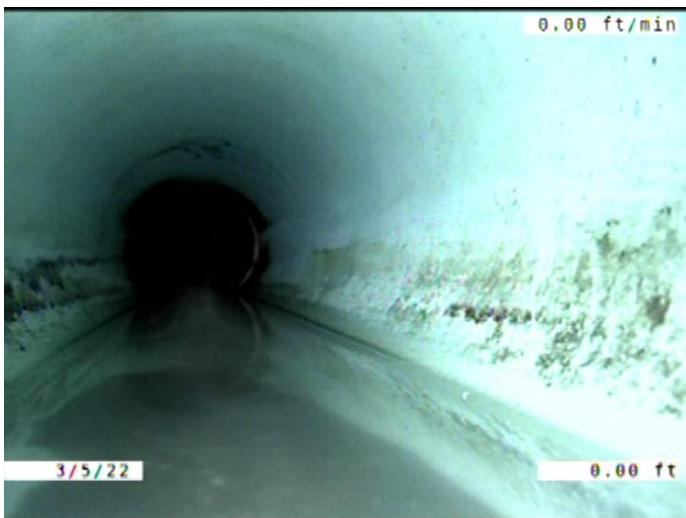
Code: **MWL**
 Description: **Miscellaneous Water Level**

Distance (ft): **.0**
 Structural Grade: **0**
 O&M Grade: **0**
 Clock Start/From:
 Clock To:
 1st Value:
 2nd Value:
 Value Percent: **5.000**
 Continuous Index:
 Within 8" of Joint: **NO**
 Remarks:

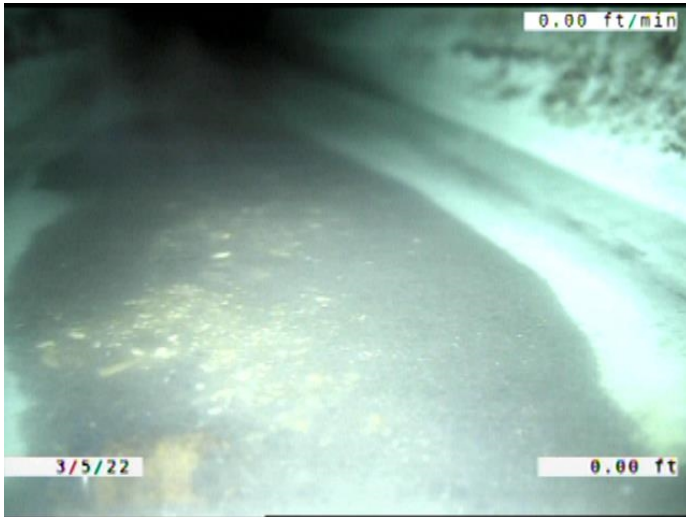
Code: **DSF**
 Description: **Deposits Settled Fine**

Distance (ft): **.0**
 Structural Grade: **0**
 O&M Grade: **2**
 Clock Start/From: **5**
 Clock To: **7**
 1st Value:
 2nd Value:
 Value Percent: **5.000**
 Continuous Index: **S01**
 Within 8" of Joint: **YES**
 Remarks:

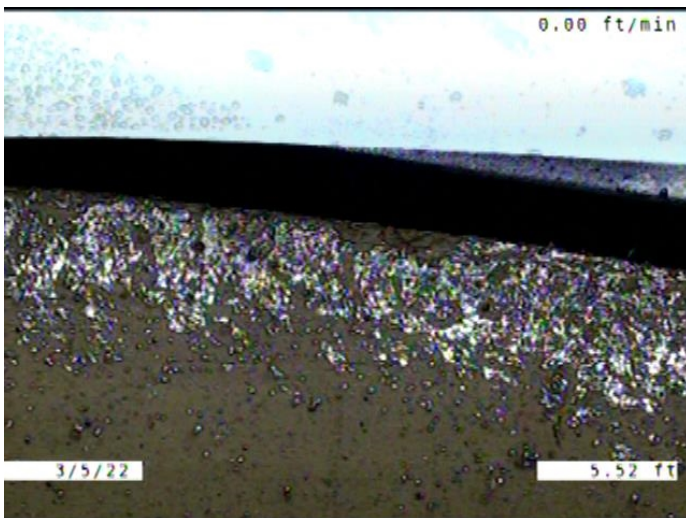
Code: **MMC**
 Description: **Miscellaneous Material Change**

Distance (ft): **5.5**
 Structural Grade: **0**
 O&M Grade: **0**
 Clock Start/From:
 Clock To:
 1st Value:
 2nd Value:
 Value Percent:
 Continuous Index:
 Within 8" of Joint: **NO**
 Remarks: **PVC TO VCP**

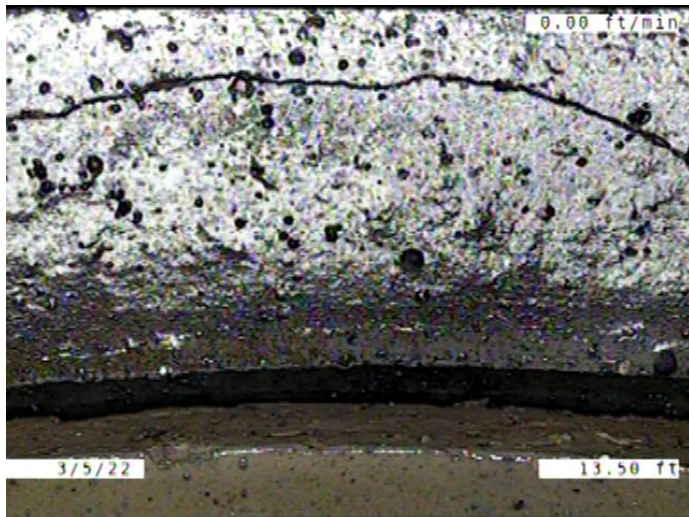
Code: **FM**
 Description: **Fracture Multiple**

Distance (ft): **13.5**
 Structural Grade: **4**
 O&M Grade: **0**
 Clock Start/From: **11**
 Clock To: **1**
 1st Value:
 2nd Value:
 Value Percent:
 Continuous Index:
 Within 8" of Joint: **YES**
 Remarks:

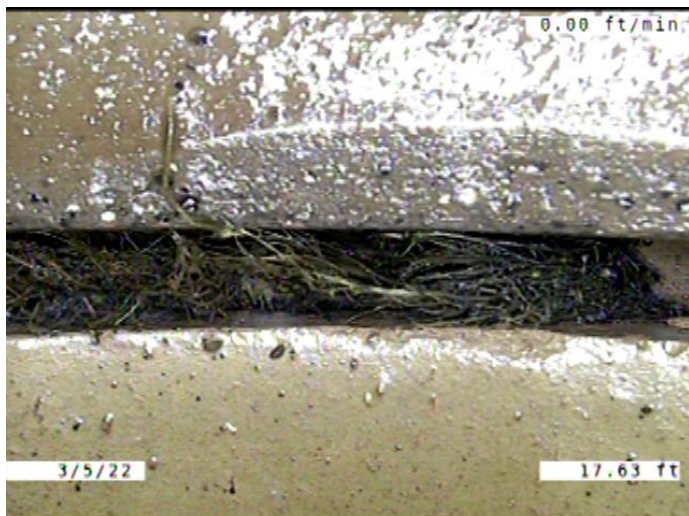
Code: **RFJ**
 Description: **Roots Fine Joint**

Distance (ft): **17.6**
 Structural Grade: **0**
 O&M Grade: **1**
 Clock Start/From: **8**
 Clock To: **4**
 1st Value:
 2nd Value:
 Value Percent:
 Continuous Index: **S02**
 Within 8" of Joint: **YES**
 Remarks:

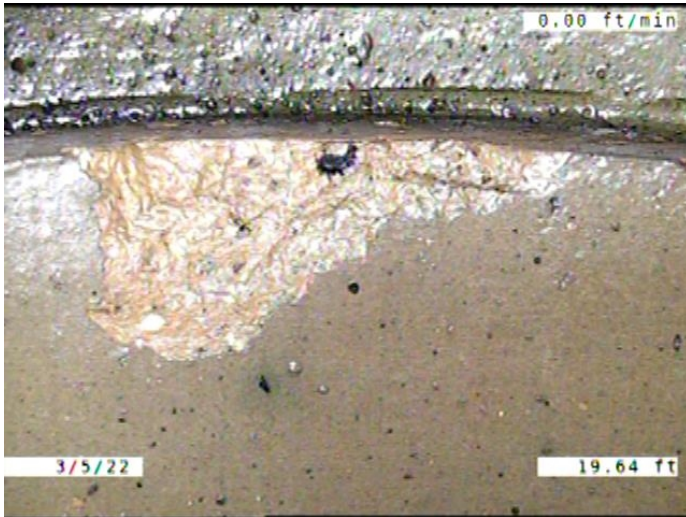
Code: **SSS**
 Description: **Surface Damage Surface Spalling**

Distance (ft): **19.6**
 Structural Grade: **2**
 O&M Grade: **0**
 Clock Start/From: **10**
 Clock To: **11**
 1st Value:
 2nd Value:
 Value Percent:
 Continuous Index:
 Within 8" of Joint: **YES**
 Remarks:

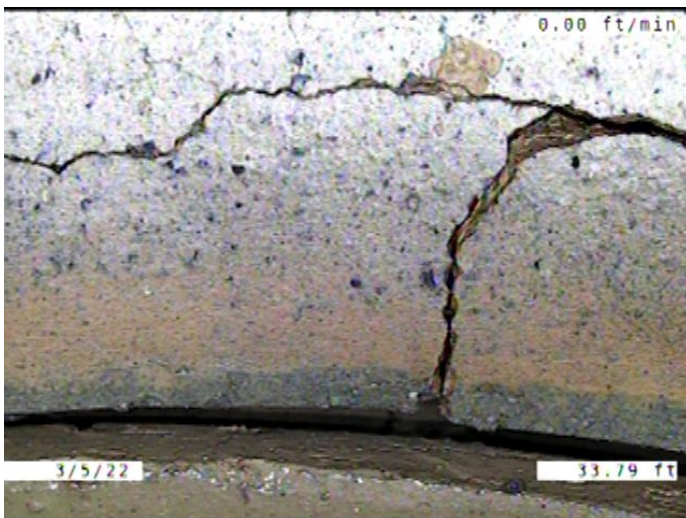
Code: **B**
 Description: **Broken**

Distance (ft): **33.8**
 Structural Grade: **4**
 O&M Grade: **0**
 Clock Start/From: **11**
 Clock To: **2**
 1st Value:
 2nd Value:
 Value Percent:
 Continuous Index:
 Within 8" of Joint: **YES**
 Remarks:

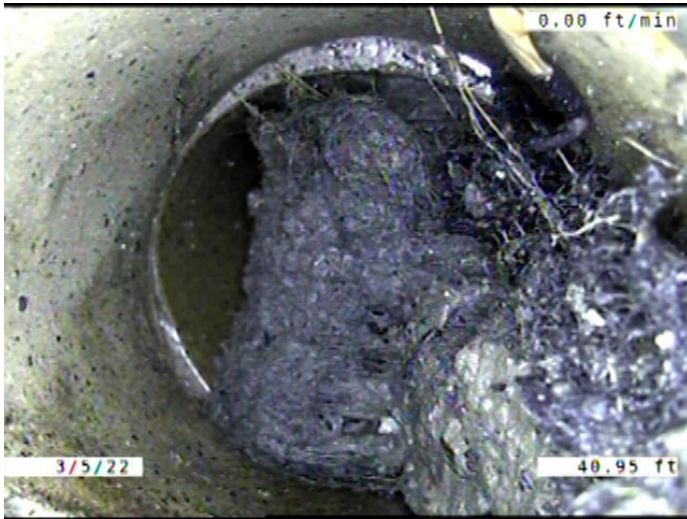
Code: **TFD**
 Description: **Tap Factory Defective**

Distance (ft): **41.0**
 Structural Grade: **0**
 O&M Grade: **3**
 Clock Start/From: **2**
 Clock To:
 1st Value: **4.000**
 2nd Value:
 Value Percent:
 Continuous Index:
 Within 8" of Joint: **YES**
 Remarks: **BROKEN. 95% PLUGGED WITH ROOTS**

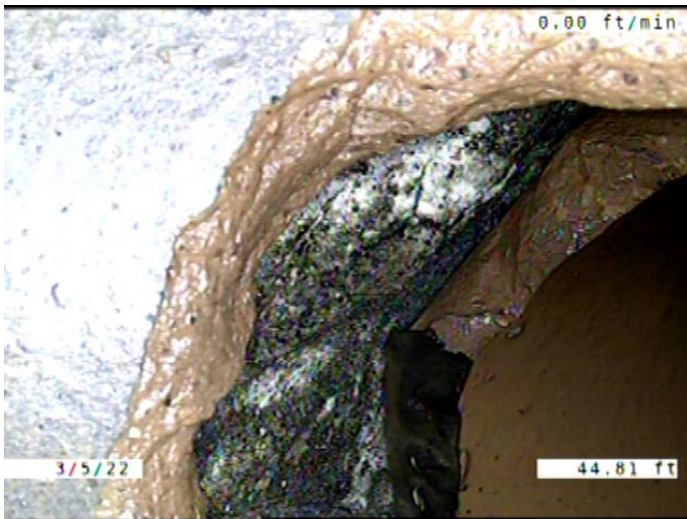
Code: **SSS**
 Description: **Surface Damage Surface Spalling**

Distance (ft): **44.8**
 Structural Grade: **2**
 O&M Grade: **0**
 Clock Start/From: **1**
 Clock To: **3**
 1st Value:
 2nd Value:
 Value Percent:
 Continuous Index:
 Within 8" of Joint: **YES**
 Remarks:

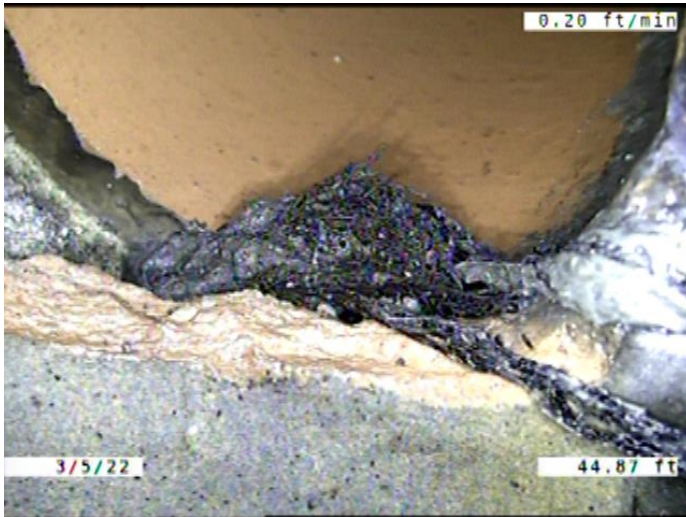
Code: **RFC**
 Description: **Roots Fine Connection**

Distance (ft): **44.9**
 Structural Grade: **0**
 O&M Grade: **1**
 Clock Start/From: **2**
 Clock To:
 1st Value:
 2nd Value:
 Value Percent:
 Continuous Index:
 Within 8" of Joint: **NO**
 Remarks:

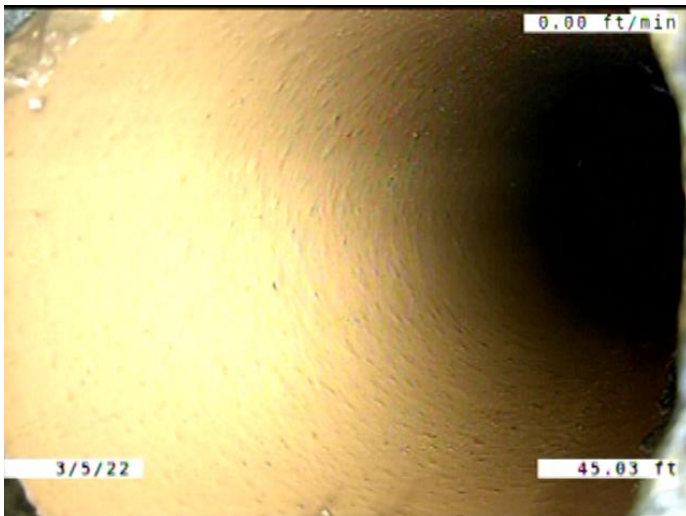
Code: **TB**
 Description: **Tap Break-in/Hammer**

Distance (ft): **45.0**
 Structural Grade: **0**
 O&M Grade: **0**
 Clock Start/From: **2**
 Clock To:
 1st Value: **4.000**
 2nd Value:
 Value Percent:
 Continuous Index:
 Within 8" of Joint: **YES**
 Remarks:

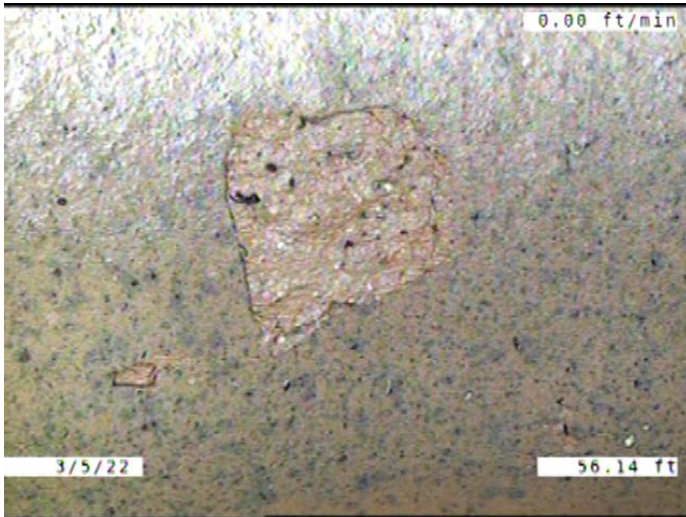
Code: **SSS**
Description: **Surface Damage Surface Spalling**

Distance (ft): **56.1**
Structural Grade: **2**
O&M Grade: **0**
Clock Start/From: **10**
Clock To: **12**
1st Value:
2nd Value:
Value Percent:
Continuous Index:
Within 8" of Joint: **YES**
Remarks:

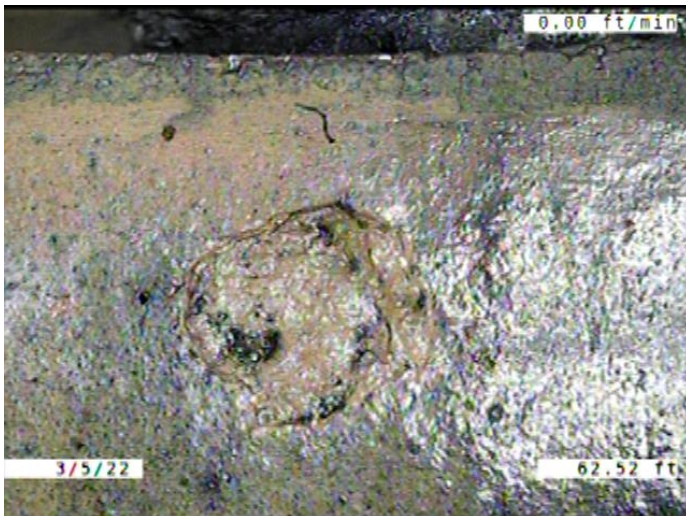
Code: **SSS**
Description: **Surface Damage Surface Spalling**

Distance (ft): **62.5**
Structural Grade: **2**
O&M Grade: **0**
Clock Start/From: **8**
Clock To: **9**
1st Value:
2nd Value:
Value Percent:
Continuous Index:
Within 8" of Joint: **YES**
Remarks:

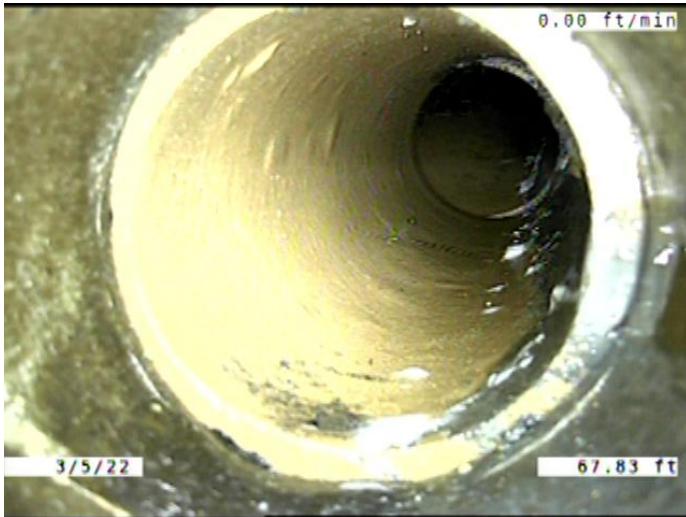
Code: **TF**
Description: **Tap Factory**

Distance (ft): **67.8**
Structural Grade: **0**
O&M Grade: **0**
Clock Start/From: **2**
Clock To:
1st Value: **4.000**
2nd Value:
Value Percent:
Continuous Index:
Within 8" of Joint: **YES**
Remarks:

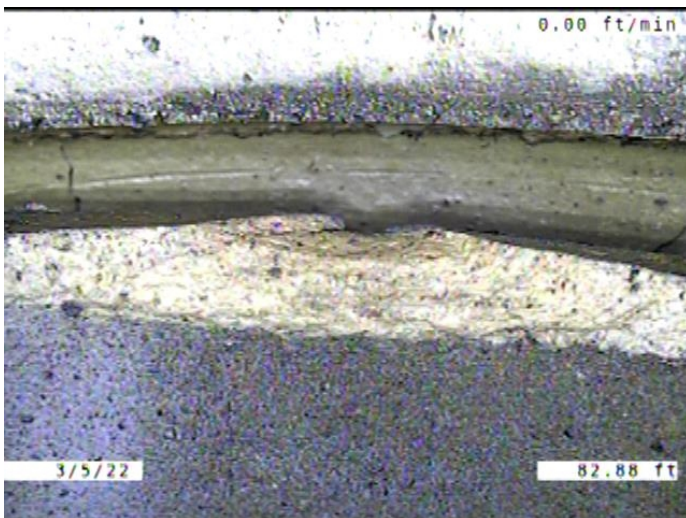
Code: **SZ**
Description: **Surface Damage Other**

Distance (ft): **82.9**
Structural Grade: **0**
O&M Grade: **0**
Clock Start/From: **2**
Clock To:
1st Value:
2nd Value:
Value Percent:
Continuous Index:
Within 8" of Joint: **YES**
Remarks: **A PIECE CHIPPED AWAY FROM THE JOINT.**

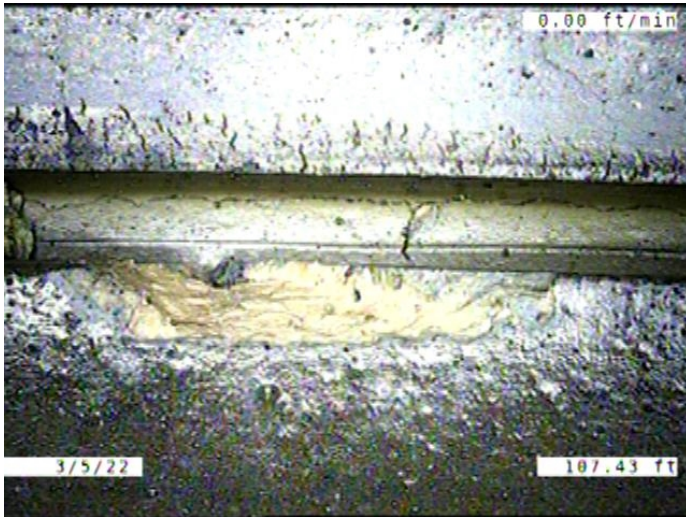
Code:	SZ
Description:	Surface Damage Other
Distance (ft):	107.4
Structural Grade:	0
O&M Grade:	0
Clock Start/From:	12
Clock To:	1
1st Value:	
2nd Value:	
Value Percent:	
Continuous Index:	
Within 8" of Joint:	YES
Remarks:	A PIECE CHIPPED AWAY FROM THE JOINT.

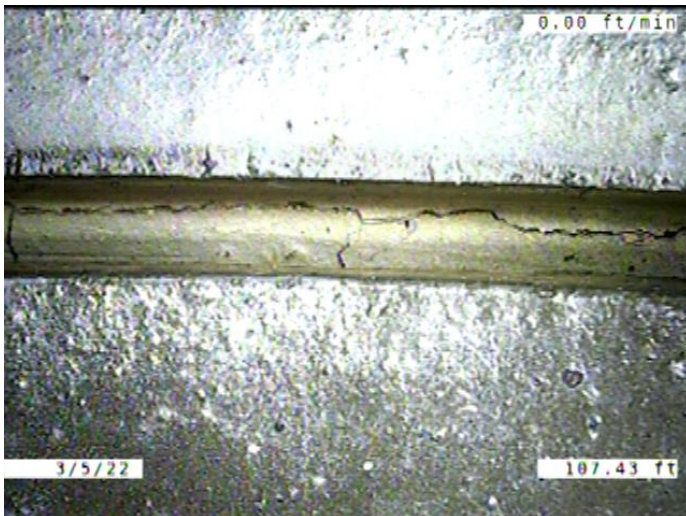
Code:	CM
Description:	Crack Multiple
Distance (ft):	107.4
Structural Grade:	3
O&M Grade:	0
Clock Start/From:	9
Clock To:	3
1st Value:	
2nd Value:	
Value Percent:	
Continuous Index:	
Within 8" of Joint:	YES
Remarks:

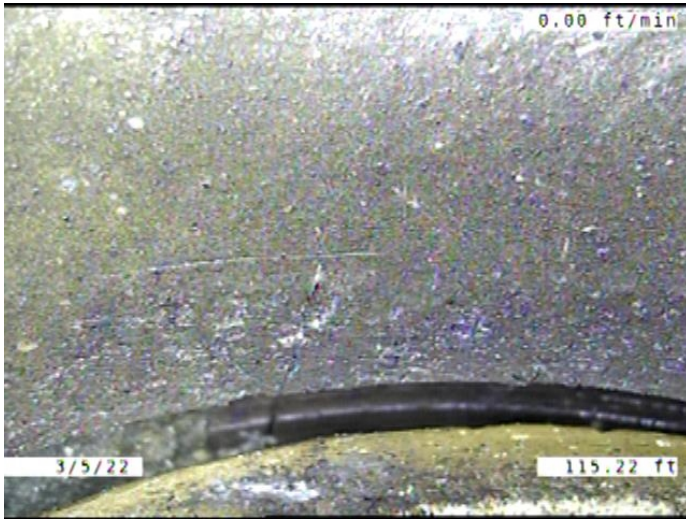
Code: **CS**
Description: **Crack Spiral**

Distance (ft): **115.2**
Structural Grade: **2**
O&M Grade: **0**
Clock Start/From: **9**
Clock To: **10**
1st Value:
2nd Value:
Value Percent:
Continuous Index:
Within 8" of Joint: **YES**
Remarks:

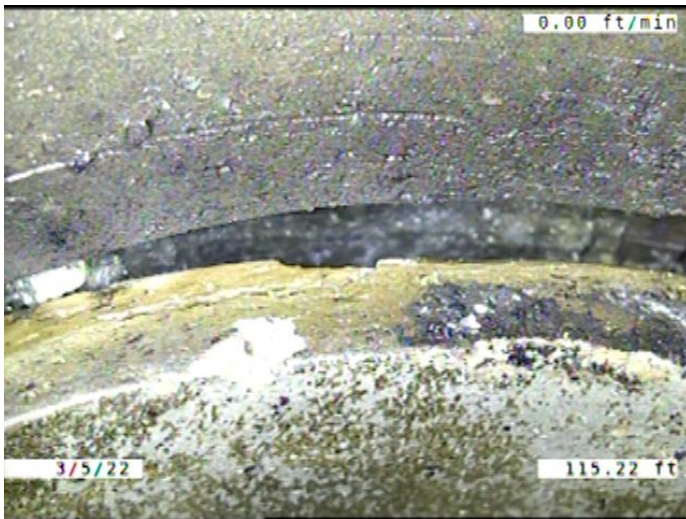
Code: **JOMD**
Description: **Joint Offset Medium Defective**

Distance (ft): **115.2**
Structural Grade: **3**
O&M Grade: **0**
Clock Start/From:
Clock To:
1st Value:
2nd Value:
Value Percent:
Continuous Index:
Within 8" of Joint: **NO**
Remarks:

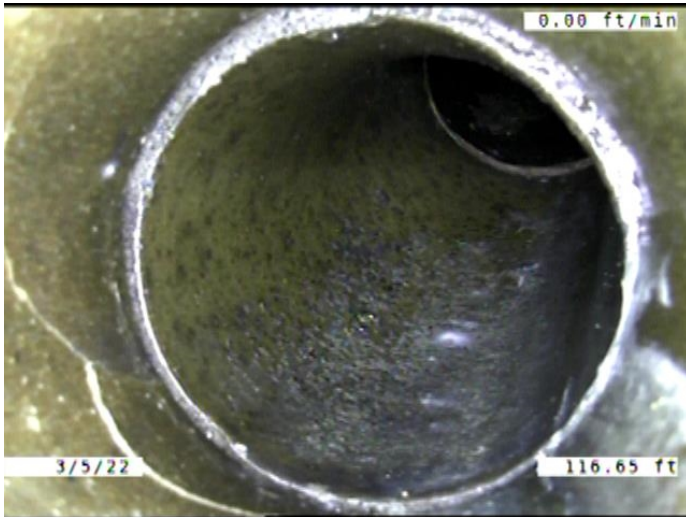
Code: **TFD**
 Description: **Tap Factory Defective**

Distance (ft): **116.6**
 Structural Grade: **0**
 O&M Grade: **3**
 Clock Start/From: **2**
 Clock To:
 1st Value: **4.000**
 2nd Value:
 Value Percent:
 Continuous Index:
 Within 8" of Joint: **YES**
 Remarks: **BROKEN.**

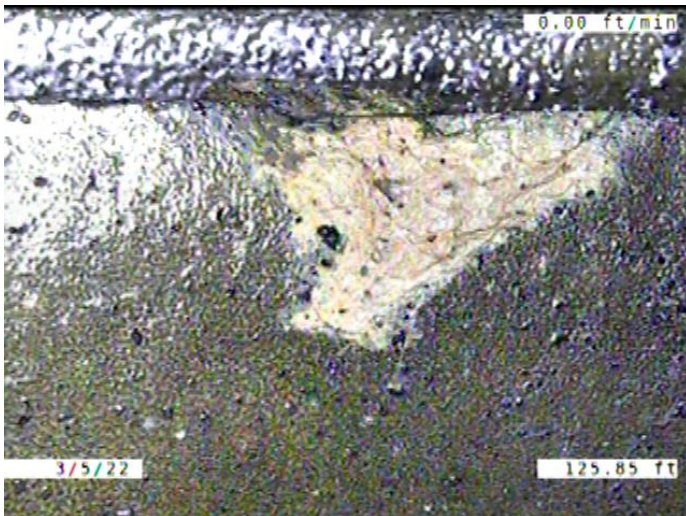
Code: **SZ**
 Description: **Surface Damage Other**

Distance (ft): **125.8**
 Structural Grade: **0**
 O&M Grade: **0**
 Clock Start/From: **9**
 Clock To:
 1st Value:
 2nd Value:
 Value Percent:
 Continuous Index:
 Within 8" of Joint: **YES**
 Remarks: **A PIECE CHIPPED AWAY FROM THE JOINT.**

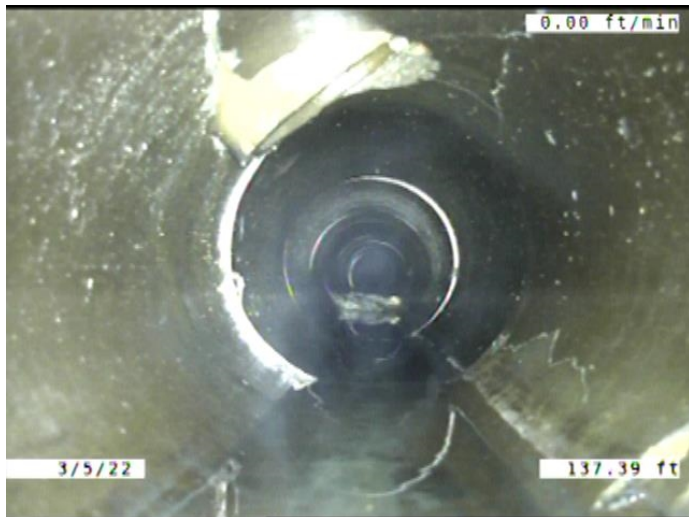
Code: **B**
 Description: **Broken**

Distance (ft): **137.4**
 Structural Grade: **4**
 O&M Grade: **0**
 Clock Start/From: **10**
 Clock To: **5**
 1st Value:
 2nd Value:
 Value Percent:
 Continuous Index:
 Within 8" of Joint: **YES**
 Remarks:

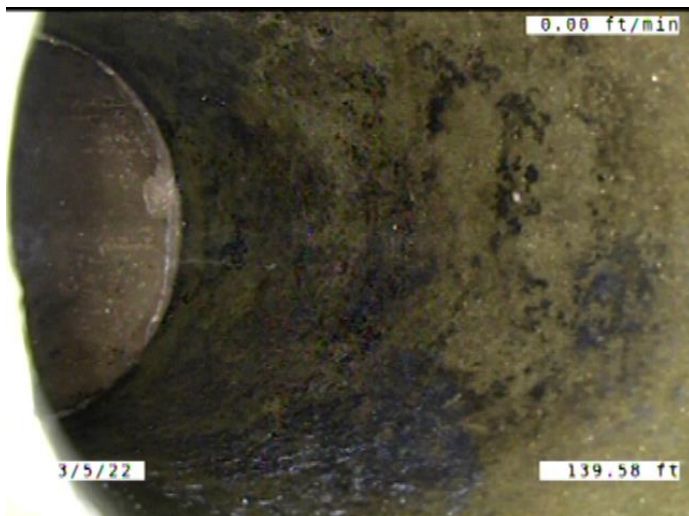
Code: **TBI**
 Description: **Tap Break-in Intruding**

Distance (ft): **139.6**
 Structural Grade: **0**
 O&M Grade: **2**
 Clock Start/From: **11**
 Clock To:
 1st Value: **4.000**
 2nd Value: **2.000**
 Value Percent:
 Continuous Index:
 Within 8" of Joint: **YES**
 Remarks:

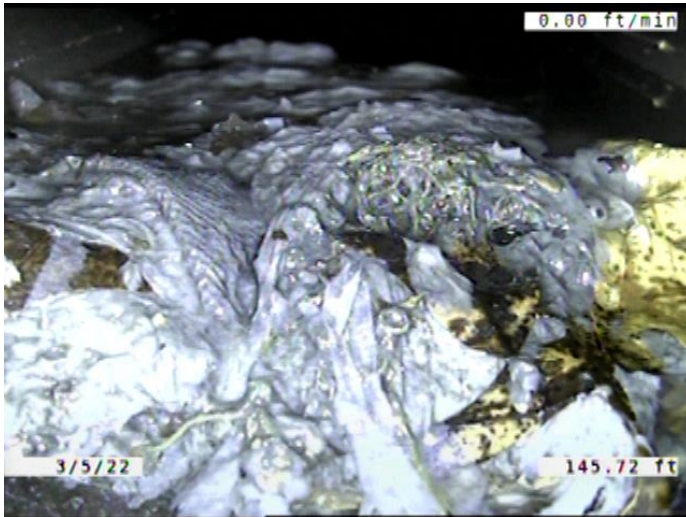
Code: **DAR**
Description: **Deposits Attached Ragging**

Distance (ft): **145.7**
Structural Grade: **0**
O&M Grade: **2**
Clock Start/From: **5**
Clock To: **7**
1st Value:
2nd Value:
Value Percent: **5.000**
Continuous Index:
Within 8" of Joint: **YES**
Remarks:

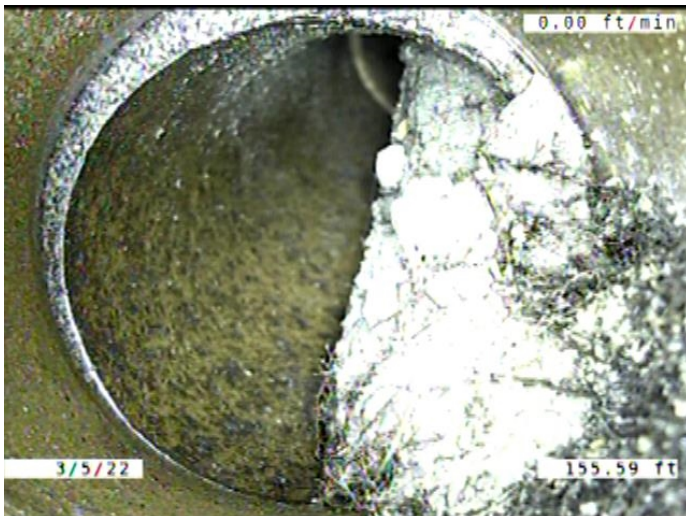
Code: **TF**
Description: **Tap Factory**

Distance (ft): **155.6**
Structural Grade: **0**
O&M Grade: **0**
Clock Start/From: **2**
Clock To:
1st Value: **4.000**
2nd Value:
Value Percent:
Continuous Index:
Within 8" of Joint: **YES**
Remarks: **ROOTS GROWING IN THE SERVICE**

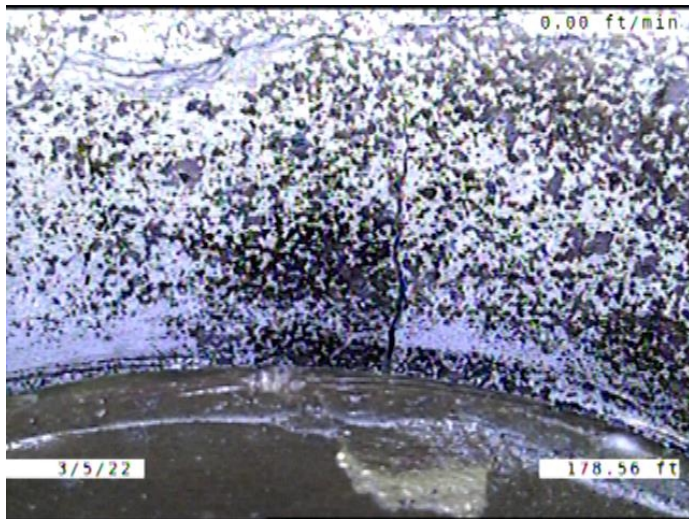
Code: **FM**
 Description: **Fracture Multiple**

Distance (ft): **178.6**
 Structural Grade: **4**
 O&M Grade: **0**
 Clock Start/From: **10**
 Clock To: **2**
 1st Value:
 2nd Value:
 Value Percent:
 Continuous Index:
 Within 8" of Joint: **YES**
 Remarks:

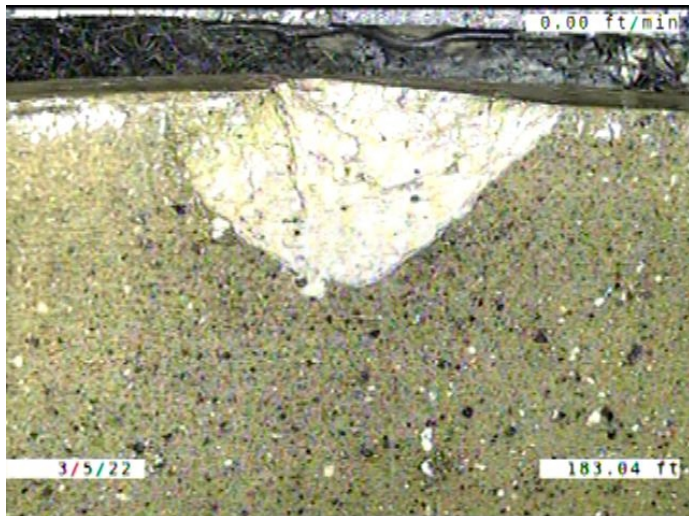
Code: **SZ**
 Description: **Surface Damage Other**

Distance (ft): **183.0**
 Structural Grade: **0**
 O&M Grade: **0**
 Clock Start/From: **9**
 Clock To:
 1st Value:
 2nd Value:
 Value Percent:
 Continuous Index:
 Within 8" of Joint: **YES**
 Remarks: **A PIECE CHIPPED AWAY FROM THE JOINT.**

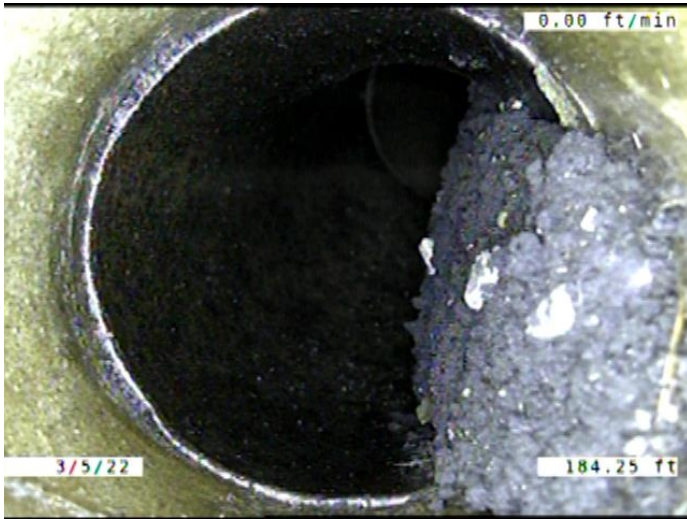
Code: **TF**
 Description: **Tap Factory**

Distance (ft): **184.2**
 Structural Grade: **0**
 O&M Grade: **0**
 Clock Start/From: **2**
 Clock To:
 1st Value: **4.000**
 2nd Value:
 Value Percent:
 Continuous Index:
 Within 8" of Joint: **YES**
 Remarks:

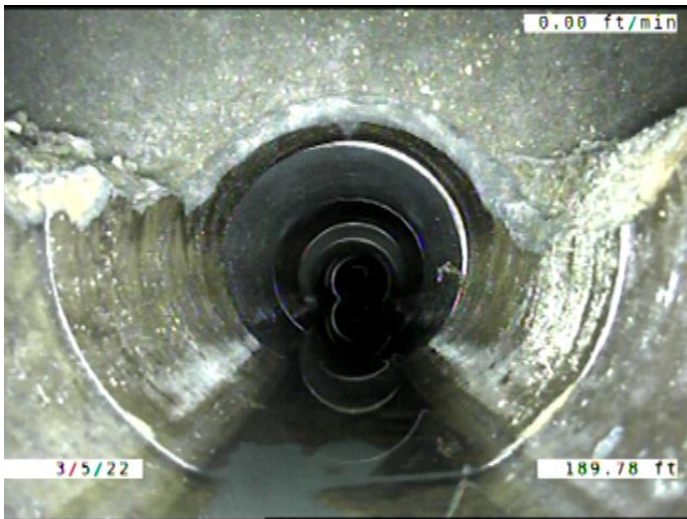
Code: **DSF**
 Description: **Deposits Settled Fine**

Distance (ft): **189.8**
 Structural Grade: **0**
 O&M Grade: **2**
 Clock Start/From: **5**
 Clock To: **7**
 1st Value:
 2nd Value:
 Value Percent: **5.000**
 Continuous Index: **F01**
 Within 8" of Joint: **YES**
 Remarks:

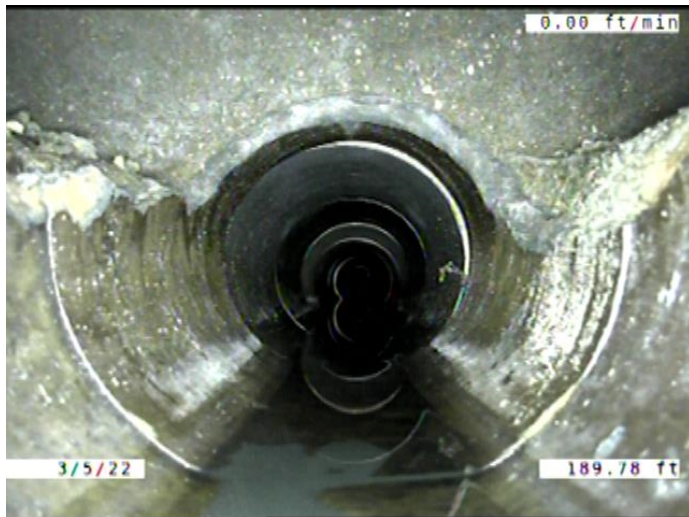
Code: **RFJ**
 Description: **Roots Fine Joint**

Distance (ft): **189.8**
 Structural Grade: **0**
 O&M Grade: **1**
 Clock Start/From: **8**
 Clock To: **4**
 1st Value:
 2nd Value:
 Value Percent:
 Continuous Index: **F02**
 Within 8" of Joint: **YES**
 Remarks:

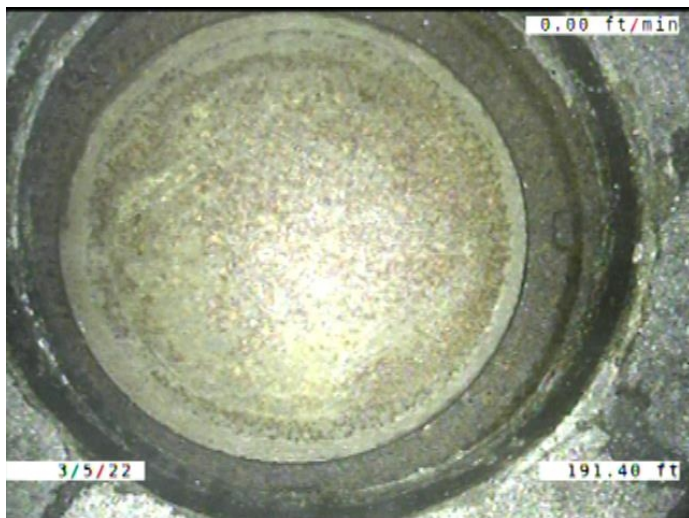
Code: **AMH**
 Description: **Manhole**

Distance (ft): **191.4**
 Structural Grade: **0**
 O&M Grade: **0**
 Clock Start/From:
 Clock To:
 1st Value:
 2nd Value:
 Value Percent:
 Continuous Index:
 Within 8" of Joint: **NO**
 Remarks: **M-706-043**
