## Profile/Photo Observation Report

Street:	<b>ALLEY BETWEEN WATER ST &amp; FLEMI</b>	Flow Control:	<b>Not Controlled</b>
City:	<b>Hobart, IN</b>	Year Renewed:	
Location:	<b>Alley</b>	Tape/Media #:	
Purpose:	<b>Maintenance Related</b>	Dia/Height:	<b>12"</b>
Use:	<b>Sanitary</b>	Material:	<b>VCP</b>
Drain Area:	<b>NA</b>	Lining:	<b>Cured in Place</b>
Category:	<b>NA</b>		
Comment:	<b>debris at 19'.</b>

Location Details:		Direction of Survey:	<b>Upstream</b>
US MH:	<b>M-706-044</b>	DS MH:	<b>M-706-045</b>
		Total Length Surveyed (ft):	<b>20.9</b>

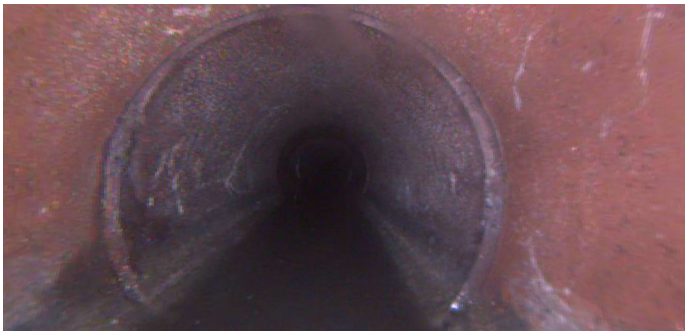
Code: **AMH**  
Description: **Manhole**

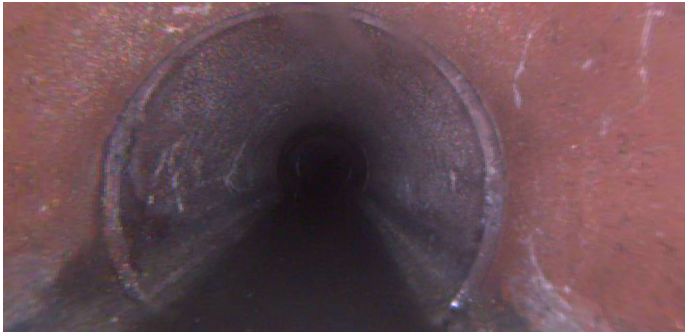
Code:	<b>MWL</b>
Description:	<b>Water Level</b>

Distance (ft):	<b>.0</b>
Structural Grade:	<b>0</b>
O&M Grade:	<b>0</b>
Clock Start/From:	
Clock To:	
1st Value:	
2nd Value:	
Value Percent:	<b>5.000</b>
Continuous Index:	
Within 8" of Joint:	<b>NO</b>
Remarks:

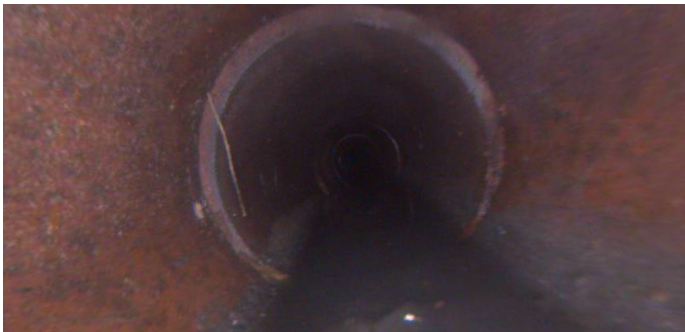
Code:	<b>RFJ</b>
Description:	<b>Roots Fine Joint</b>

Distance (ft):	<b>6.8</b>
Structural Grade:	<b>0</b>
O&M Grade:	<b>1</b>
Clock Start/From:	<b>10</b>
Clock To:	
1st Value:	
2nd Value:	
Value Percent:	
Continuous Index:	
Within 8" of Joint:	<b>YES</b>
Remarks:

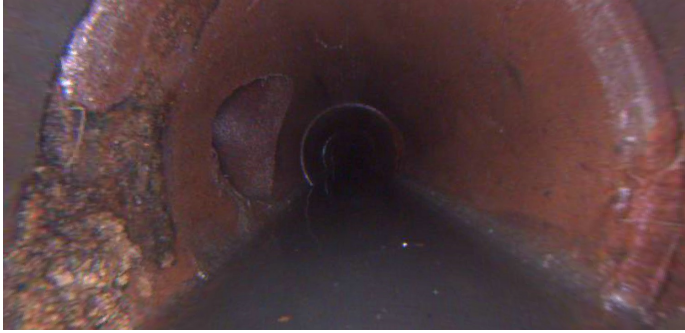
Code: **DAE**  
Description: **Deposits Attached Encrustation**

Distance (ft): **9.2**  
Structural Grade: **0**  
O&M Grade: **2**  
Clock Start/From: **8**  
Clock To: **9**  
1st Value:  
2nd Value:  
Value Percent: **5.000**  
Continuous Index:  
Within 8" of Joint: **YES**  
Remarks:

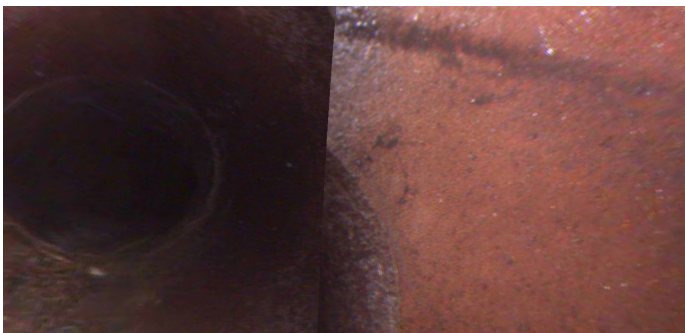
Code: **TF**  
Description: **Tap Factory**

Distance (ft): **10.6**  
Structural Grade: **0**  
O&M Grade: **0**  
Clock Start/From: **10**  
Clock To:  
1st Value: **4.000**  
2nd Value:  
Value Percent:  
Continuous Index:  
Within 8" of Joint: **YES**  
Remarks:

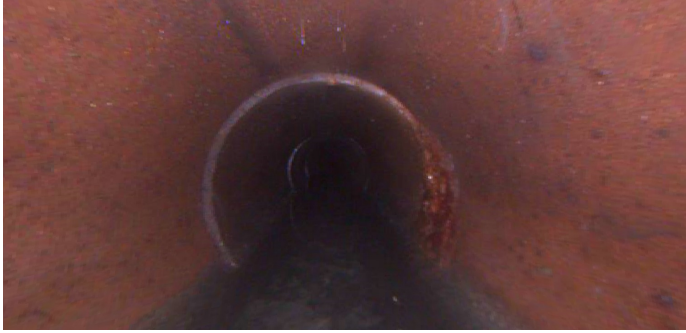
Code: **DAE**  
Description: **Deposits Attached Encrustation**

Distance (ft): **10.6**  
Structural Grade: **0**  
O&M Grade: **2**  
Clock Start/From: **3**  
Clock To: **5**  
1st Value:  
2nd Value:  
Value Percent: **5.000**  
Continuous Index:  
Within 8" of Joint: **YES**  
Remarks:

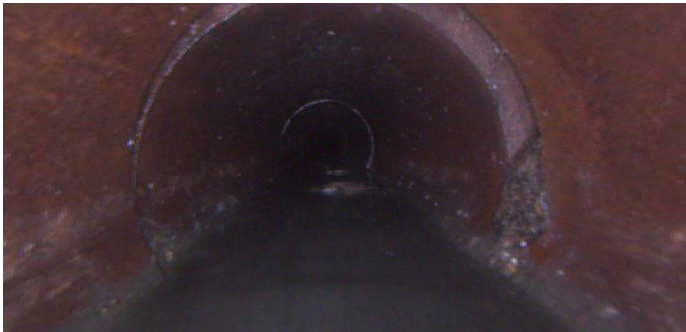
Code: **MSA**  
Description: **Abandoned Survey**

Distance (ft): **20.9**  
Structural Grade: **0**  
O&M Grade: **0**  
Clock Start/From:  
Clock To:  
1st Value:  
2nd Value:  
Value Percent:  
Continuous Index:  
Within 8" of Joint: **NO**  
Remarks: **debris under water**
