Profile/Photo Observation Report

Date:	04/18/2018	Weather:		Coding:	PACP 6.0
Pipe Length (ft):	183.6	Owner:	NA	Pre Clean:	Not Known
P.O.#:		Surveyor:	Byrd Fitzgerald	PSR:	P-706-046-045
Customer:		Clean Date:	01/01/1900	Shape:	C

Street:	Capitol	Flow Control:	Not Controlled
City:	Hobart, IN	Year Renewed:	
Location:	Alley	Tape/Media #:	
Purpose:	Maintenance Related	Dia/Height:	10"
Use:	Sanitary	Material:	VCP
Drain Area:	NA	Lining:	Cured in Place
Category:	NA		
Comment:	debris at 76'.

Location Details:		Direction of Survey:	Downstream
US MH:	M-706-045	DS MH:	M-706-046
		Total Length Surveyed (ft):	77.8

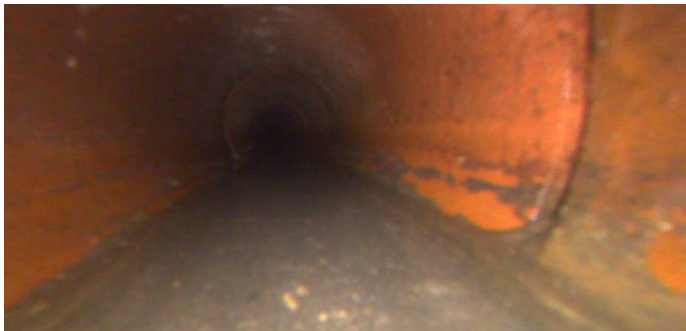
Code: **AMH**
Description: **Manhole**

Distance (ft): **.0**
Structural Grade: **0**
O&M Grade: **0**
Clock Start/From:
Clock To:
1st Value:
2nd Value:
Value Percent:
Continuous Index:
Within 8" of Joint: **NO**
Remarks: **M-706-045**

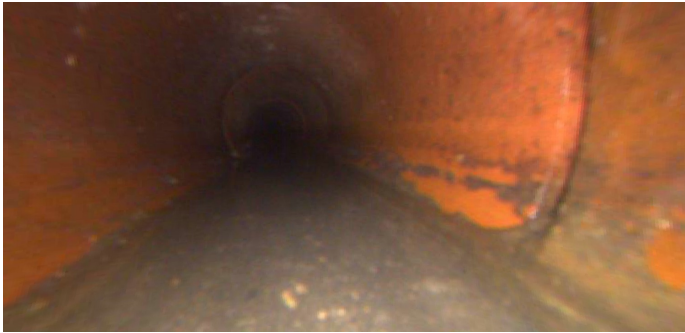
Code:	MWL
Description:	Water Level

Distance (ft):	.0
Structural Grade:	0
O&M Grade:	0
Clock Start/From:	
Clock To:	
1st Value:	
2nd Value:	
Value Percent:	5.000
Continuous Index:	
Within 8" of Joint:	NO
Remarks:

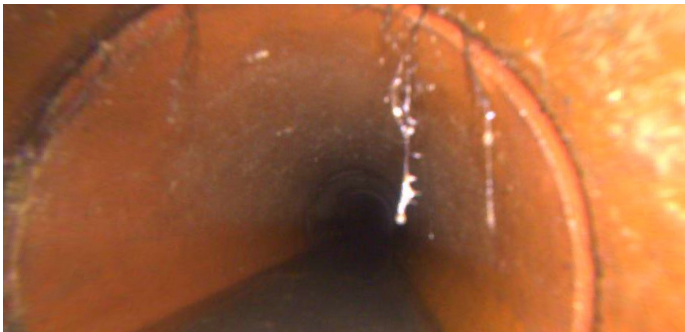
Code:	RFJ
Description:	Roots Fine Joint

Distance (ft):	7.0
Structural Grade:	0
O&M Grade:	1
Clock Start/From:	10
Clock To:	2
1st Value:	
2nd Value:	
Value Percent:	
Continuous Index:	
Within 8" of Joint:	YES
Remarks:

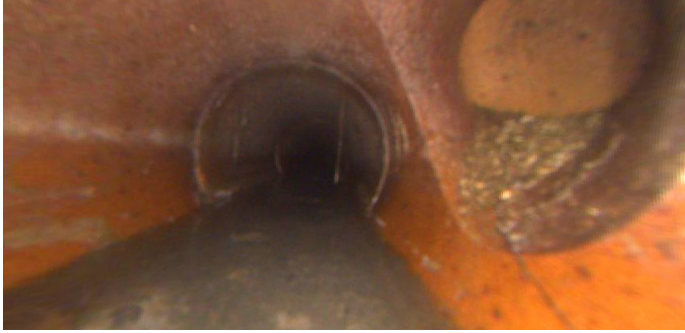
Code: **TFC**
Description: **Tap Factory Capped**

Distance (ft): **12.2**
Structural Grade: **0**
O&M Grade: **0**
Clock Start/From: **2**
Clock To:
1st Value: **4.000**
2nd Value:
Value Percent:
Continuous Index:
Within 8" of Joint: **YES**
Remarks:

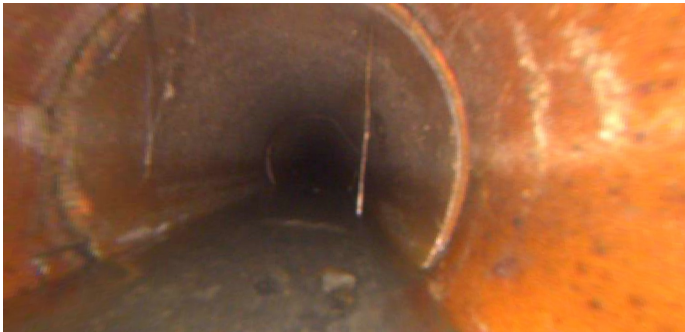
Code: **RFJ**
Description: **Roots Fine Joint**

Distance (ft): **12.8**
Structural Grade: **0**
O&M Grade: **1**
Clock Start/From: **11**
Clock To: **1**
1st Value:
2nd Value:
Value Percent:
Continuous Index: **S02**
Within 8" of Joint: **YES**
Remarks: **wandering**

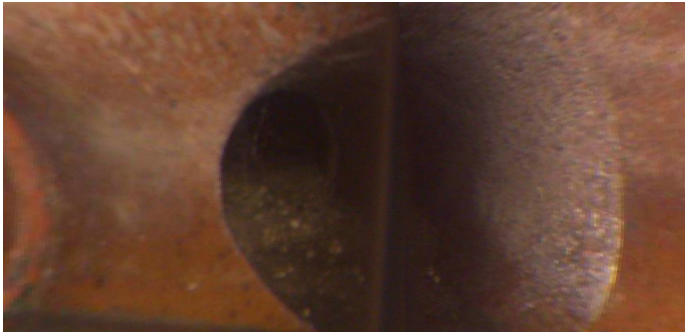
Code: **TFD**
Description: **Tap Factory Defective**

Distance (ft): **39.0**
Structural Grade: **0**
O&M Grade: **2**
Clock Start/From: **3**
Clock To:
1st Value: **4.000**
2nd Value:
Value Percent:
Continuous Index:
Within 8" of Joint: **YES**
Remarks: **partially blocked by debris**

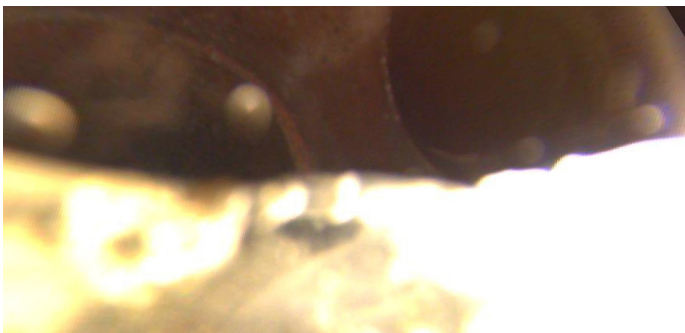
Code: **TF**
Description: **Tap Factory**

Distance (ft): **75.5**
Structural Grade: **0**
O&M Grade: **0**
Clock Start/From: **2**
Clock To:
1st Value: **4.000**
2nd Value:
Value Percent:
Continuous Index:
Within 8" of Joint: **YES**
Remarks:

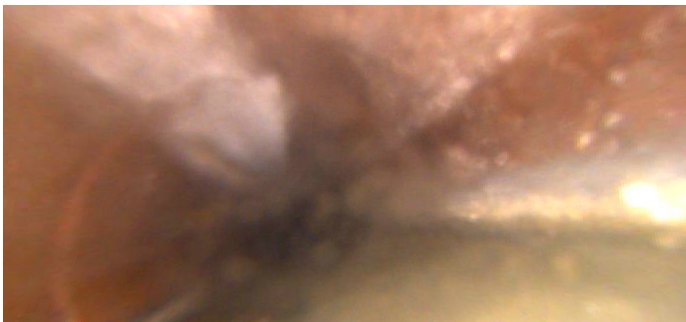
Code: **MSA**
Description: **Abandoned Survey**

Distance (ft): **77.8**
Structural Grade: **0**
O&M Grade: **0**
Clock Start/From:
Clock To:
1st Value:
2nd Value:
Value Percent:
Continuous Index:
Within 8" of Joint: **NO**
Remarks: **camera stopped/no blockage**

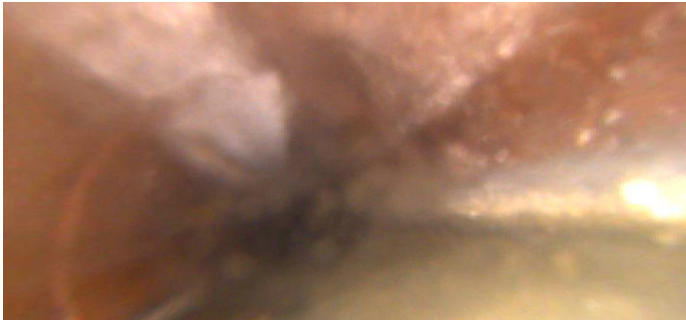
Code:	RFJ
Description:	Roots Fine Joint
Distance (ft):	77.8
Structural Grade:	0
O&M Grade:	1
Clock Start/From:	11
Clock To:	1
1st Value:	
2nd Value:	
Value Percent:	
Continuous Index:	F02
Within 8" of Joint:	YES
Remarks:	wandering
