Profile/Photo Observation Report

Date:	03/05/2022	Weather:		Coding:	PACP 7.0
Pipe Length (ft):	184.0	Owner:	City of Hobart	Pre Clean:	Heavy Cleaning
P.O.#:	YES502259	Surveyor:	S. Bucklin	PSR:	P-706-046-045
Customer:	City of Hobart, IN (Red	Clean Date:	02/27/2022	Shape:	C

Street:	Fleming Street	Flow Control:	Not Controlled
City:	Hobart, IN	Year Renewed:	
Location:	Alley	Tape/Media #:	
Purpose:	Routine Assessment	Dia/Height:	10"
Use:	Sanitary Sewage Pipe	Material:	VCP
Drain Area:		Lining:	None
Category:	NA		
Comment:			
Location Details:		Direction of Survey:	Upstream
US MH:	M-706-046	DS MH:	M-706-045
		Total Length Surveyed (ft):	180.5

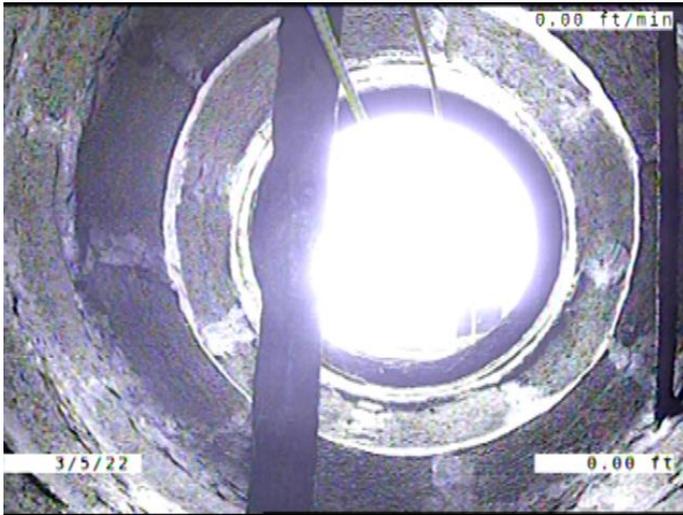
Code: **AMH**
Description: **Manhole**

Distance (ft): **.0**
Structural Grade: **0**
O&M Grade: **0**
Clock Start/From:
Clock To:
1st Value:
2nd Value:
Value Percent:
Continuous Index:
Within 8" of Joint: **NO**
Remarks: **M-706-045**

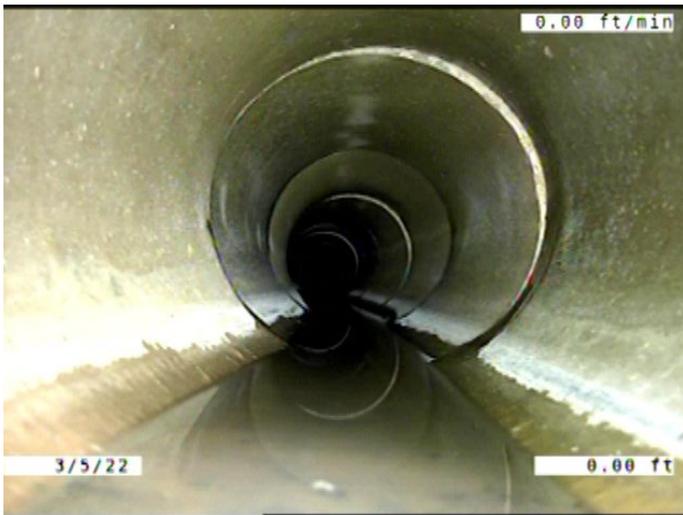
Code: **MWL**
Description: **Miscellaneous Water Level**

Distance (ft): **.0**
Structural Grade: **0**
O&M Grade: **0**
Clock Start/From:
Clock To:
1st Value:
2nd Value:
Value Percent: **5.000**
Continuous Index:
Within 8" of Joint: **NO**
Remarks:

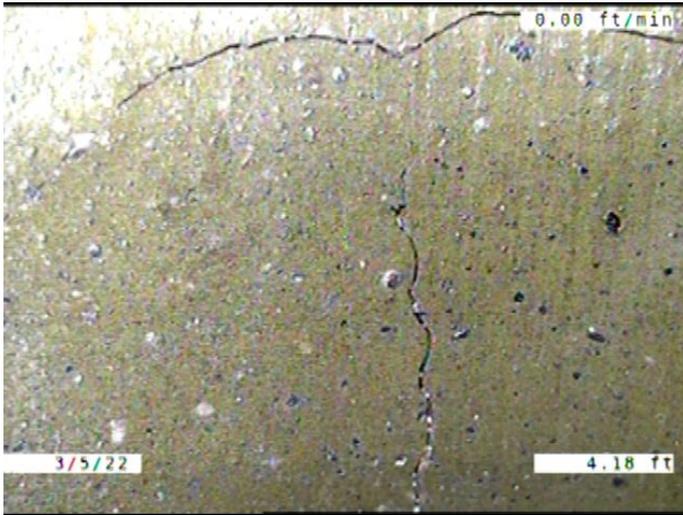
Code: **FM**
Description: **Fracture Multiple**

Distance (ft): **4.2**
Structural Grade: **4**
O&M Grade: **0**
Clock Start/From: **8**
Clock To: **2**
1st Value:
2nd Value:
Value Percent:
Continuous Index:
Within 8" of Joint: **YES**
Remarks:

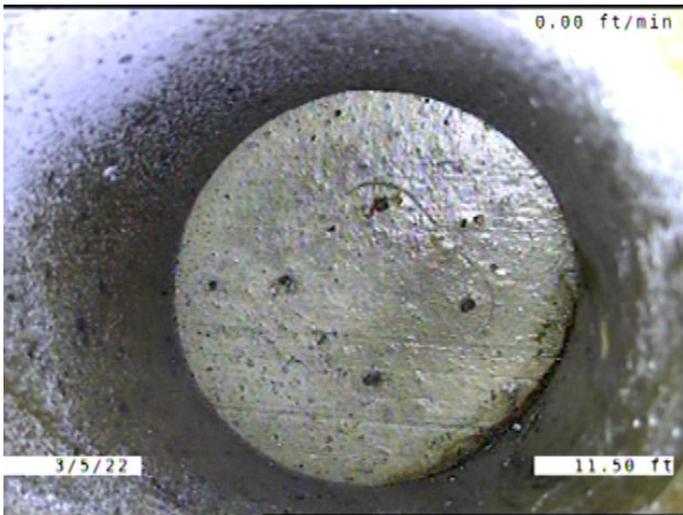
Code: **TFC**
Description: **Tap Factory Capped**

Distance (ft): **11.5**
Structural Grade: **0**
O&M Grade: **0**
Clock Start/From: **2**
Clock To:
1st Value: **4.000**
2nd Value:
Value Percent:
Continuous Index:
Within 8" of Joint: **YES**
Remarks:

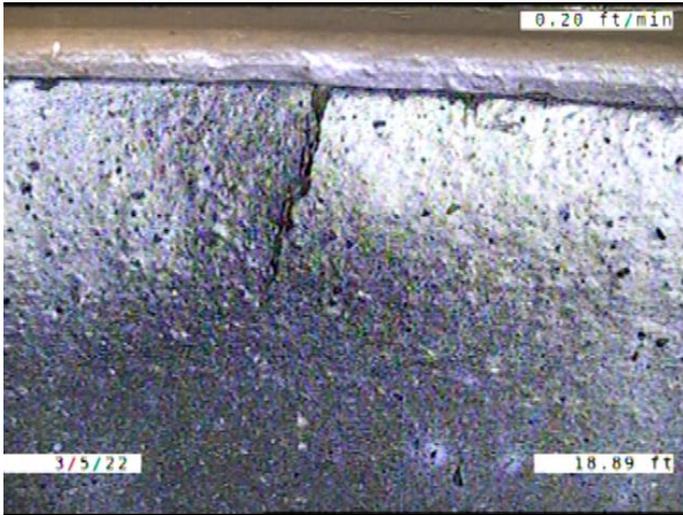
Code: **FL**
Description: **Fracture Longitudinal**

Distance (ft): **18.9**
Structural Grade: **3**
O&M Grade: **0**
Clock Start/From: **1**
Clock To:
1st Value:
2nd Value:
Value Percent:
Continuous Index:
Within 8" of Joint: **YES**
Remarks:

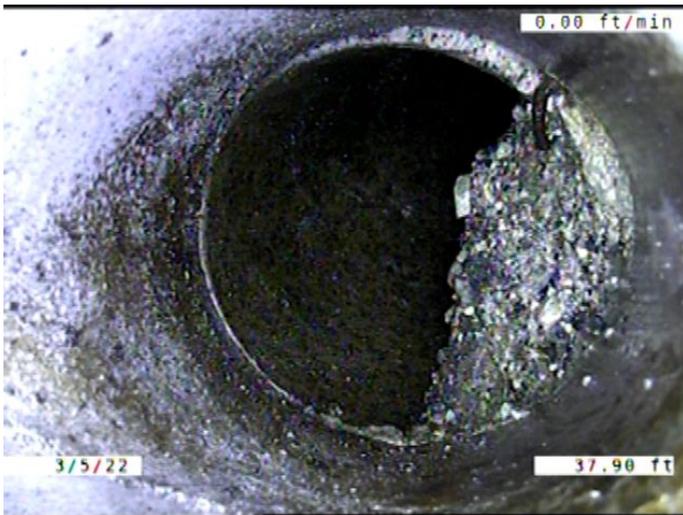
Code: **TF**
Description: **Tap Factory**

Distance (ft): **37.9**
Structural Grade: **0**
O&M Grade: **0**
Clock Start/From: **2**
Clock To:
1st Value: **4.000**
2nd Value:
Value Percent:
Continuous Index:
Within 8" of Joint: **YES**
Remarks:

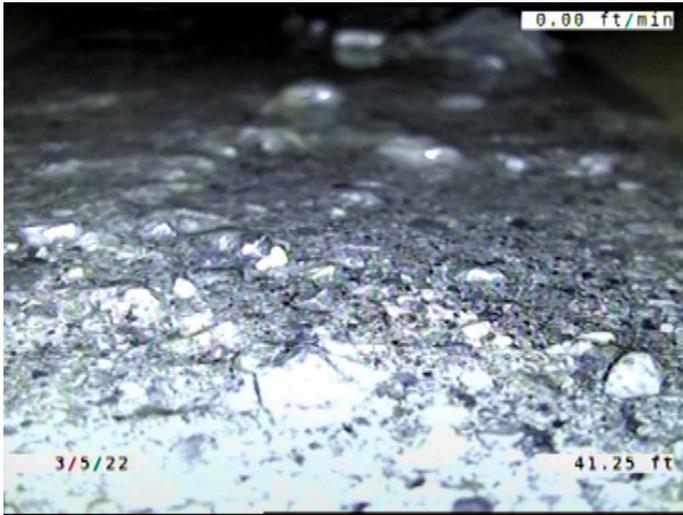
Code: **DSF**
Description: **Deposits Settled Fine**

Distance (ft): **41.2**
Structural Grade: **0**
O&M Grade: **2**
Clock Start/From: **5**
Clock To: **7**
1st Value:
2nd Value:
Value Percent: **5.000**
Continuous Index: **S01**
Within 8" of Joint: **YES**
Remarks:

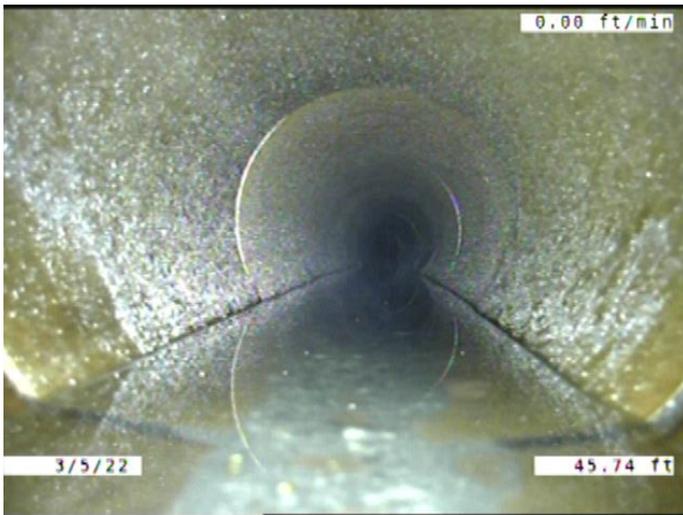
Code: **MWLS**
Description: **Miscellaneous Water Level Sag**

Distance (ft): **45.7**
Structural Grade: **2**
O&M Grade: **0**
Clock Start/From:
Clock To:
1st Value:
2nd Value:
Value Percent: **5.000**
Continuous Index: **S02**
Within 8" of Joint: **NO**
Remarks:

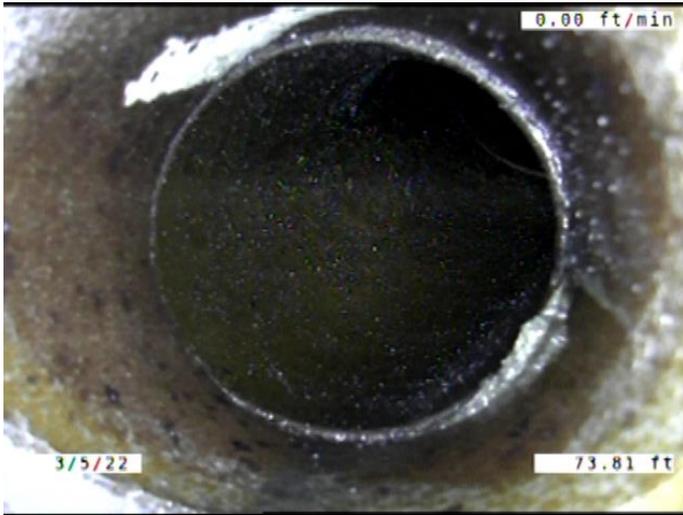
Code: **TF**
Description: **Tap Factory**

Distance (ft): **73.8**
Structural Grade: **0**
O&M Grade: **0**
Clock Start/From: **2**
Clock To:
1st Value: **4.000**
2nd Value:
Value Percent:
Continuous Index:
Within 8" of Joint: **YES**
Remarks:

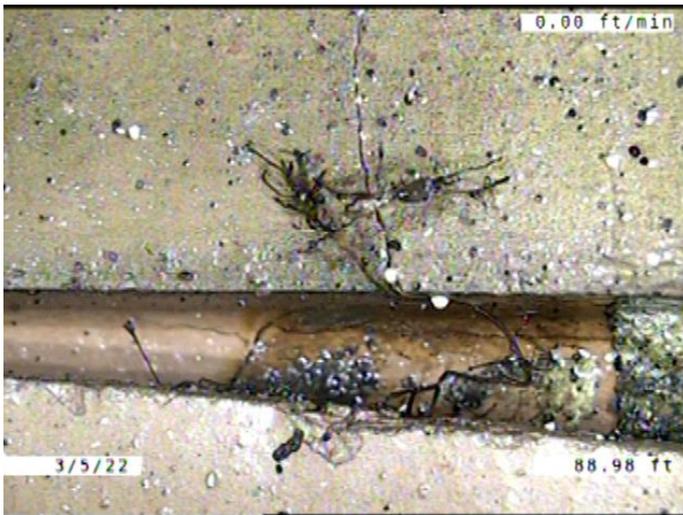
Code: **CM**
Description: **Crack Multiple**

Distance (ft): **89.0**
Structural Grade: **3**
O&M Grade: **0**
Clock Start/From: **2**
Clock To: **3**
1st Value:
2nd Value:
Value Percent:
Continuous Index:
Within 8" of Joint: **YES**
Remarks:

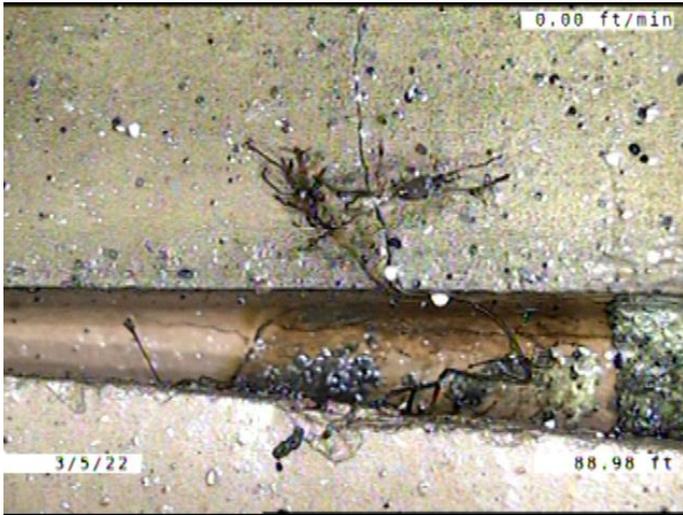
Code: **ISJ**
Description: **Infiltration Stain Joint**

Distance (ft): **89.0**
Structural Grade: **0**
O&M Grade: **1**
Clock Start/From: **2**
Clock To: **3**
1st Value:
2nd Value:
Value Percent:
Continuous Index:
Within 8" of Joint: **YES**
Remarks:

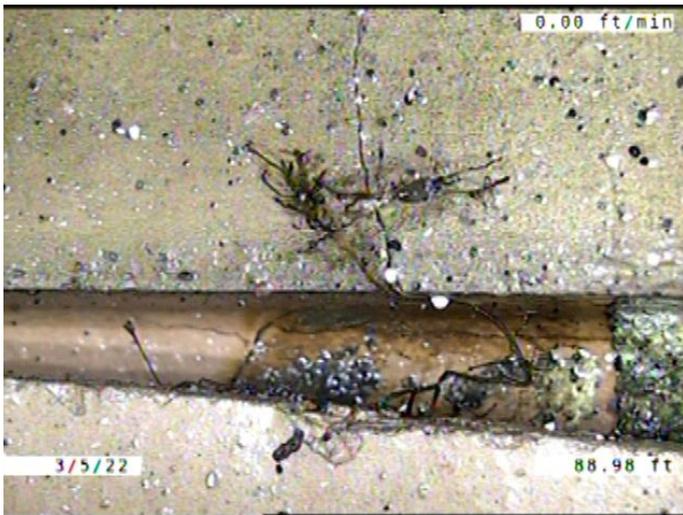
Code: **RFJ**
Description: **Roots Fine Joint**

Distance (ft): **89.0**
Structural Grade: **0**
O&M Grade: **1**
Clock Start/From: **2**
Clock To: **3**
1st Value:
2nd Value:
Value Percent:
Continuous Index:
Within 8" of Joint: **YES**
Remarks:

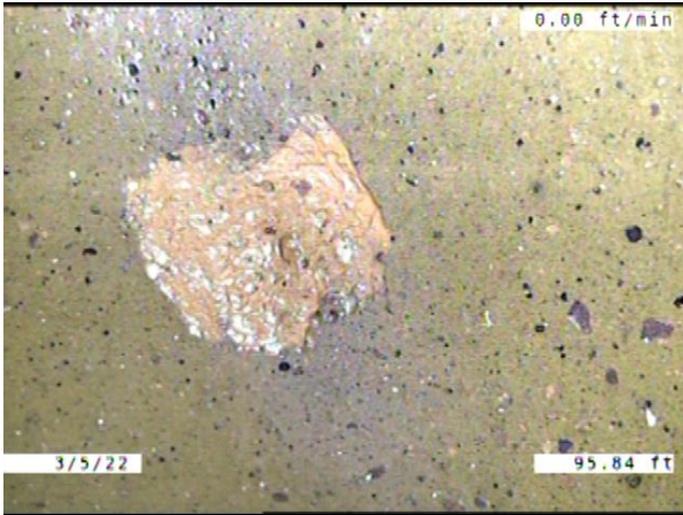
Code: **SSS**
 Description: **Surface Damage Surface Spalling**

Distance (ft): **95.8**
 Structural Grade: **2**
 O&M Grade: **0**
 Clock Start/From: **2**
 Clock To:
 1st Value:
 2nd Value:
 Value Percent:
 Continuous Index:
 Within 8" of Joint: **YES**
 Remarks:

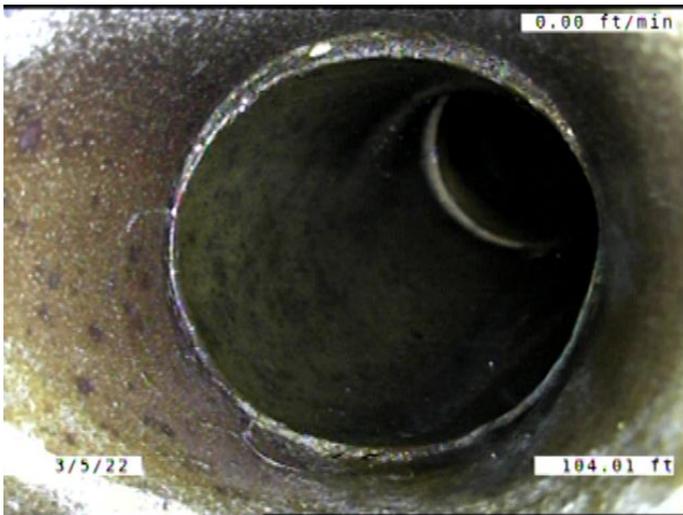
Code: **TF**
 Description: **Tap Factory**

Distance (ft): **104.0**
 Structural Grade: **0**
 O&M Grade: **0**
 Clock Start/From: **2**
 Clock To:
 1st Value: **4.000**
 2nd Value:
 Value Percent:
 Continuous Index:
 Within 8" of Joint: **YES**
 Remarks:

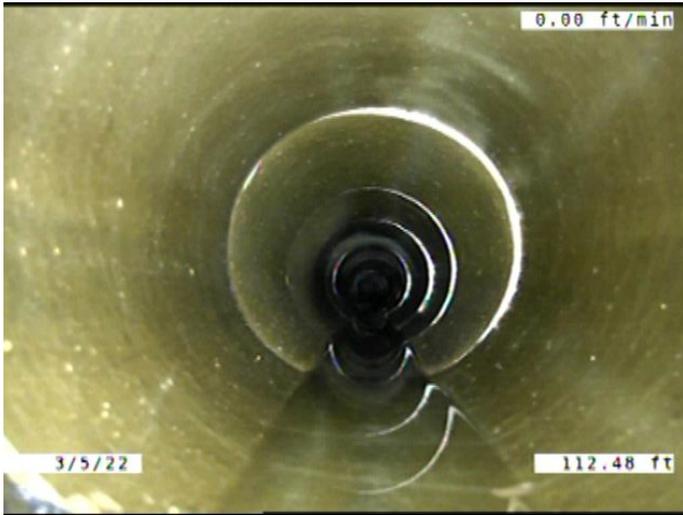
Code: **MWLS**
Description: **Miscellaneous Water Level Sag**

Distance (ft): **112.5**
Structural Grade: **2**
O&M Grade: **0**
Clock Start/From:
Clock To:
1st Value:
2nd Value:
Value Percent: **5.000**
Continuous Index: **F02**
Within 8" of Joint: **NO**
Remarks:

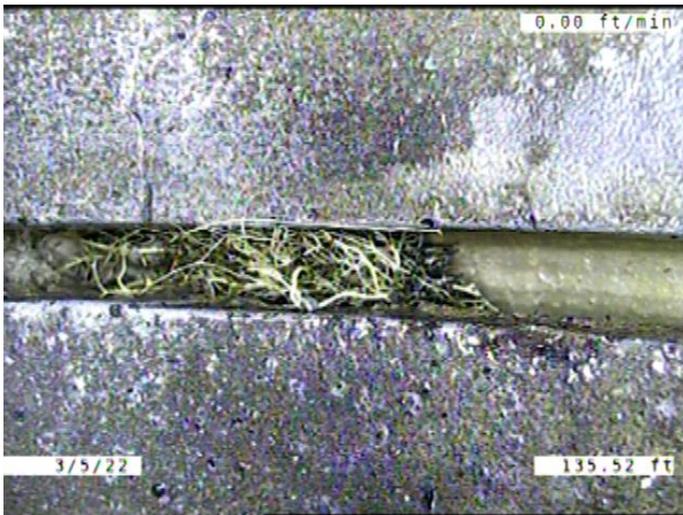
Code: **RFJ**
Description: **Roots Fine Joint**

Distance (ft): **135.5**
Structural Grade: **0**
O&M Grade: **1**
Clock Start/From: **2**
Clock To:
1st Value:
2nd Value:
Value Percent:
Continuous Index:
Within 8" of Joint: **YES**
Remarks:

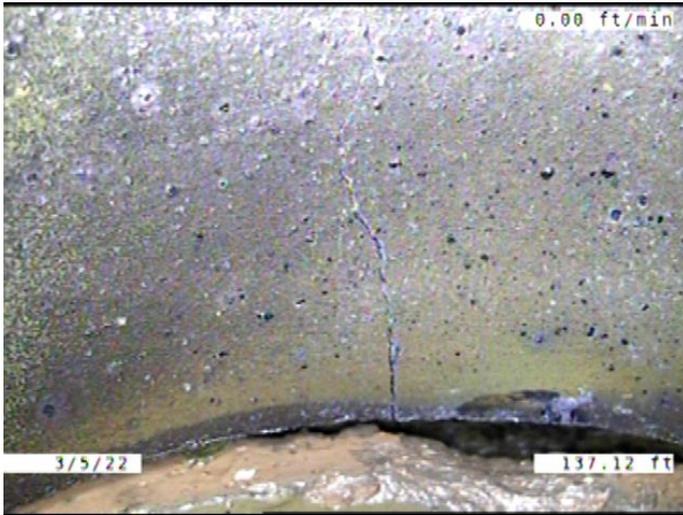
Code: **CL**
 Description: **Crack Longitudinal**

Distance (ft): **137.1**
 Structural Grade: **2**
 O&M Grade: **0**
 Clock Start/From: **11**
 Clock To:
 1st Value:
 2nd Value:
 Value Percent:
 Continuous Index:
 Within 8" of Joint: **YES**
 Remarks:

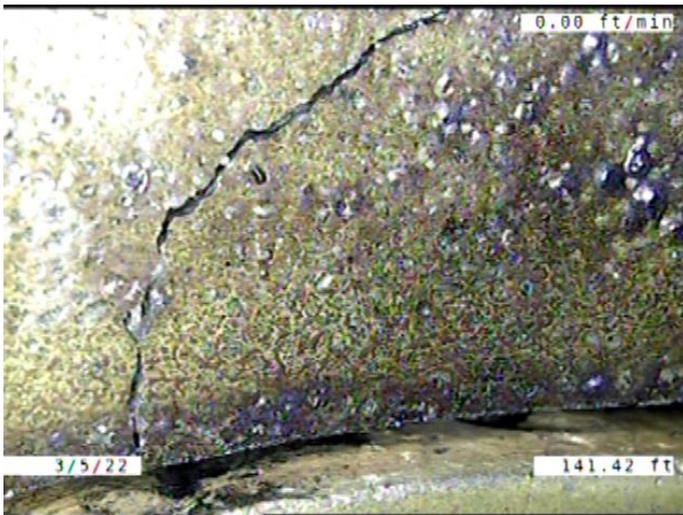
Code: **FM**
 Description: **Fracture Multiple**

Distance (ft): **141.4**
 Structural Grade: **4**
 O&M Grade: **0**
 Clock Start/From: **8**
 Clock To: **2**
 1st Value:
 2nd Value:
 Value Percent:
 Continuous Index:
 Within 8" of Joint: **YES**
 Remarks:

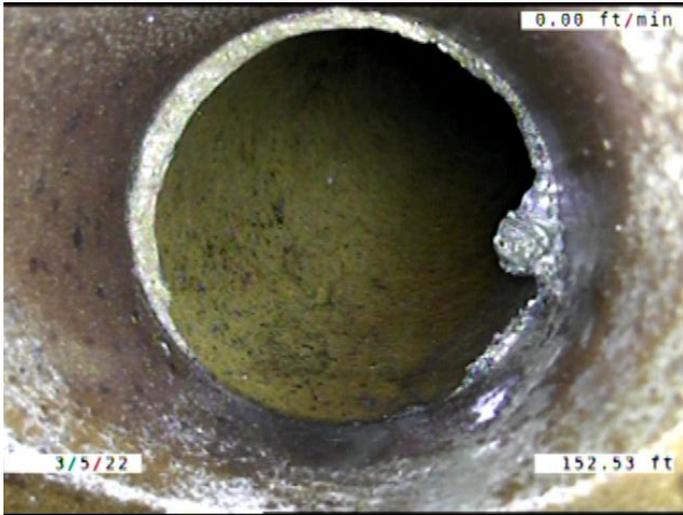
Code: **TF**
Description: **Tap Factory**

Distance (ft): **152.5**
Structural Grade: **0**
O&M Grade: **0**
Clock Start/From: **2**
Clock To:
1st Value: **4.000**
2nd Value:
Value Percent:
Continuous Index:
Within 8" of Joint: **YES**
Remarks:

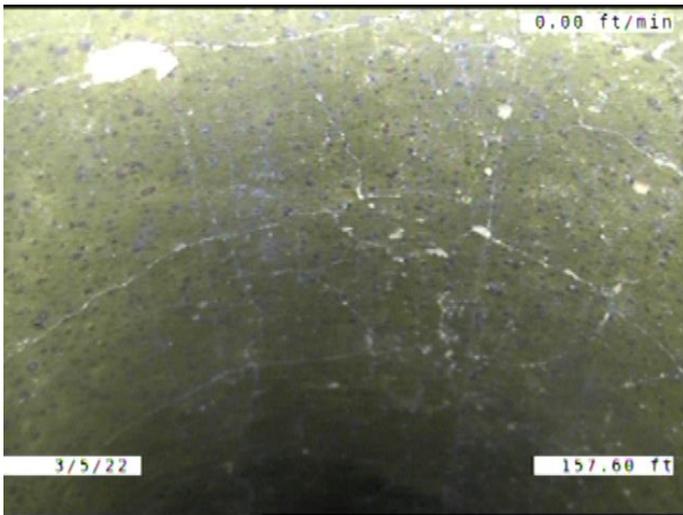
Code: **CM**
Description: **Crack Multiple**

Distance (ft): **157.6**
Structural Grade: **3**
O&M Grade: **0**
Clock Start/From: **12**
Clock To: **12**
1st Value:
2nd Value:
Value Percent:
Continuous Index:
Within 8" of Joint: **YES**
Remarks:

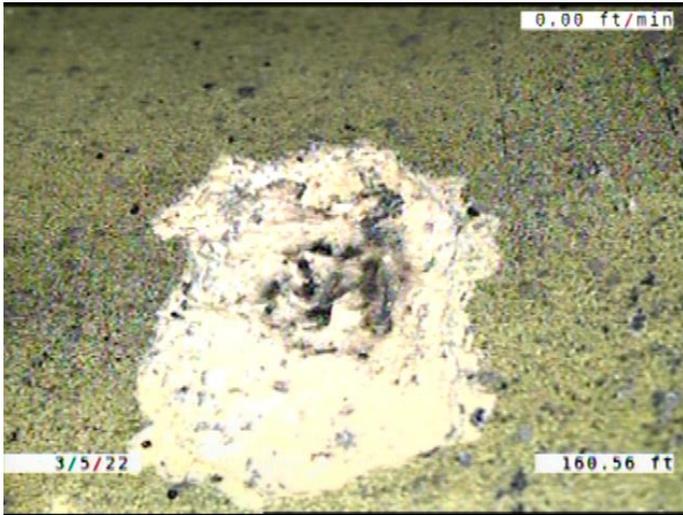
Code: **SSS**
Description: **Surface Damage Surface Spalling**

Distance (ft): **160.6**
Structural Grade: **2**
O&M Grade: **0**
Clock Start/From: **5**
Clock To: **7**
1st Value:
2nd Value:
Value Percent:
Continuous Index:
Within 8" of Joint: **YES**
Remarks:

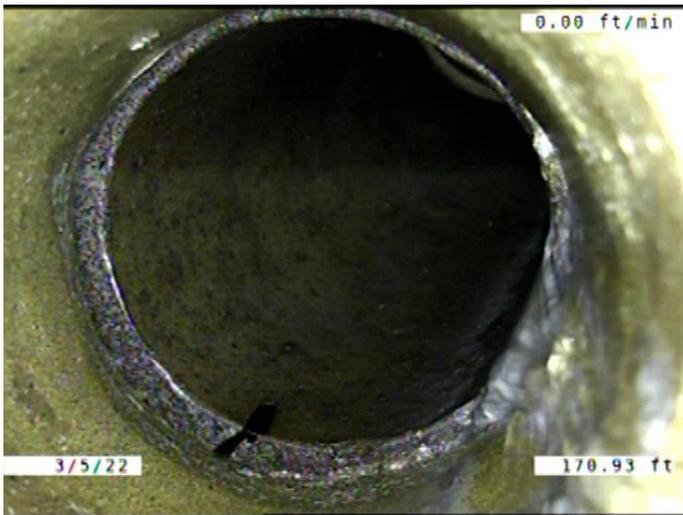
Code: **TFA**
Description: **Tap Factory Activity**

Distance (ft): **170.9**
Structural Grade: **0**
O&M Grade: **0**
Clock Start/From: **2**
Clock To:
1st Value: **4.000**
2nd Value:
Value Percent:
Continuous Index:
Within 8" of Joint: **YES**
Remarks:

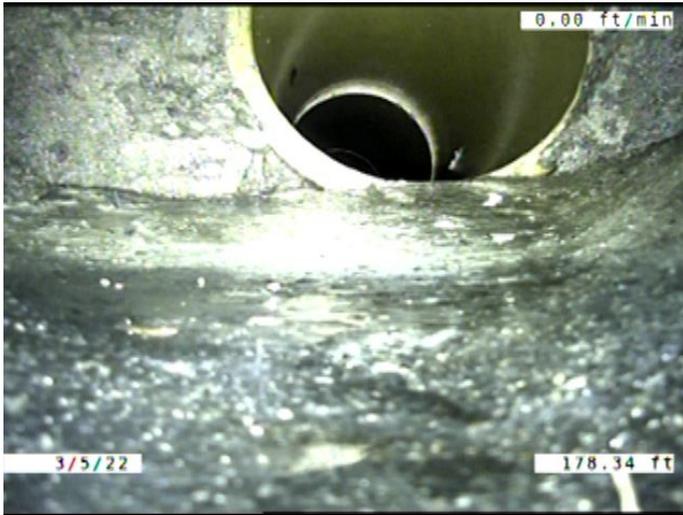
Code: **DSF**
 Description: **Deposits Settled Fine**

Distance (ft): **178.3**
 Structural Grade: **0**
 O&M Grade: **2**
 Clock Start/From: **5**
 Clock To: **7**
 1st Value:
 2nd Value:
 Value Percent: **5.000**
 Continuous Index: **F01**
 Within 8" of Joint: **YES**
 Remarks:

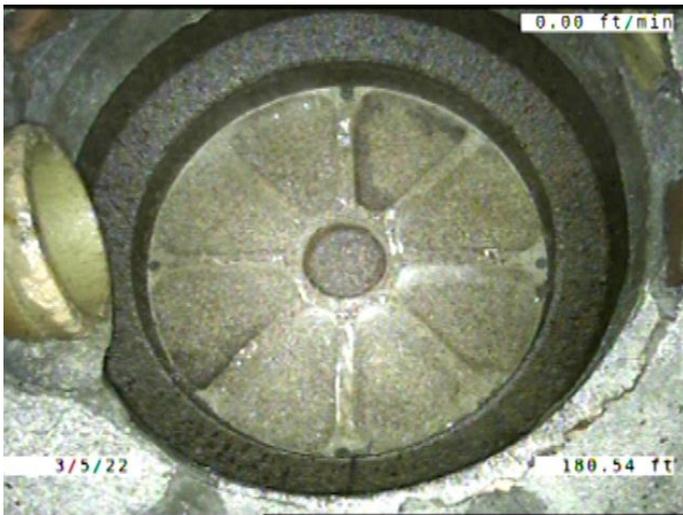
Code: **AMH**
 Description: **Manhole**

Distance (ft): **180.5**
 Structural Grade: **0**
 O&M Grade: **0**
 Clock Start/From:
 Clock To:
 1st Value:
 2nd Value:
 Value Percent:
 Continuous Index:
 Within 8" of Joint: **NO**
 Remarks: **M-706-046**
