Profile/Photo Observation Report

Street:	Fleming Street	Flow Control:	Not Controlled
City:	Hobart, IN	Year Renewed:	
Location:	Alley	Tape/Media #:	
Purpose:	Routine Assessment	Dia/Height:	10"
Use:	Sanitary Sewage Pipe	Material:	VCP
Drain Area:		Lining:	None
Category:	NA

Location Details:		Direction of Survey:	Upstream
US MH:	M-706-046.1	DS MH:	M-706-046
		Total Length Surveyed (ft):	36.8

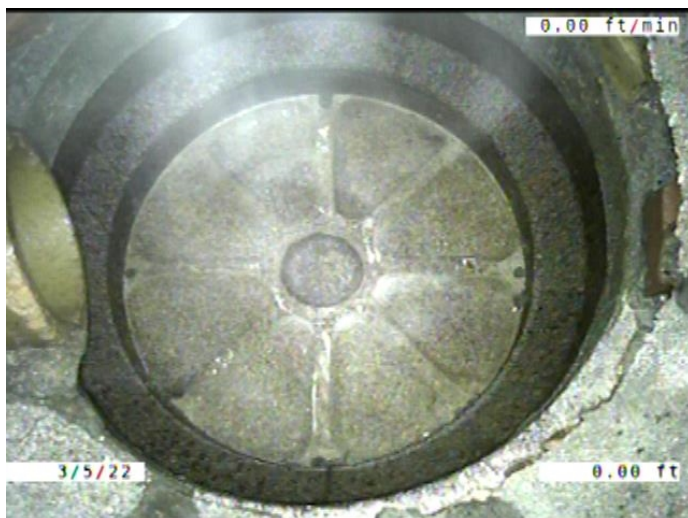
Code: **AMH**
Description: **Manhole**

Distance (ft): **.0**
Structural Grade: **0**
O&M Grade: **0**
Clock Start/From:
Clock To:
1st Value:
2nd Value:
Value Percent:
Continuous Index:
Within 8" of Joint: **NO**
Remarks: **M-706-046**

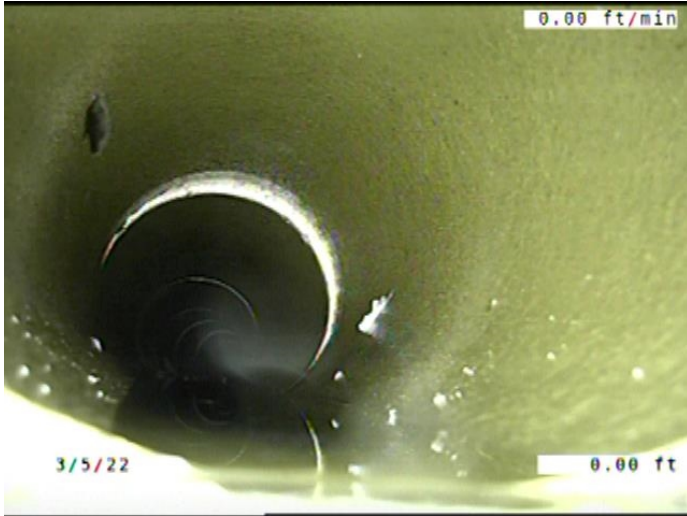
Code: **MWL**
Description: **Miscellaneous Water Level**

Distance (ft): **.0**
Structural Grade: **0**
O&M Grade: **0**
Clock Start/From:
Clock To:
1st Value:
2nd Value:
Value Percent: **5.000**
Continuous Index:
Within 8" of Joint: **NO**
Remarks:

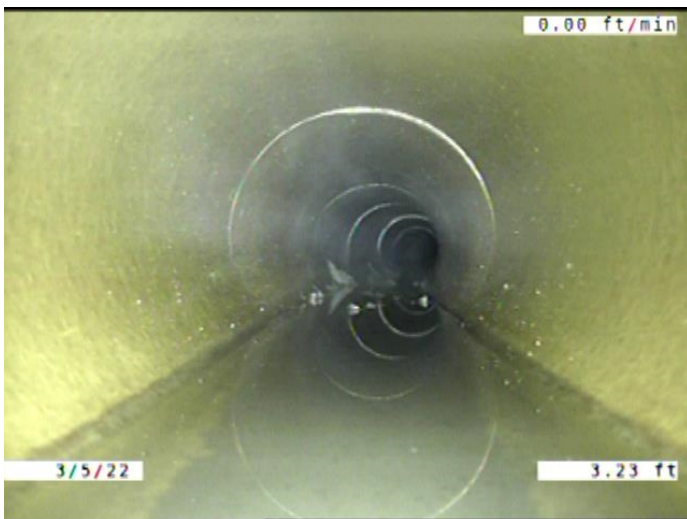
Code: **DSF**
Description: **Deposits Settled Fine**

Distance (ft): **3.2**
Structural Grade: **0**
O&M Grade: **2**
Clock Start/From: **5**
Clock To: **7**
1st Value:
2nd Value:
Value Percent: **5.000**
Continuous Index: **S01**
Within 8" of Joint: **YES**
Remarks:

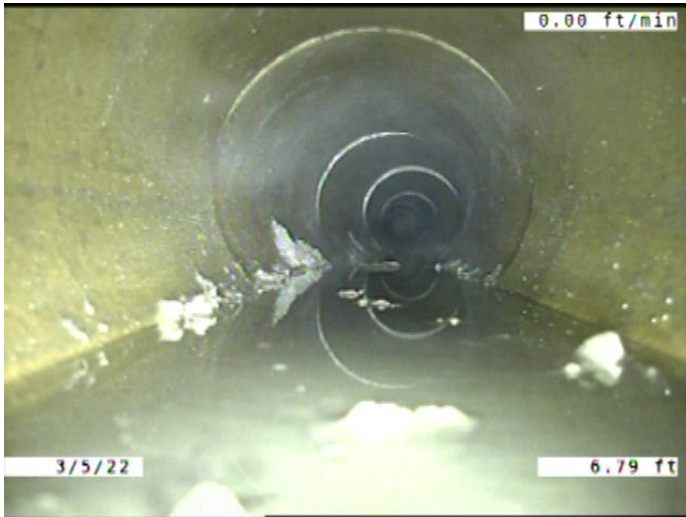
Code: **MWLS**
Description: **Miscellaneous Water Level Sag**

Distance (ft): **6.8**
Structural Grade: **2**
O&M Grade: **0**
Clock Start/From:
Clock To:
1st Value:
2nd Value:
Value Percent: **10.000**
Continuous Index: **S02**
Within 8" of Joint: **NO**
Remarks:

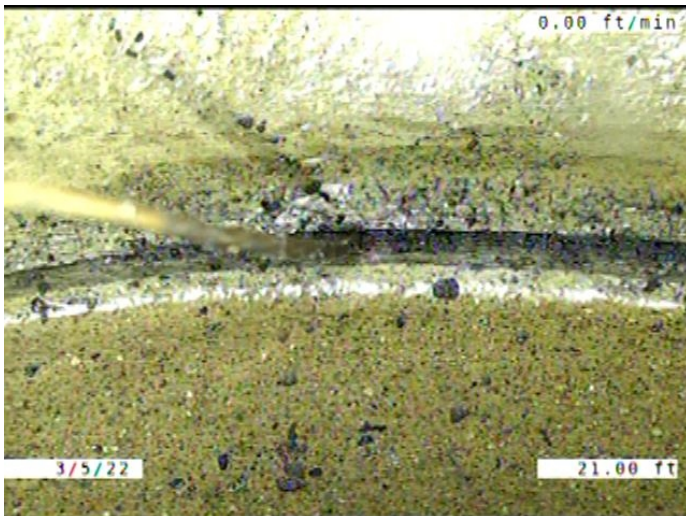
Code: **RFJ**
Description: **Roots Fine Joint**

Distance (ft): **21.0**
Structural Grade: **0**
O&M Grade: **1**
Clock Start/From: **11**
Clock To:
1st Value:
2nd Value:
Value Percent:
Continuous Index:
Within 8" of Joint: **YES**
Remarks:

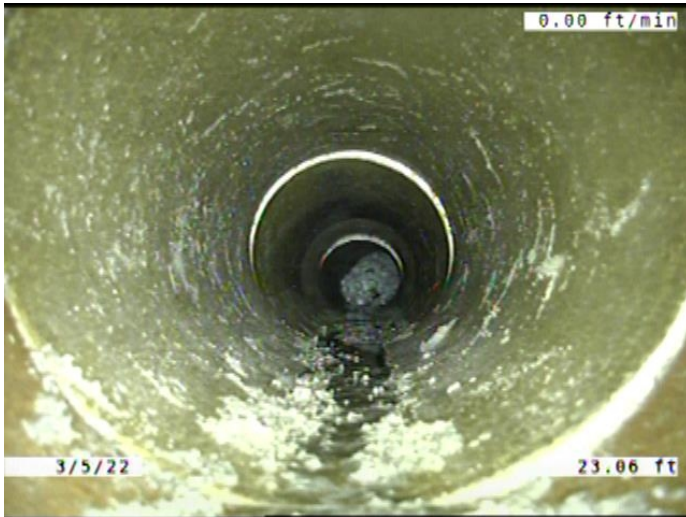
Code: **MWLS**
 Description: **Miscellaneous Water Level Sag**

Distance (ft): **23.1**
 Structural Grade: **2**
 O&M Grade: **0**
 Clock Start/From:
 Clock To:
 1st Value:
 2nd Value:
 Value Percent: **10.000**
 Continuous Index: **F02**
 Within 8" of Joint: **NO**
 Remarks:

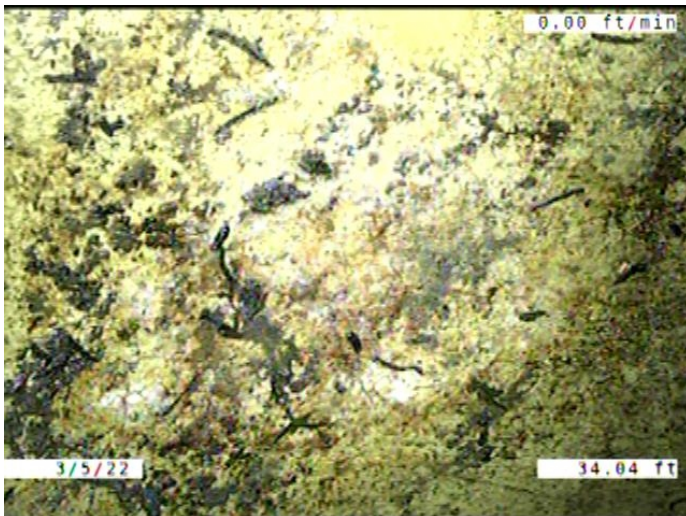
Code: **ISB**
 Description: **Infiltration Stain Barrel**

Distance (ft): **34.0**
 Structural Grade: **0**
 O&M Grade: **1**
 Clock Start/From: **10**
 Clock To:
 1st Value:
 2nd Value:
 Value Percent:
 Continuous Index:
 Within 8" of Joint: **NO**
 Remarks:

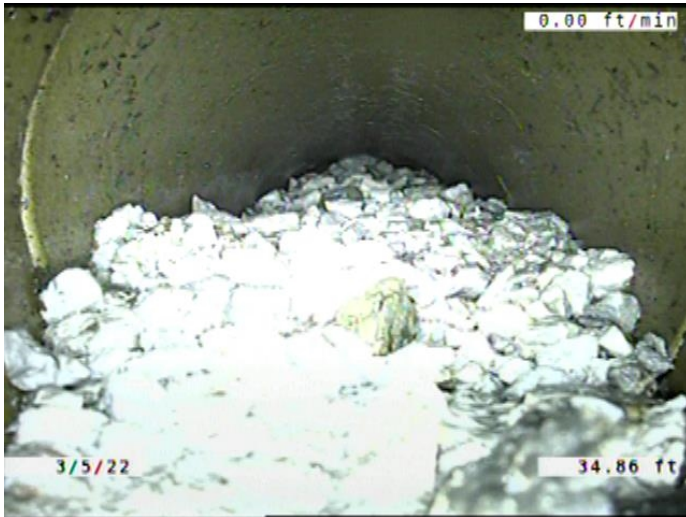
Code: **DSGV**
Description: **Deposits Settled Gravel**

Distance (ft): **34.9**
Structural Grade: **0**
O&M Grade: **5**
Clock Start/From: **12**
Clock To: **12**
1st Value:
2nd Value:
Value Percent: **100.000**
Continuous Index:
Within 8" of Joint: **YES**
Remarks:

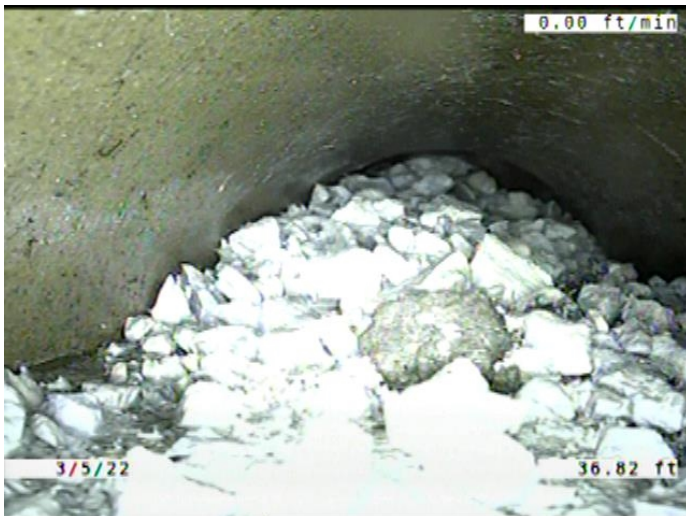
Code: **DSF**
Description: **Deposits Settled Fine**

Distance (ft): **36.8**
Structural Grade: **0**
O&M Grade: **2**
Clock Start/From: **5**
Clock To: **7**
1st Value:
2nd Value:
Value Percent: **5.000**
Continuous Index: **F01**
Within 8" of Joint: **YES**
Remarks:

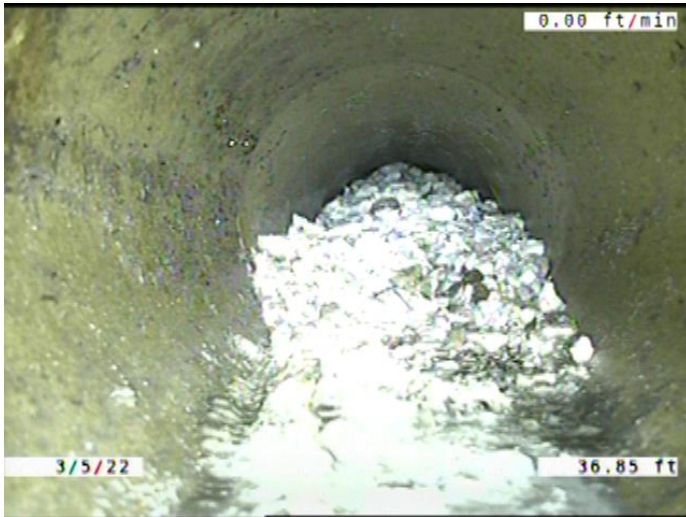
Code:	MSA
Description:	Miscellaneous Survey Abandoned
Distance (ft):	36.8
Structural Grade:	0
O&M Grade:	0
Clock Start/From:	
Clock To:	
1st Value:	
2nd Value:	
Value Percent:	
Continuous Index:	
Within 8" of Joint:	NO
Remarks:	CAMERA CANT MAKE IT PAST GRAVEL. 100% PLUGGED
