Profile/Photo Observation Report

Street:	GARFIELD ST & MAIN ST	Flow Control:	Not Controlled
City:	Hobart, IN	Year Renewed:	
Location:	Light Highway	Tape/Media #:	
Purpose:	Maintenance Related	Dia/Height:	8"
Use:	Sanitary	Material:	VCP
Drain Area:	NA	Lining:	Cured in Place
Category:	NA		
Comment:	roots at 162'.

Location Details:		Direction of Survey:	Upstream
US MH:	M-706-049	DS MH:	M-706-018
		Total Length Surveyed (ft):	163.9

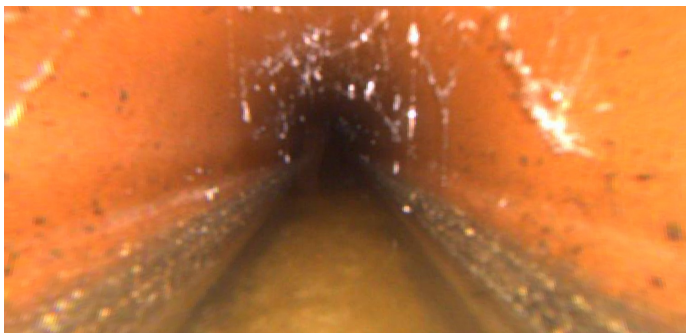
Code: **AMH**
Description: **Manhole**

Distance (ft): **.0**
Structural Grade: **0**
O&M Grade: **0**
Clock Start/From:
Clock To:
1st Value:
2nd Value:
Value Percent:
Continuous Index:
Within 8" of Joint: **NO**
Remarks: **M-706-018**

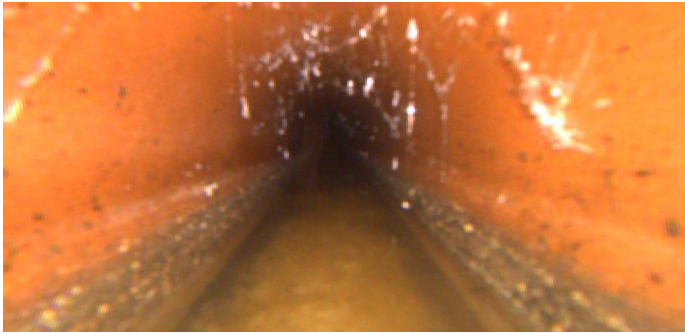
Code:	MWL
Description:	Water Level

Distance (ft):	.0
Structural Grade:	0
O&M Grade:	0
Clock Start/From:	
Clock To:	
1st Value:	
2nd Value:	
Value Percent:	5.000
Continuous Index:	
Within 8" of Joint:	NO
Remarks:

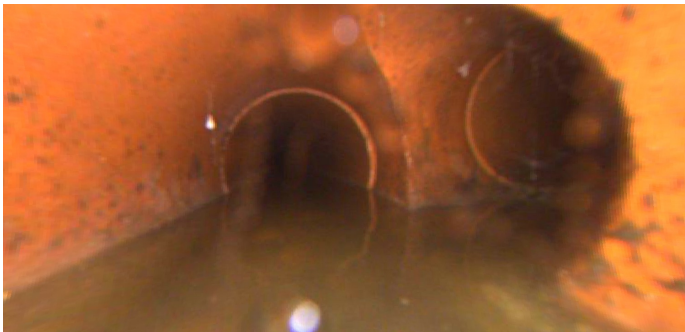
Code:	TF
Description:	Tap Factory

Distance (ft):	91.6
Structural Grade:	0
O&M Grade:	0
Clock Start/From:	3
Clock To:	
1st Value:	4.000
2nd Value:	
Value Percent:	
Continuous Index:	
Within 8" of Joint:	YES
Remarks:

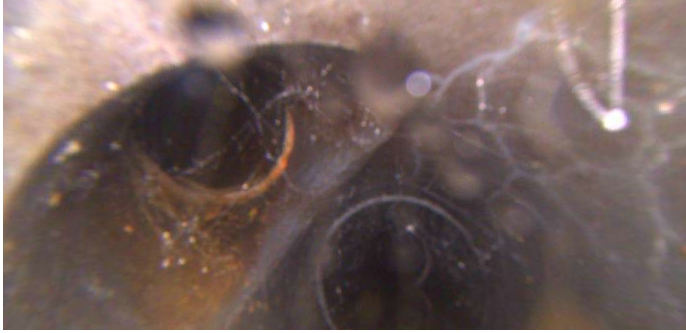
Code: **TF**
Description: **Tap Factory**

Distance (ft): **108.3**
Structural Grade: **0**
O&M Grade: **0**
Clock Start/From: **10**
Clock To:
1st Value: **4.000**
2nd Value:
Value Percent:
Continuous Index:
Within 8" of Joint:
Remarks:

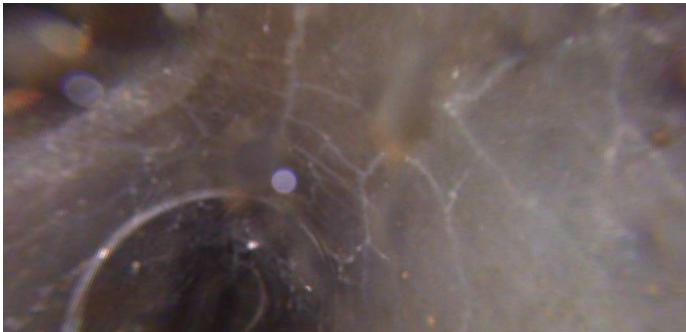
Code: **CM**
Description: **Crack Multiple**

Distance (ft): **108.6**
Structural Grade: **3**
O&M Grade: **0**
Clock Start/From: **7**
Clock To: **5**
1st Value:
2nd Value:
Value Percent:
Continuous Index:
Within 8" of Joint:
Remarks:

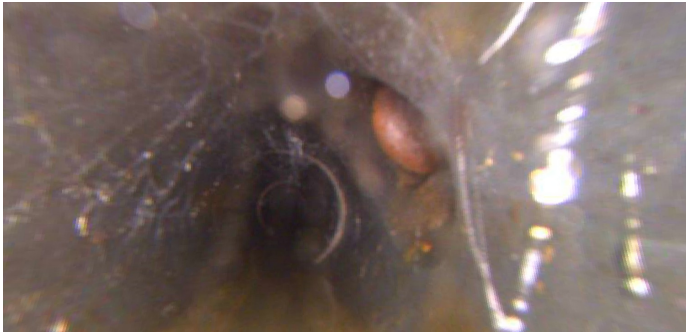
Code: **TFC**
Description: **Tap Factory Capped**

Distance (ft): **109.9**
Structural Grade: **0**
O&M Grade: **0**
Clock Start/From: **2**
Clock To:
1st Value: **4.000**
2nd Value:
Value Percent:
Continuous Index:
Within 8" of Joint: **YES**
Remarks:

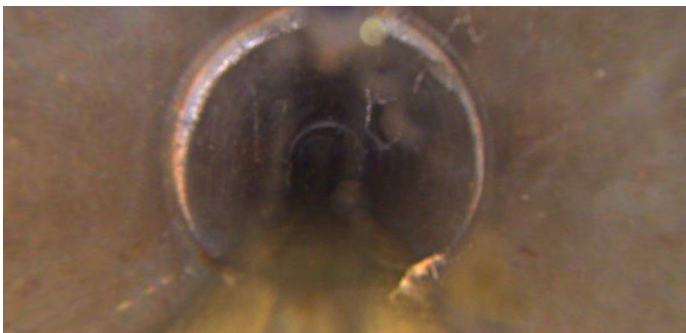
Code: **RFJ**
Description: **Roots Fine Joint**

Distance (ft): **135.2**
Structural Grade: **0**
O&M Grade: **1**
Clock Start/From: **4**
Clock To:
1st Value:
2nd Value:
Value Percent:
Continuous Index:
Within 8" of Joint: **YES**
Remarks:

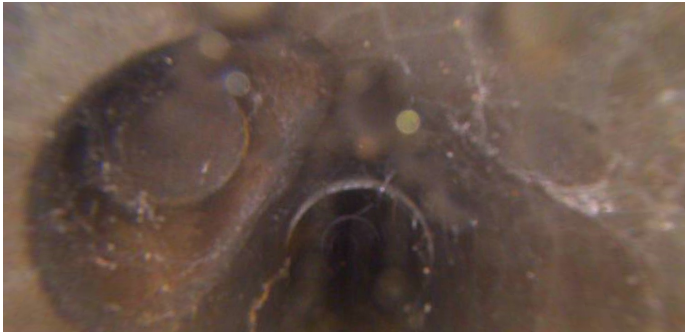
Code: **TFC**
Description: **Tap Factory Capped**

Distance (ft): **136.5**
Structural Grade: **0**
O&M Grade: **0**
Clock Start/From: **10**
Clock To:
1st Value: **4.000**
2nd Value:
Value Percent:
Continuous Index:
Within 8" of Joint:
Remarks:

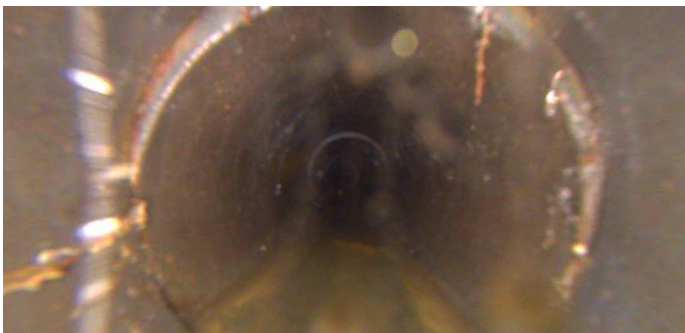
Code: **RFJ**
Description: **Roots Fine Joint**

Distance (ft): **137.4**
Structural Grade: **0**
O&M Grade: **1**
Clock Start/From: **8**
Clock To: **4**
1st Value:
2nd Value:
Value Percent:
Continuous Index:
Within 8" of Joint: **YES**
Remarks:

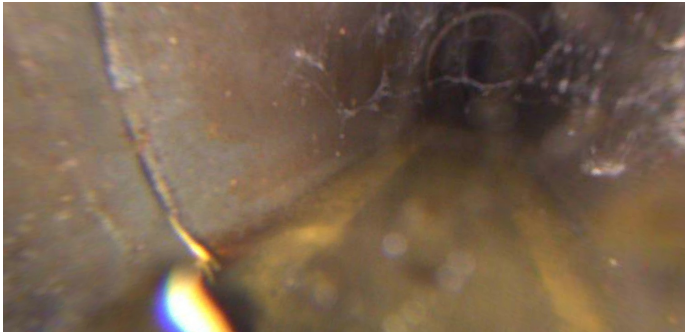
Code: **RFJ**
Description: **Roots Fine Joint**

Distance (ft): **151.9**
Structural Grade: **0**
O&M Grade: **1**
Clock Start/From: **8**
Clock To:
1st Value:
2nd Value:
Value Percent:
Continuous Index:
Within 8" of Joint: **YES**
Remarks:

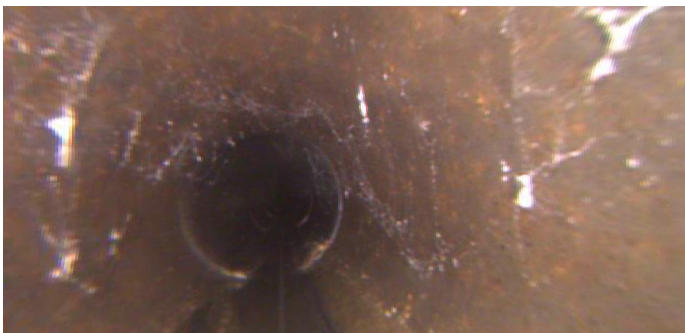
Code: **MGO**
Description: **General Observation**

Distance (ft): **159.6**
Structural Grade: **0**
O&M Grade: **0**
Clock Start/From:
Clock To:
1st Value:
2nd Value:
Value Percent:
Continuous Index:
Within 8" of Joint: **NO**
Remarks: **rear camera/cob webs**

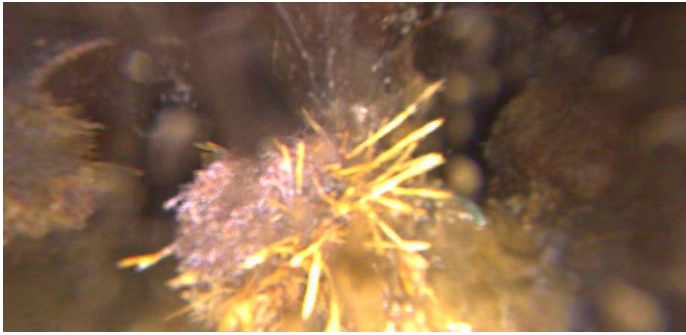
Code: **TFD**
Description: **Tap Factory Defective**

Distance (ft): **163.2**
Structural Grade: **0**
O&M Grade: **2**
Clock Start/From: **3**
Clock To:
1st Value: **4.000**
2nd Value:
Value Percent:
Continuous Index:
Within 8" of Joint:
Remarks: **roots**

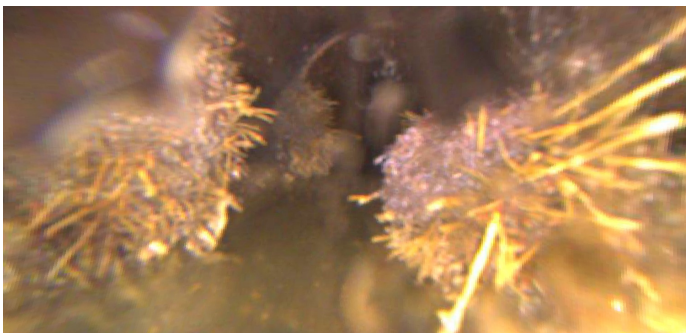
Code: **RMJ**
Description: **Roots Medium Joint**

Distance (ft): **163.2**
Structural Grade: **0**
O&M Grade: **3**
Clock Start/From: **7**
Clock To: **5**
1st Value:
2nd Value:
Value Percent: **25.000**
Continuous Index:
Within 8" of Joint: **YES**
Remarks:

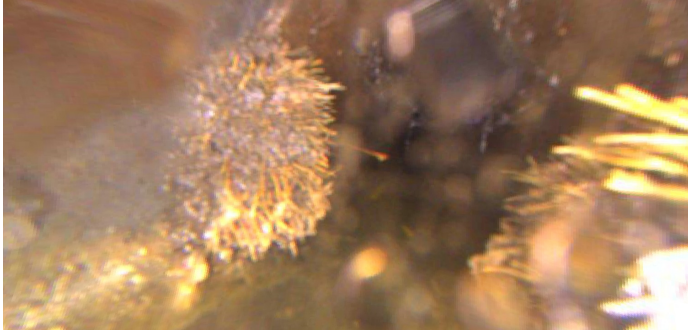
Code:	MSA
Description:	Abandoned Survey
Distance (ft):	163.9
Structural Grade:	0
O&M Grade:	0
Clock Start/From:	
Clock To:	
1st Value:	
2nd Value:	
Value Percent:	
Continuous Index:	
Within 8" of Joint:	NO
Remarks:	rmj
