Profile/Photo Observation Report

Street:	Capitol	Flow Control:	Not Controlled
City:	Hobart, IN	Year Renewed:	
Location:	Light Highway	Tape/Media #:	
Purpose:	Maintenance Related	Dia/Height:	8"
Use:	Sanitary	Material:	VCP
Drain Area:	NA	Lining:	Cured in Place
Category:	NA		
Comment:	roots at 162'.

Location Details:		Direction of Survey:	Upstream
US MH:	M-706-049	DS MH:	M-706-018
		Total Length Surveyed (ft):	163.9

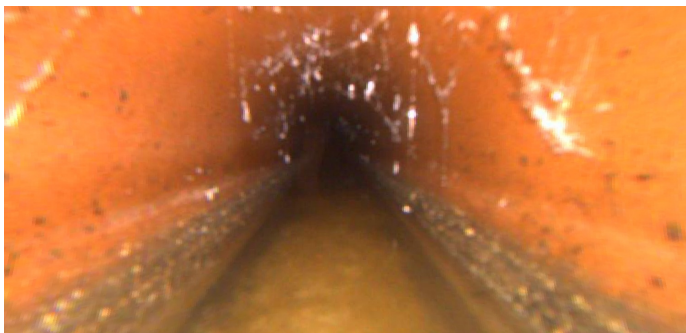
Code: **AMH**
Description: **Manhole**

Distance (ft): **.0**
Structural Grade: **0**
O&M Grade: **0**
Clock Start/From:
Clock To:
1st Value:
2nd Value:
Value Percent:
Continuous Index:
Within 8" of Joint: **NO**
Remarks: **M-706-018**

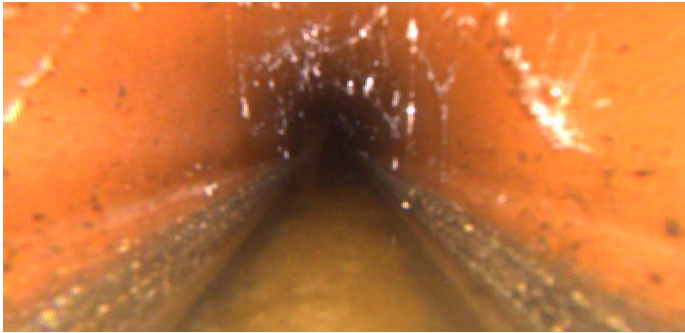
Code:	MWL
Description:	Water Level

Distance (ft):	.0
Structural Grade:	0
O&M Grade:	0
Clock Start/From:	
Clock To:	
1st Value:	
2nd Value:	
Value Percent:	5.000
Continuous Index:	
Within 8" of Joint:	NO
Remarks:

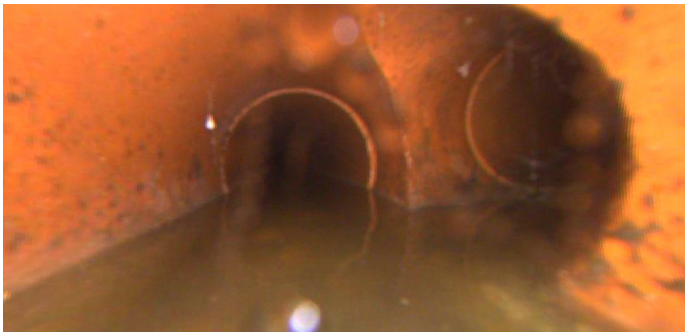
Code:	TF
Description:	Tap Factory

Distance (ft):	91.6
Structural Grade:	0
O&M Grade:	0
Clock Start/From:	3
Clock To:	
1st Value:	4.000
2nd Value:	
Value Percent:	
Continuous Index:	
Within 8" of Joint:	YES
Remarks:

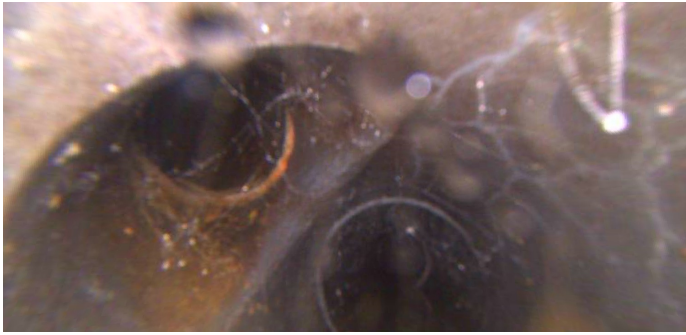
Code: **TF**
Description: **Tap Factory**

Distance (ft): **108.3**
Structural Grade: **0**
O&M Grade: **0**
Clock Start/From: **10**
Clock To:
1st Value: **4.000**
2nd Value:
Value Percent:
Continuous Index:
Within 8" of Joint:
Remarks:

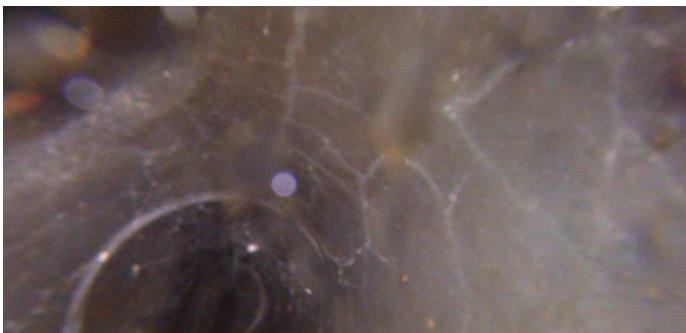
Code: **CM**
Description: **Crack Multiple**

Distance (ft): **108.6**
Structural Grade: **3**
O&M Grade: **0**
Clock Start/From: **7**
Clock To: **5**
1st Value:
2nd Value:
Value Percent:
Continuous Index:
Within 8" of Joint:
Remarks:

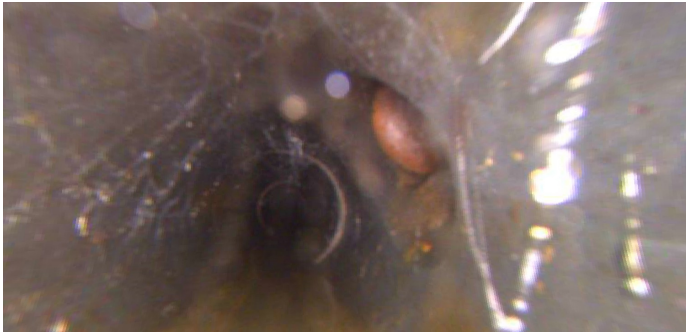
Code: **TFC**
Description: **Tap Factory Capped**

Distance (ft): **109.9**
Structural Grade: **0**
O&M Grade: **0**
Clock Start/From: **2**
Clock To:
1st Value: **4.000**
2nd Value:
Value Percent:
Continuous Index:
Within 8" of Joint: **YES**
Remarks:

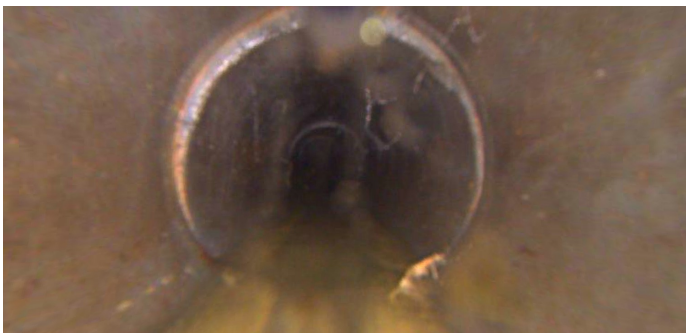
Code: **RFJ**
Description: **Roots Fine Joint**

Distance (ft): **135.2**
Structural Grade: **0**
O&M Grade: **1**
Clock Start/From: **4**
Clock To:
1st Value:
2nd Value:
Value Percent:
Continuous Index:
Within 8" of Joint: **YES**
Remarks:

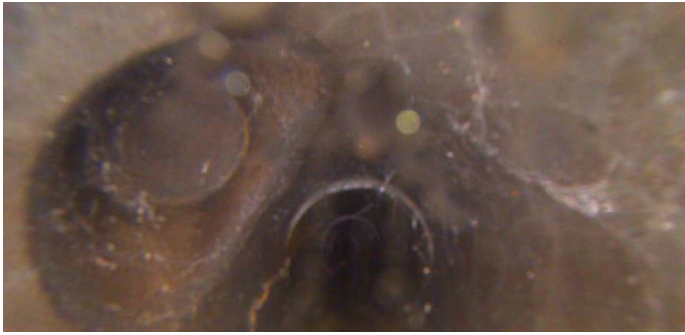
Code: **TFC**
Description: **Tap Factory Capped**

Distance (ft): **136.5**
Structural Grade: **0**
O&M Grade: **0**
Clock Start/From: **10**
Clock To:
1st Value: **4.000**
2nd Value:
Value Percent:
Continuous Index:
Within 8" of Joint:
Remarks:

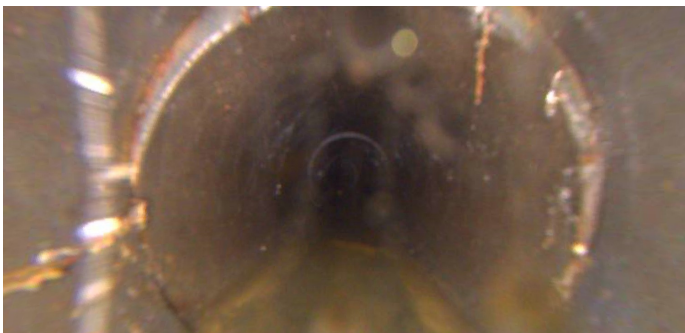
Code: **RFJ**
Description: **Roots Fine Joint**

Distance (ft): **137.4**
Structural Grade: **0**
O&M Grade: **1**
Clock Start/From: **8**
Clock To: **4**
1st Value:
2nd Value:
Value Percent:
Continuous Index:
Within 8" of Joint: **YES**
Remarks:

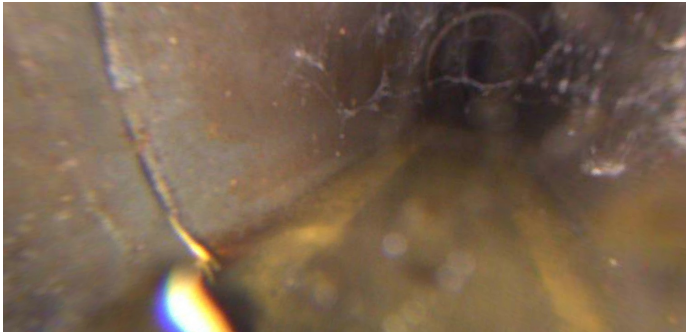
Code: **RFJ**
Description: **Roots Fine Joint**

Distance (ft): **151.9**
Structural Grade: **0**
O&M Grade: **1**
Clock Start/From: **8**
Clock To:
1st Value:
2nd Value:
Value Percent:
Continuous Index:
Within 8" of Joint: **YES**
Remarks:

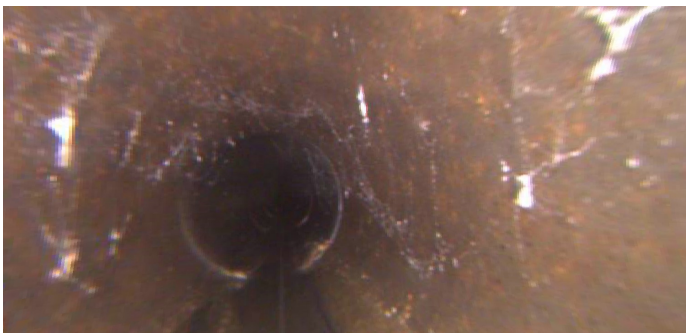
Code: **MGO**
Description: **General Observation**

Distance (ft): **159.6**
Structural Grade: **0**
O&M Grade: **0**
Clock Start/From:
Clock To:
1st Value:
2nd Value:
Value Percent:
Continuous Index:
Within 8" of Joint: **NO**
Remarks: **rear camera/cob webs**

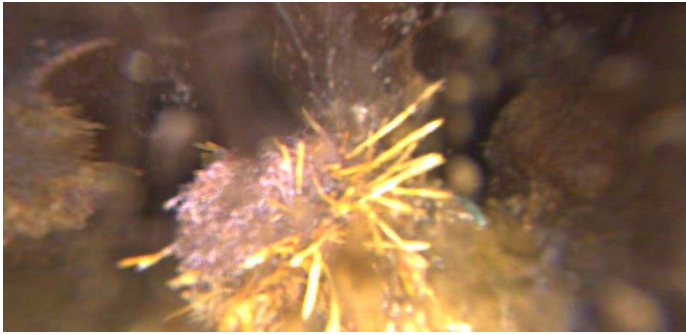
Code: **TFD**
Description: **Tap Factory Defective**

Distance (ft): **163.2**
Structural Grade: **0**
O&M Grade: **2**
Clock Start/From: **3**
Clock To:
1st Value: **4.000**
2nd Value:
Value Percent:
Continuous Index:
Within 8" of Joint:
Remarks: **roots**

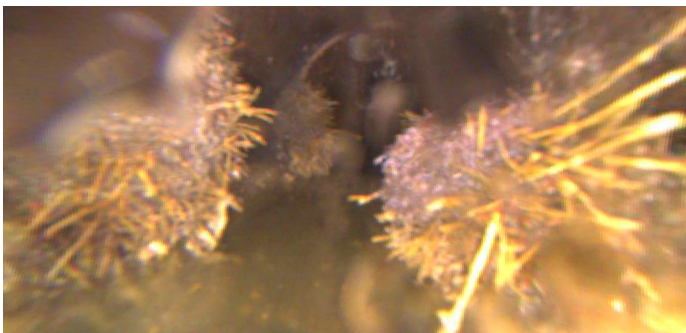
Code: **RMJ**
Description: **Roots Medium Joint**

Distance (ft): **163.2**
Structural Grade: **0**
O&M Grade: **3**
Clock Start/From: **7**
Clock To: **5**
1st Value:
2nd Value:
Value Percent: **25.000**
Continuous Index:
Within 8" of Joint: **YES**
Remarks:

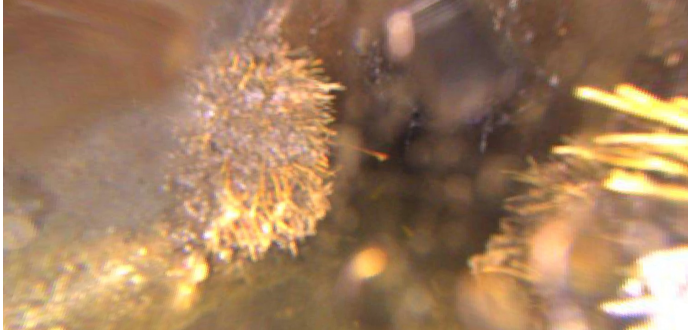
Code:	MSA
Description:	Abandoned Survey
Distance (ft):	163.9
Structural Grade:	0
O&M Grade:	0
Clock Start/From:	
Clock To:	
1st Value:	
2nd Value:	
Value Percent:	
Continuous Index:	
Within 8" of Joint:	NO
Remarks:	rmj
