## Profile/Photo Observation Report

Date:	03/03/2022	Weather:		Coding:	PACP 7.0
Pipe Length (ft):	235.0	Owner:	City of Hobart	Pre Clean:	Heavy Cleaning
P.O.#:	YES502259	Surveyor:	S. Bucklin	PSR:	P-706-049-018
Customer:	City of Hobart, IN (Red	Clean Date:	02/23/2022	Shape:	C

Street:	South Garfield Street	Flow Control:	Not Controlled
City:	Hobart, IN	Year Renewed:	
Location:	Local rural streets with light traffic, t	Tape/Media #:	
Purpose:	Routine Assessment	Dia/Height:	8"
Use:	Sanitary Sewage Pipe	Material:	VCP
Drain Area:		Lining:	None
Category:	NA		
Comment:			
Location Details:		Direction of Survey:	Downstream
US MH:	M-706-049	DS MH:	M-706-018
		Total Length Surveyed (ft):	233.5

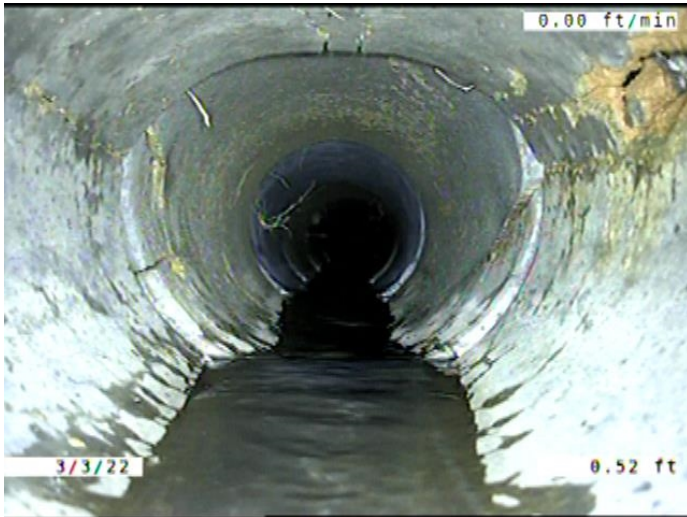
Code: **FM**  
 Description: **Fracture Multiple**

Distance (ft): **.5**  
 Structural Grade: **4**  
 O&M Grade: **0**  
 Clock Start/From: **12**  
 Clock To: **12**  
 1st Value:  
 2nd Value:  
 Value Percent:  
 Continuous Index: **S01**  
 Within 8" of Joint: **YES**  
 Remarks: **Wandering**

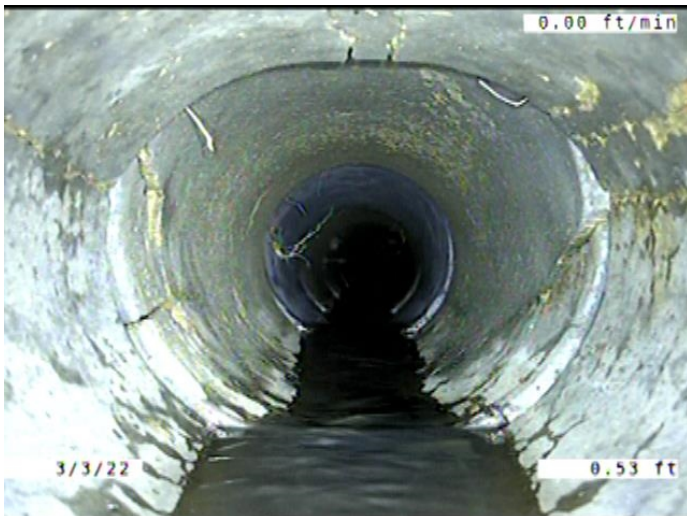
Code: **DR**  
 Description: **Deformed Rigid**

Distance (ft): **.5**  
 Structural Grade: **4**  
 O&M Grade: **0**  
 Clock Start/From:  
 Clock To:  
 1st Value:  
 2nd Value:  
 Value Percent: **5.000**  
 Continuous Index:  
 Within 8" of Joint: **NO**  
 Remarks:

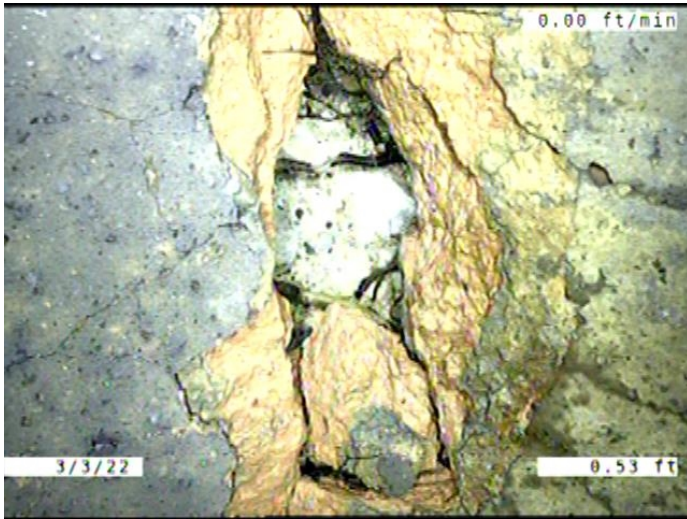
Code: **H**  
 Description: **Hole**

Distance (ft): **.5**  
 Structural Grade: **4**  
 O&M Grade: **0**  
 Clock Start/From: **2**  
 Clock To:  
 1st Value:  
 2nd Value:  
 Value Percent:  
 Continuous Index:  
 Within 8" of Joint: **YES**  
 Remarks:

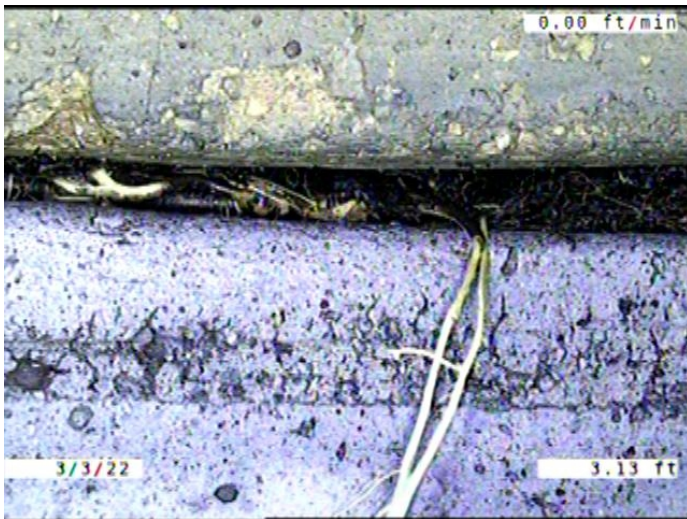
Code: **RFJ**  
 Description: **Roots Fine Joint**

Distance (ft): **3.1**  
 Structural Grade: **0**  
 O&M Grade: **1**  
 Clock Start/From: **8**  
 Clock To: **4**  
 1st Value:  
 2nd Value:  
 Value Percent:  
 Continuous Index: **S02**  
 Within 8" of Joint: **YES**  
 Remarks:

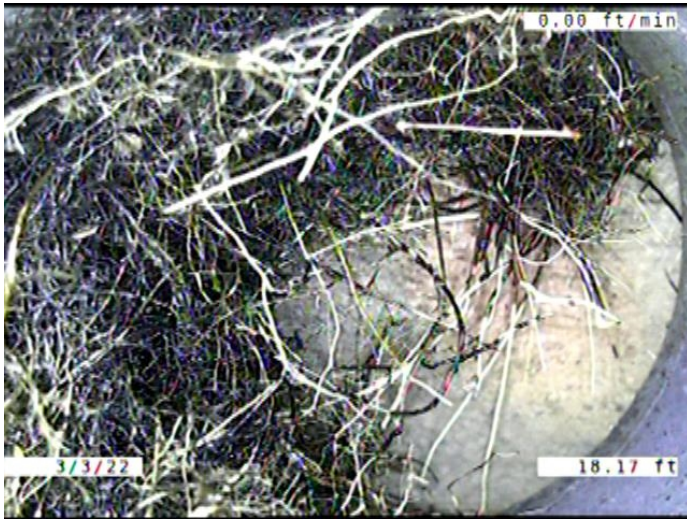
Code:	<b>TFC</b>
Description:	<b>Tap Factory Capped</b>
Distance (ft):	<b>18.2</b>
Structural Grade:	<b>0</b>
O&M Grade:	<b>0</b>
Clock Start/From:	<b>10</b>
Clock To:	
1st Value:	<b>4.000</b>
2nd Value:	
Value Percent:	
Continuous Index:	
Within 8" of Joint:	<b>YES</b>
Remarks:	<b>ROOTS GROWING AROUND THE CAP.</b>

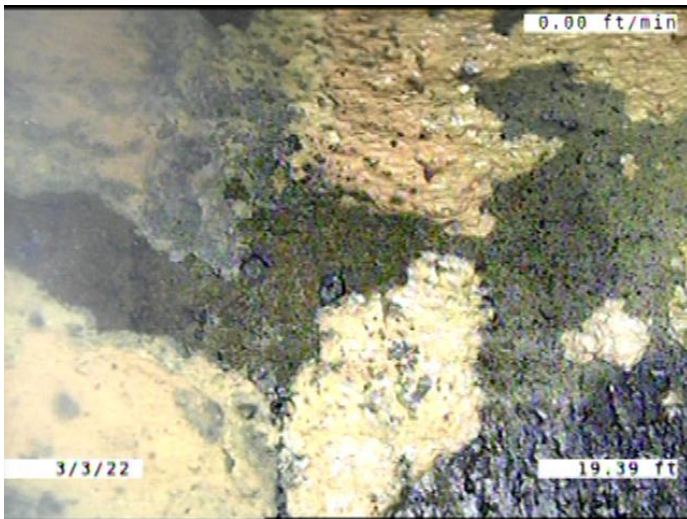
Code:	<b>SSS</b>
Description:	<b>Surface Damage Surface Spalling</b>
Distance (ft):	<b>19.4</b>
Structural Grade:	<b>2</b>
O&M Grade:	<b>0</b>
Clock Start/From:	<b>12</b>
Clock To:	<b>12</b>
1st Value:	
2nd Value:	
Value Percent:	
Continuous Index:	
Within 8" of Joint:	<b>YES</b>
Remarks:

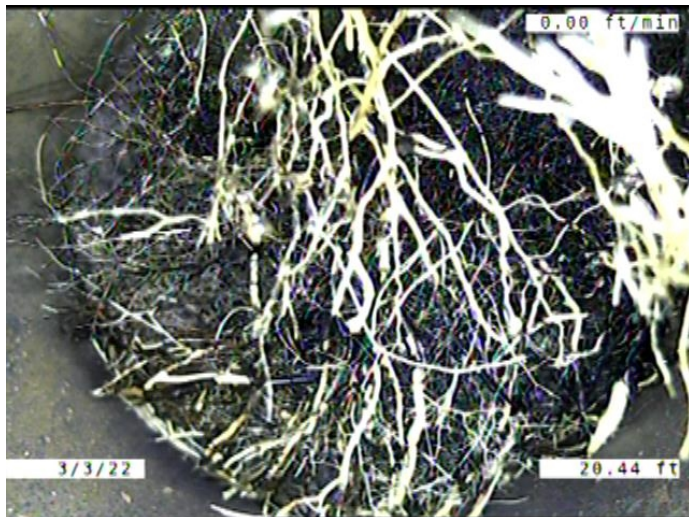
Code: **TF**  
 Description: **Tap Factory**

Distance (ft): **20.4**  
 Structural Grade: **0**  
 O&M Grade: **0**  
 Clock Start/From: **2**  
 Clock To:  
 1st Value: **4.000**  
 2nd Value:  
 Value Percent:  
 Continuous Index:  
 Within 8" of Joint: **YES**  
 Remarks: **95% PLUGGED WITH ROOTS.**

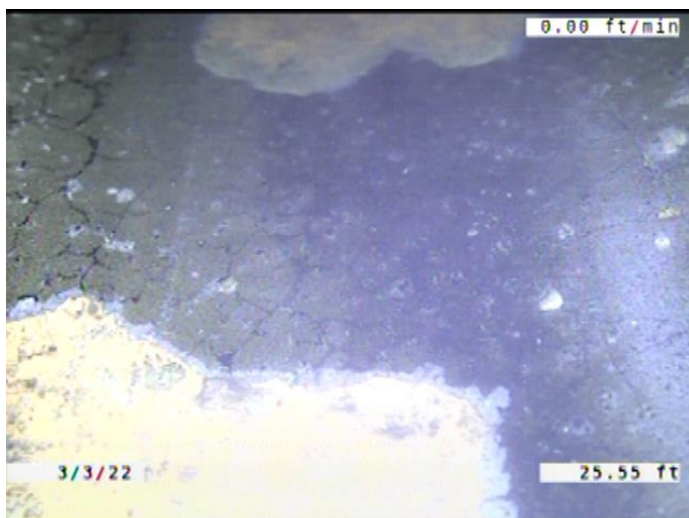
Code: **SSS**  
 Description: **Surface Damage Surface Spalling**

Distance (ft): **25.6**  
 Structural Grade: **2**  
 O&M Grade: **0**  
 Clock Start/From: **3**  
 Clock To: **8**  
 1st Value:  
 2nd Value:  
 Value Percent:  
 Continuous Index:  
 Within 8" of Joint: **YES**  
 Remarks:

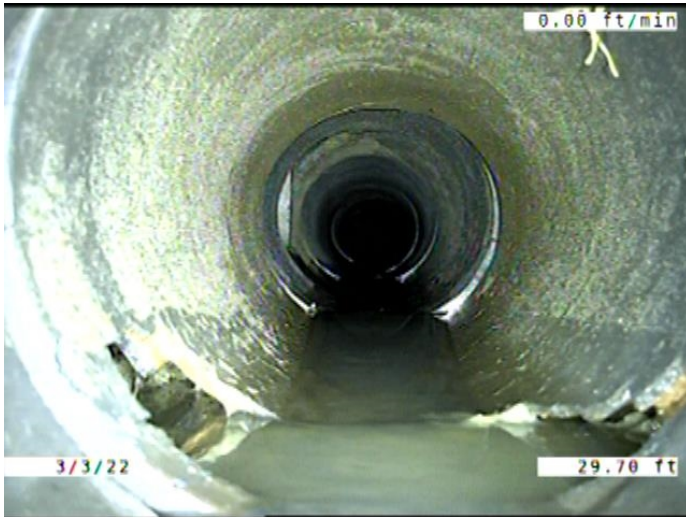
Code: **HVV**  
 Description: **Hole Void Visible**

Distance (ft): **29.7**  
 Structural Grade: **5**  
 O&M Grade: **0**  
 Clock Start/From: **4**  
 Clock To: **8**  
 1st Value:  
 2nd Value:  
 Value Percent:  
 Continuous Index:  
 Within 8" of Joint: **YES**  
 Remarks:

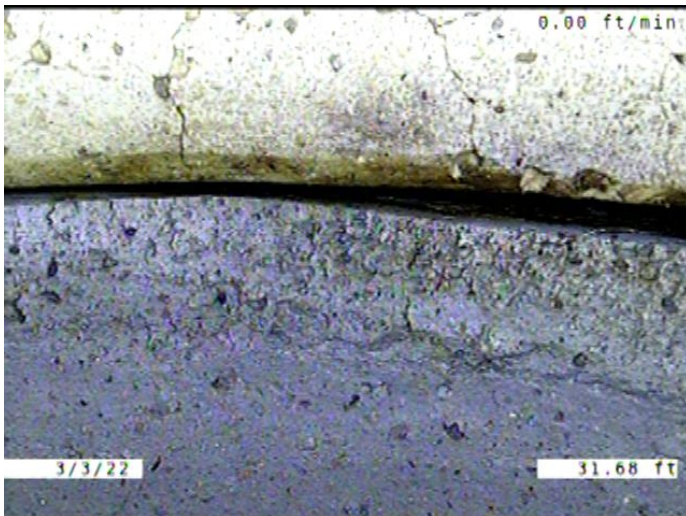
Code: **ISJ**  
 Description: **Infiltration Stain Joint**

Distance (ft): **31.7**  
 Structural Grade: **0**  
 O&M Grade: **1**  
 Clock Start/From: **1**  
 Clock To: **3**  
 1st Value:  
 2nd Value:  
 Value Percent:  
 Continuous Index:  
 Within 8" of Joint: **YES**  
 Remarks:

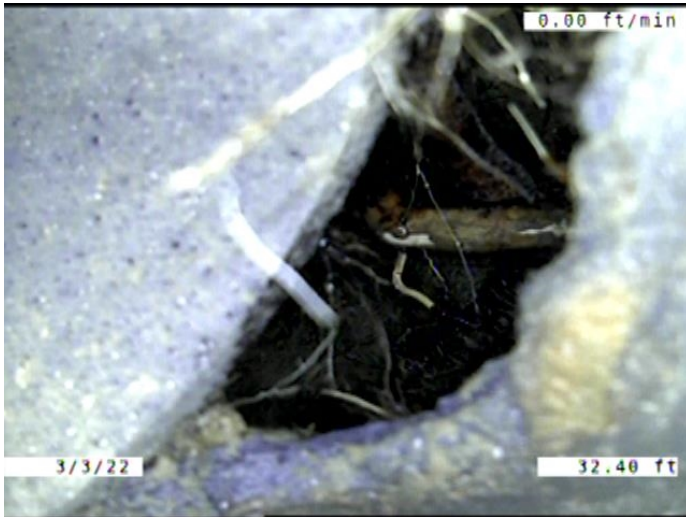
Code: **SSS**  
Description: **Surface Damage Surface Spalling**

Distance (ft): **32.4**  
Structural Grade: **2**  
O&M Grade: **0**  
Clock Start/From: **8**  
Clock To: **11**  
1st Value:  
2nd Value:  
Value Percent:  
Continuous Index:  
Within 8" of Joint: **YES**  
Remarks:

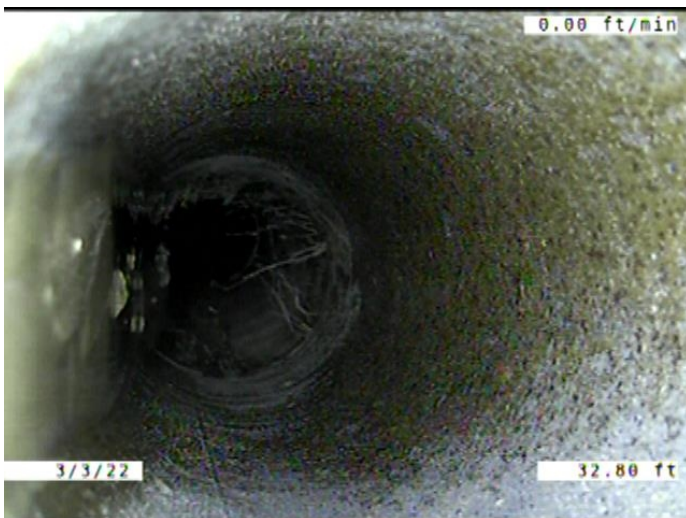
Code: **TBI**  
Description: **Tap Break-in Intruding**

Distance (ft): **32.8**  
Structural Grade: **0**  
O&M Grade: **2**  
Clock Start/From: **9**  
Clock To:  
1st Value: **6.000**  
2nd Value: **1.000**  
Value Percent:  
Continuous Index:  
Within 8" of Joint: **YES**  
Remarks:

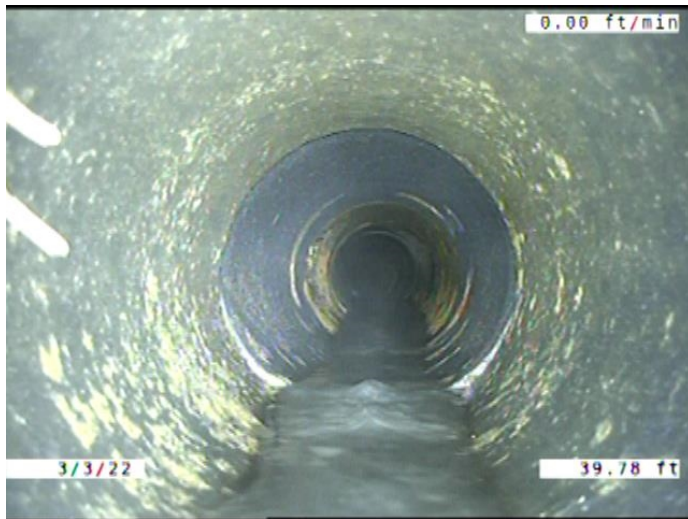
Code: **SSS**  
 Description: **Surface Damage Surface Spalling**

Distance (ft): **39.8**  
 Structural Grade: **2**  
 O&M Grade: **0**  
 Clock Start/From: **12**  
 Clock To: **12**  
 1st Value:  
 2nd Value:  
 Value Percent:  
 Continuous Index: **S03**  
 Within 8" of Joint: **YES**  
 Remarks:

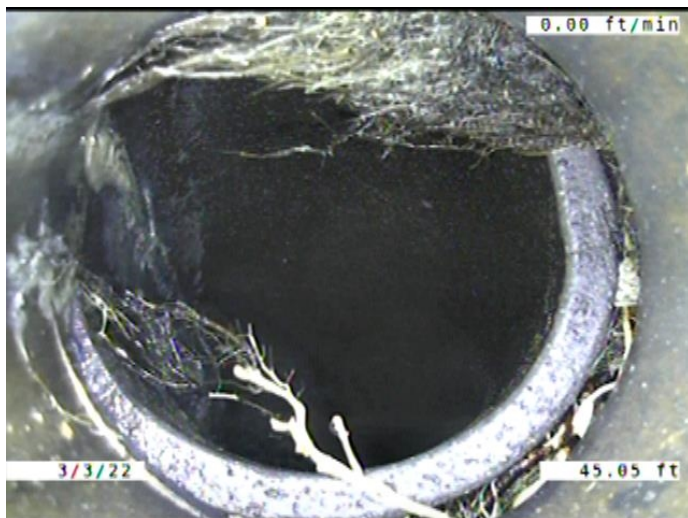
Code: **TFD**  
 Description: **Tap Factory Defective**

Distance (ft): **45.0**  
 Structural Grade: **0**  
 O&M Grade: **3**  
 Clock Start/From: **9**  
 Clock To:  
 1st Value: **4.000**  
 2nd Value:  
 Value Percent:  
 Continuous Index:  
 Within 8" of Joint: **YES**  
 Remarks: **BROKEN. ROOTS GROWING FROM THE SERVICE TO MAIN CONNECTION**

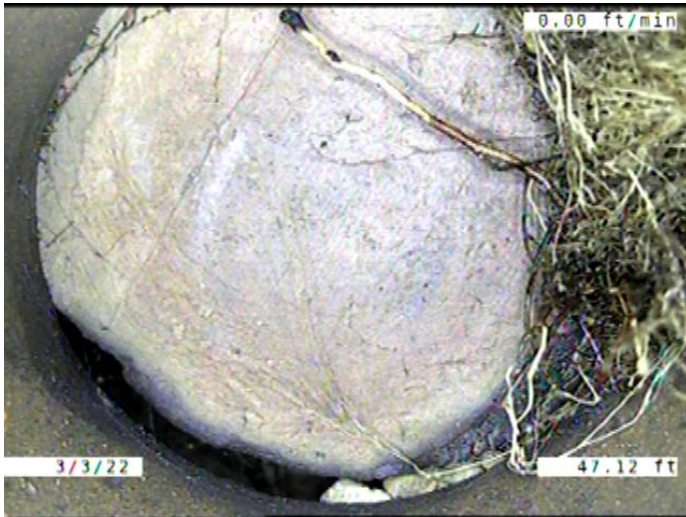
Code:	<b>TFD</b>
Description:	<b>Tap Factory Defective</b>
Distance (ft):	<b>47.1</b>
Structural Grade:	<b>0</b>
O&M Grade:	<b>3</b>
Clock Start/From:	<b>2</b>
Clock To:	
1st Value:	<b>4.000</b>
2nd Value:	
Value Percent:	
Continuous Index:	
Within 8" of Joint:	<b>YES</b>
Remarks:	<b>CAPPED. CAP BROKEN,. SOIL VISIBLE. ROOTS GROWING AROUND</b>

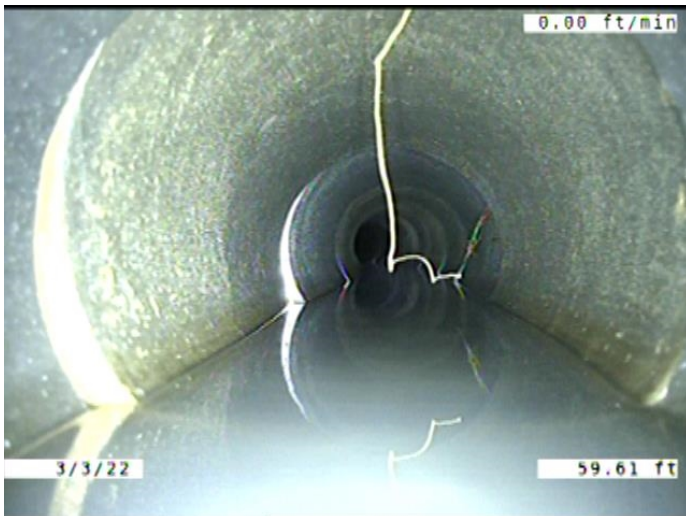
Code:	<b>MWLS</b>
Description:	<b>Miscellaneous Water Level Sag</b>
Distance (ft):	<b>59.6</b>
Structural Grade:	<b>2</b>
O&M Grade:	<b>0</b>
Clock Start/From:	
Clock To:	
1st Value:	
2nd Value:	
Value Percent:	<b>10.000</b>
Continuous Index:	<b>S04</b>
Within 8" of Joint:	<b>NO</b>
Remarks:

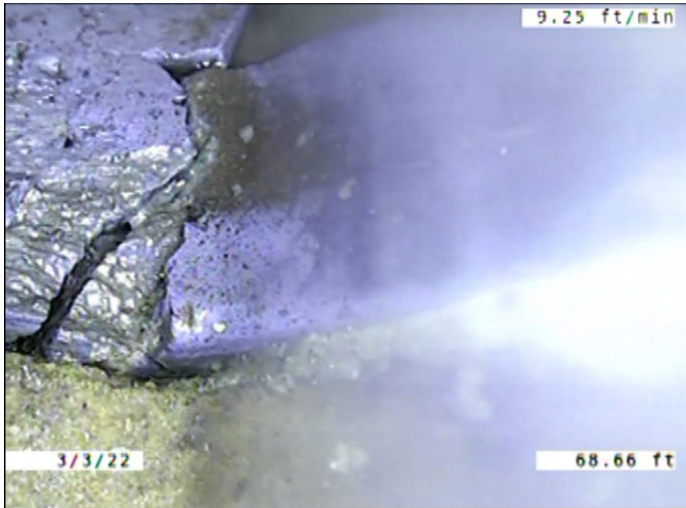
Code: **B**  
Description: **Broken**

Distance (ft): **68.7**  
Structural Grade: **4**  
O&M Grade: **0**  
Clock Start/From: **6**  
Clock To: **7**  
1st Value:  
2nd Value:  
Value Percent:  
Continuous Index:  
Within 8" of Joint: **YES**  
Remarks:

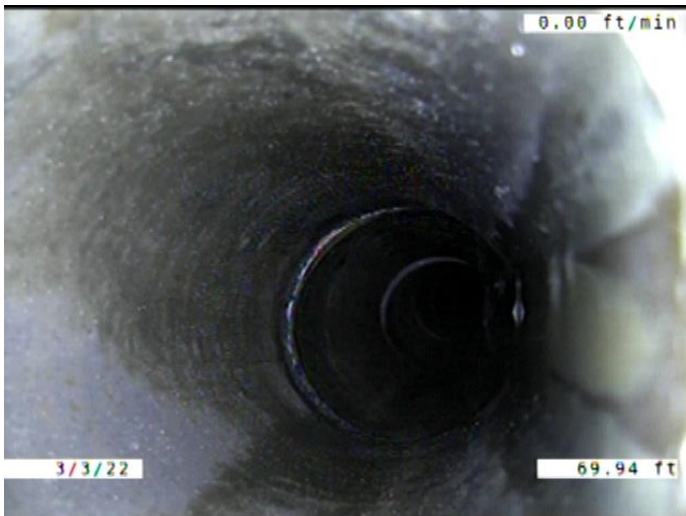
Code: **TBI**  
Description: **Tap Break-in Intruding**

Distance (ft): **69.9**  
Structural Grade: **0**  
O&M Grade: **2**  
Clock Start/From: **3**  
Clock To:  
1st Value: **6.000**  
2nd Value: **1.000**  
Value Percent:  
Continuous Index:  
Within 8" of Joint: **YES**  
Remarks:

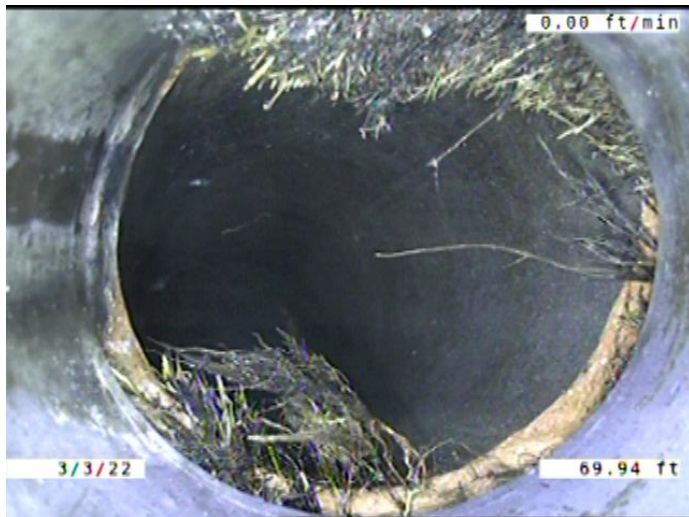
Code: **TF**  
 Description: **Tap Factory**

Distance (ft): **69.9**  
 Structural Grade: **0**  
 O&M Grade: **0**  
 Clock Start/From: **10**  
 Clock To:  
 1st Value: **4.000**

2nd Value:  
 Value Percent:  
 Continuous Index:  
 Within 8" of Joint: **YES**  
 Remarks: **ROOTS GROWING FROM THE SERVICE TO MAIN CONNECTION**

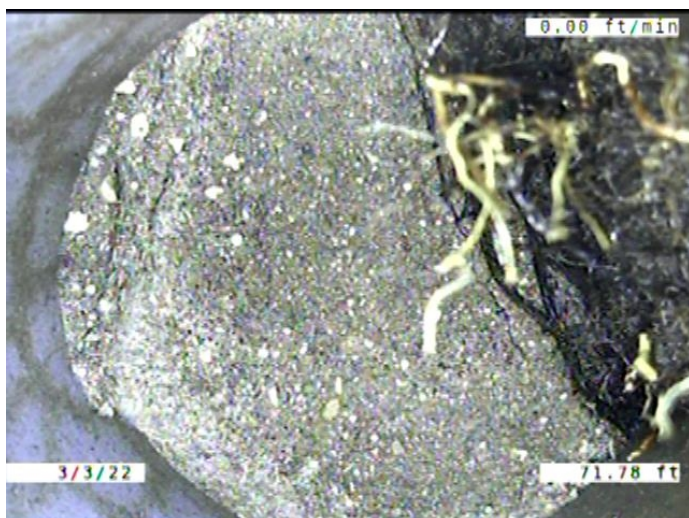
Code: **TFC**  
 Description: **Tap Factory Capped**

Distance (ft): **71.8**  
 Structural Grade: **0**  
 O&M Grade: **0**  
 Clock Start/From: **2**  
 Clock To:  
 1st Value: **4.000**

2nd Value:  
 Value Percent:  
 Continuous Index:  
 Within 8" of Joint: **YES**  
 Remarks: **CAP CRACKED. ROOTS GROWING AROUND THE CAP.**

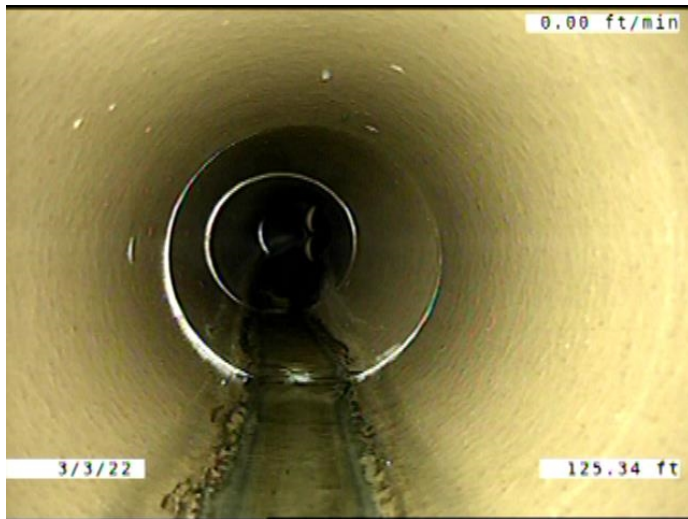
Code: **FM**  
Description: **Fracture Multiple**

Distance (ft): **125.3**  
Structural Grade: **4**  
O&M Grade: **0**  
Clock Start/From: **12**  
Clock To: **12**  
1st Value:  
2nd Value:  
Value Percent:  
Continuous Index: **F01**  
Within 8" of Joint: **YES**  
Remarks: **Wandering**

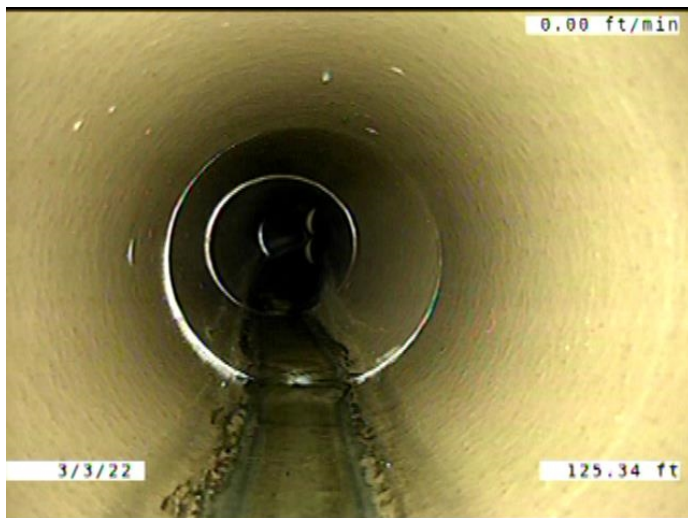
Code: **RFJ**  
Description: **Roots Fine Joint**

Distance (ft): **125.3**  
Structural Grade: **0**  
O&M Grade: **1**  
Clock Start/From: **8**  
Clock To: **4**  
1st Value:  
2nd Value:  
Value Percent:  
Continuous Index: **F02**  
Within 8" of Joint: **YES**  
Remarks:

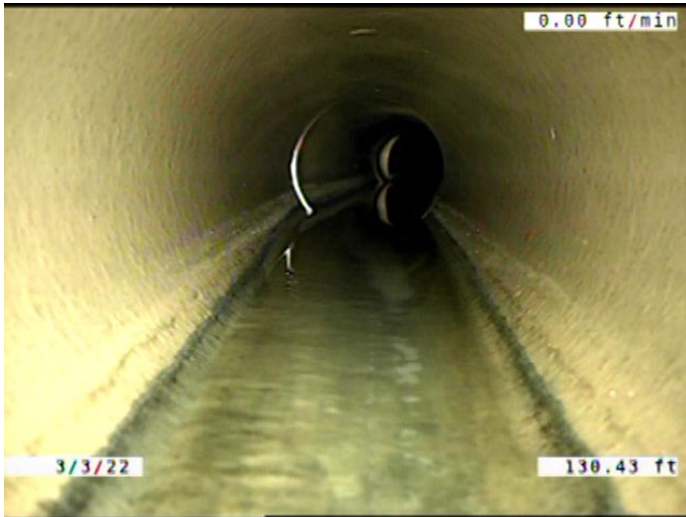
Code: **MWLS**  
Description: **Miscellaneous Water Level Sag**

Distance (ft): **130.4**  
Structural Grade: **2**  
O&M Grade: **0**  
Clock Start/From:  
Clock To:  
1st Value:  
2nd Value:  
Value Percent: **10.000**  
Continuous Index: **S05**  
Within 8" of Joint: **NO**  
Remarks:

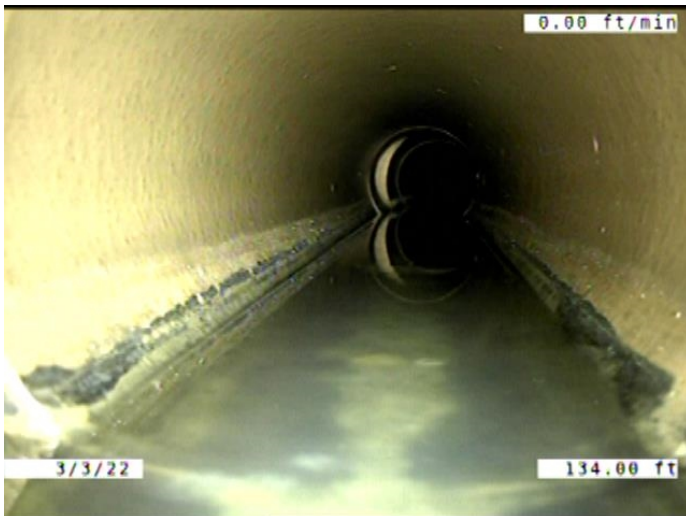
Code: **LR**  
Description: **Line Right**

Distance (ft): **134.0**  
Structural Grade: **0**  
O&M Grade: **1**  
Clock Start/From:  
Clock To:  
1st Value:  
2nd Value:  
Value Percent: **5.000**  
Continuous Index:  
Within 8" of Joint: **NO**  
Remarks:

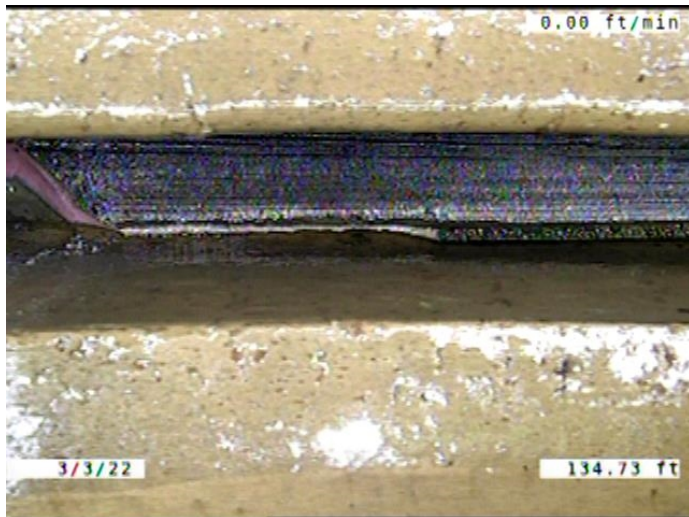
Code: **JAM**  
 Description: **Joint Angular Medium**

Distance (ft): **134.7**  
 Structural Grade: **3**  
 O&M Grade: **0**  
 Clock Start/From:  
 Clock To:  
 1st Value:  
 2nd Value:  
 Value Percent:  
 Continuous Index:  
 Within 8" of Joint: **NO**  
 Remarks:

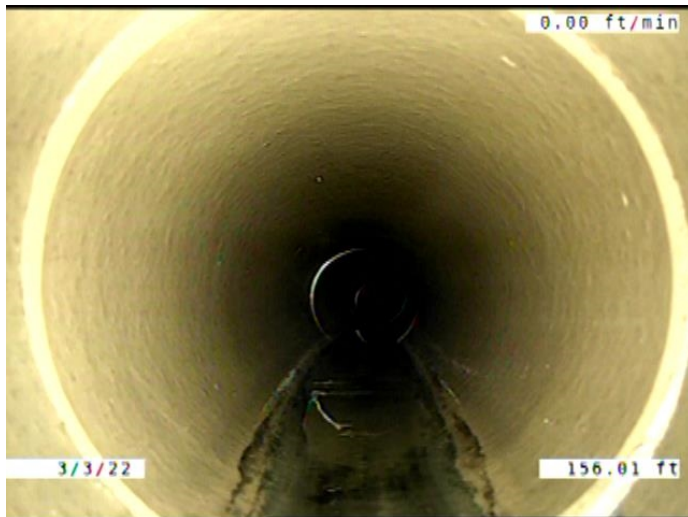
Code: **MWLS**  
Description: **Miscellaneous Water Level Sag**

Distance (ft): **156.0**  
Structural Grade: **2**  
O&M Grade: **0**  
Clock Start/From:  
Clock To:  
1st Value:  
2nd Value:  
Value Percent: **10.000**  
Continuous Index: **F05**  
Within 8" of Joint: **NO**  
Remarks:

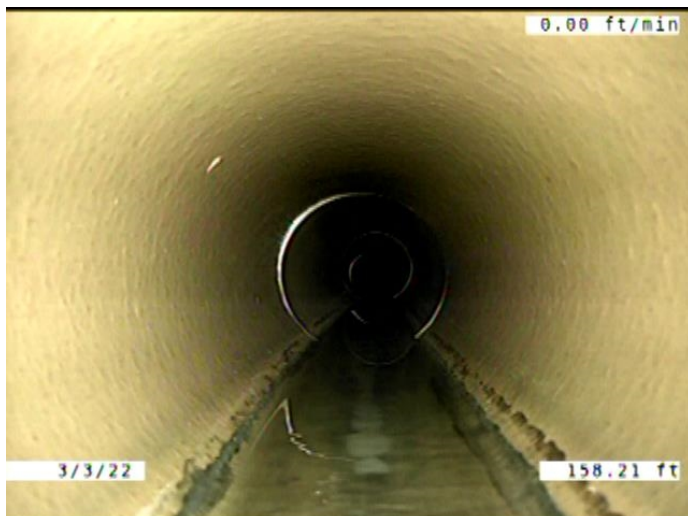
Code: **MWLS**  
Description: **Miscellaneous Water Level Sag**

Distance (ft): **158.2**  
Structural Grade: **2**  
O&M Grade: **0**  
Clock Start/From:  
Clock To:  
1st Value:  
2nd Value:  
Value Percent: **5.000**  
Continuous Index: **S06**  
Within 8" of Joint: **NO**  
Remarks:

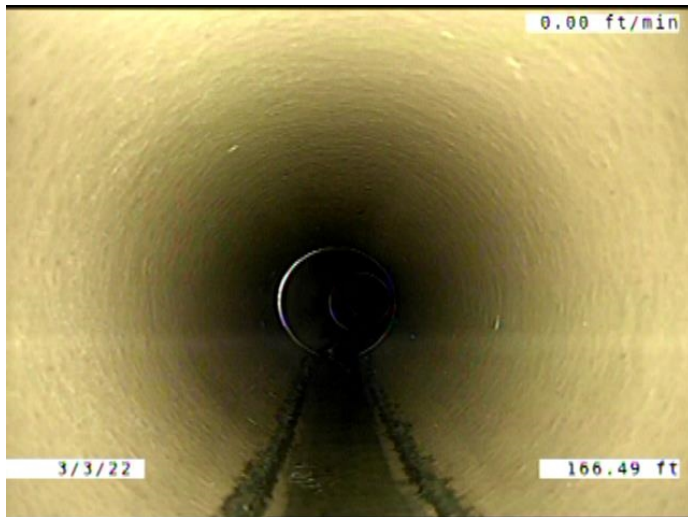
Code: **MWLS**  
 Description: **Miscellaneous Water Level Sag**

Distance (ft): **166.5**  
 Structural Grade: **2**  
 O&M Grade: **0**  
 Clock Start/From:  
 Clock To:  
 1st Value:  
 2nd Value:  
 Value Percent: **5.000**  
 Continuous Index: **F06**  
 Within 8" of Joint: **NO**  
 Remarks:

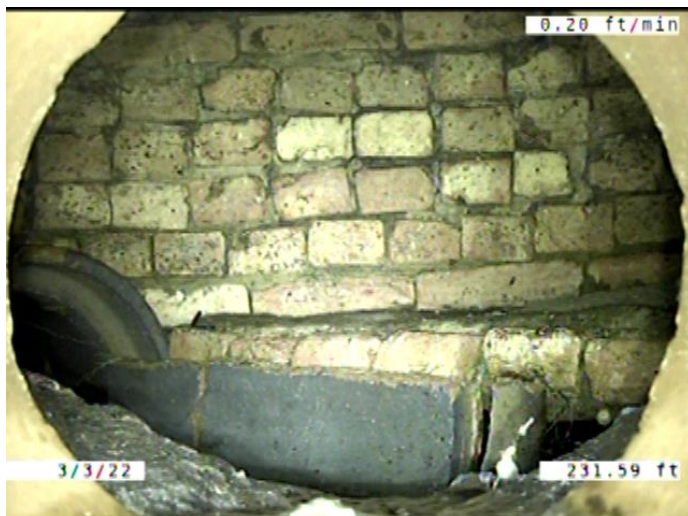
Code: **SSS**  
 Description: **Surface Damage Surface Spalling**

Distance (ft): **231.6**  
 Structural Grade: **2**  
 O&M Grade: **0**  
 Clock Start/From: **12**  
 Clock To: **12**  
 1st Value:  
 2nd Value:  
 Value Percent:  
 Continuous Index: **F03**  
 Within 8" of Joint: **YES**  
 Remarks:
