## Profile/Photo Observation Report

Street:	<b>Capitol</b>	Flow Control:	<b>Not Controlled</b>
City:	<b>Hobart, IN</b>	Year Renewed:	
Location:	<b>Light Highway</b>	Tape/Media #:	
Purpose:	<b>Maintenance Related</b>	Dia/Height:	<b>8"</b>
Use:	<b>Sanitary</b>	Material:	<b>PVC</b>
Drain Area:	<b>NA</b>	Lining:	<b>Cured in Place</b>
Category:	<b>NA</b>		
Comment:	<b>mh confirmed at 113'.</b>

Location Details:		Direction of Survey:	<b>Upstream</b>
US MH:	<b>M-706-050</b>	DS MH:	<b>M-706-051</b>
		Total Length Surveyed (ft):	<b>114.4</b>

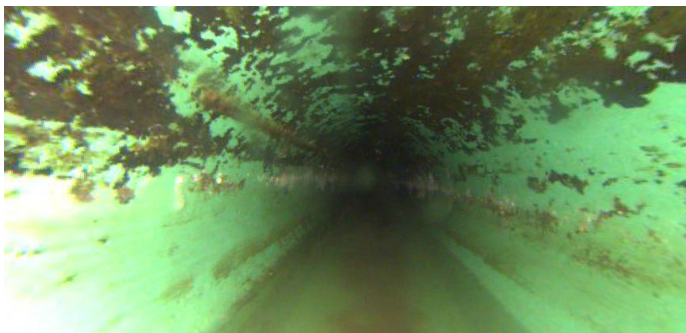
Code: **AMH**  
Description: **Manhole**

Distance (ft): **.0**  
Structural Grade: **0**  
O&M Grade: **0**  
Clock Start/From:  
Clock To:  
1st Value:  
2nd Value:  
Value Percent:  
Continuous Index:  
Within 8" of Joint: **NO**  
Remarks: **M-706-051**

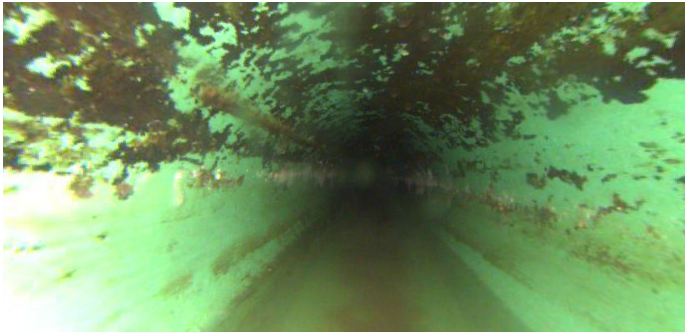
Code:	<b>MWL</b>
Description:	<b>Water Level</b>

Distance (ft):	<b>.0</b>
Structural Grade:	<b>0</b>
O&M Grade:	<b>0</b>
Clock Start/From:	
Clock To:	
1st Value:	
2nd Value:	
Value Percent:	<b>10.000</b>
Continuous Index:	
Within 8" of Joint:	<b>NO</b>
Remarks:

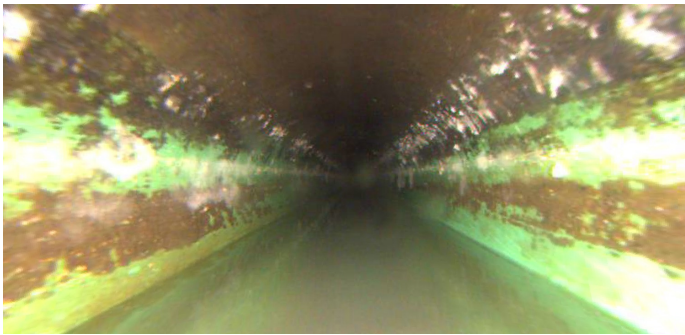
Code:	<b>DAGS</b>
Description:	<b>Deposits Attached Grease</b>

Distance (ft):	<b>6.8</b>
Structural Grade:	<b>0</b>
O&M Grade:	<b>2</b>
Clock Start/From:	<b>8</b>
Clock To:	<b>4</b>
1st Value:	
2nd Value:	
Value Percent:	<b>5.000</b>
Continuous Index:	<b>S01</b>
Within 8" of Joint:	<b>NO</b>
Remarks:

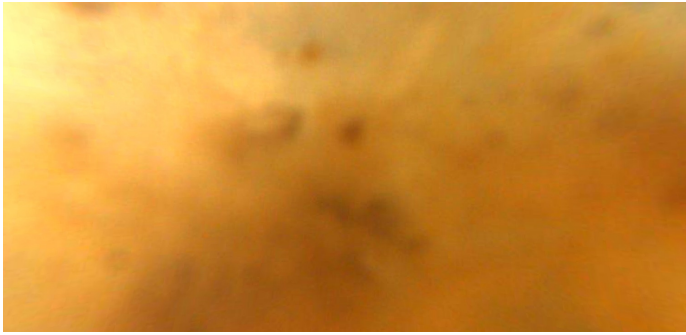
Code: **DAGS**  
Description: **Deposits Attached Grease**

Distance (ft): **72.7**  
Structural Grade: **0**  
O&M Grade: **2**  
Clock Start/From: **8**  
Clock To: **4**  
1st Value:  
2nd Value:  
Value Percent: **5.000**  
Continuous Index: **F01**  
Within 8" of Joint: **NO**  
Remarks:

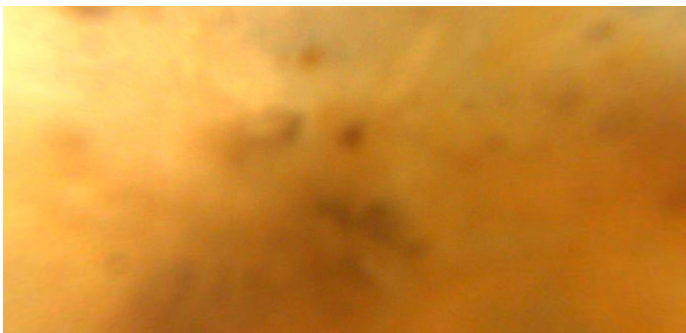
Code: **MWL**  
Description: **Water Level**

Distance (ft): **72.7**  
Structural Grade: **0**  
O&M Grade: **0**  
Clock Start/From:  
Clock To:  
1st Value:  
2nd Value:  
Value Percent: **100.000**  
Continuous Index:  
Within 8" of Joint: **NO**  
Remarks:

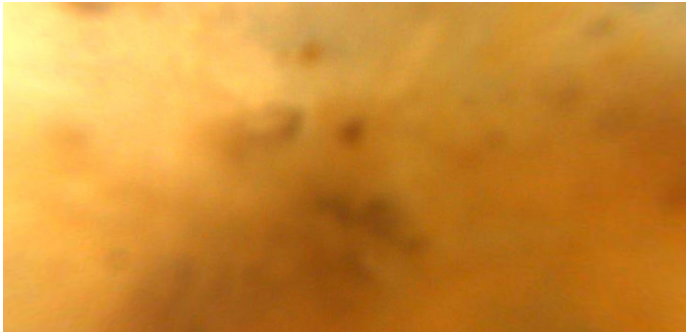
Code: **MCU**  
Description: **Camera Underwater**

Distance (ft): **72.7**  
Structural Grade: **0**  
O&M Grade: **4**  
Clock Start/From:  
Clock To:  
1st Value:  
2nd Value:  
Value Percent:  
Continuous Index: **S02**  
Within 8" of Joint: **NO**  
Remarks:

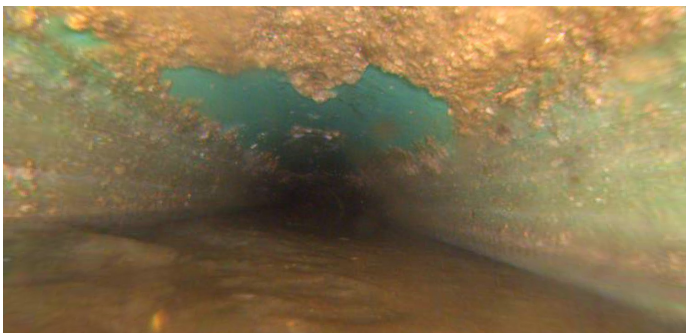
Code: **MGO**  
Description: **General Observation**

Distance (ft): **81.3**  
Structural Grade: **0**  
O&M Grade: **0**  
Clock Start/From:  
Clock To:  
1st Value:  
2nd Value:  
Value Percent:  
Continuous Index:  
Within 8" of Joint: **NO**  
Remarks: **rear camera**

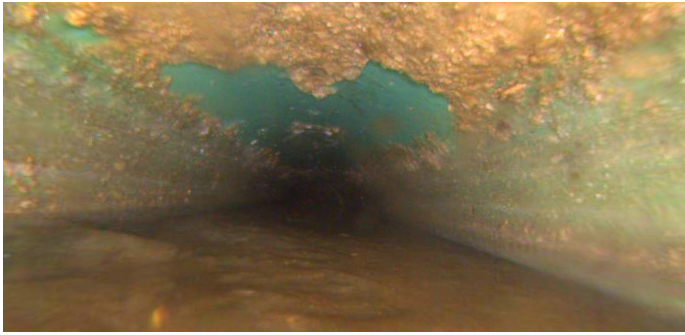
Code: **MCU**  
Description: **Camera Underwater**

Distance (ft): **81.3**  
Structural Grade: **0**  
O&M Grade: **4**  
Clock Start/From:  
Clock To:  
1st Value:  
2nd Value:  
Value Percent:  
Continuous Index: **F02**  
Within 8" of Joint: **NO**  
Remarks:

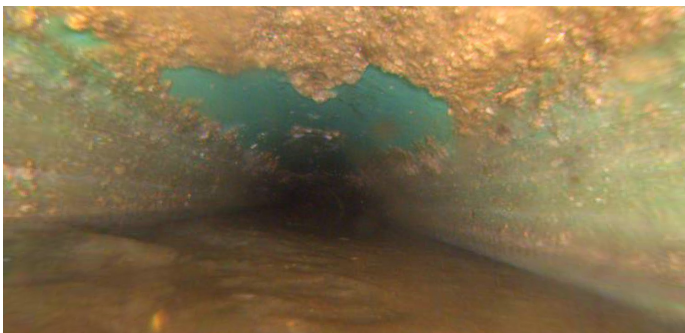
Code: **DAGS**  
Description: **Deposits Attached Grease**

Distance (ft): **81.3**  
Structural Grade: **0**  
O&M Grade: **2**  
Clock Start/From: **8**  
Clock To: **4**  
1st Value:  
2nd Value:  
Value Percent: **5.000**  
Continuous Index: **S03**  
Within 8" of Joint: **NO**  
Remarks:

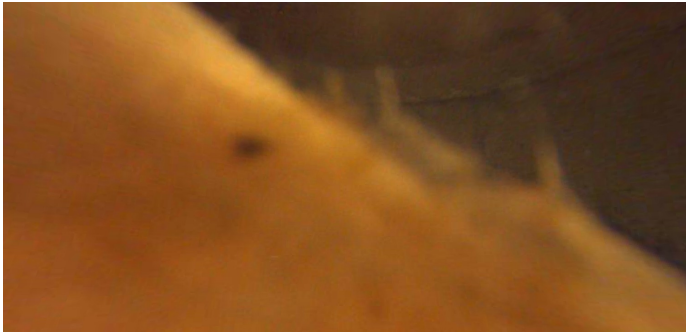
Code: **DAGS**  
Description: **Deposits Attached Grease**

Distance (ft): **114.4**  
Structural Grade: **0**  
O&M Grade: **2**  
Clock Start/From: **8**  
Clock To: **4**  
1st Value:  
2nd Value:  
Value Percent: **5.000**  
Continuous Index: **F03**  
Within 8" of Joint: **NO**  
Remarks:

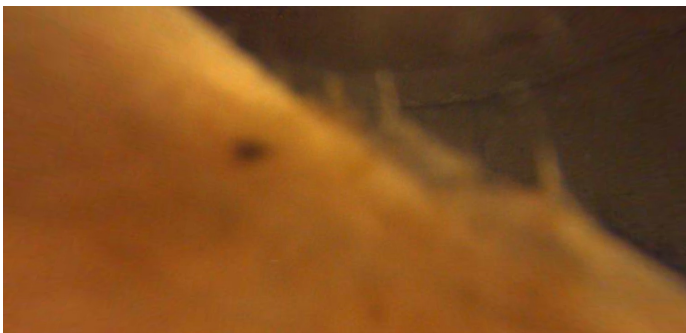
Code: **AMH**  
Description: **Manhole**

Distance (ft): **114.4**  
Structural Grade: **0**  
O&M Grade: **0**  
Clock Start/From:  
Clock To:  
1st Value:  
2nd Value:  
Value Percent:  
Continuous Index:  
Within 8" of Joint: **NO**  
Remarks: **M-706-050**
