## Profile/Photo Observation Report

Date:	<b>02/12/2022</b>	Weather:		Coding:	<b>PACP 7.0</b>
Pipe Length (ft):	<b>254.4</b>	Owner:	<b>City of Hobart</b>	Pre Clean:	<b>Heavy Cleaning</b>
P.O.#:	<b>YES502259</b>	Surveyor:	<b>S. Bucklin</b>	PSR:	<b>P-706-051-052</b>
Customer:	<b>City of Hobart</b>	Clean Date:	<b>02/11/2022</b>	Shape:	<b>C</b>

Street:	<b>Beacon Drive</b>	Flow Control:	<b>Not Controlled</b>
City:	<b>Hobart, IN</b>	Year Renewed:	
Location:	<b>Local rural streets with light traffic, t</b>	Tape/Media #:	
Purpose:	<b>Routine Assessment</b>	Dia/Height:	<b>8"</b>
Use:	<b>Sanitary Sewage Pipe</b>	Material:	<b>PVC</b>
Drain Area:		Lining:	<b>None</b>
Category:	<b>NA</b>		
Comment:			
Location Details:		Direction of Survey:	<b>Downstream</b>
US MH:	<b>M-706-051</b>	DS MH:	<b>M-706-052</b>
		Total Length Surveyed (ft):	<b>254.4</b>

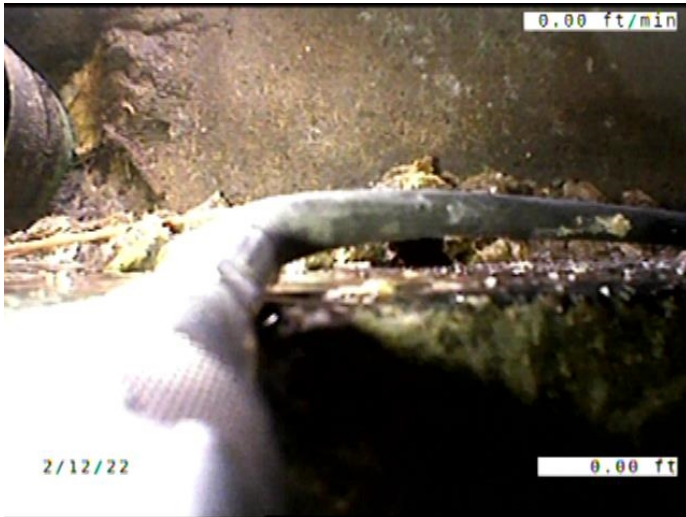
Code: **AMH**  
Description: **Manhole**

Distance (ft): **.0**  
Structural Grade: **0**  
O&M Grade: **0**  
Clock Start/From:  
Clock To:  
1st Value:  
2nd Value:  
Value Percent:  
Continuous Index:  
Within 8" of Joint: **NO**  
Remarks: **M-706-051**

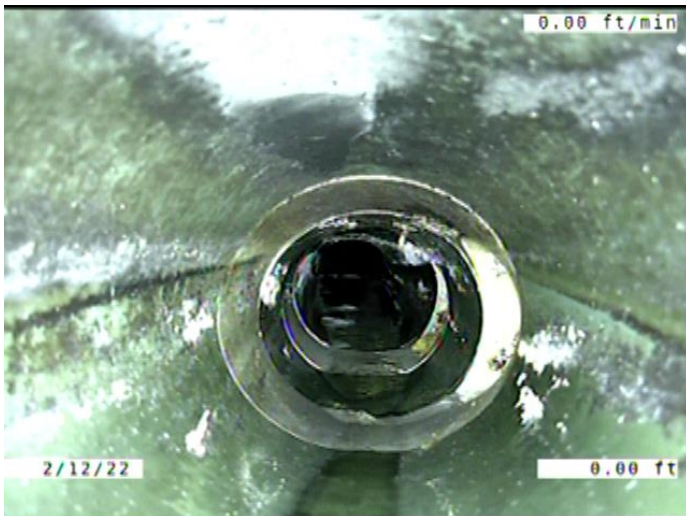
Code: **MWL**  
Description: **Miscellaneous Water Level**

Distance (ft): **.0**  
Structural Grade: **0**  
O&M Grade: **0**  
Clock Start/From:  
Clock To:  
1st Value:  
2nd Value:  
Value Percent: **5.000**  
Continuous Index:  
Within 8" of Joint: **NO**  
Remarks:

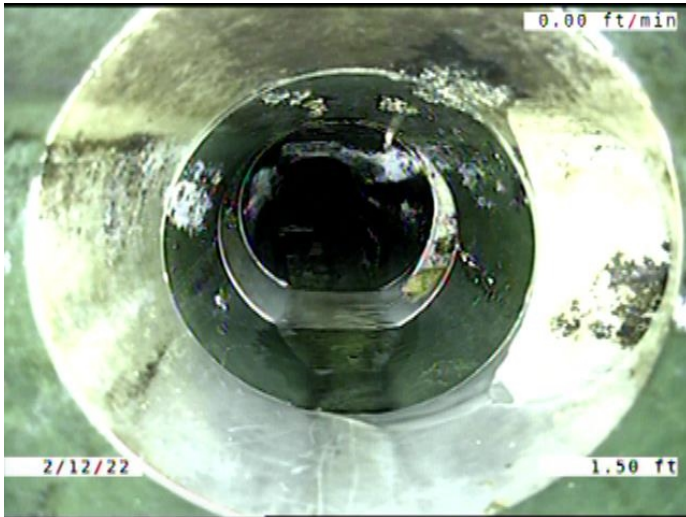
Code: **MGO**  
 Description: **Miscellaneous General Observation**

Distance (ft): **1.5**  
 Structural Grade: **0**  
 O&M Grade: **0**  
 Clock Start/From:  
 Clock To:  
 1st Value:  
 2nd Value:  
 Value Percent:  
 Continuous Index:  
 Within 8" of Joint: **NO**  
 Remarks: **TIGHT ACCESS IN THE MANHOLE. HAD TO START IN THE PIPE.**

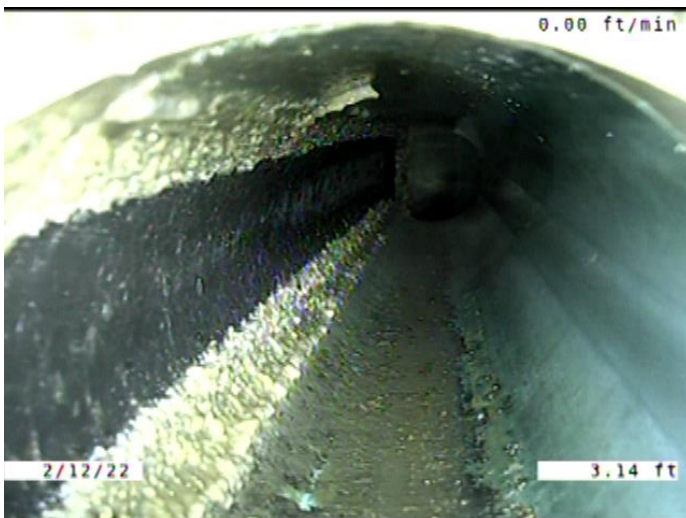
Code: **TFA**  
 Description: **Tap Factory Activity**

Distance (ft): **3.1**  
 Structural Grade: **0**  
 O&M Grade: **0**  
 Clock Start/From: **3**  
 Clock To:  
 1st Value: **4.000**  
 2nd Value:  
 Value Percent:  
 Continuous Index:  
 Within 8" of Joint: **YES**  
 Remarks:

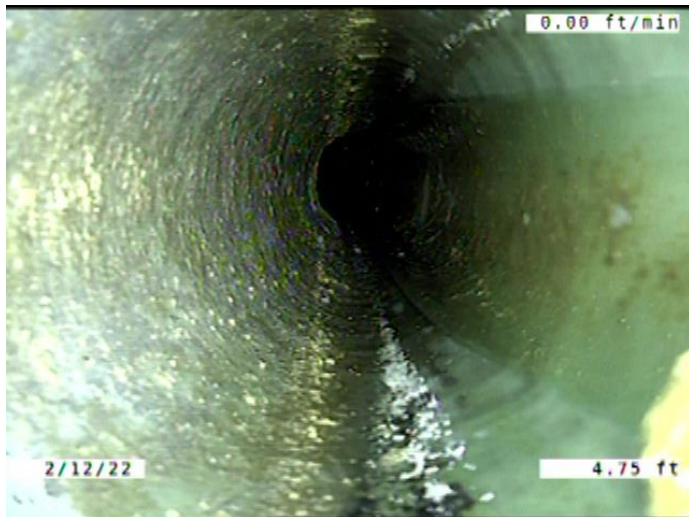
Code: **TF**  
 Description: **Tap Factory**

Distance (ft): **4.7**  
 Structural Grade: **0**  
 O&M Grade: **0**  
 Clock Start/From: **3**  
 Clock To:  
 1st Value: **4.000**  
 2nd Value:  
 Value Percent:  
 Continuous Index:  
 Within 8" of Joint: **YES**  
 Remarks:

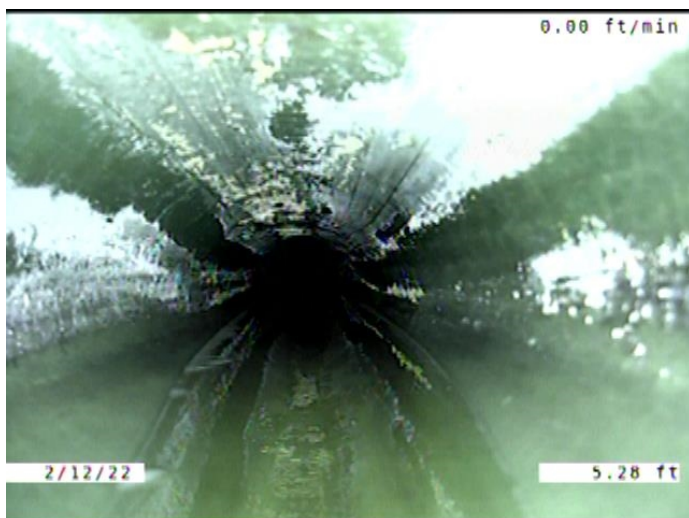
Code: **MWLS**  
 Description: **Miscellaneous Water Level Sag**

Distance (ft): **5.3**  
 Structural Grade: **2**  
 O&M Grade: **0**  
 Clock Start/From:  
 Clock To:  
 1st Value:  
 2nd Value:  
 Value Percent: **15.000**  
 Continuous Index: **S01**  
 Within 8" of Joint: **NO**  
 Remarks:

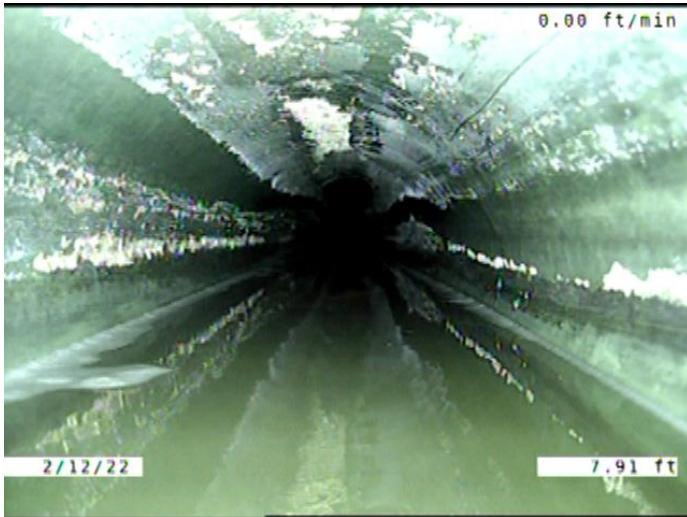
Code: **DAGS**  
 Description: **Deposits Attached Grease**

Distance (ft): **7.9**  
 Structural Grade: **0**  
 O&M Grade: **2**  
 Clock Start/From: **9**  
 Clock To: **3**  
 1st Value:  
 2nd Value:  
 Value Percent: **5.000**  
 Continuous Index: **S02**  
 Within 8" of Joint: **YES**  
 Remarks:

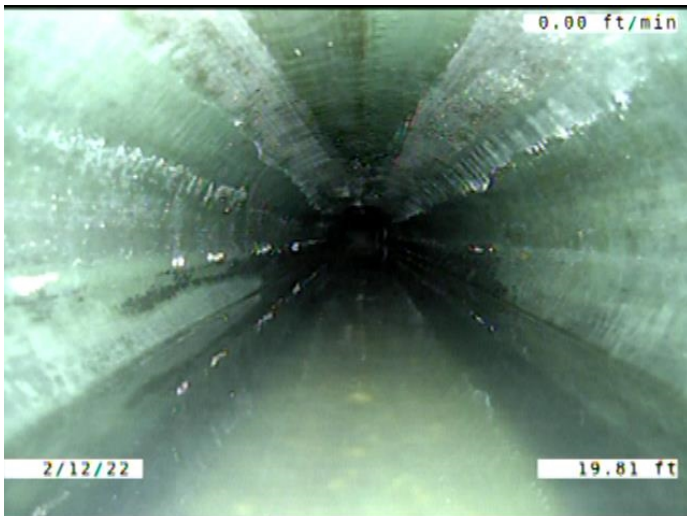
Code: **DAGS**  
 Description: **Deposits Attached Grease**

Distance (ft): **19.8**  
 Structural Grade: **0**  
 O&M Grade: **2**  
 Clock Start/From: **9**  
 Clock To: **3**  
 1st Value:  
 2nd Value:  
 Value Percent: **5.000**  
 Continuous Index: **F02**  
 Within 8" of Joint: **YES**  
 Remarks:

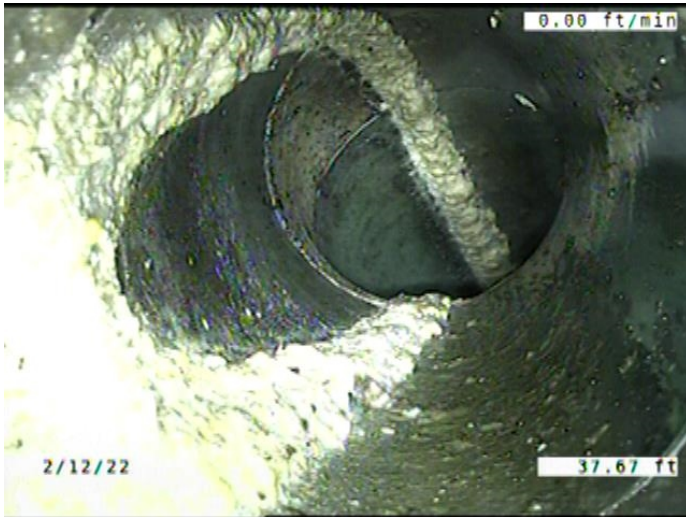
Code: **TF**  
Description: **Tap Factory**

Distance (ft): **37.7**  
Structural Grade: **0**  
O&M Grade: **0**  
Clock Start/From: **2**  
Clock To:  
1st Value: **4.000**  
2nd Value:  
Value Percent:  
Continuous Index:  
Within 8" of Joint: **YES**  
Remarks:

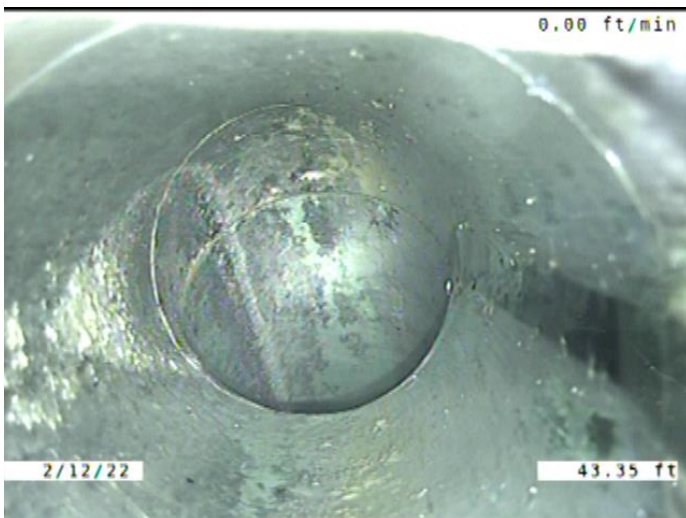
Code: **TF**  
Description: **Tap Factory**

Distance (ft): **43.3**  
Structural Grade: **0**  
O&M Grade: **0**  
Clock Start/From: **3**  
Clock To:  
1st Value: **4.000**  
2nd Value:  
Value Percent:  
Continuous Index:  
Within 8" of Joint: **YES**  
Remarks:

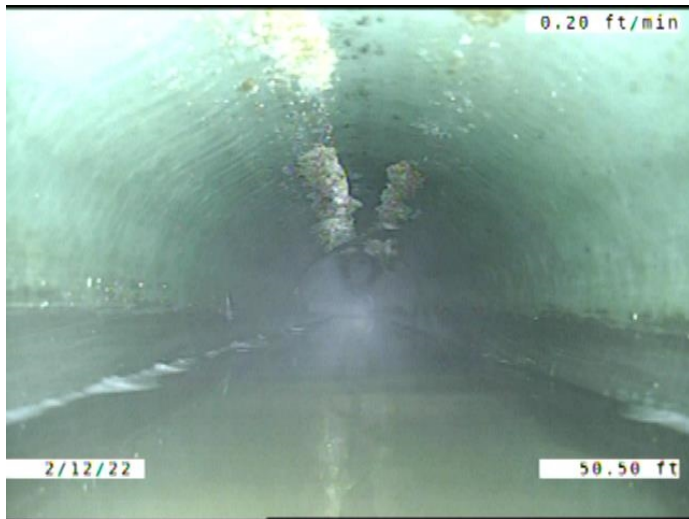
Code: **DAGS**  
 Description: **Deposits Attached Grease**

Distance (ft): **50.5**  
 Structural Grade: **0**  
 O&M Grade: **2**  
 Clock Start/From: **11**  
 Clock To: **1**  
 1st Value:  
 2nd Value:  
 Value Percent: **5.000**  
 Continuous Index: **S03**  
 Within 8" of Joint: **YES**  
 Remarks:

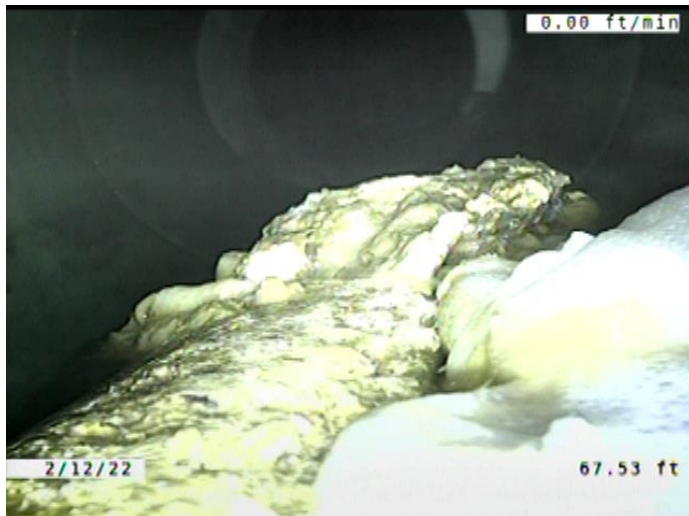
Code: **DAGS**  
 Description: **Deposits Attached Grease**

Distance (ft): **67.5**  
 Structural Grade: **0**  
 O&M Grade: **2**  
 Clock Start/From: **5**  
 Clock To: **7**  
 1st Value:  
 2nd Value:  
 Value Percent: **10.000**  
 Continuous Index:  
 Within 8" of Joint: **YES**  
 Remarks:

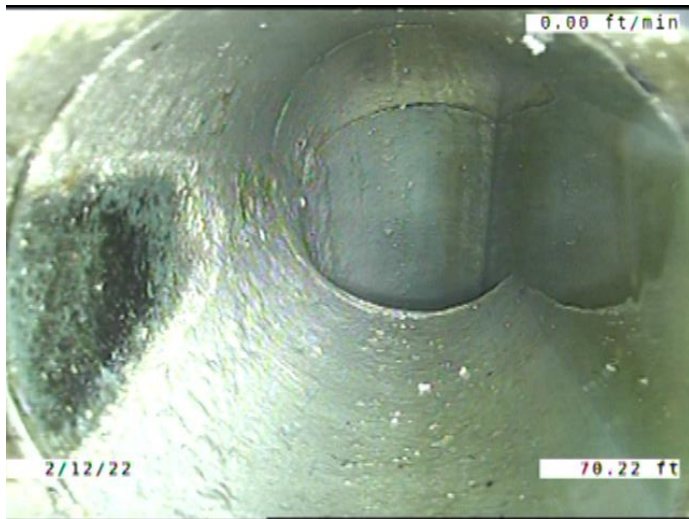
Code: **TFA**  
Description: **Tap Factory Activity**

Distance (ft): **70.2**  
Structural Grade: **0**  
O&M Grade: **0**  
Clock Start/From: **3**  
Clock To:  
1st Value: **4.000**  
2nd Value:  
Value Percent:  
Continuous Index:  
Within 8" of Joint: **YES**  
Remarks:

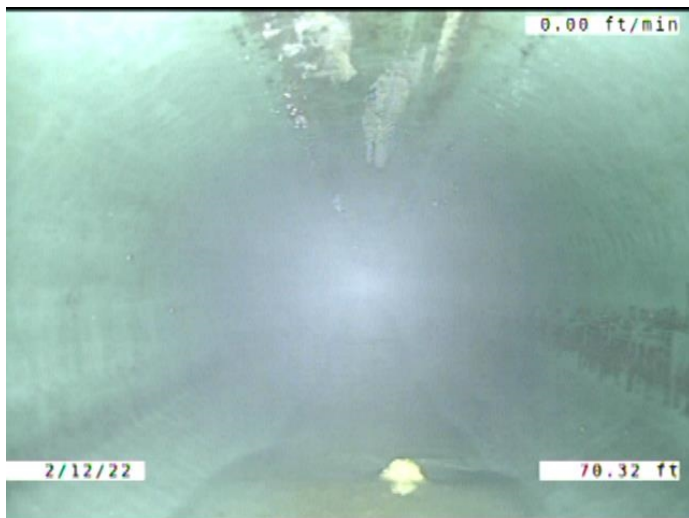
Code: **MWLS**  
Description: **Miscellaneous Water Level Sag**

Distance (ft): **70.3**  
Structural Grade: **2**  
O&M Grade: **0**  
Clock Start/From:  
Clock To:  
1st Value:  
2nd Value:  
Value Percent: **15.000**  
Continuous Index: **F01**  
Within 8" of Joint: **NO**  
Remarks:

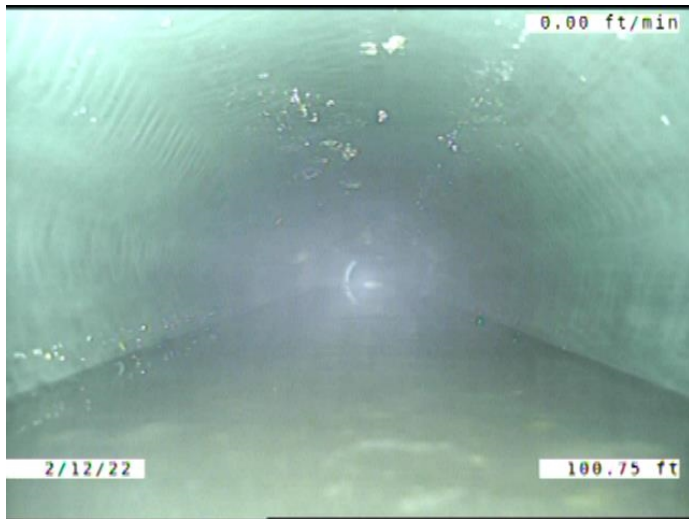
Code: **MWL**  
Description: **Miscellaneous Water Level**

Distance (ft): **100.7**  
Structural Grade: **0**  
O&M Grade: **0**  
Clock Start/From:  
Clock To:  
1st Value:  
2nd Value:  
Value Percent: **20.000**  
Continuous Index:  
Within 8" of Joint: **NO**  
Remarks:

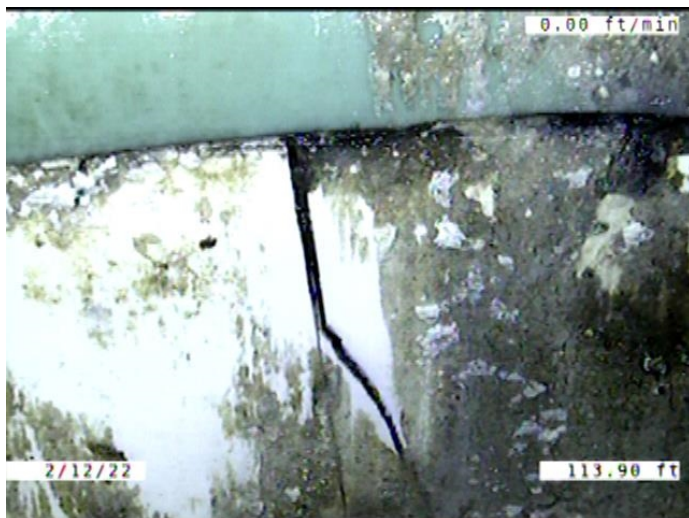
Code: **FM**  
Description: **Fracture Multiple**

Distance (ft): **113.9**  
Structural Grade: **4**  
O&M Grade: **0**  
Clock Start/From: **12**  
Clock To: **1**  
1st Value:  
2nd Value:  
Value Percent:  
Continuous Index:  
Within 8" of Joint: **YES**  
Remarks:

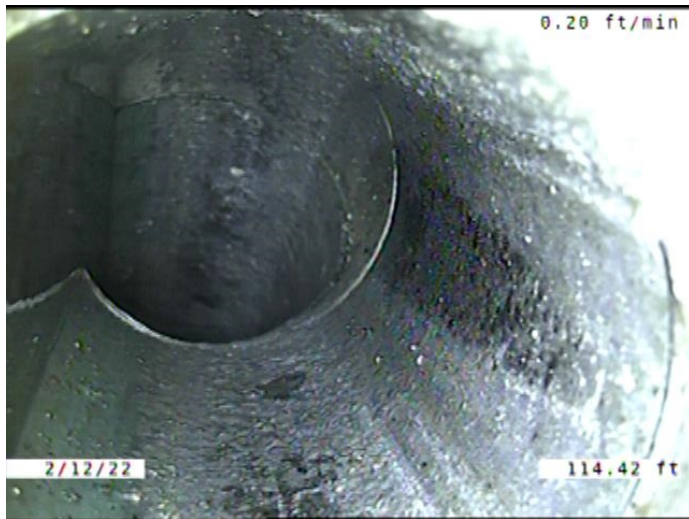
Code: **TF**  
Description: **Tap Factory**

Distance (ft): **114.4**  
Structural Grade: **0**  
O&M Grade: **0**  
Clock Start/From: **9**  
Clock To:  
1st Value: **4.000**  
2nd Value:  
Value Percent:  
Continuous Index:  
Within 8" of Joint: **YES**  
Remarks:

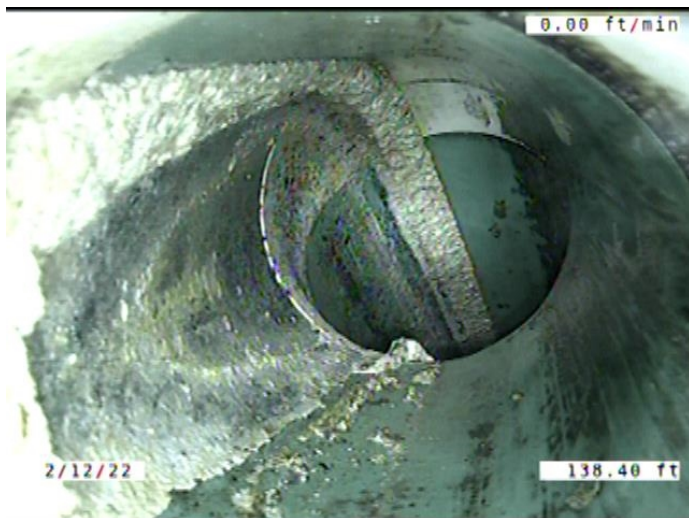
Code: **TF**  
Description: **Tap Factory**

Distance (ft): **138.4**  
Structural Grade: **0**  
O&M Grade: **0**  
Clock Start/From: **2**  
Clock To:  
1st Value: **4.000**  
2nd Value:  
Value Percent:  
Continuous Index:  
Within 8" of Joint: **YES**  
Remarks:

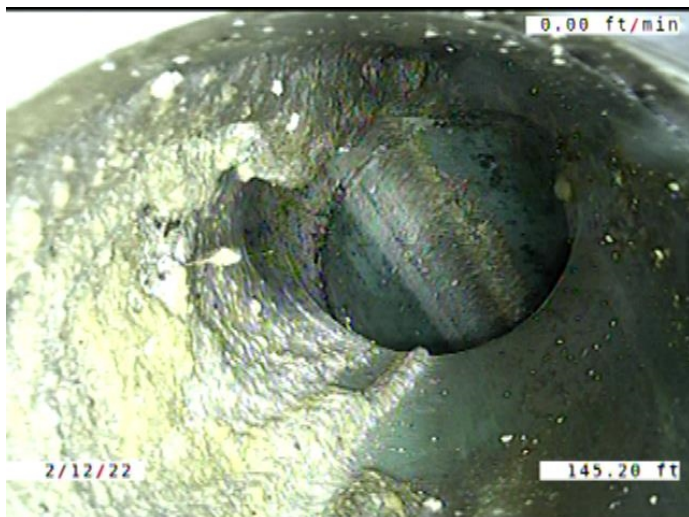
Code: **TB**  
Description: **Tap Break-in/Hammer**

Distance (ft): **145.2**  
Structural Grade: **0**  
O&M Grade: **0**  
Clock Start/From: **2**  
Clock To:  
1st Value: **4.000**  
2nd Value:  
Value Percent:  
Continuous Index:  
Within 8" of Joint: **YES**  
Remarks:

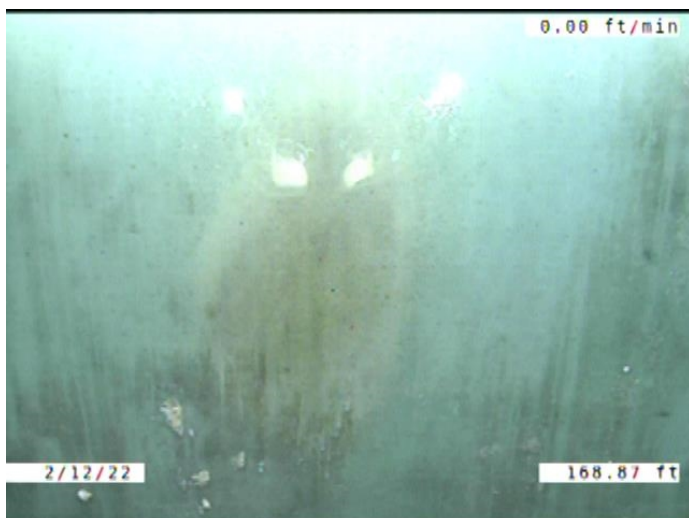
Code: **DFBR**  
Description: **Deformed Flexible Bulging Round**

Distance (ft): **168.9**  
Structural Grade: **3**  
O&M Grade: **0**  
Clock Start/From: **11**  
Clock To: **12**  
1st Value:  
2nd Value:  
Value Percent: **5.000**  
Continuous Index:  
Within 8" of Joint: **NO**  
Remarks:

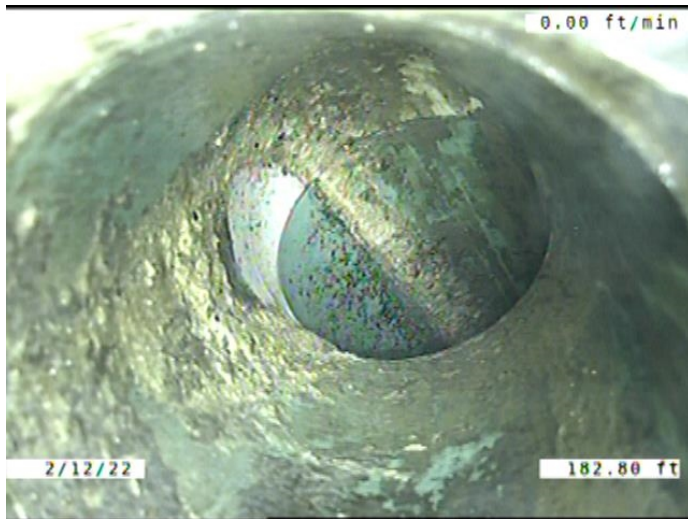
Code: **TFA**  
Description: **Tap Factory Activity**

Distance (ft): **182.8**  
Structural Grade: **0**  
O&M Grade: **0**  
Clock Start/From: **2**  
Clock To:  
1st Value: **4.000**  
2nd Value:  
Value Percent:  
Continuous Index:  
Within 8" of Joint: **YES**  
Remarks:

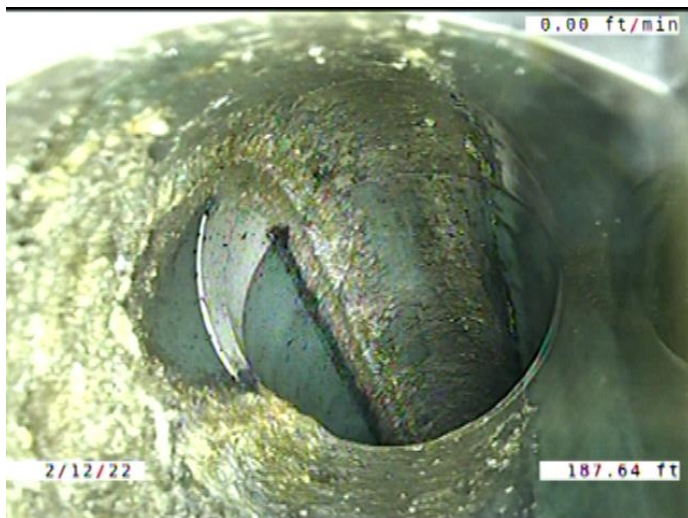
Code: **TF**  
Description: **Tap Factory**

Distance (ft): **187.6**  
Structural Grade: **0**  
O&M Grade: **0**  
Clock Start/From: **3**  
Clock To:  
1st Value: **4.000**  
2nd Value:  
Value Percent:  
Continuous Index:  
Within 8" of Joint: **YES**  
Remarks:

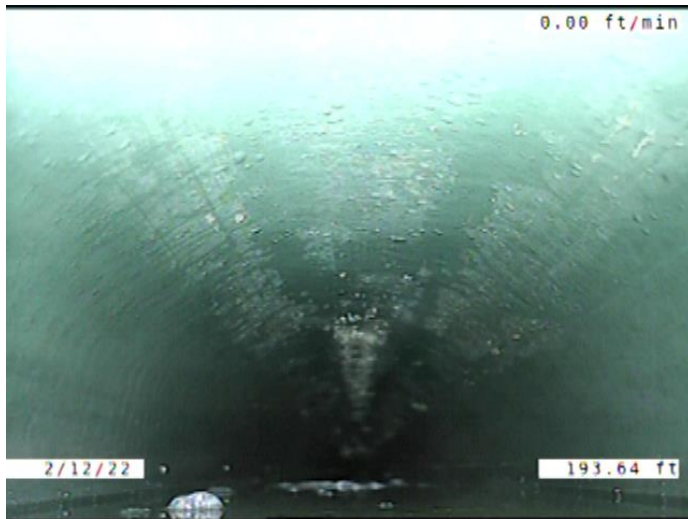
Code: **MWL**  
Description: **Miscellaneous Water Level**

Distance (ft): **193.6**  
Structural Grade: **0**  
O&M Grade: **0**  
Clock Start/From:  
Clock To:  
1st Value:  
2nd Value:  
Value Percent: **30.000**  
Continuous Index:  
Within 8" of Joint: **NO**  
Remarks:

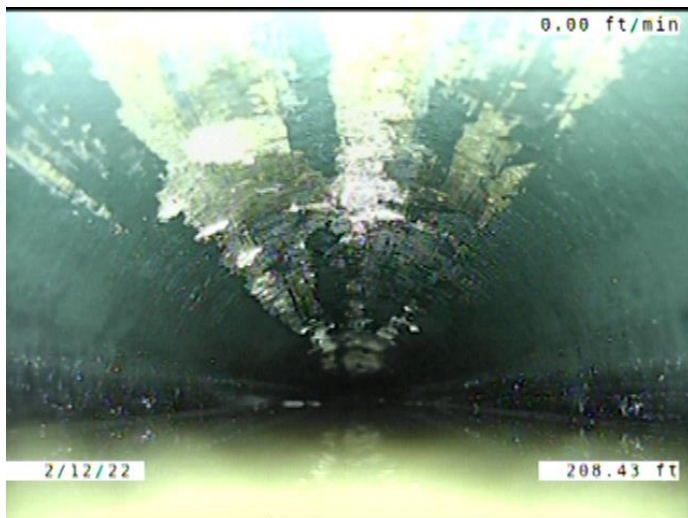
Code: **MGO**  
Description: **Miscellaneous General Observation**

Distance (ft): **208.4**  
Structural Grade: **0**  
O&M Grade: **0**  
Clock Start/From:  
Clock To:  
1st Value:  
2nd Value:  
Value Percent:  
Continuous Index:  
Within 8" of Joint: **NO**  
Remarks: **WATER LEVEL WENT DOWN BECAUSE  
I REMOVED A PAPER JAM IN THE DO**

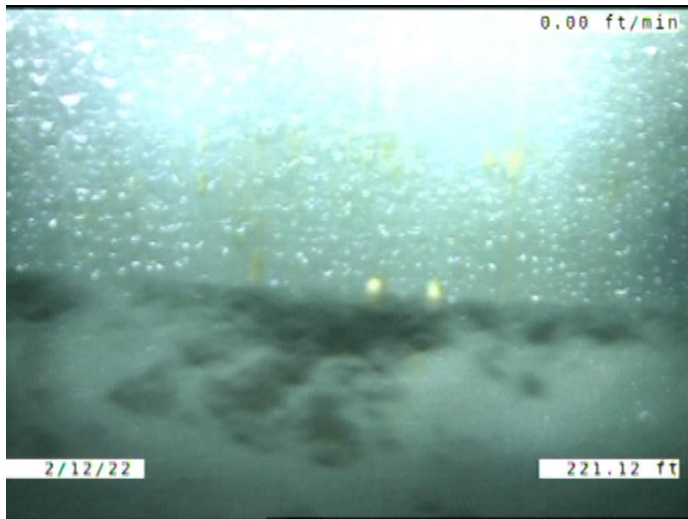
Code: **MWL**  
Description: **Miscellaneous Water Level**

Distance (ft): **221.1**  
Structural Grade: **0**  
O&M Grade: **0**  
Clock Start/From:  
Clock To:  
1st Value:  
2nd Value:  
Value Percent: **45.000**  
Continuous Index:  
Within 8" of Joint: **NO**  
Remarks:

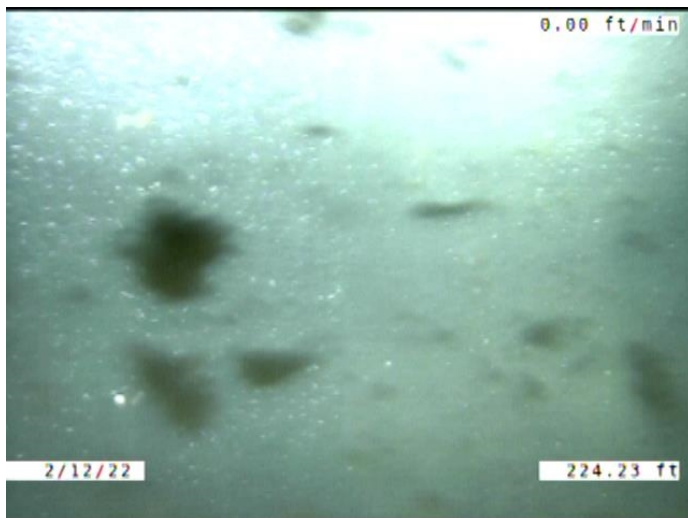
Code: **MCU**  
Description: **Miscellaneous Camera Underwater**

Distance (ft): **224.2**  
Structural Grade: **0**  
O&M Grade: **4**  
Clock Start/From:  
Clock To:  
1st Value:  
2nd Value:  
Value Percent:  
Continuous Index: **S04**  
Within 8" of Joint: **NO**  
Remarks:

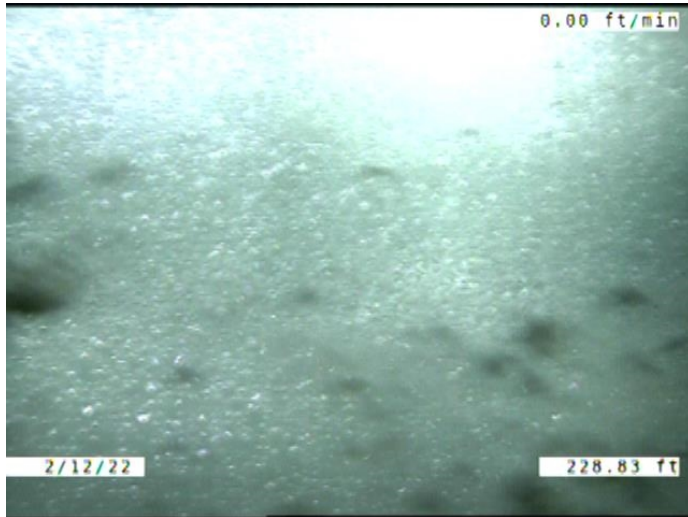
Code: **MGO**  
Description: **Miscellaneous General Observation**

Distance (ft): **228.8**  
Structural Grade: **0**  
O&M Grade: **0**  
Clock Start/From:  
Clock To:  
1st Value:  
2nd Value:  
Value Percent:  
Continuous Index:  
Within 8" of Joint: **NO**  
Remarks: **3% INCLINE IN THE PIPE AT THIS POINT**

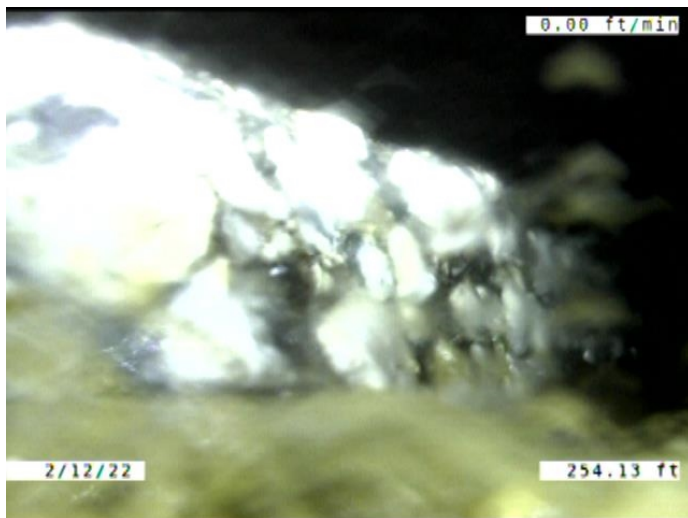
Code: **DAGS**  
Description: **Deposits Attached Grease**

Distance (ft): **254.1**  
Structural Grade: **0**  
O&M Grade: **2**  
Clock Start/From: **11**  
Clock To: **1**  
1st Value:  
2nd Value:  
Value Percent: **5.000**  
Continuous Index: **F03**  
Within 8" of Joint: **YES**  
Remarks:

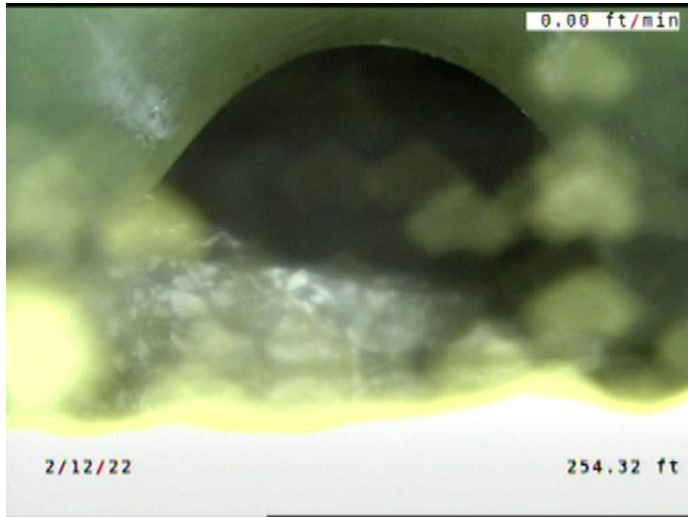
Code: **MGO**  
Description: **Miscellaneous General Observation**

Distance (ft): **254.3**  
Structural Grade: **0**  
O&M Grade: **0**  
Clock Start/From:  
Clock To:  
1st Value:  
2nd Value:  
Value Percent:  
Continuous Index:  
Within 8" of Joint: **NO**  
Remarks: **PIPE DOES NOT ENTER THE  
DOWNSTREAM MANHOLE AT THE RI**

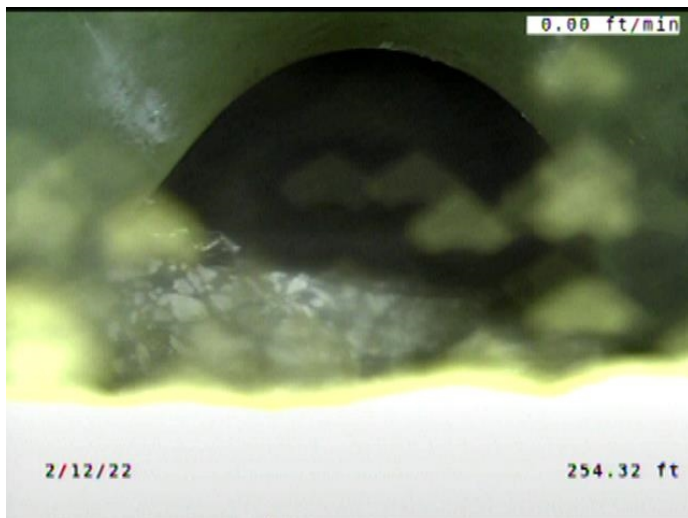
Code: **MGO**  
Description: **Miscellaneous General Observation**

Distance (ft): **254.3**  
Structural Grade: **0**  
O&M Grade: **0**  
Clock Start/From:  
Clock To:  
1st Value:  
2nd Value:  
Value Percent:  
Continuous Index:  
Within 8" of Joint: **NO**  
Remarks: **PIPE HAS AN INCLINE OF 0.5% TO 3%  
FROM 228.8' TO THE DOWNSTREAM**

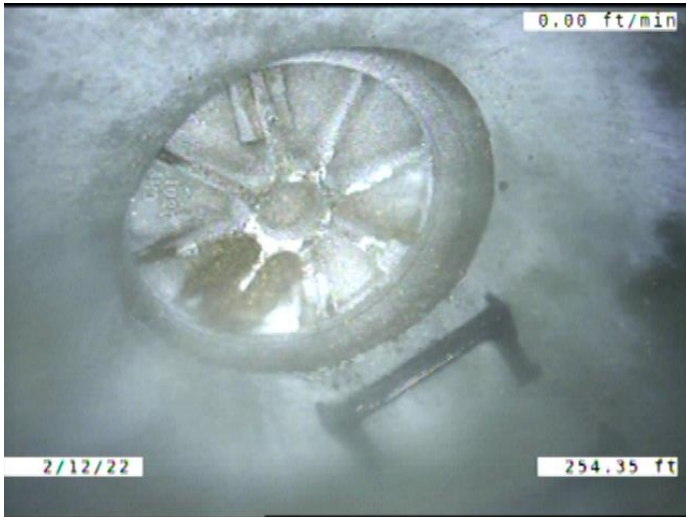
Code:	AMH
Description:	Manhole
Distance (ft):	254.4
Structural Grade:	0
O&M Grade:	0
Clock Start/From:	
Clock To:	
1st Value:	
2nd Value:	
Value Percent:	
Continuous Index:	
Within 8" of Joint:	NO
Remarks:	M-706-052
