Profile/Photo Observation Report

Street:	FLEMING ST & BEACON DR	Flow Control:	Not Controlled
City:	Hobart, IN	Year Renewed:	
Location:	Light Highway	Tape/Media #:	
Purpose:	Maintenance Related	Dia/Height:	8"
Use:	Sanitary	Material:	PVC
Drain Area:	NA	Lining:	Cured in Place
Category:	NA		
Comment:	mh confirmed by wheel, heavy soft debris in line, DS bell blocked by debris.		
Location Details:		Direction of Survey:	Downstream
US MH:	M-706-052	DS MH:	M-706-056
		Total Length Surveyed (ft):	119.3

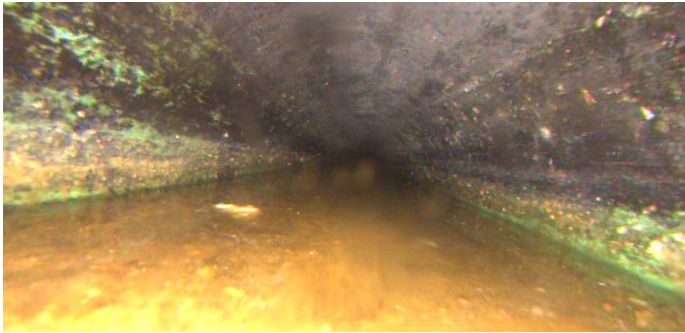
Code:	MWL
Description:	Water Level

Distance (ft):	.0
Structural Grade:	0
O&M Grade:	0
Clock Start/From:	
Clock To:	
1st Value:	
2nd Value:	
Value Percent:	40.000
Continuous Index:	
Within 8" of Joint:	NO
Remarks:

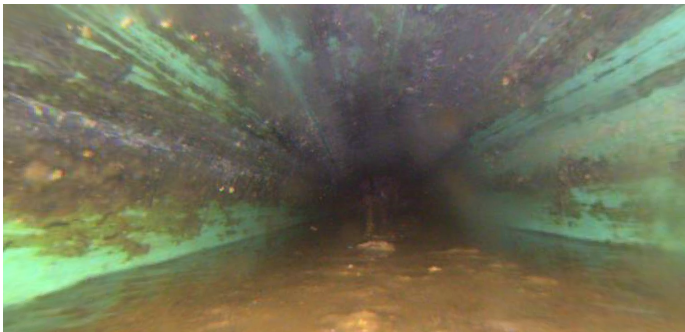
Code:	MGO
Description:	General Observation

Distance (ft):	4.7
Structural Grade:	0
O&M Grade:	0
Clock Start/From:	
Clock To:	
1st Value:	
2nd Value:	
Value Percent:	
Continuous Index:	
Within 8" of Joint:	NO
Remarks:	rear camera

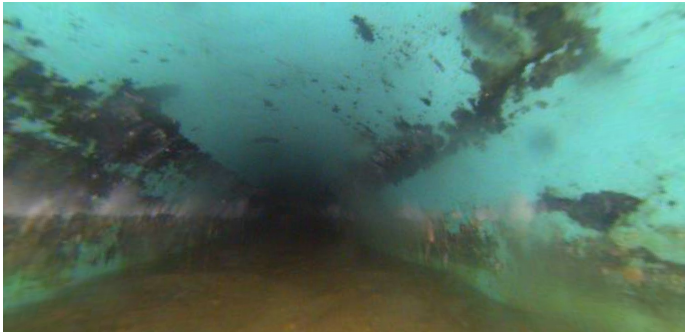
Code: **DAGS**
Description: **Deposits Attached Grease**

Distance (ft): **22.0**
Structural Grade: **0**
O&M Grade: **2**
Clock Start/From: **8**
Clock To: **4**
1st Value:
2nd Value:
Value Percent: **5.000**
Continuous Index: **S01**
Within 8" of Joint: **NO**
Remarks:

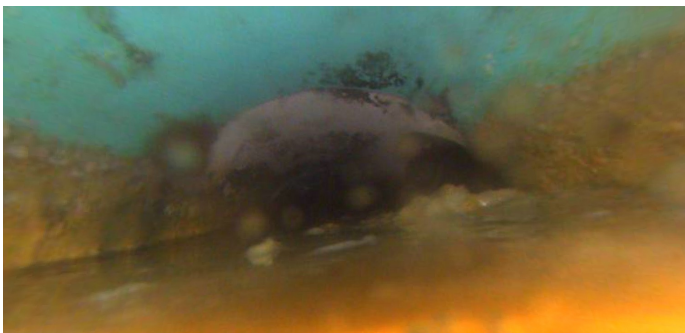
Code: **TFA**
Description: **Tap Factory Active**

Distance (ft): **52.4**
Structural Grade: **0**
O&M Grade: **0**
Clock Start/From: **9**
Clock To:
1st Value: **4.000**
2nd Value:
Value Percent:
Continuous Index:
Within 8" of Joint:
Remarks:

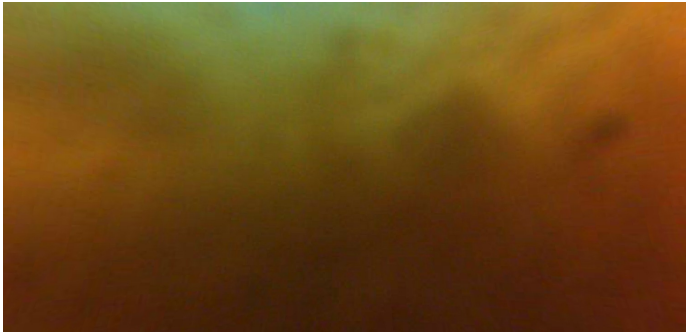
Code: **DAGS**
Description: **Deposits Attached Grease**

Distance (ft): **62.6**
Structural Grade: **0**
O&M Grade: **2**
Clock Start/From: **8**
Clock To: **4**
1st Value:
2nd Value:
Value Percent: **5.000**
Continuous Index: **F01**
Within 8" of Joint: **NO**
Remarks:

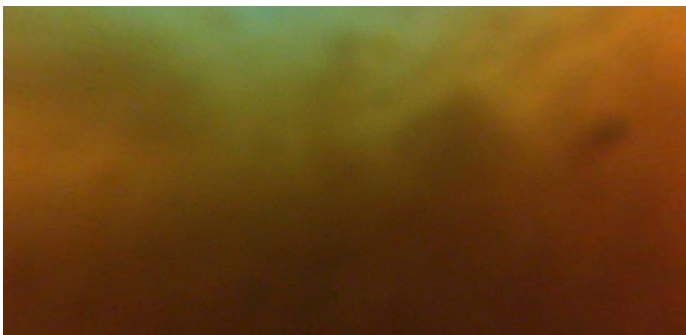
Code: **MCU**
Description: **Camera Underwater**

Distance (ft): **62.6**
Structural Grade: **0**
O&M Grade: **4**
Clock Start/From:
Clock To:
1st Value:
2nd Value:
Value Percent:
Continuous Index: **S02**
Within 8" of Joint: **NO**
Remarks:
