Profile/Photo Observation Report

Date:	04/14/2018	Weather:		Coding:	PACP 6.0
Pipe Length (ft):	123.8	Owner:	NA	Pre Clean:	Not Known
P.O.#:		Surveyor:	Jen Costello	PSR:	P-706-052-056
Customer:		Clean Date:	01/01/1900	Shape:	C

Street:	Capitol	Flow Control:	Not Controlled
City:	Hobart, IN	Year Renewed:	
Location:	Light Highway	Tape/Media #:	
Purpose:	Maintenance Related	Dia/Height:	8"
Use:	Sanitary	Material:	PVC
Drain Area:	NA	Lining:	Cured in Place
Category:	NA		
Comment:	mh confirmed by wheel, heavy soft debris in line, DS bell blocked by debris.		
Location Details:		Direction of Survey:	Downstream
US MH:	M-706-052	DS MH:	M-706-056
		Total Length Surveyed (ft):	119.3

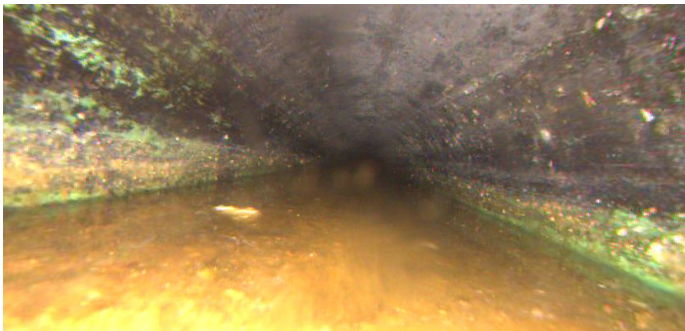
Code: **AMH**
Description: **Manhole**

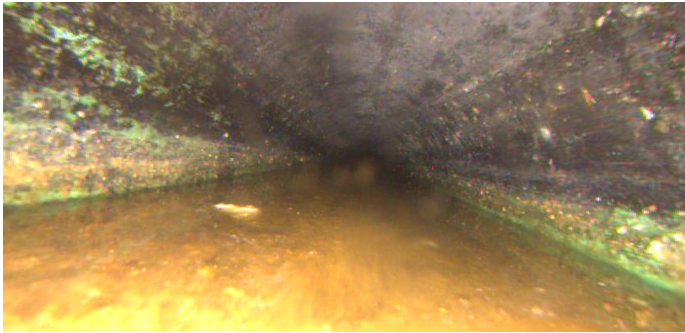
Code:	MWL
Description:	Water Level

Distance (ft):	.0
Structural Grade:	0
O&M Grade:	0
Clock Start/From:	
Clock To:	
1st Value:	
2nd Value:	
Value Percent:	40.000
Continuous Index:	
Within 8" of Joint:	NO
Remarks:

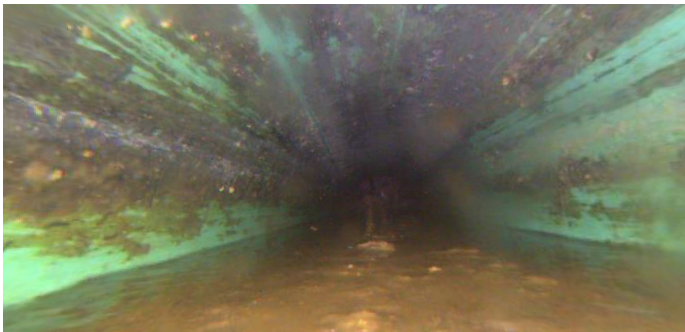
Code:	MGO
Description:	General Observation

Distance (ft):	4.7
Structural Grade:	0
O&M Grade:	0
Clock Start/From:	
Clock To:	
1st Value:	
2nd Value:	
Value Percent:	
Continuous Index:	
Within 8" of Joint:	NO
Remarks:	rear camera

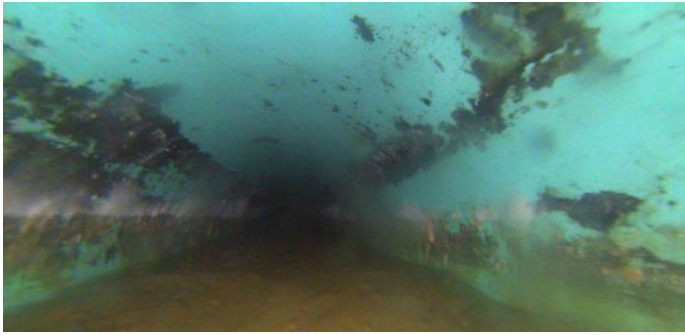
Code: **DAGS**
Description: **Deposits Attached Grease**

Distance (ft): **22.0**
Structural Grade: **0**
O&M Grade: **2**
Clock Start/From: **8**
Clock To: **4**
1st Value:
2nd Value:
Value Percent: **5.000**
Continuous Index: **S01**
Within 8" of Joint: **NO**
Remarks:

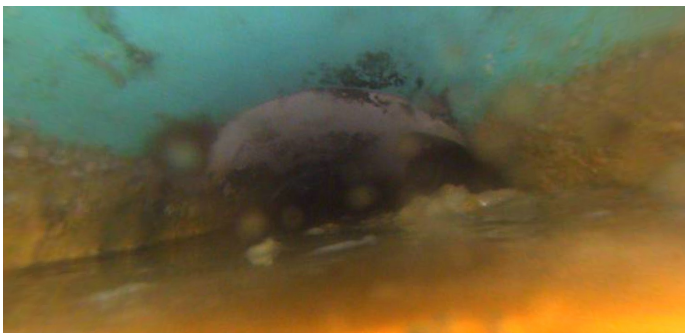
Code: **TFA**
Description: **Tap Factory Active**

Distance (ft): **52.4**
Structural Grade: **0**
O&M Grade: **0**
Clock Start/From: **9**
Clock To:
1st Value: **4.000**
2nd Value:
Value Percent:
Continuous Index:
Within 8" of Joint:
Remarks:

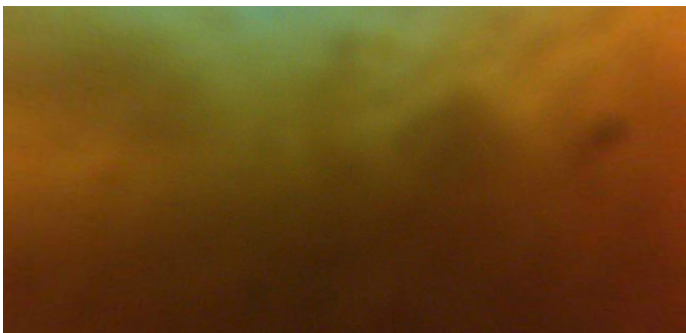
Code: **MCU**
Description: **Camera Underwater**

Distance (ft): **62.6**
Structural Grade: **0**
O&M Grade: **4**
Clock Start/From:
Clock To:
1st Value:
2nd Value:
Value Percent:
Continuous Index: **S02**
Within 8" of Joint: **NO**
Remarks:
