Profile/Photo Observation Report

Street:	FLEMING ST & BEACON DR	Flow Control:	Not Controlled
City:	Hobart, IN	Year Renewed:	
Location:	Light Highway	Tape/Media #:	
Purpose:	Maintenance Related	Dia/Height:	8"
Use:	Sanitary	Material:	PVC
Drain Area:	NA	Lining:	Cured in Place
Category:	NA		
Comment:

Location Details:		Direction of Survey:	Upstream
US MH:	M-706-054	DS MH:	M-706-055
		Total Length Surveyed (ft):	180.9

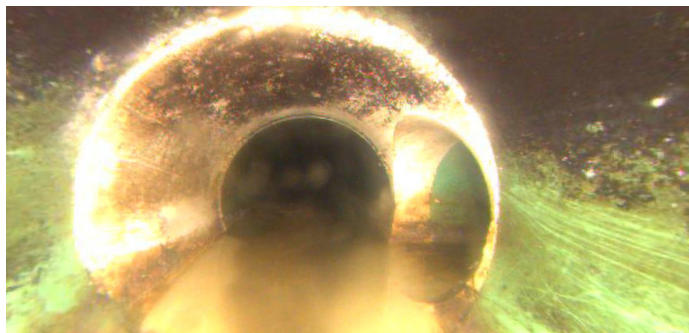
Code: **AMH**
 Description: **Manhole**

Distance (ft): **.0**
 Structural Grade: **0**
 O&M Grade: **0**
 Clock Start/From:
 Clock To:
 1st Value:
 2nd Value:
 Value Percent:
 Continuous Index:
 Within 8" of Joint: **NO**
 Remarks: **M-706-055**

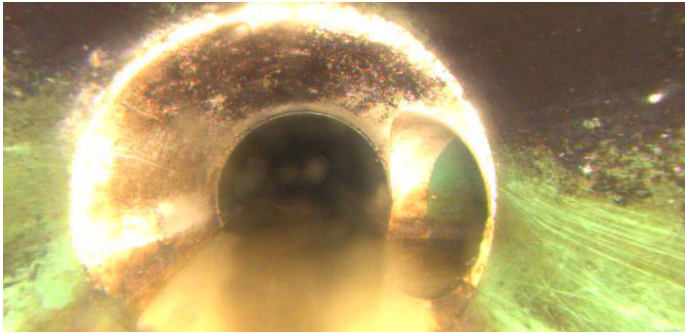
Code:	MWL
Description:	Water Level

Distance (ft):	.0
Structural Grade:	0
O&M Grade:	0
Clock Start/From:	
Clock To:	
1st Value:	
2nd Value:	
Value Percent:	10.000
Continuous Index:	
Within 8" of Joint:	NO
Remarks:

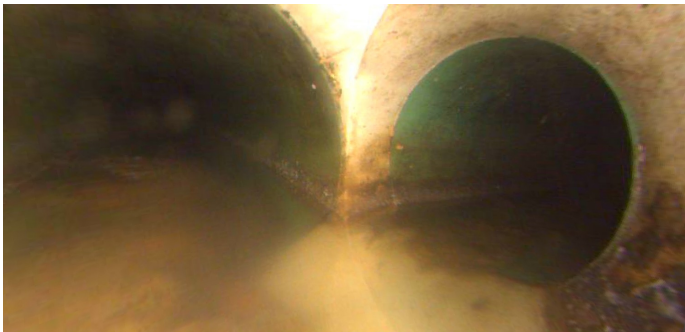
Code:	TFA
Description:	Tap Factory Active

Distance (ft):	.8
Structural Grade:	0
O&M Grade:	0
Clock Start/From:	3
Clock To:	
1st Value:	4.000
2nd Value:	
Value Percent:	
Continuous Index:	
Within 8" of Joint:	
Remarks:

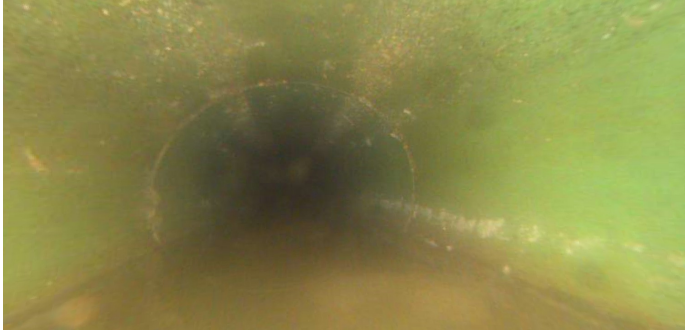
Code: **MWL**
Description: **Water Level**

Distance (ft): **27.4**
Structural Grade: **0**
O&M Grade: **0**
Clock Start/From:
Clock To:
1st Value:
2nd Value:
Value Percent: **30.000**
Continuous Index:
Within 8" of Joint: **NO**
Remarks:

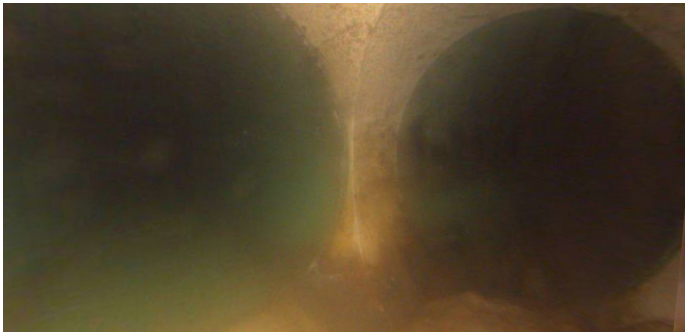
Code: **TFA**
Description: **Tap Factory Active**

Distance (ft): **34.4**
Structural Grade: **0**
O&M Grade: **0**
Clock Start/From: **3**
Clock To:
1st Value: **4.000**
2nd Value:
Value Percent:
Continuous Index:
Within 8" of Joint:
Remarks:

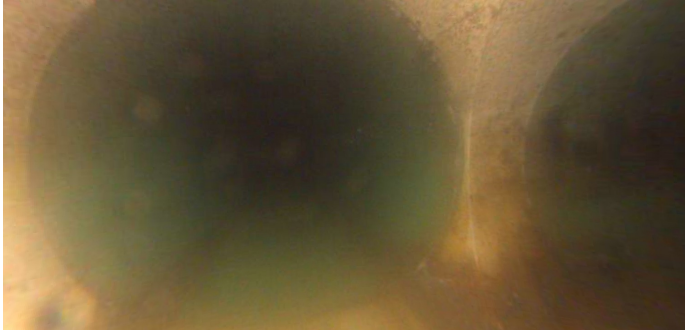
Code: **MWL**
Description: **Water Level**

Distance (ft): **34.4**
Structural Grade: **0**
O&M Grade: **0**
Clock Start/From:
Clock To:
1st Value:
2nd Value:
Value Percent: **5.000**
Continuous Index:
Within 8" of Joint: **NO**
Remarks:

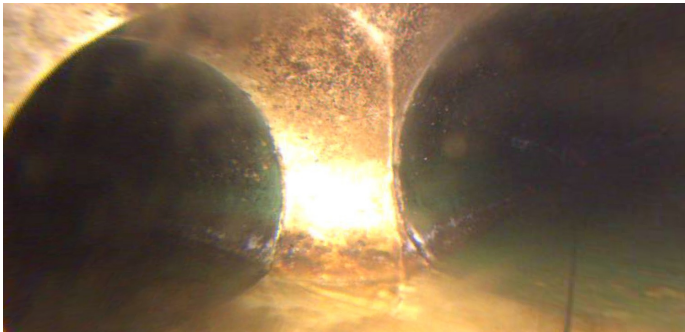
Code: **TFA**
Description: **Tap Factory Active**

Distance (ft): **41.5**
Structural Grade: **0**
O&M Grade: **0**
Clock Start/From: **3**
Clock To:
1st Value: **4.000**
2nd Value:
Value Percent:
Continuous Index:
Within 8" of Joint:
Remarks:

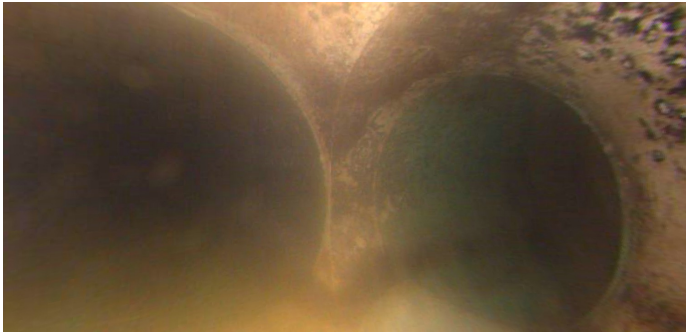
Code: **TF**
Description: **Tap Factory**

Distance (ft): **65.3**
Structural Grade: **0**
O&M Grade: **0**
Clock Start/From: **3**
Clock To:
1st Value: **4.000**
2nd Value:
Value Percent:
Continuous Index:
Within 8" of Joint:
Remarks:

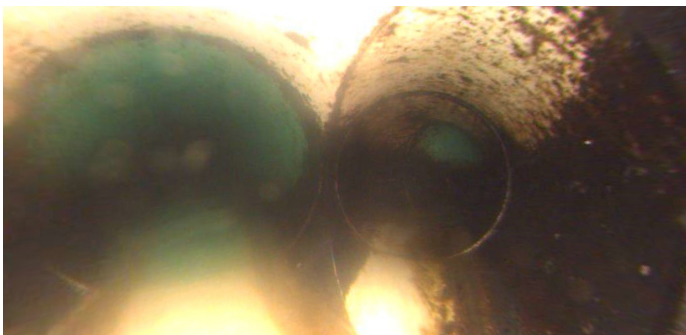
Code: **TFA**
Description: **Tap Factory Active**

Distance (ft): **139.5**
Structural Grade: **0**
O&M Grade: **0**
Clock Start/From: **3**
Clock To:
1st Value: **4.000**
2nd Value:
Value Percent:
Continuous Index:
Within 8" of Joint:
Remarks:

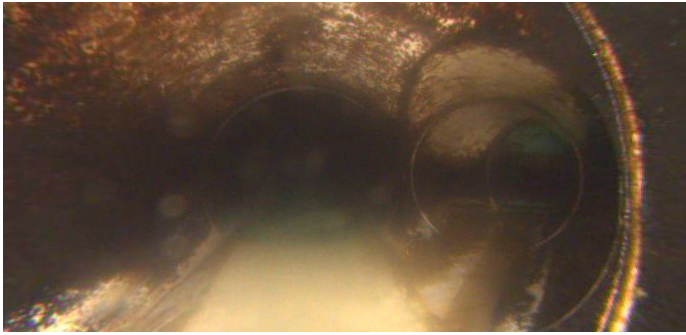
Code: **TFA**
Description: **Tap Factory Active**

Distance (ft): **142.1**
Structural Grade: **0**
O&M Grade: **0**
Clock Start/From: **3**
Clock To:
1st Value: **4.000**
2nd Value:
Value Percent:
Continuous Index:
Within 8" of Joint:
Remarks:

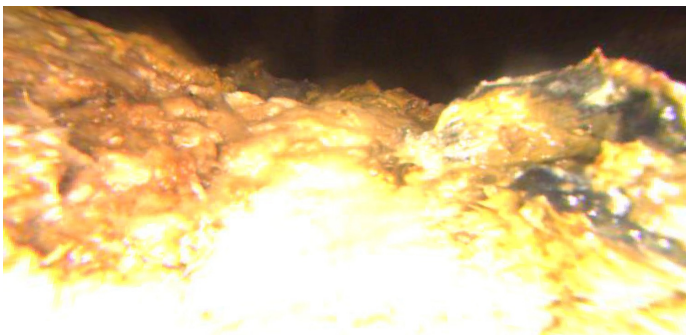
Code: **AMH**
Description: **Manhole**

Distance (ft): **180.9**
Structural Grade: **0**
O&M Grade: **0**
Clock Start/From:
Clock To:
1st Value:
2nd Value:
Value Percent:
Continuous Index:
Within 8" of Joint: **NO**
Remarks: **M-706-054**
