Profile/Photo Observation Report

Date:	04/15/2018	Weather:		Coding:	PACP 6.0
Pipe Length (ft):	269.4	Owner:	NA	Pre Clean:	Not Known
P.O.#:		Surveyor:	Selasie Honu	PSR:	P-706-057-027
Customer:		Clean Date:	01/01/1900	Shape:	C

Street:	Capitol	Flow Control:	Not Controlled
City:	Hobart, IN	Year Renewed:	
Location:	Light Highway	Tape/Media #:	
Purpose:	Maintenance Related	Dia/Height:	10"
Use:	Sanitary	Material:	PVC
Drain Area:	NA	Lining:	Cured in Place
Category:	NA		
Comment:

Location Details:		Direction of Survey:	Downstream
US MH:	M-706-057	DS MH:	M-606-027
		Total Length Surveyed (ft):	274.3

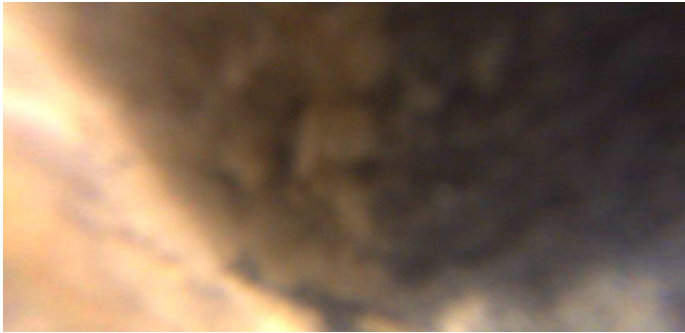
Code:	MWL
Description:	Water Level

Distance (ft):	.0
Structural Grade:	0
O&M Grade:	0
Clock Start/From:	
Clock To:	
1st Value:	
2nd Value:	
Value Percent:	5.000
Continuous Index:	
Within 8" of Joint:	NO
Remarks:

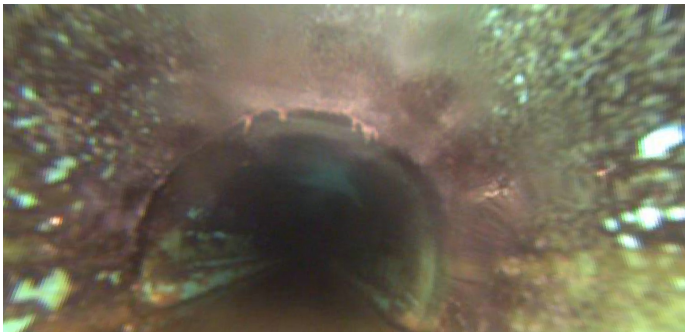
Code:	RFJ
Description:	Roots Fine Joint

Distance (ft):	88.9
Structural Grade:	0
O&M Grade:	1
Clock Start/From:	11
Clock To:	1
1st Value:	
2nd Value:	
Value Percent:	
Continuous Index:	
Within 8" of Joint:	YES
Remarks:

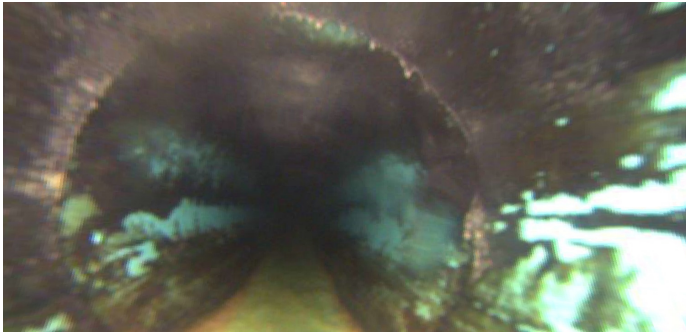
Code: **RFJ**
Description: **Roots Fine Joint**

Distance (ft): **115.5**
Structural Grade: **0**
O&M Grade: **1**
Clock Start/From: **9**
Clock To: **4**
1st Value:
2nd Value:
Value Percent:
Continuous Index:
Within 8" of Joint: **YES**
Remarks:

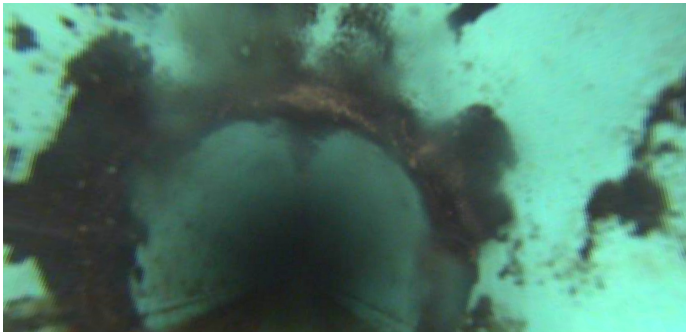
Code: **RFJ**
Description: **Roots Fine Joint**

Distance (ft): **128.6**
Structural Grade: **0**
O&M Grade: **1**
Clock Start/From: **12**
Clock To: **1**
1st Value:
2nd Value:
Value Percent:
Continuous Index:
Within 8" of Joint: **YES**
Remarks:

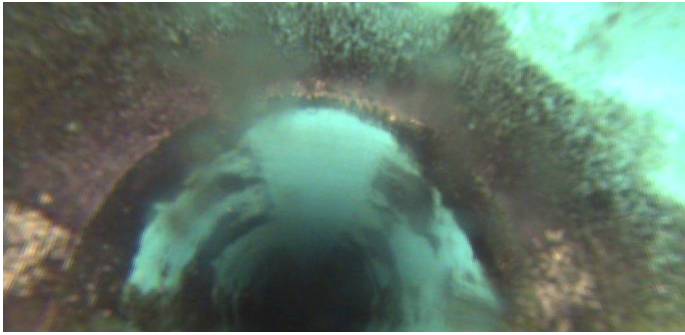
Code: **RFJ**
Description: **Roots Fine Joint**

Distance (ft): **233.5**
Structural Grade: **0**
O&M Grade: **1**
Clock Start/From: **12**
Clock To: **1**
1st Value:
2nd Value:
Value Percent:
Continuous Index:
Within 8" of Joint: **YES**
Remarks:

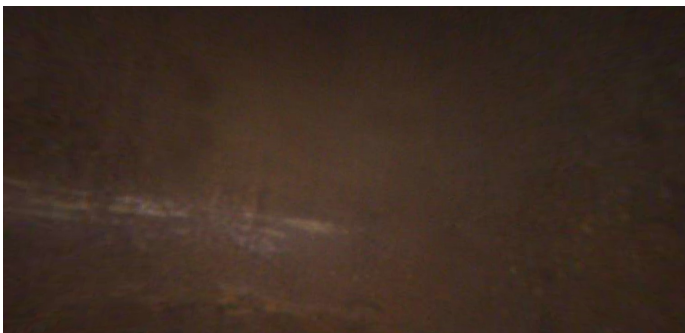
Code: **AMH**
Description: **Manhole**

Distance (ft): **274.3**
Structural Grade: **0**
O&M Grade: **0**
Clock Start/From:
Clock To:
1st Value:
2nd Value:
Value Percent:
Continuous Index:
Within 8" of Joint: **NO**
Remarks: **M-606-027**
