Profile/Photo Observation Report

Street:	PAULA CT & DEBIE LN	Flow Control:	Not Controlled
City:	Hobart, IN	Year Renewed:	
Location:	Light Highway	Tape/Media #:	
Purpose:	Maintenance Related	Dia/Height:	8"
Use:	Sanitary	Material:	PVC
Drain Area:	NA	Lining:	Cured in Place
Category:	NA		
Comment:	mh confirmed, flow incorrect.

Location Details:		Direction of Survey:	Downstream
US MH:	M-706-059	DS MH:	M-706-068
		Total Length Surveyed (ft):	100.4

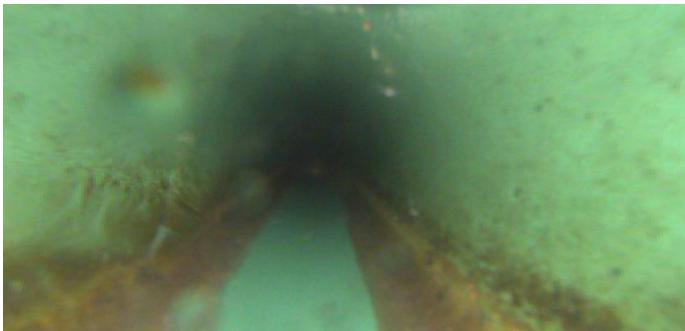
Code: **AMH**
Description: **Manhole**

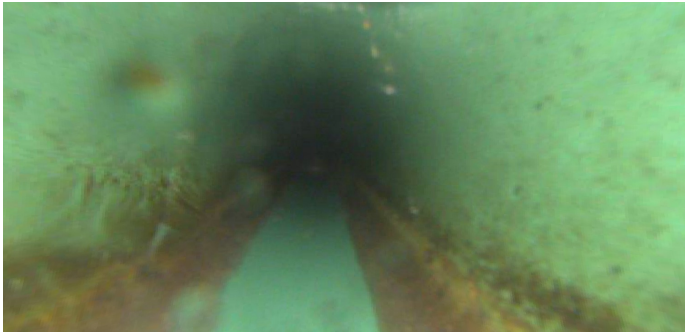
Code:	MWL
Description:	Water Level

Distance (ft):	.0
Structural Grade:	0
O&M Grade:	0
Clock Start/From:	
Clock To:	
1st Value:	
2nd Value:	
Value Percent:	5.000
Continuous Index:	
Within 8" of Joint:	NO
Remarks:

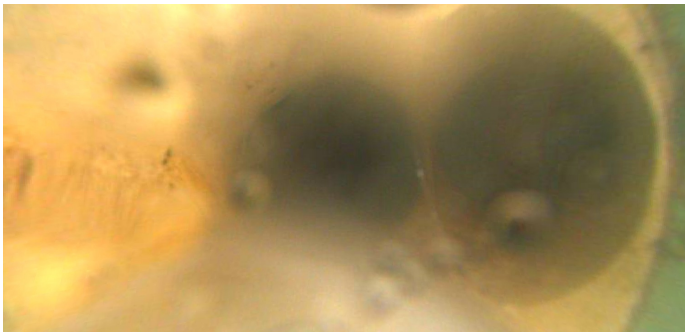
Code:	TFA
Description:	Tap Factory Active

Distance (ft):	38.4
Structural Grade:	0
O&M Grade:	0
Clock Start/From:	3
Clock To:	
1st Value:	4.000
2nd Value:	
Value Percent:	
Continuous Index:	
Within 8" of Joint:	
Remarks:

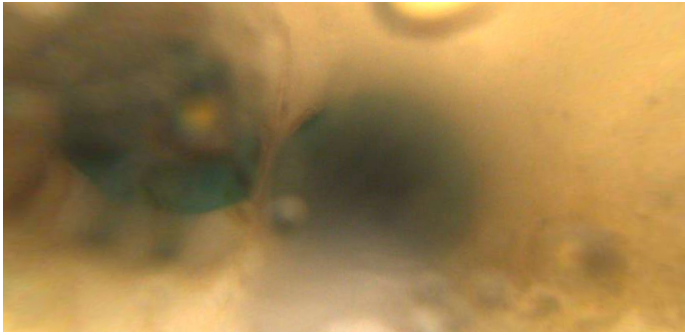
Code: **TFA**
Description: **Tap Factory Active**

Distance (ft): **41.3**
Structural Grade: **0**
O&M Grade: **0**
Clock Start/From: **9**
Clock To:
1st Value: **4.000**
2nd Value:
Value Percent:
Continuous Index:
Within 8" of Joint:
Remarks:

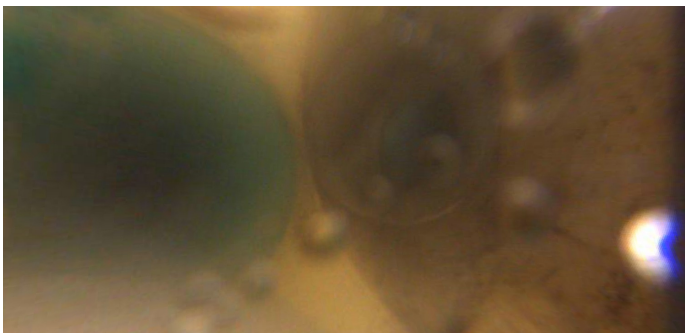
Code: **TF**
Description: **Tap Factory**

Distance (ft): **58.2**
Structural Grade: **0**
O&M Grade: **0**
Clock Start/From: **3**
Clock To:
1st Value: **4.000**
2nd Value:
Value Percent:
Continuous Index:
Within 8" of Joint:
Remarks:

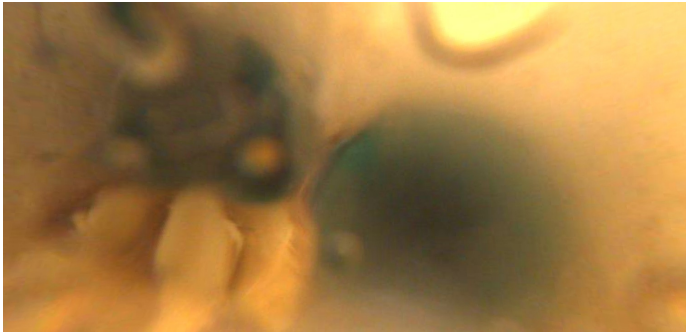
Code: **TF**
Description: **Tap Factory**

Distance (ft): **60.9**
Structural Grade: **0**
O&M Grade: **0**
Clock Start/From: **10**
Clock To:
1st Value: **4.000**
2nd Value:
Value Percent:
Continuous Index:
Within 8" of Joint:
Remarks:

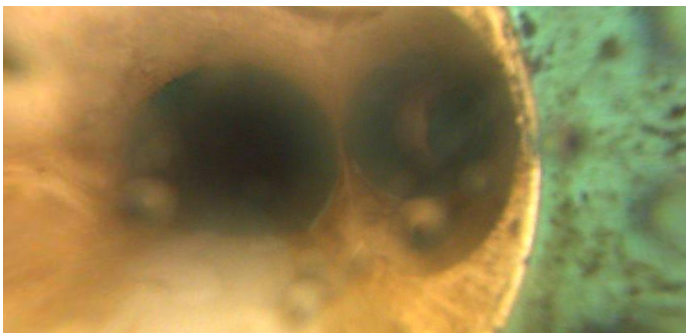
Code: **TF**
Description: **Tap Factory**

Distance (ft): **85.9**
Structural Grade: **0**
O&M Grade: **0**
Clock Start/From: **3**
Clock To:
1st Value: **4.000**
2nd Value:
Value Percent:
Continuous Index:
Within 8" of Joint:
Remarks:

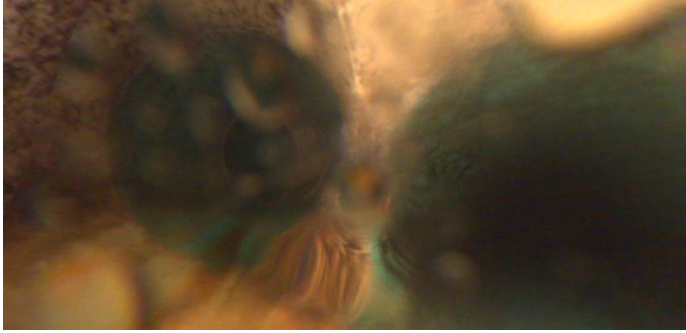
Code: **TF**
Description: **Tap Factory**

Distance (ft): **89.2**
Structural Grade: **0**
O&M Grade: **0**
Clock Start/From: **9**
Clock To:
1st Value: **4.000**
2nd Value:
Value Percent:
Continuous Index:
Within 8" of Joint:
Remarks:
